**Hallroyd Homes Limited**

**Barnsley Road  
Silkstone**

**Highway Condition Report**

| Report Ref: | 10985/PT/001/01 | May 2019 | | |

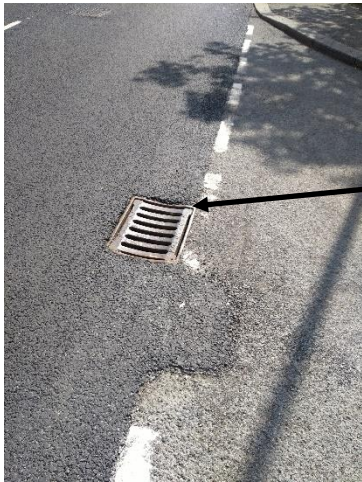
Image 1

There is a minor issue at the tie in to Vicarage Farm Court whereby the surfacing around an existing gully grate is beginning to break away and is slightly higher than the grate, images 1 & 2 in Appendix C show.

Minor damage around gully grate

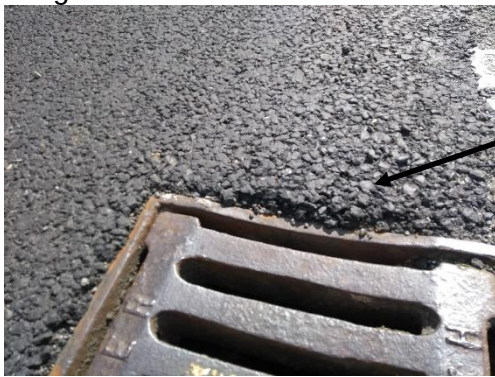
Image 2

Minor damage around gully grate

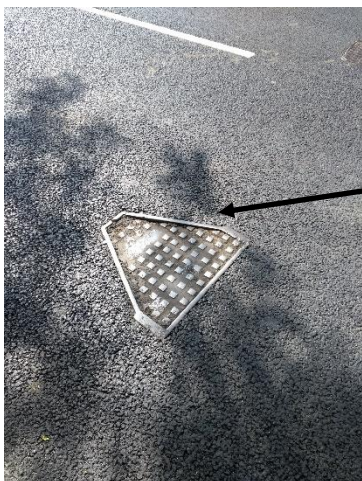
Image 3

There was a manhole at approximate chainage 55m whereby the cover lid is sunken below the level of the surfacing as shown in image 3 in Appendix C

Manhole cover lid slightly sunken

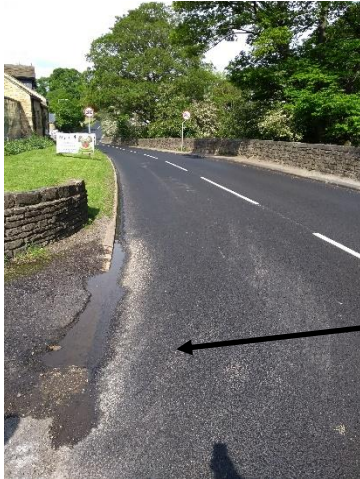
Image 4

There was water observed running in the channel which appears to originate from a local access to a warehouse, although this was only running slowly it has the potential to cause damage if allowed to continue. Images 4 – 6 show the location of this issue.

Water leak ponding and running down channel

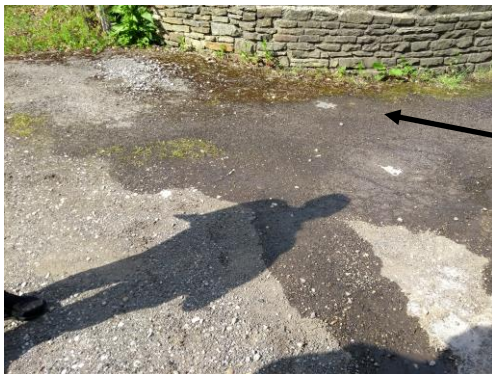
Image 5

Water origin

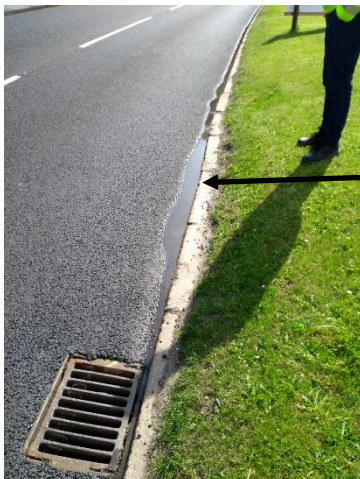
Image 6

Water running in channel
