A Refurbishment and Demolition Asbestos Survey  
The Butchers  
Sheffield Road  
Penistone  
S36 6HH

Survey Date: 7<sup>th</sup> March 2014

- A survey Refurbishment and Demolition –Sampling and identification survey was carried out on the site, the purpose being to identify any asbestos containing materials (ACMs) and to keep a copy of the findings for future references.

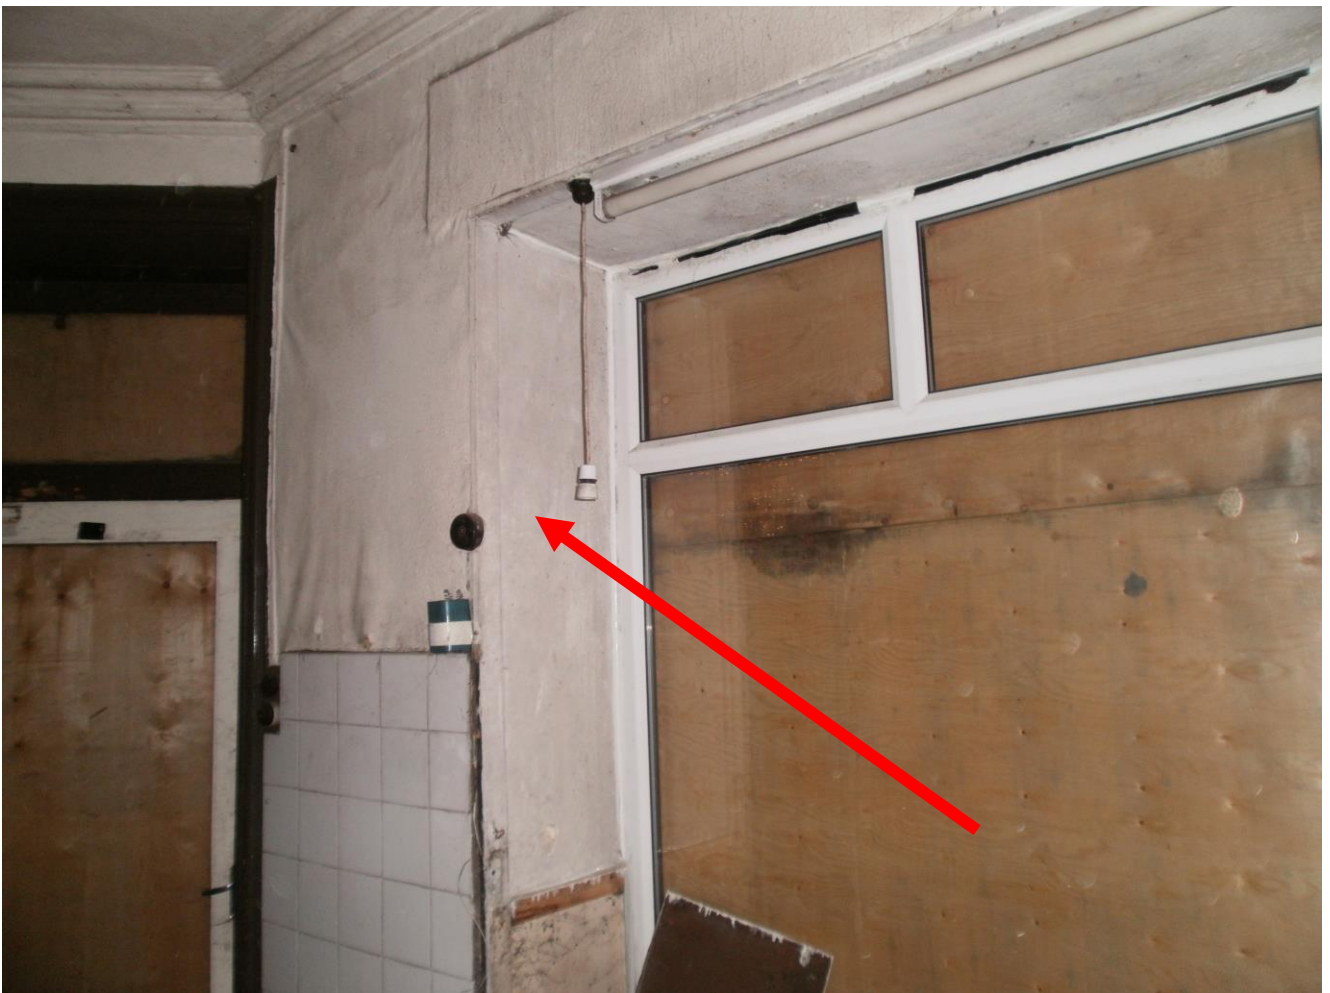
Location – Ground floor main building	Material Assessment Score = 2
Photo Number = 2892	Risk = Low risk

Sample Location:	Panels to butches shop front window
Sample Reference:	Sample 2
Result:	Chrysotile
Recommendations:	Programme for planned removal

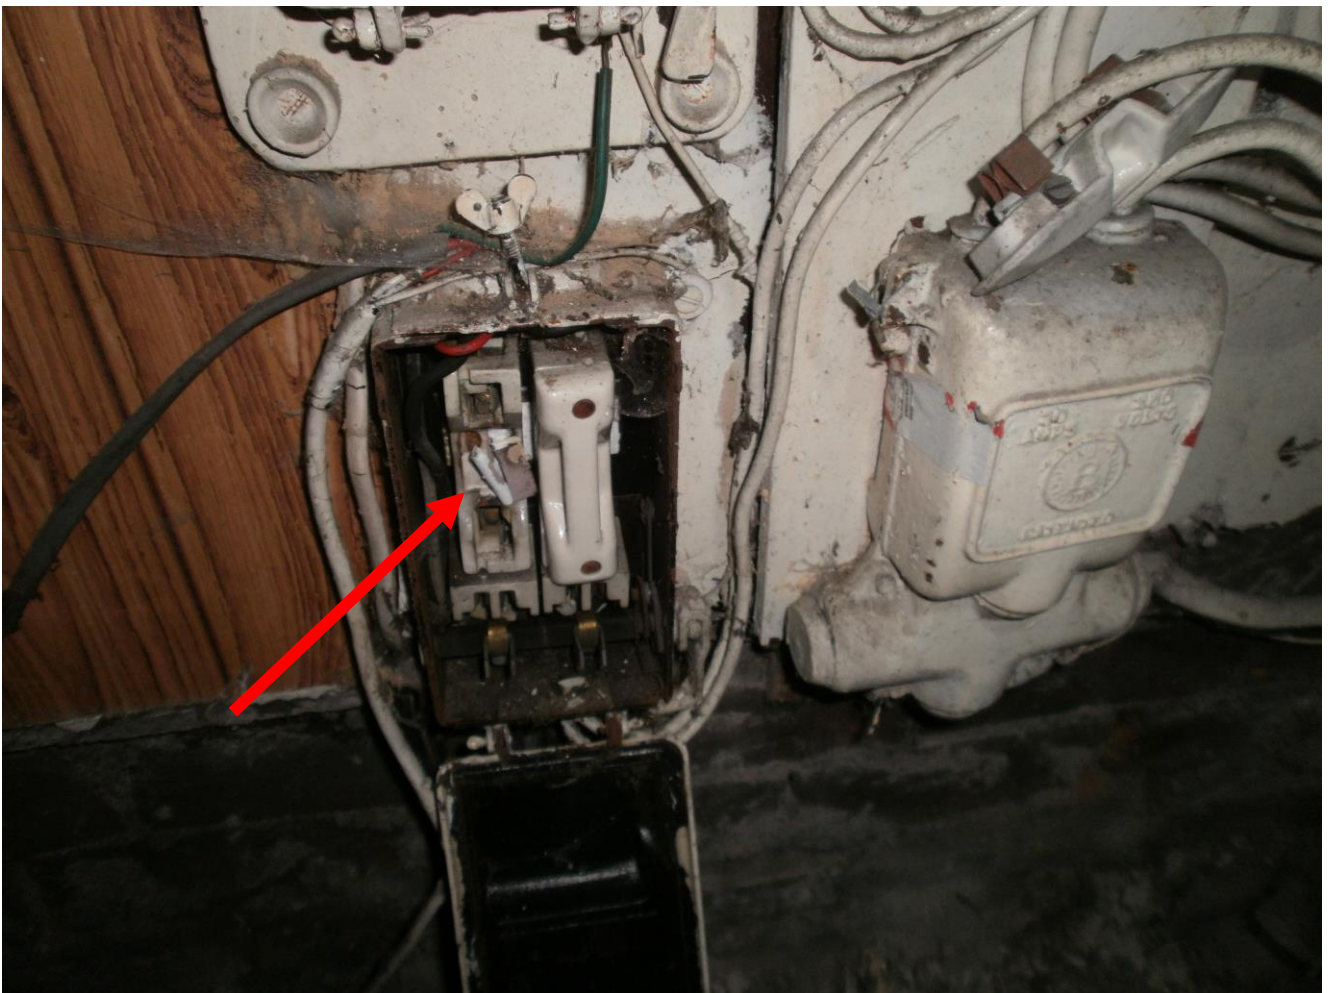
Location – Ground floor main building	Material Assessment Score = 2
Photo Number = 2893	Risk = Low risk

Sample Location:	Fuse pads in hallway
Sample Reference:	Sample 3
Result:	Chrysotile
Recommendations:	Programme for planned removal

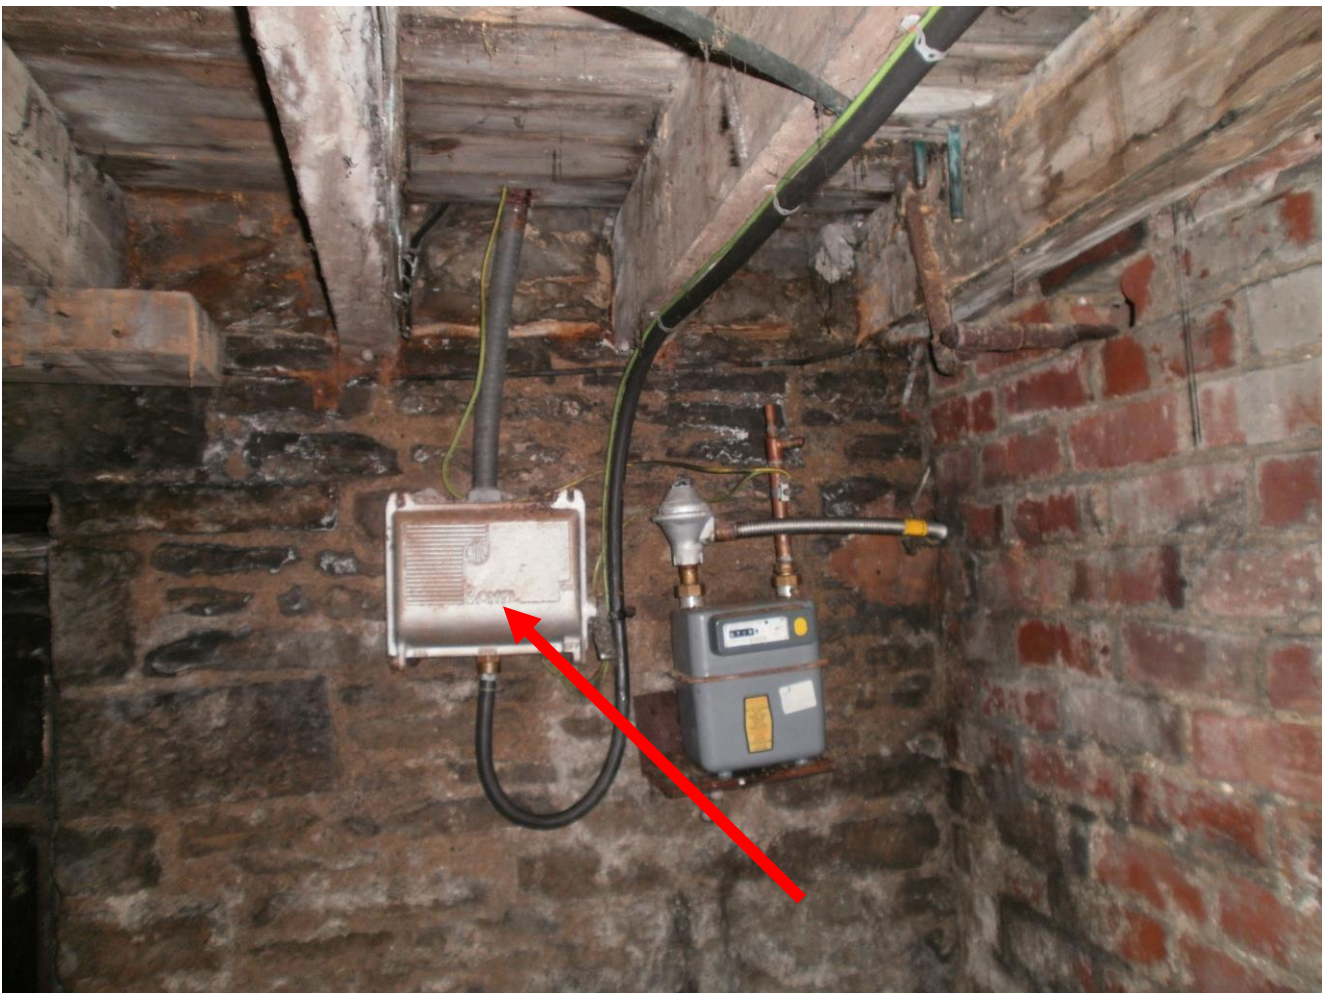
Location – Ground floor main building	Material Assessment Score = 2
Photo Number = 2894	Risk = Low risk

Sample Location:	Cellar fuse pads
Sample Reference:	VIS3
Result:	Chrysotile
Recommendations:	Programme for planned removal

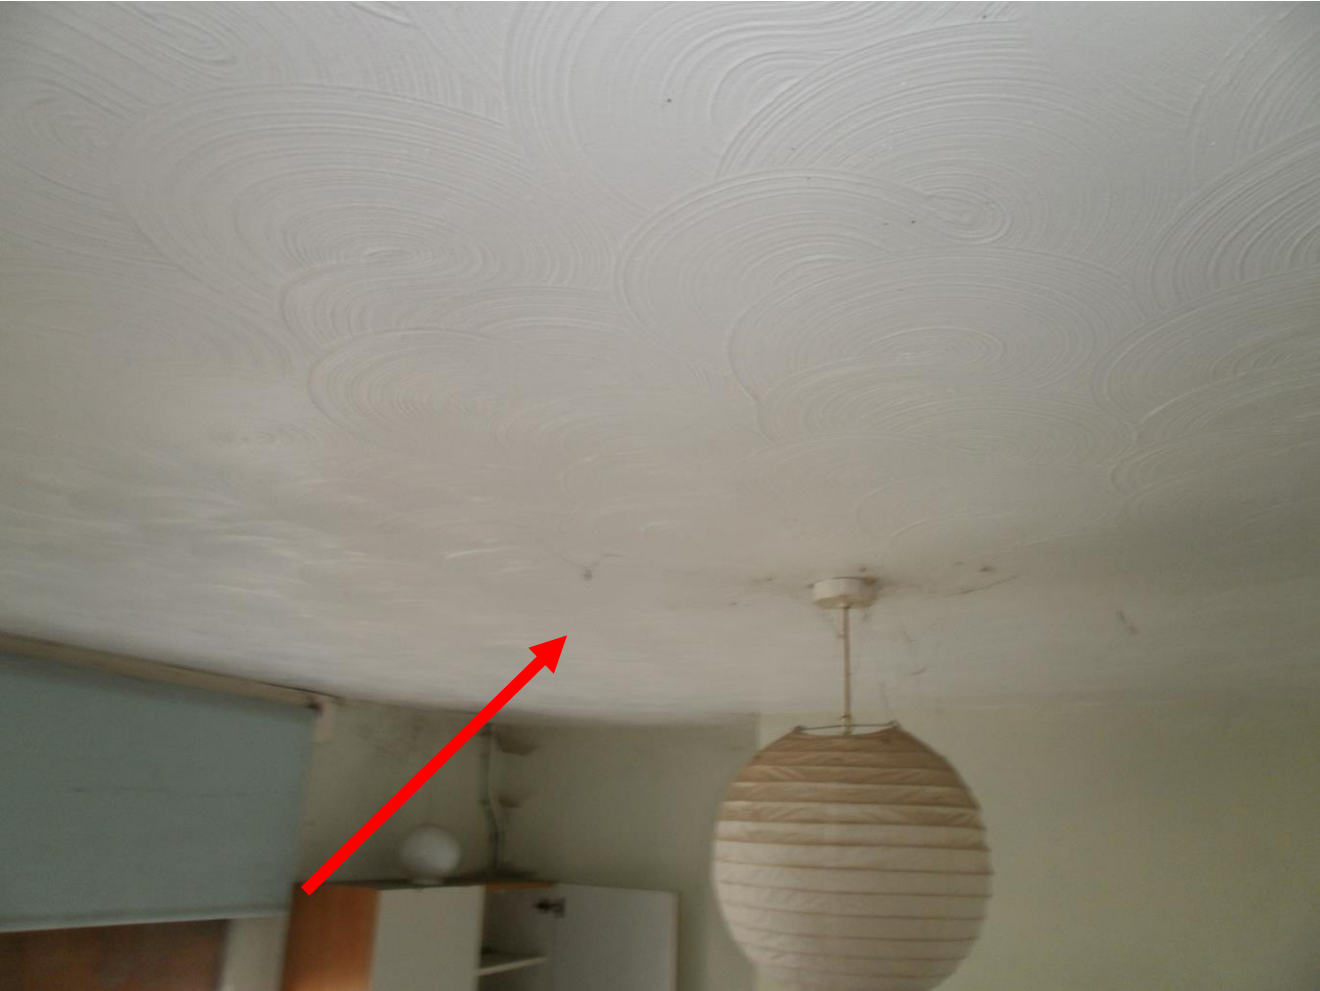
<b>Location – Ground floor House</b>	<b>Material Assessment Score = 0</b>
<b>Photo Number = 2895</b>	<b>Risk = None</b>

<b>Sample Location:</b>	House kitchen ceiling
<b>Sample Reference:</b>	Sample 4
<b>Result:</b>	<b>NADIS</b>
<b>Recommendations:</b>	No further action required regarding asbestos

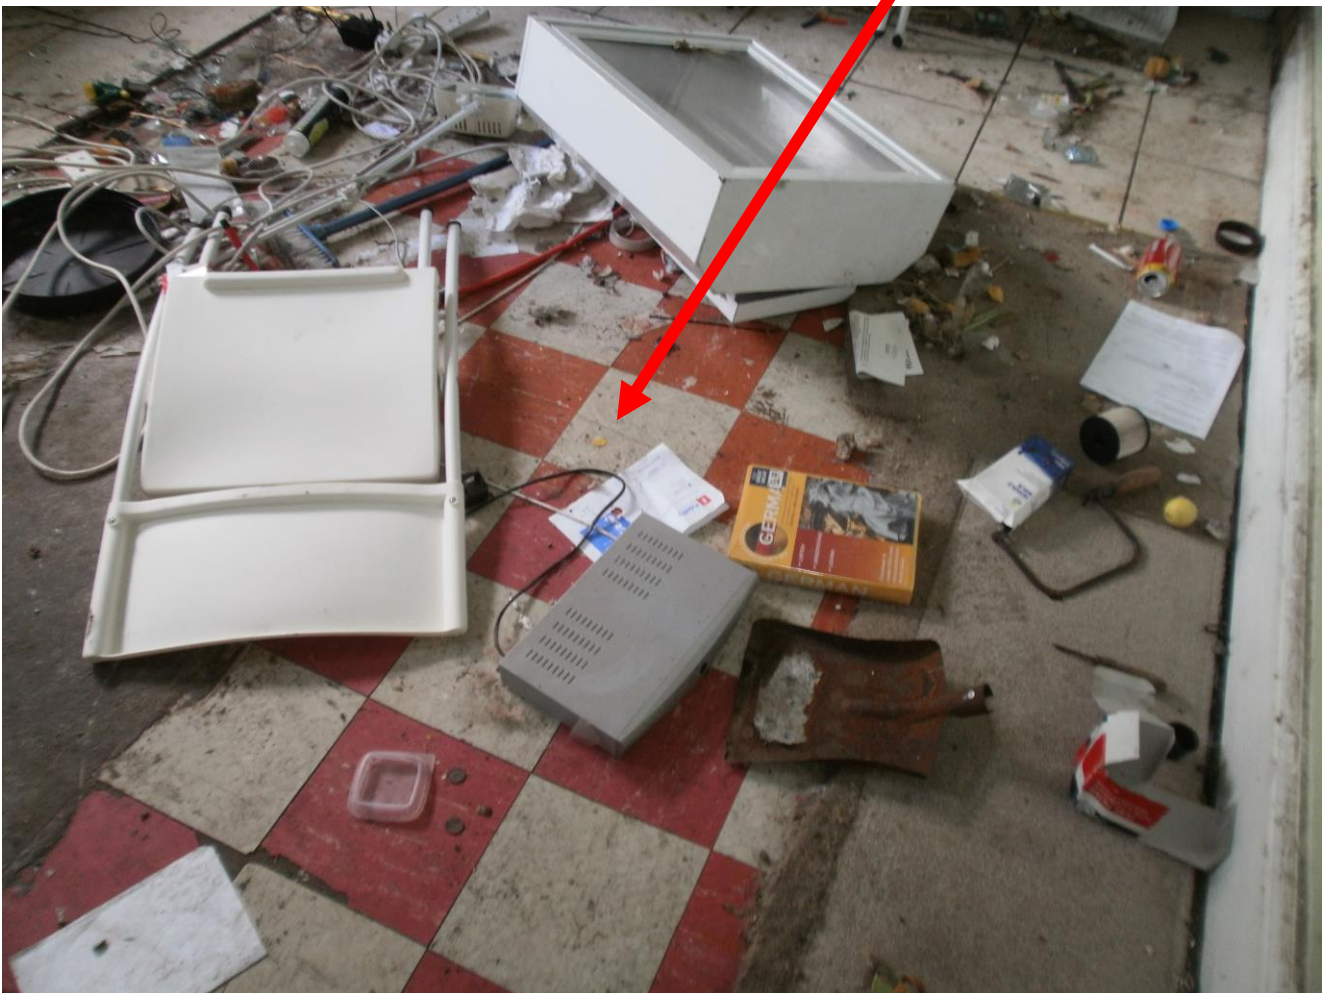
Location – Ground floor House	Material Assessment Score = 2
Photo Number = 2896	Risk = Low risk

Sample Location:	House kitchen vinyl floor tiles
Sample Reference:	Sample 5
Result:	Chrysotile
Recommendations:	Programme for planned removal

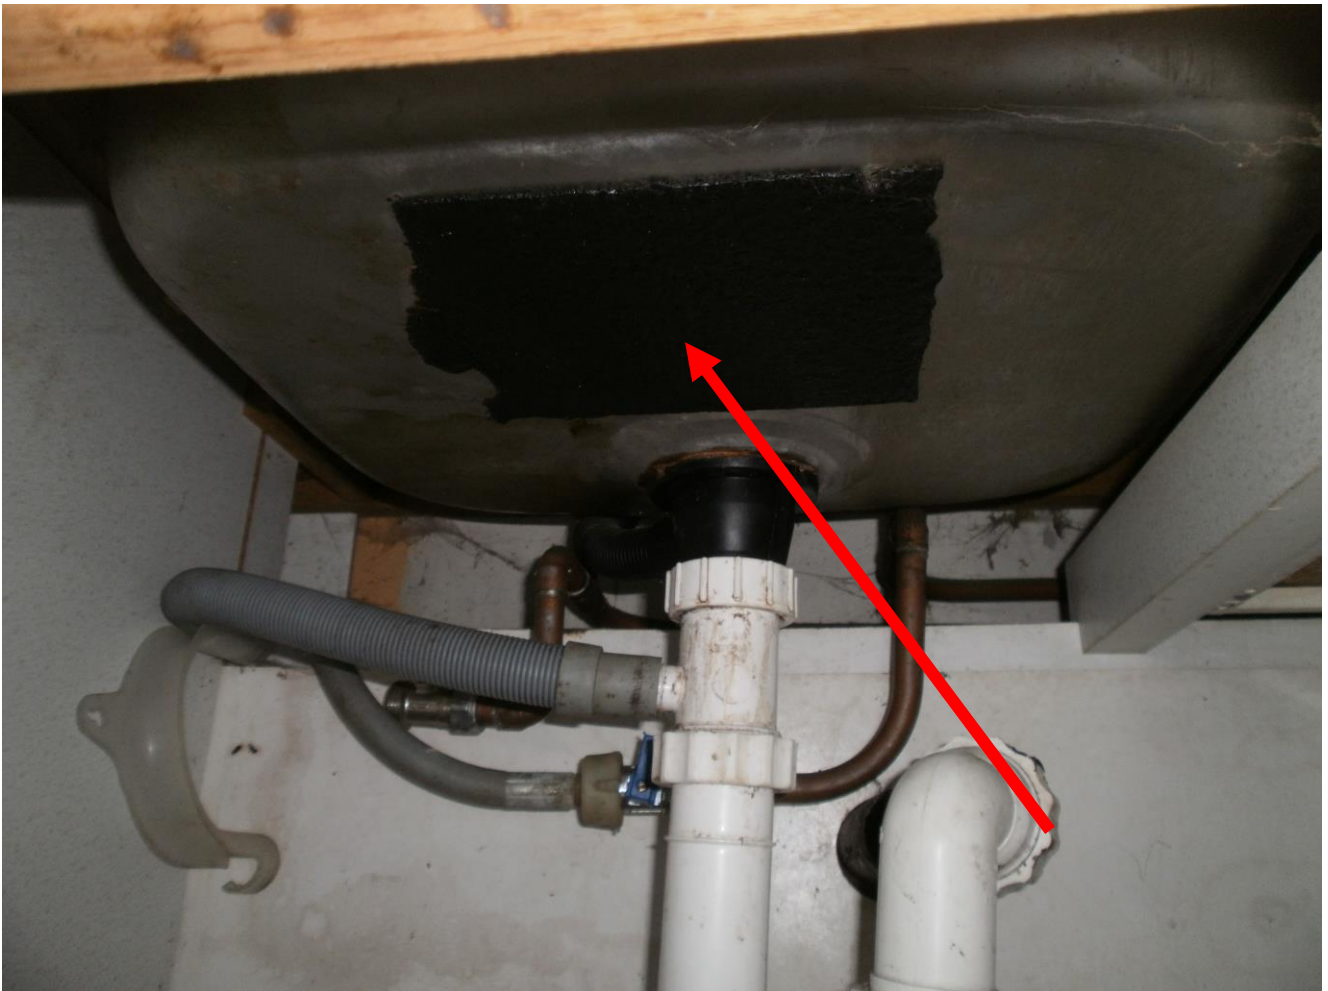
Location – Ground floor House	Material Assessment Score = 0
Photo Number = 2897	Risk = None

Sample Location:	House kitchen mastic sink pad
Sample Reference:	Sample 6
Result:	<b>NADIS</b>
Recommendations:	No further action required regarding asbestos

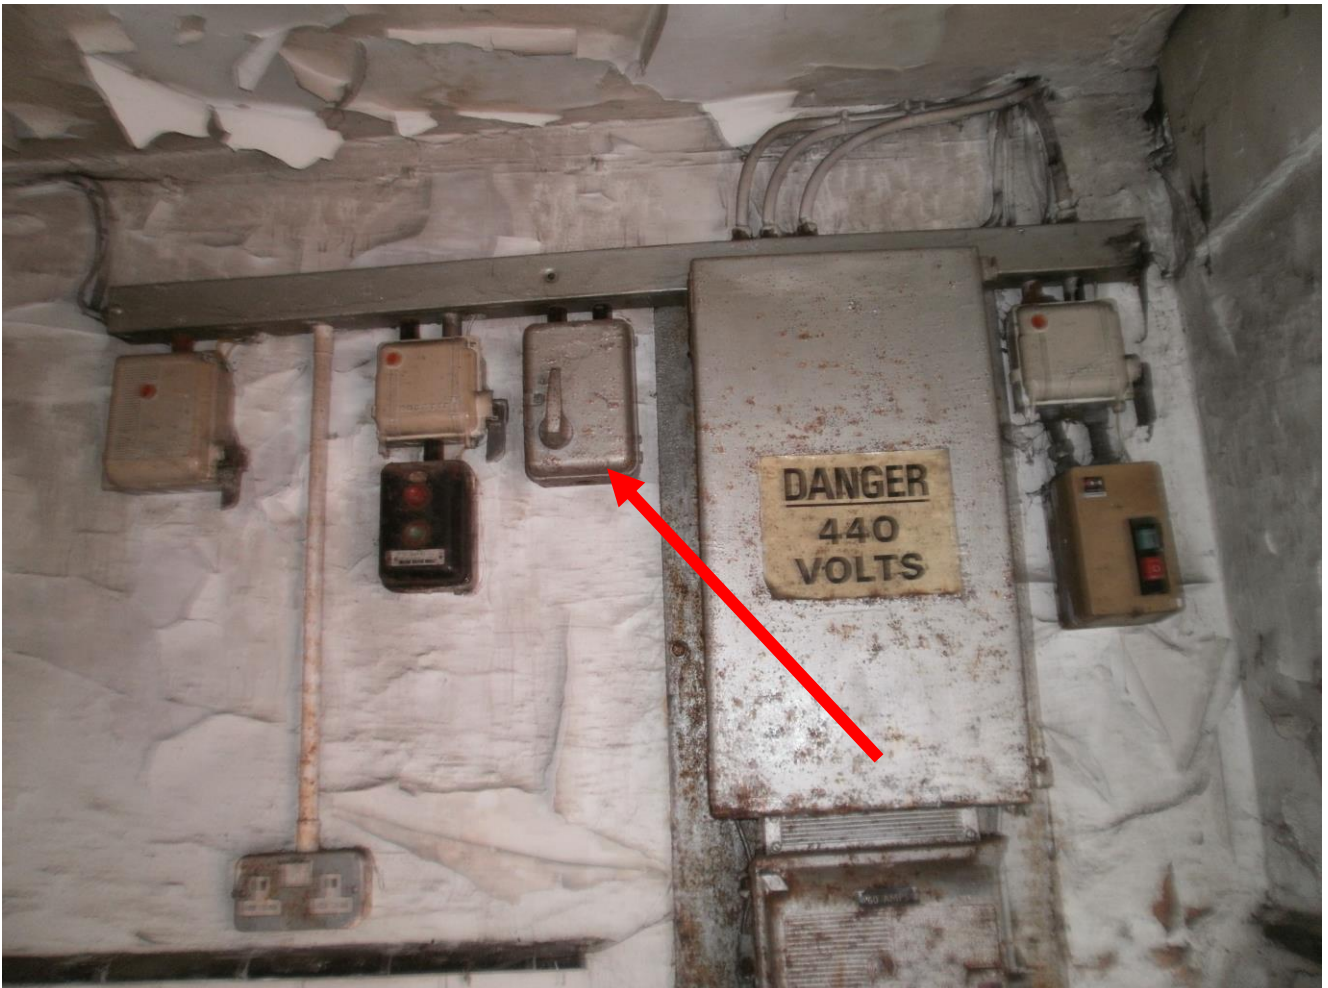
Location – Ground floor abattoir	Material Assessment Score = 2
Photo Number = 2898	Risk = Low risk

Sample Location:	Abattoir fuse pads
Sample Reference:	VIS3
Result:	Chrysotile
Recommendations:	Programme for planned removal

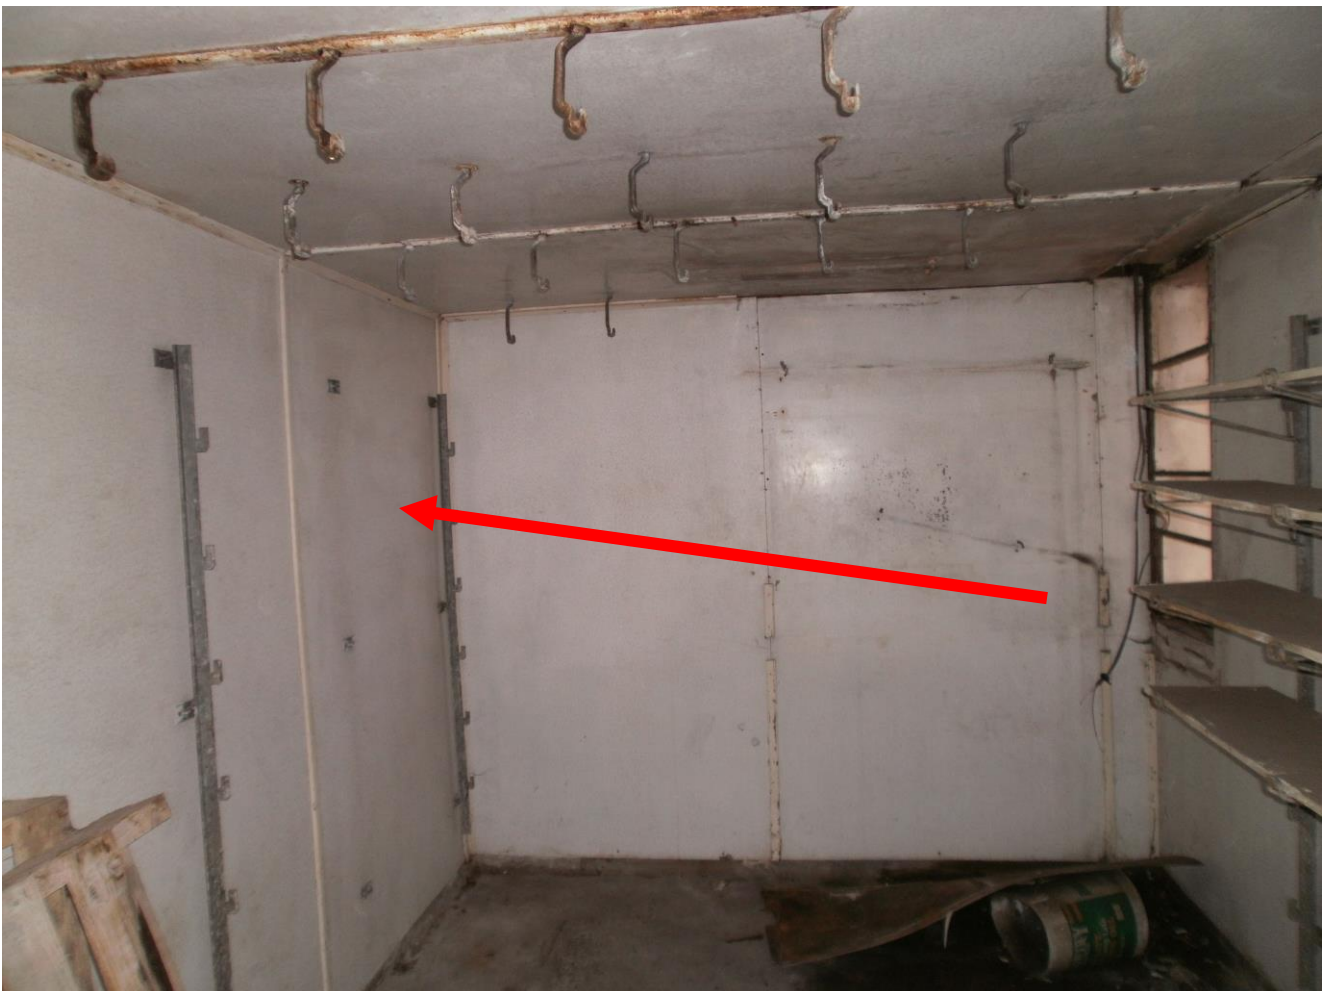
Location – Ground floor abattoir	Material Assessment Score = 2
Photo Number = 2899	Risk = Low risk

Sample Location:	Abattoir fridge internal linings
Sample Reference:	Sample 7
Result:	Chrysotile
Recommendations:	Programme for planned removal

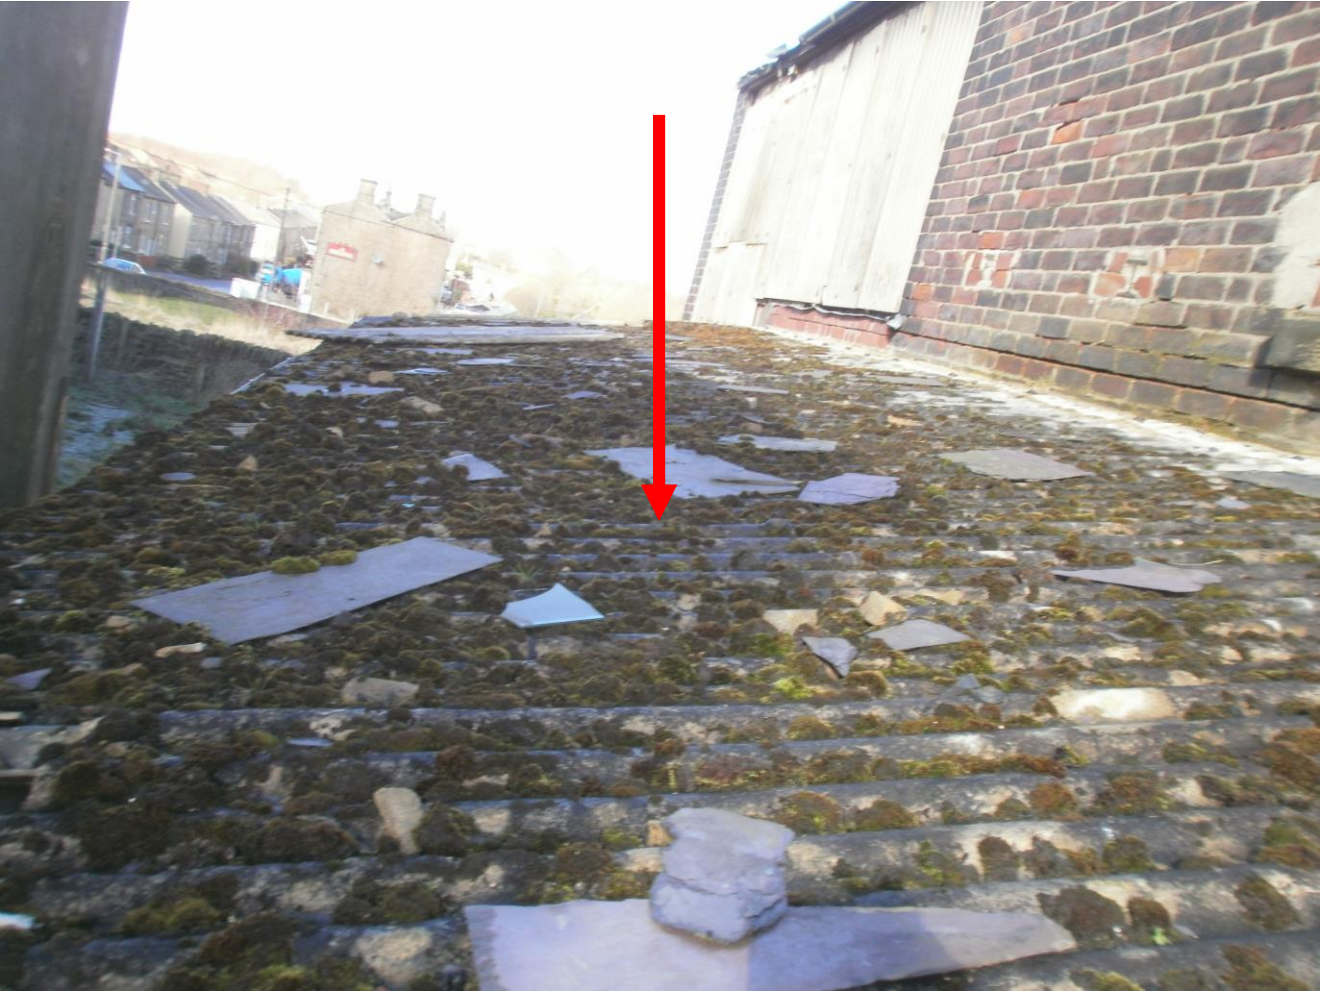
<b>Location – Externals</b>	<b>Material Assessment Score = 2</b>
<b>Photo Number = 2900</b>	<b>Risk = Low risk</b>

<b>Sample Location:</b>	Canopy corrugated roof sheets
<b>Sample Reference:</b>	Sample 8
<b>Result:</b>	<b>Chrysotile</b>
<b>Recommendations:</b>	Programme for planned removal

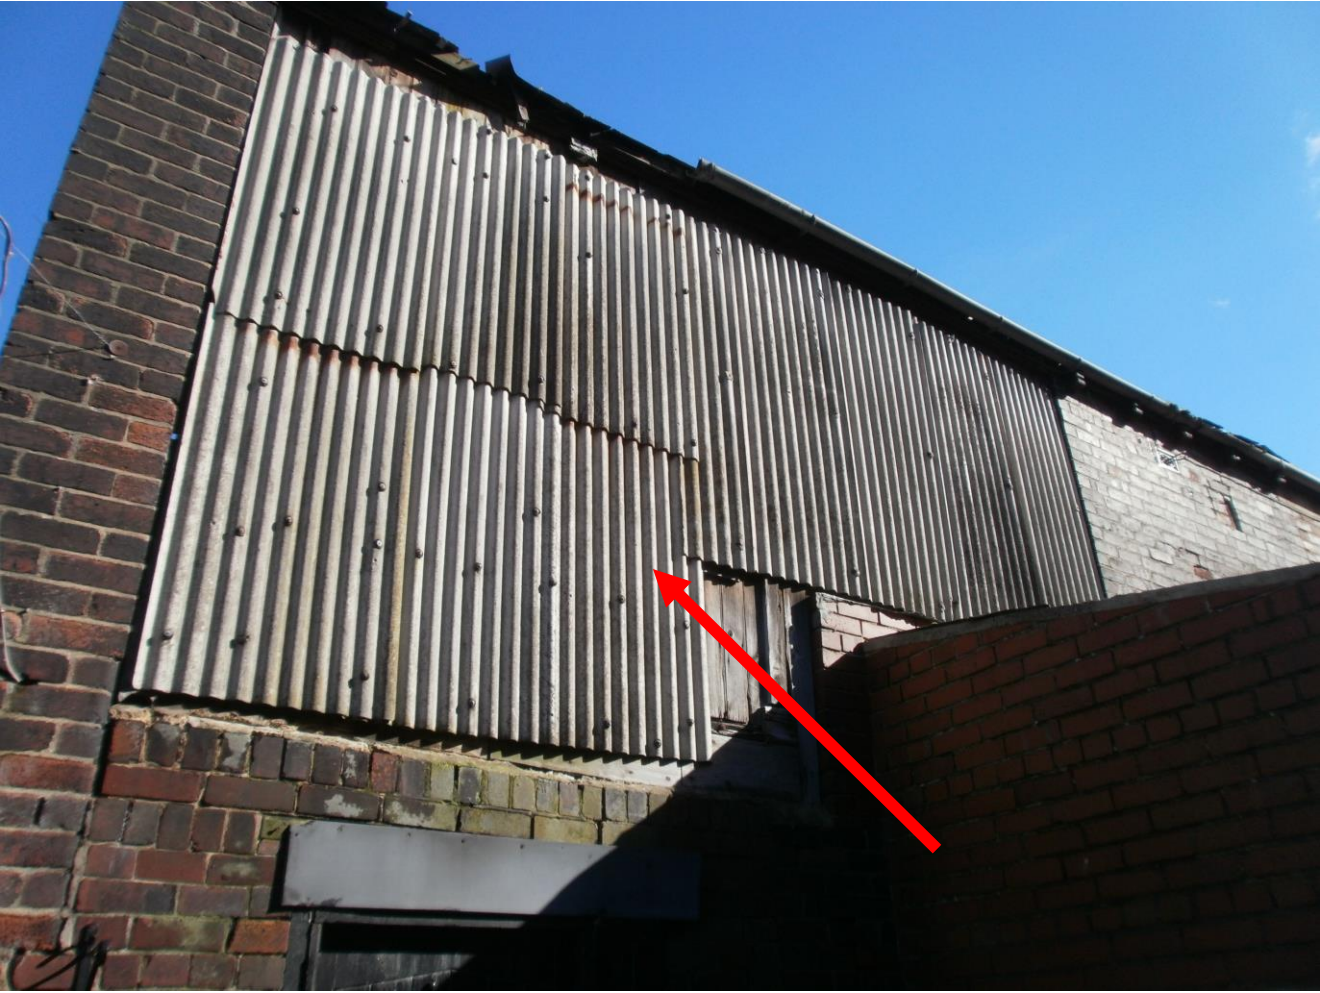
<b>Location – Externals</b>	<b>Material Assessment Score = 2</b>
<b>Photo Number = 2901</b>	<b>Risk = Low risk</b>

<b>Sample Location:</b>	Abattoir side corrugated sheets
<b>Sample Reference:</b>	VIS8
<b>Result:</b>	Chrysotile
<b>Recommendations:</b>	Programme for planned removal

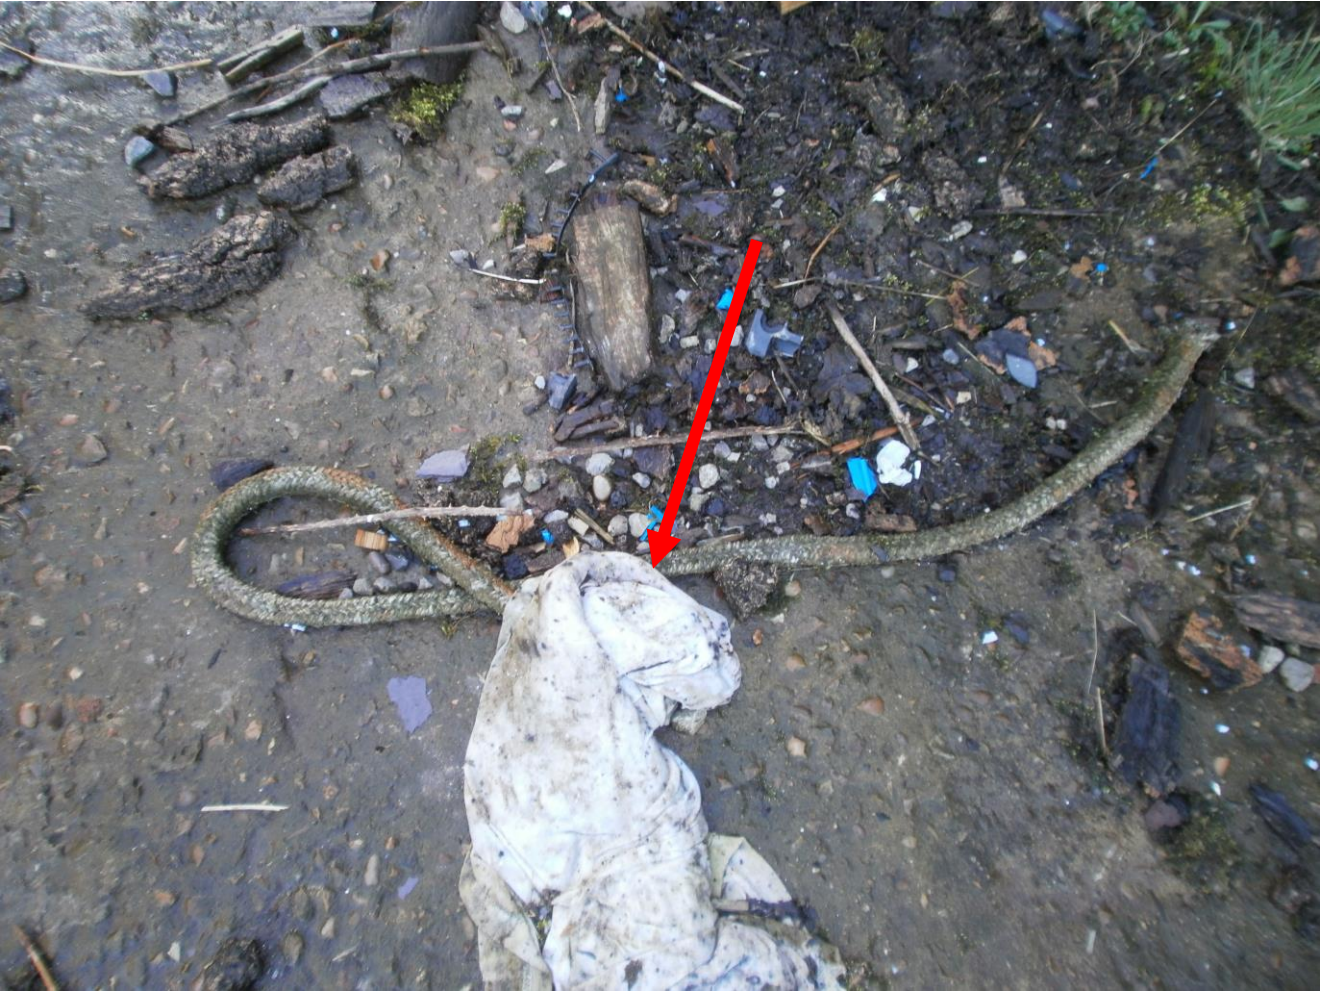
<b>Location – Externals</b>	<b>Material Assessment Score = 2</b>
<b>Photo Number = 2903</b>	<b>Risk = Low risk</b>

<b>Sample Location:</b>	Back yard woven debris
<b>Sample Reference:</b>	Sample 8
<b>Result:</b>	<b>Chrysotile</b>
<b>Recommendations:</b>	Programme for planned removal

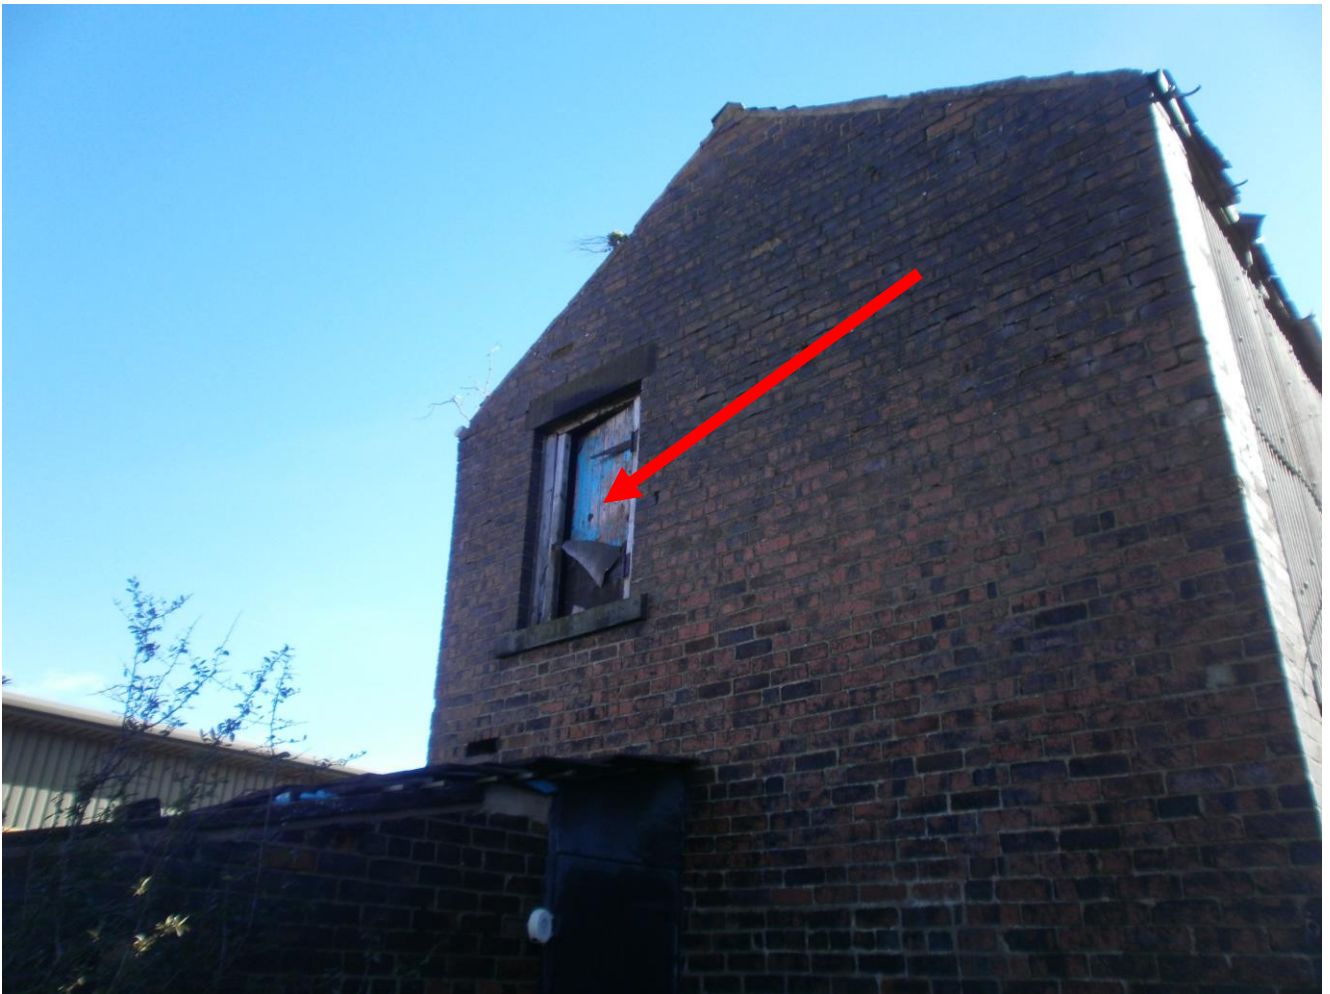
**Location – 1<sup>st</sup> floor abattoir****Photo Number = 2902****Material Assessment Score = 2****Risk = Low risk**

Abattoir first floor

No sample

**Result:****Presume (no access floors unsafe)**
