P&M STRUCTURAL
Design

Structural Inspection

Client:	Philip Pearce
Address:	1 Church Hill, Royston, Barnsley, S71 4NG
Prepared By:	Peter Stokoe BEng (Hons) CEng MStructE
Date of Inspection:	13 December 2023
Revision:	01

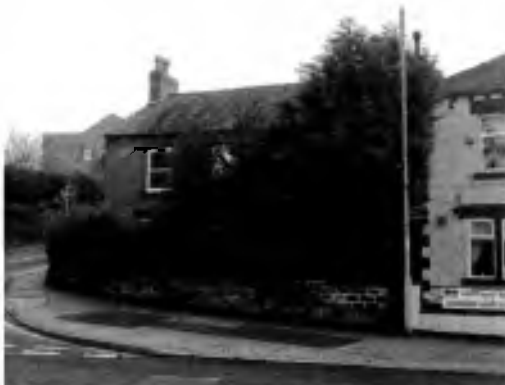
- A Conifer and Holly trees to circa 9 m in height and 2.5 m from the front and RHS gable elevations.

Photo 5: Trees to Front of Property

It is recommended that the trees to the front of the property are removed completely, as it is a risk to the stability of the house foundations. Expert advice should be sought from an arboriculturist as to the most appropriate time to remove the tree, and whether removal needs to be carried out in stages.

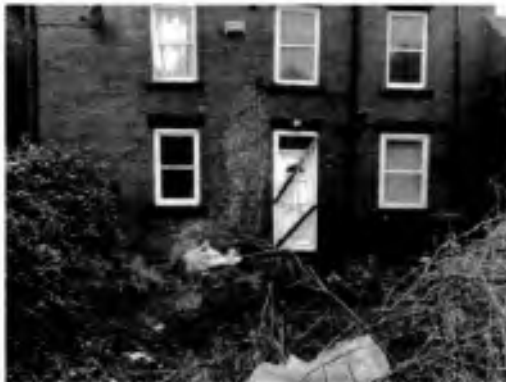
Photo 6: Roof and Foul Drainage to Rear

In view of this, it is recommended that the condition and integrity of the underground drainage system is further investigated by a specialist CCTV survey.

Appoint a specialist drainage contractor to carry out a detailed CCTV survey of the underground drainage system to confirm the extent and location of any defects, and to carry out any associated repairs to eliminate the risk of escape of water from the drains into the surrounding sub-soils.

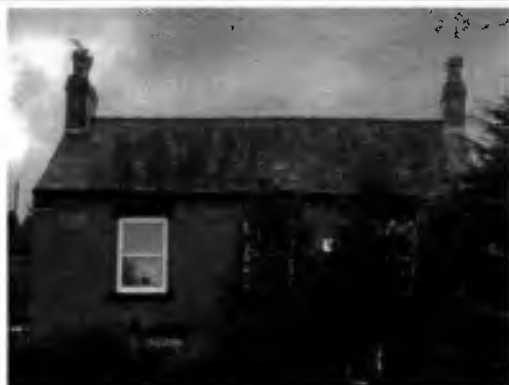
Both the front and rear of the roof slope significantly to the right-hand side from about the mid point of the building. Disruption to the tiles is evident at the mid point of the building at the front and rear of the roof.

Photo 8: Front Roof Slope

If the roof was to be maintained, then it is likely that a replacement covering would be needed.

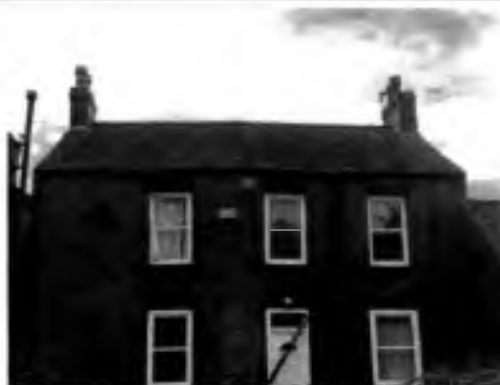
Photo 9: Rear Roof Slope

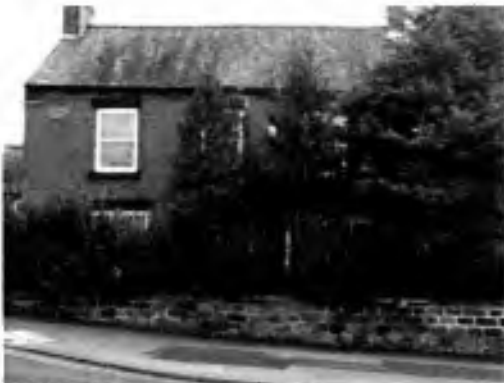
Measurements taken with the aid of a spirit level, taken on external face of the front elevation indicate the elevation to tilt inwards by approximately 10mm over a height of 1200mm or a gradient of 1:120.

Measurements taken with the aid of a spirit level, on the external face of the front elevation indicate the brick coursing falls to the right by up to 55mm past the mid point over a horizontal distance of 1200mm or a gradient of 1: 22. Prior to the midpoint the building slopes by 20mm or a gradient of 1:60.

There is noted to be localised lateral distortion to the external brickwork just below eaves level on the front elevation at the midpoint.

Photo 10: Front Wall

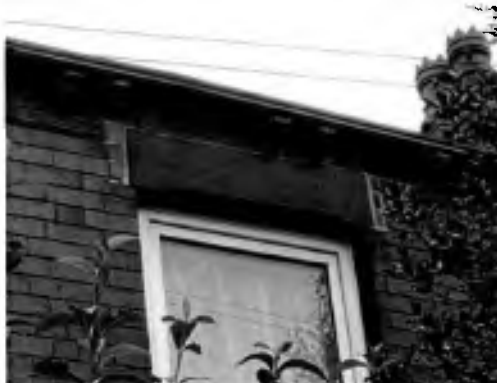
Signs of previous repointing are noted above the central first floor window and between this window and the front door opening which seem to have reopened by an estimated 10 to 15mm.

Photo 11: Central Window Gaps in
Repointing adjacent to Lintel

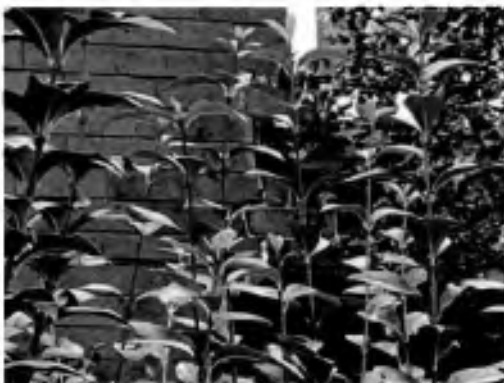
Photo 12: Cracking under Central Window

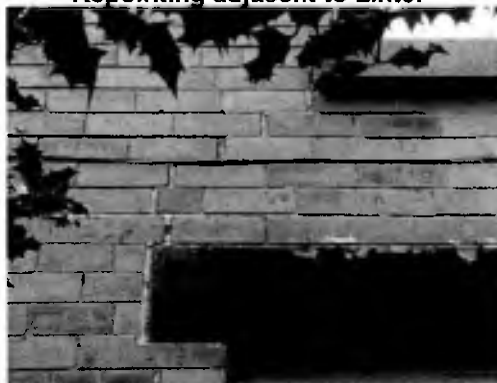
Stepped repointing over the RHS ground floor window is evident but this appears stable albeit weathered.

Photo 13: Old Pointing over RHS GF
Window

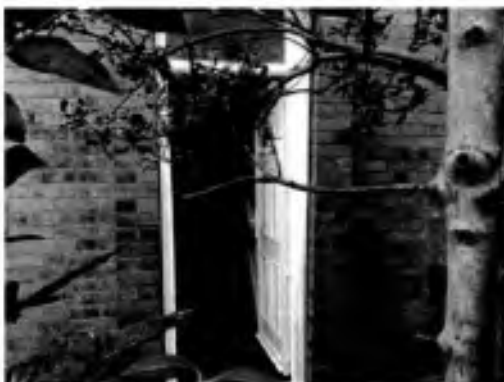
Photo 14: Tapered Infill to Front Door
Frame

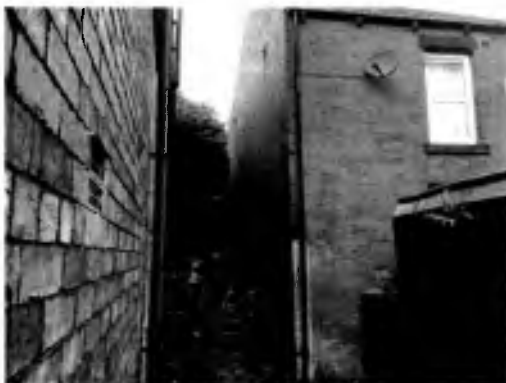
Measurements taken with the aid of a spirit level, taken on external face of the right hand side elevation indicate the elevation to tilt outwards by approximately 60mm over a height of 1200mm or a gradient of 1:20.

Where walls tilt their stability is rarely in question provided that they are adequately tied back into the structure at roof and floor levels. Walls which are unacceptably tilting at 1 in 40 may need to be rebuilt but again tying in may be all that is required. Rebuilding should be considered as a last resort as the aesthetics of building a new wall in an otherwise sloping building may be poor. Where it is recognised that the building is tilting as a whole then remedial works may need to be considered at around 1 in 100 and the building would be considered to be in a serious or dangerous condition at gradients of 1 in 50 or less.

Photo 15: RHS Gable

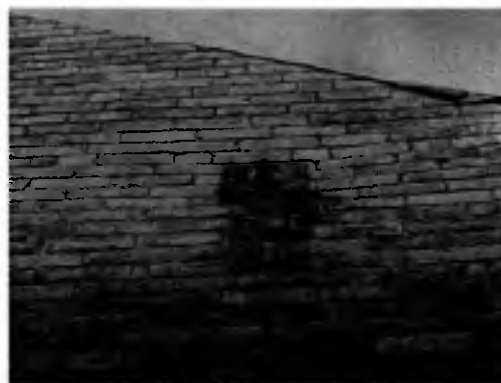
There are two Pattress plates to this elevation at about eaves level and both are corroding. The brickwork around the rear plate has dished around this plate and there are vertical cracks nearby to widths of circa 3 to 4 mm. There is some degree of distortion around the front plate but not as significant as the rear plate.

Photo 16: Rear Pattress Plate

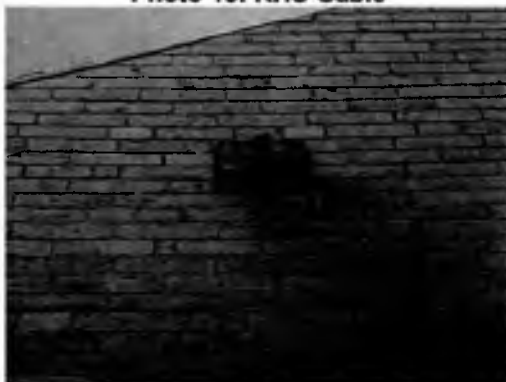
Photo 17: Front Pattress Plate

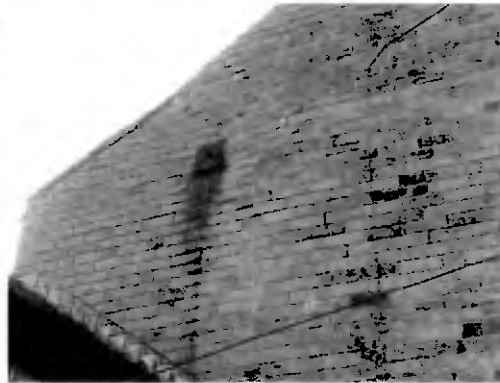
There are two corroded pattress plates on the LHS gable which mirror those on the RHS gable. The brickwork around around the rear and front pattress plate dishes inwards and there are a number of stepped cracks in the brickwork although significantly more pronounced around the rear plate.

Photo 19: Rear Pattress

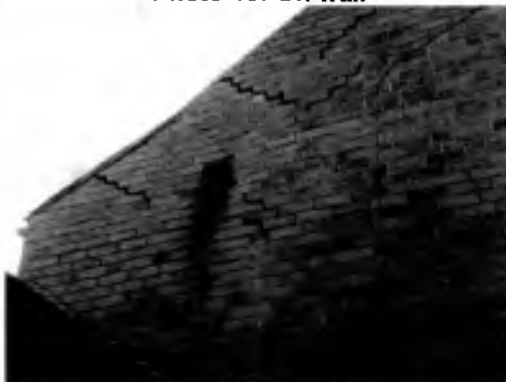
Photo 20: Cracking

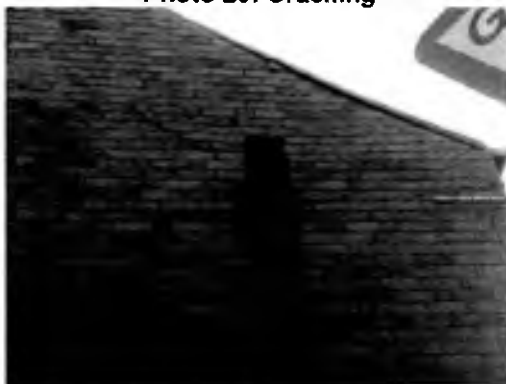
Photo 22: Cracking

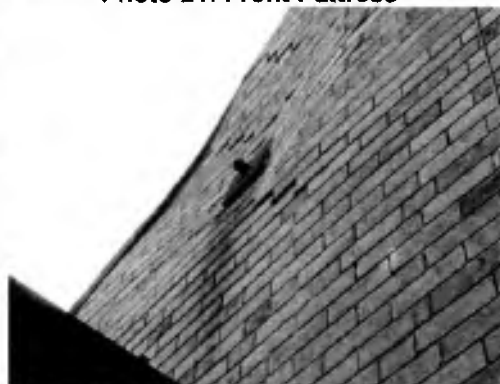
Photo 23: Deformation Rear

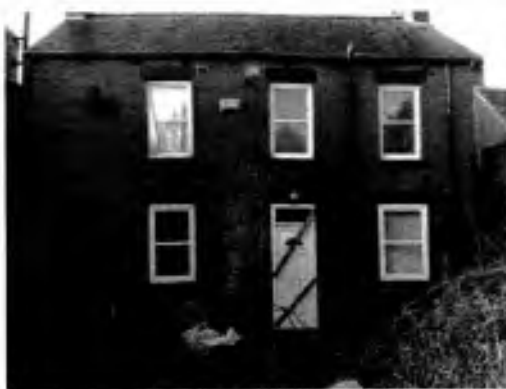
Measurements taken with the aid of a spirit level, taken on external face of the rear elevation indicate the elevation to tilt outwards by approximately 15mm over a height of 1200mm or a gradient of 1:80.

Measurements taken with the aid of a spirit level, on the on external face of the rear elevation indicate the brick coursing falls to the right by approximately 40mm over a horizontal distance of 1200mm or a gradient of 1: 30. Prior to the midpoint the building slopes by 20mm or a gradient of 1:60.

There is noted to be localised lateral distortion to the external brickwork just below eaves level on the front elevation at the midpoint.

Photo 24: Rear Wall

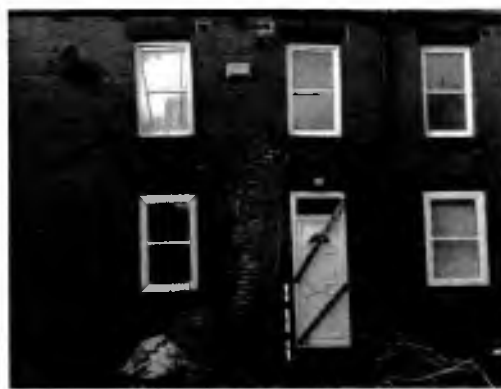
Photo 25: Cracking

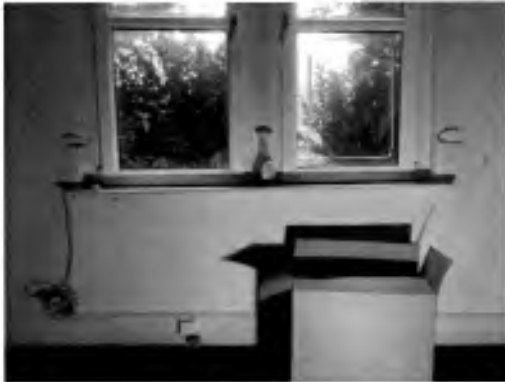
The windowsill in the front RHS reception slopes significantly to the right and there are cracks to 1.5mm over the door to the central hallway. Further cracking to 1.0mm was evident in the RHS gable wall.

Photo 31: Front RHS Sloping Windowsill

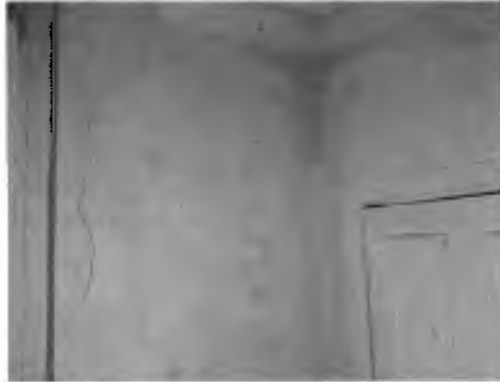
Photo 32: Cracking to 1.5 mm in Front Lounge near Door

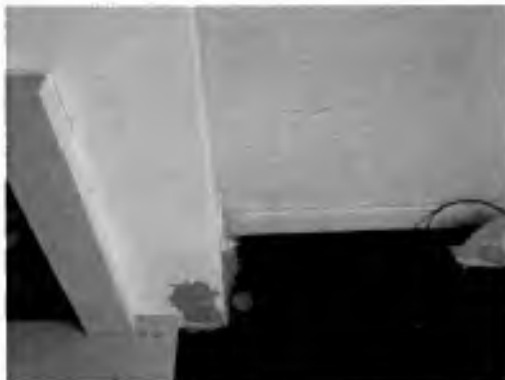
Photo 33: Cracking to 1.0mm in RHS Gable.

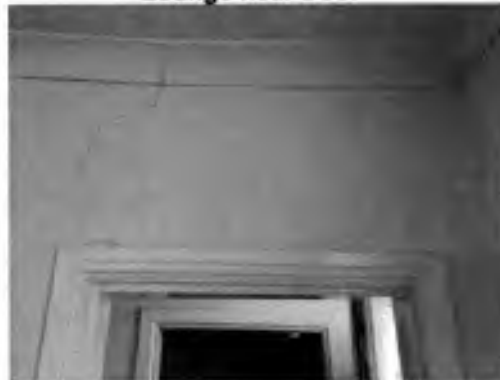
Cracking to 2.0mm was noted in the LHS reception wall to the central hall and over the pantry door in the kitchen to 5.0mm.

Photo 34: LHS Reception 2 mm Cracking over Front Doorway

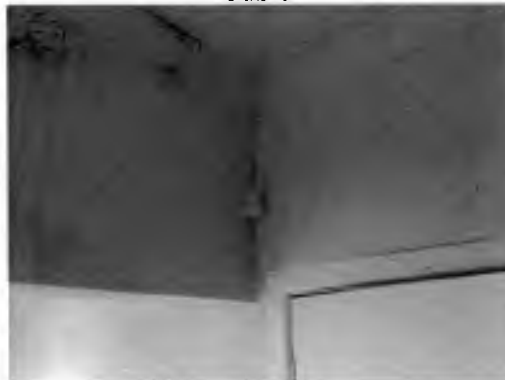
Photo 35: Kitchen Pantry under Stairs 5 mm Crack

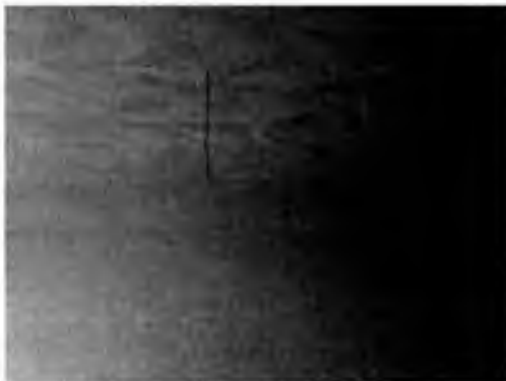
Photo 36: Front LHS 2 mm

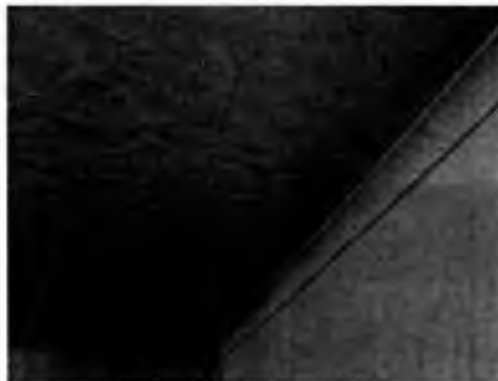
Photo 37: Front LHS 1.0

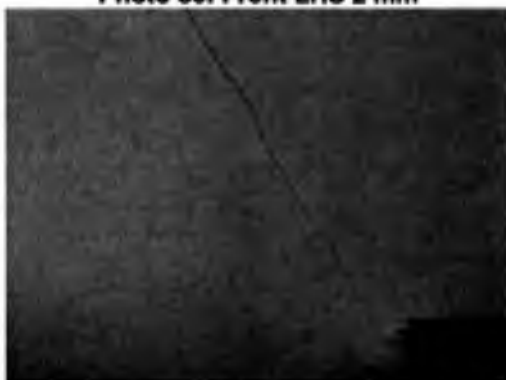
Photo 38: RHS front 1.0 mm full width

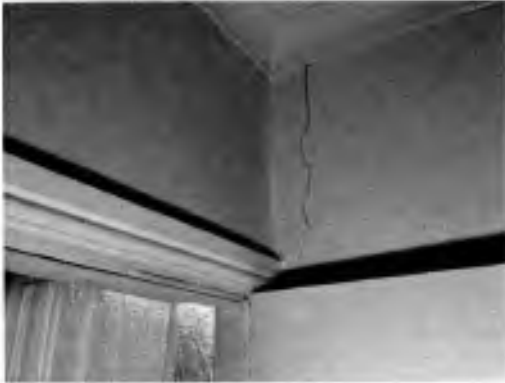
Cracking to 2.0mm was noted over the central front window to the LHS and further cracking to 1.5mm to the RHS of the window in the RHS bedroom.

Photo 40: 2.0 mm Central Front Window

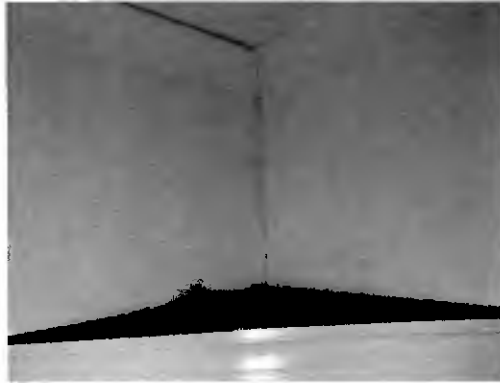
Photo 41: Cracking to 1.5 mm in Front Right Bedroom

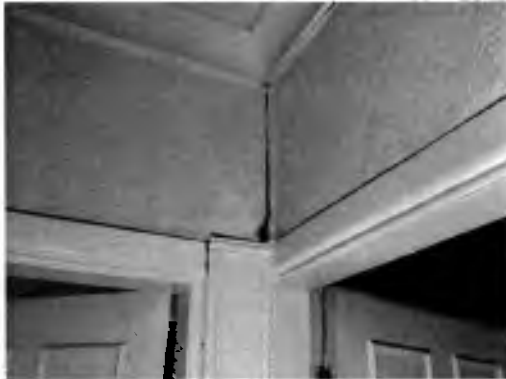
Distortion and cracking were noted over the interface of the rear bathroom and bedroom door with further cracking to 2.0mm in width on the internal face of the rear RHS bedroom.

Photo 42: 10 mm bath/rear door

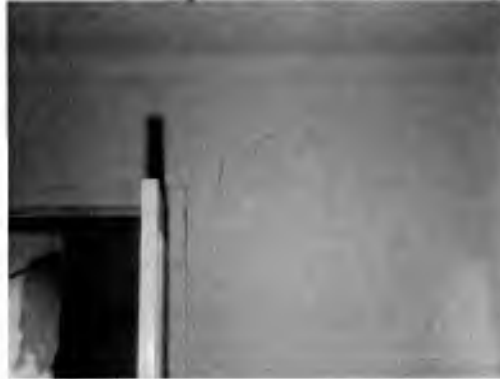
Photo 43: Rear RHS Bedroom Cracking to 2 mm.

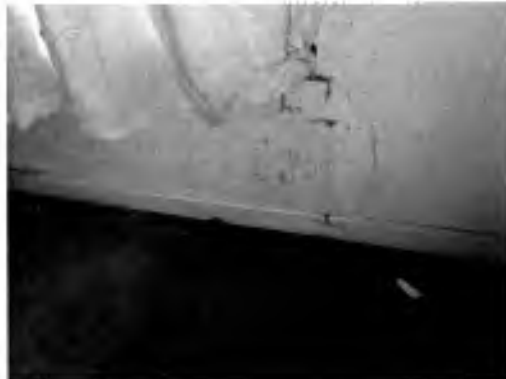
Photo 44: Rear Bedroom 1.5 mm Cracking below Window

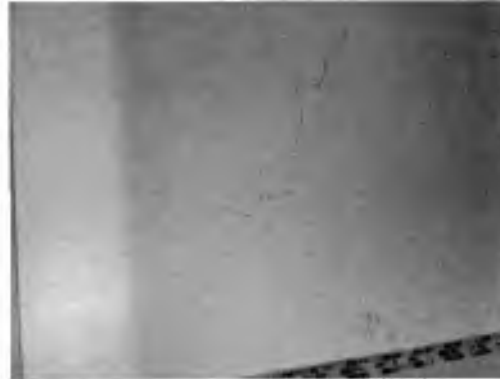
Further cracking to 2.0 mm in width was evident in the rear bathroom and to 1.0mm in the front RHS bedroom.

Photo 45: Bathroom 2 mm Rear Wall

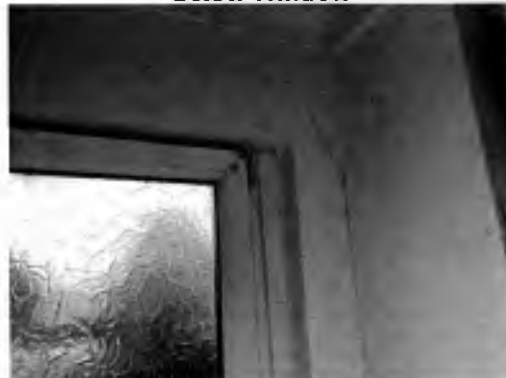
Photo 46: 2 mm Rear Bathroom Window

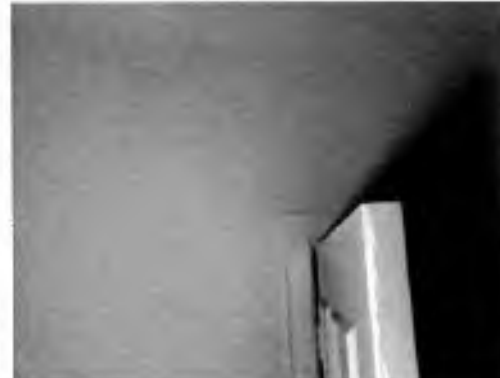
Photo 47: RHS Bedroom 1.0 mm

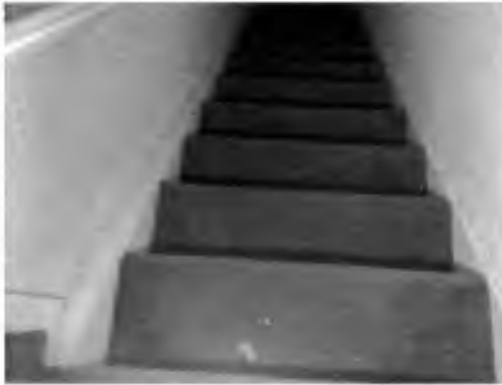
The RHS of the stair stringer has been infilled.

Photo 48: Stair Gap to RHS Filled

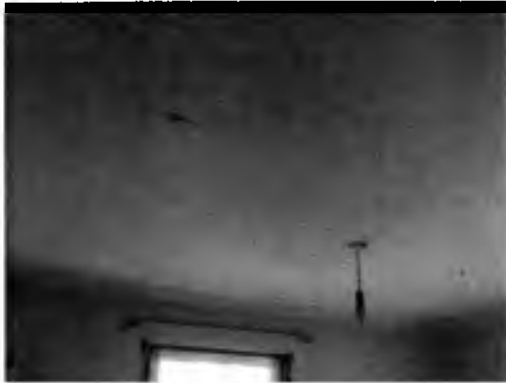
Photo 49: LHS Front Bedroom Cracking to 1.0 mm.

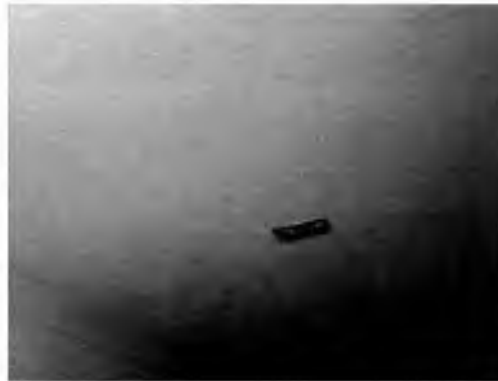
Photo 52: Bathroom Cracking to 1.0mm

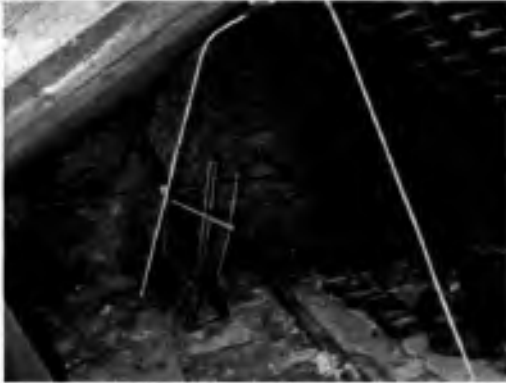
The LHS purlins appear to be supported by timbers attached to the gable rather than built into the gable as the RHS.

Photo 53: LHS Gable

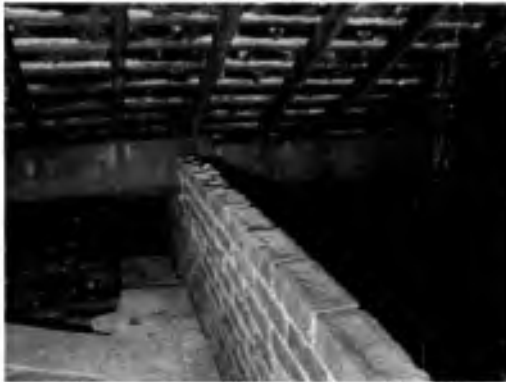
**Photo 55: Central Supporting Pier Purlin
Rotation**
