**LYONS CMC  
COAL MINING & GEOTECHNICAL  
CONSULTANCY**

Date: 8<sup>th</sup> May 2025  
Your ref: (S75 4PH)  
My Ref: SI 00391.2

**COAL MINING RISK INTERPRETATION REPORT – FOLLOWING THE SITE  
INVESTIGATION FOR PROPOSED RESIDENTIAL DEVELOPMENT AT STONE CROFT, HALL  
ROYD LANE, SILKSTONE COMMON, BARNSELEY S75 4PH**

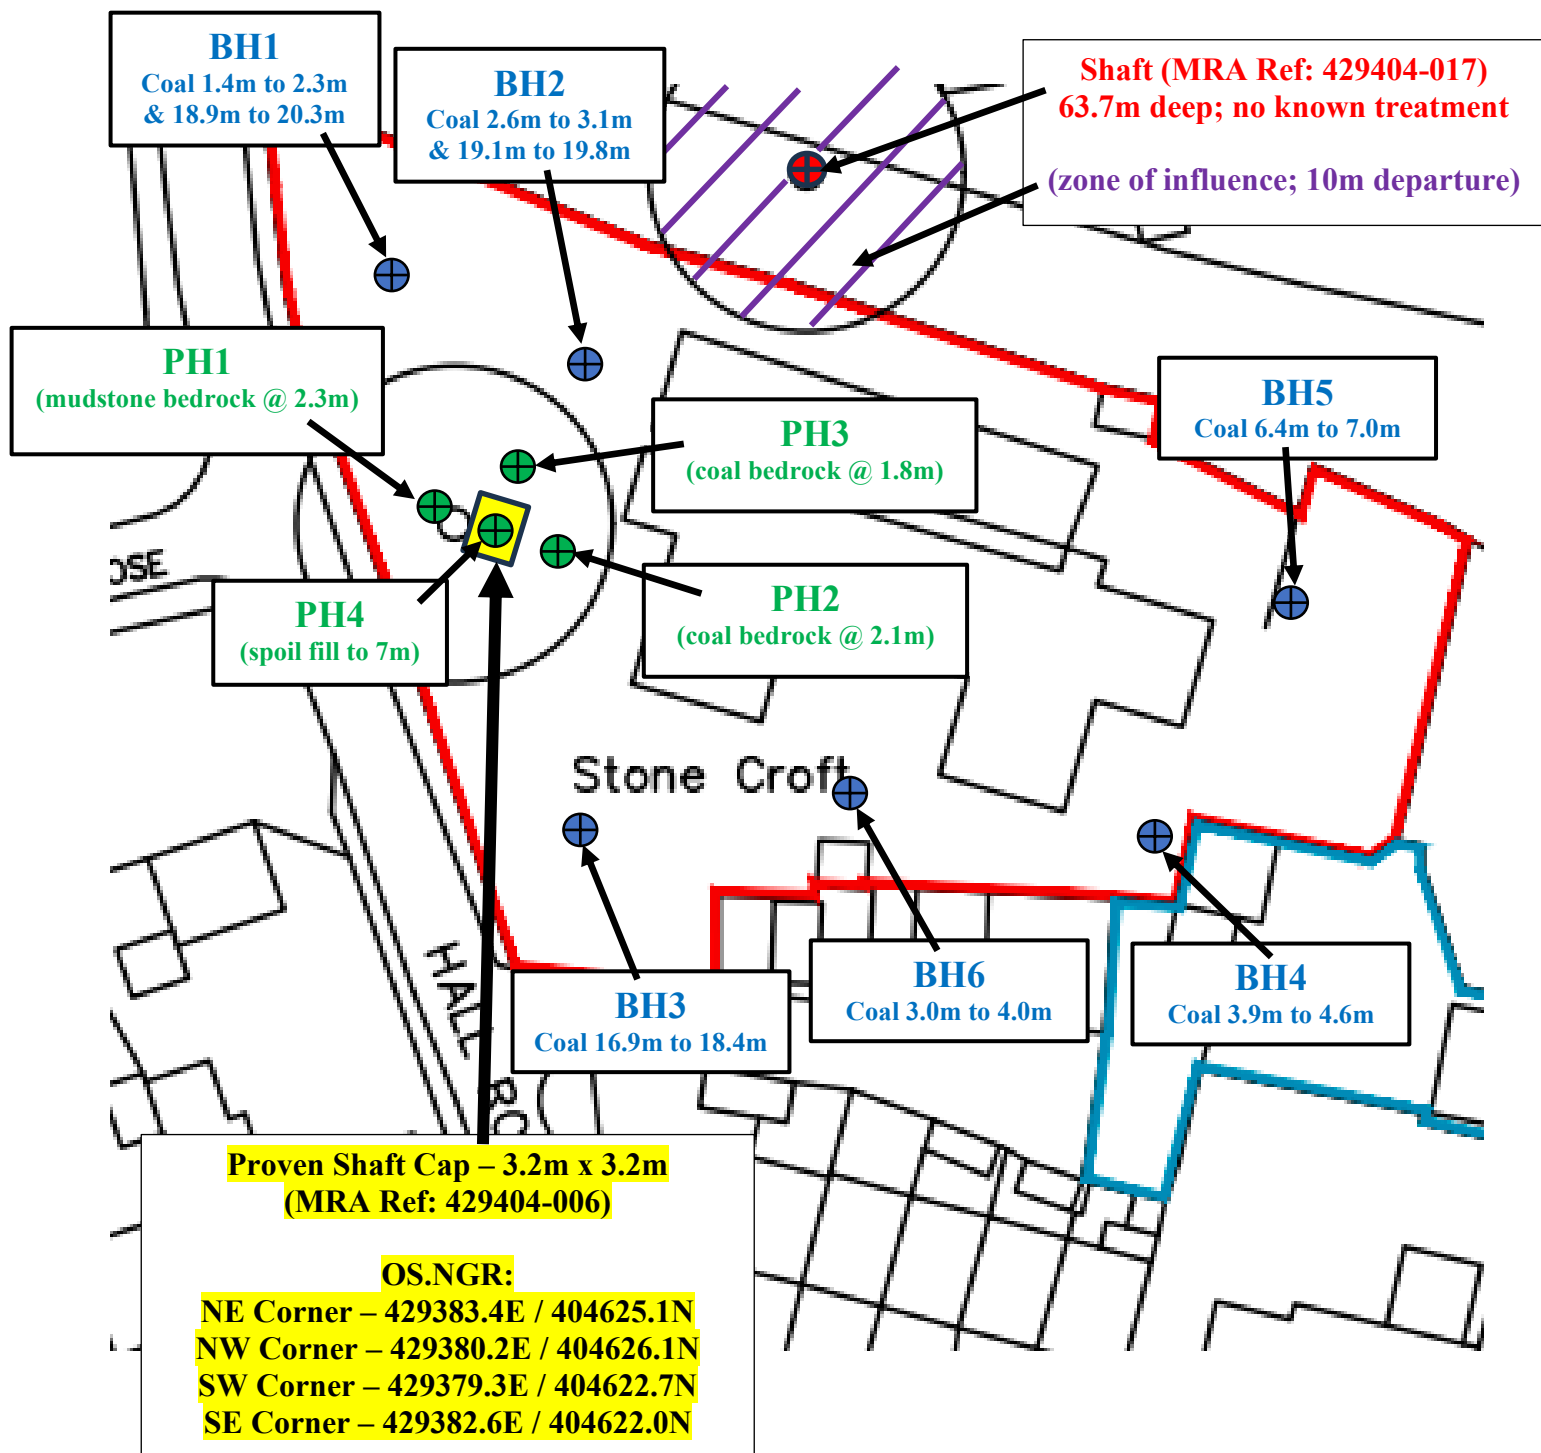
### 5.2 Borehole/Probe-hole Location Plan No. 00391/B

Prior to the intrusive site investigation, a search for utilities was undertaken both via online data providers and physically on site using a Cable Avoidance Tool (CAT). Boreholes were marked out with tape measure from boundary lines as illustrated on plan no. 00391/B outlined in appendix 5.2. As part of the mine entry watching brief, a pre survey was undertaken with no visible evidence of either the known mine shaft or any other uncharted mine entries.

- 3) Development (buildings or other) should be avoided from the small area of the ‘zone of influence’ of the adjacent mine shaft ref: 429404-017 to the north of the site, as outlined in the attached plan – which equates to a 10m radius (MRA ‘departure’) drawn from the plotted shaft position. This situation could change however, subject to a further site investigation (following site clearance), that ‘disproves’ the mine shaft within the site itself to the boundary line in that zone. If this is determined, then building foundations should be sited away from the boundary line by the same distance to bedrock/formation level (to achieve the 45°rule should the shaft be present directly adjacent the site boundary to the north).

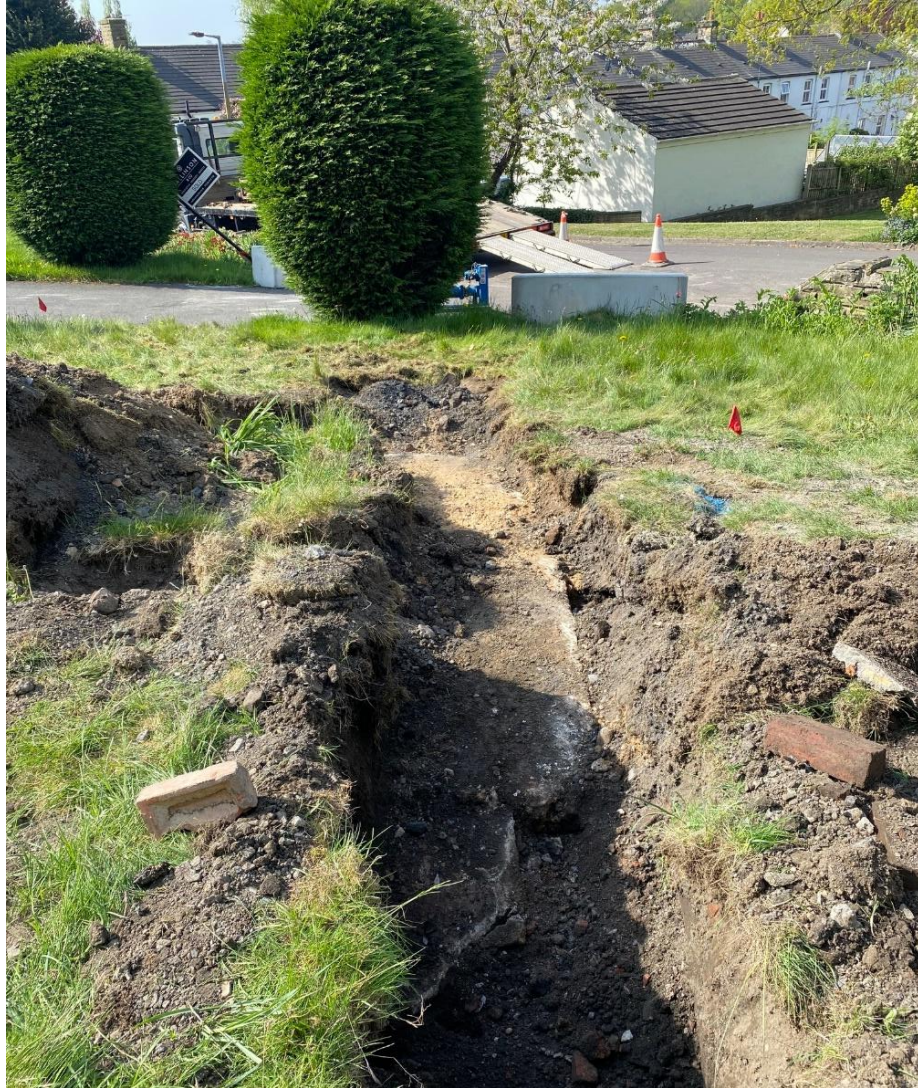
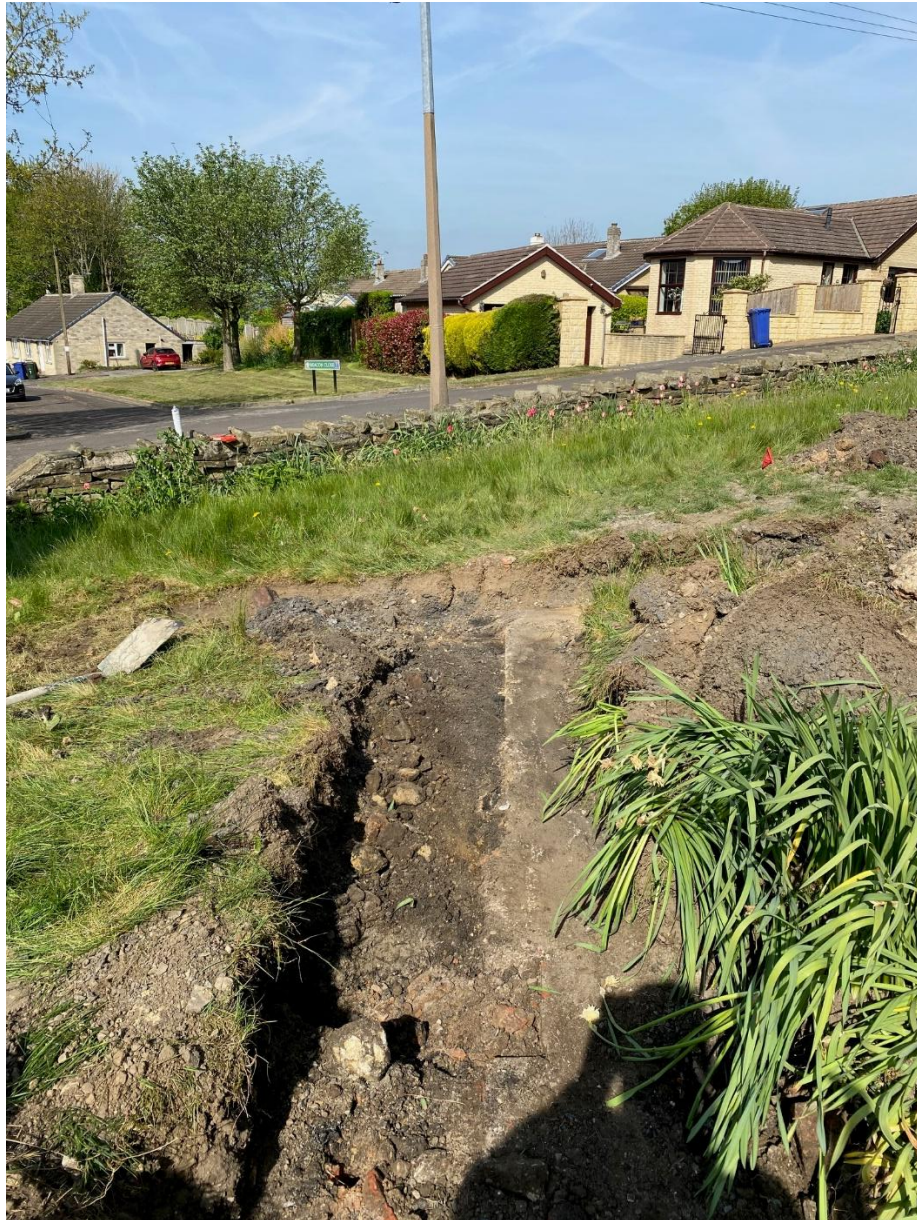
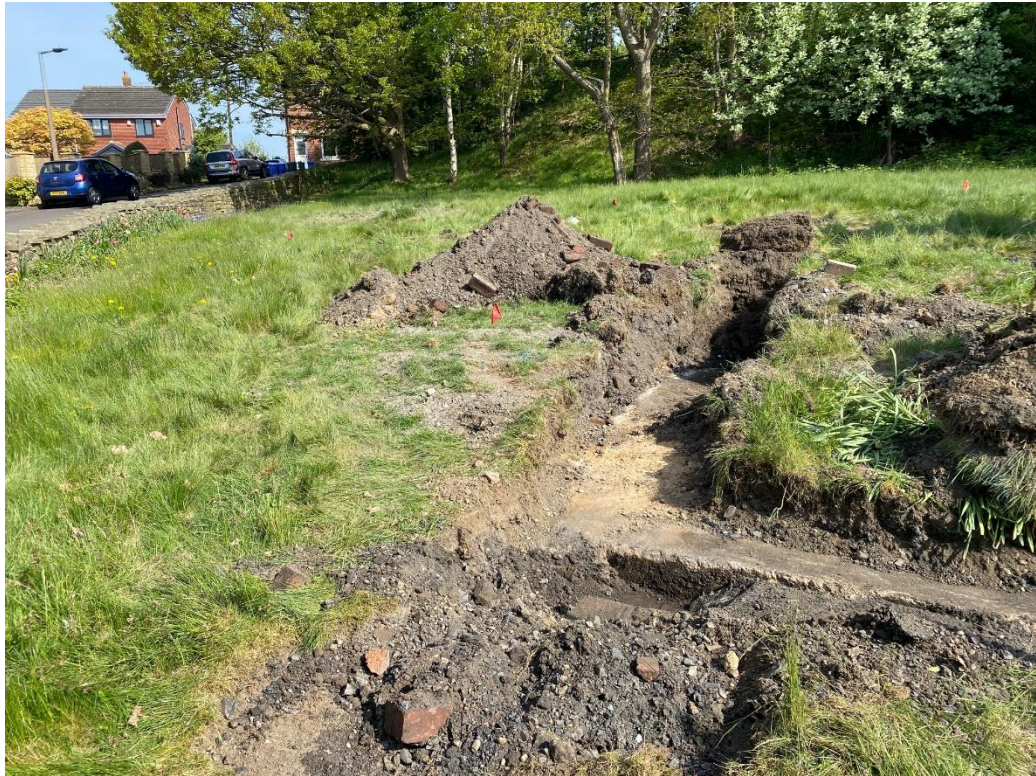
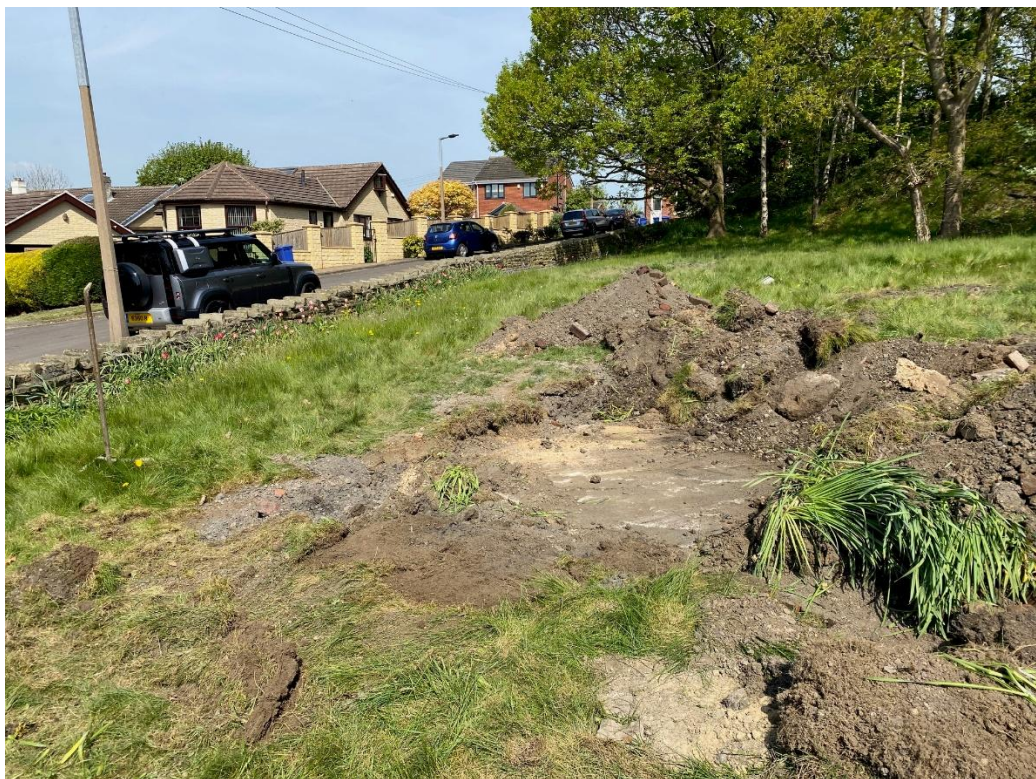
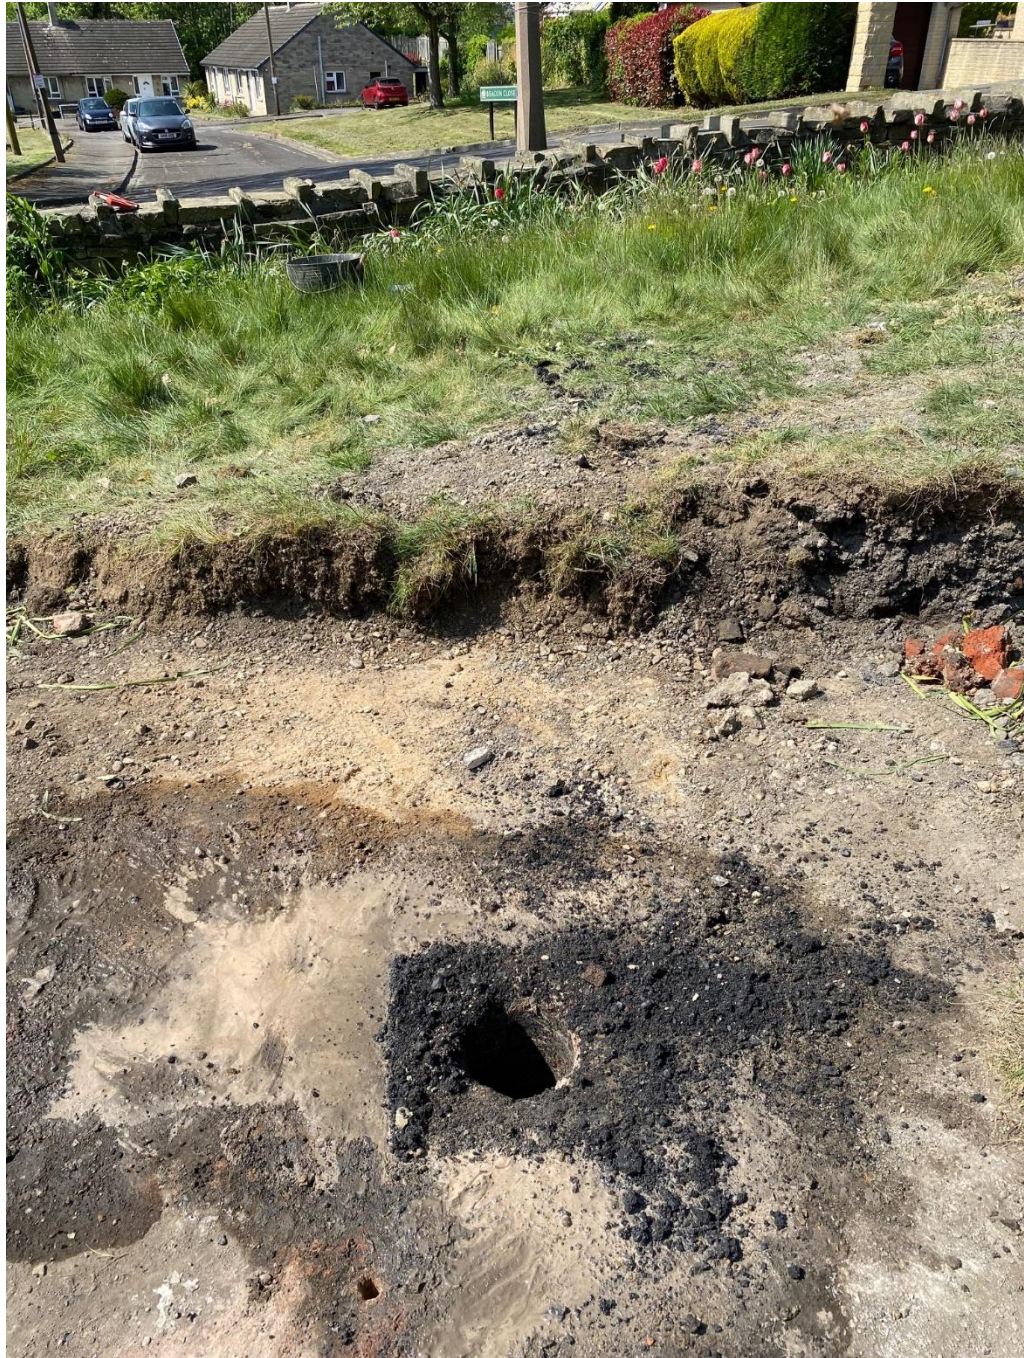
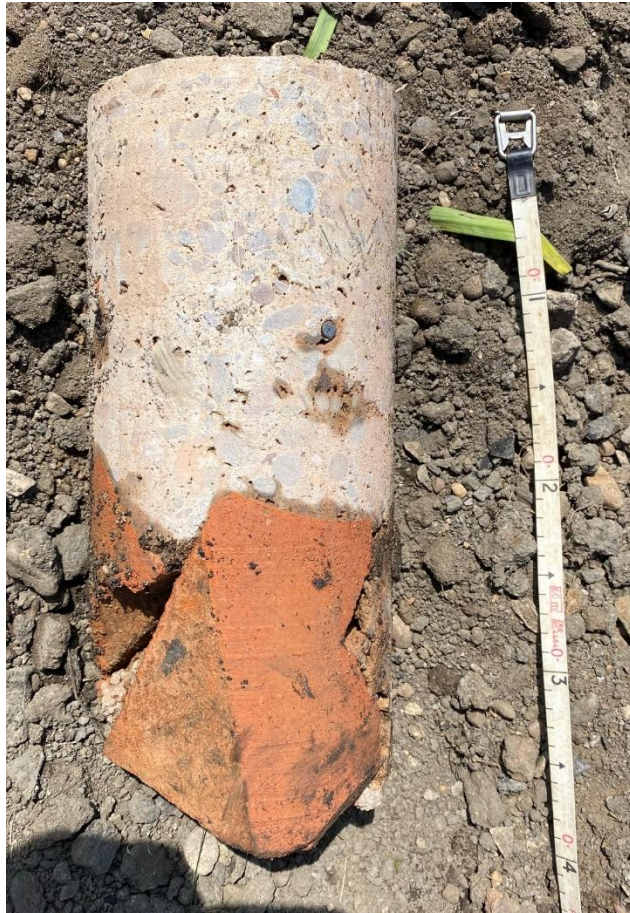
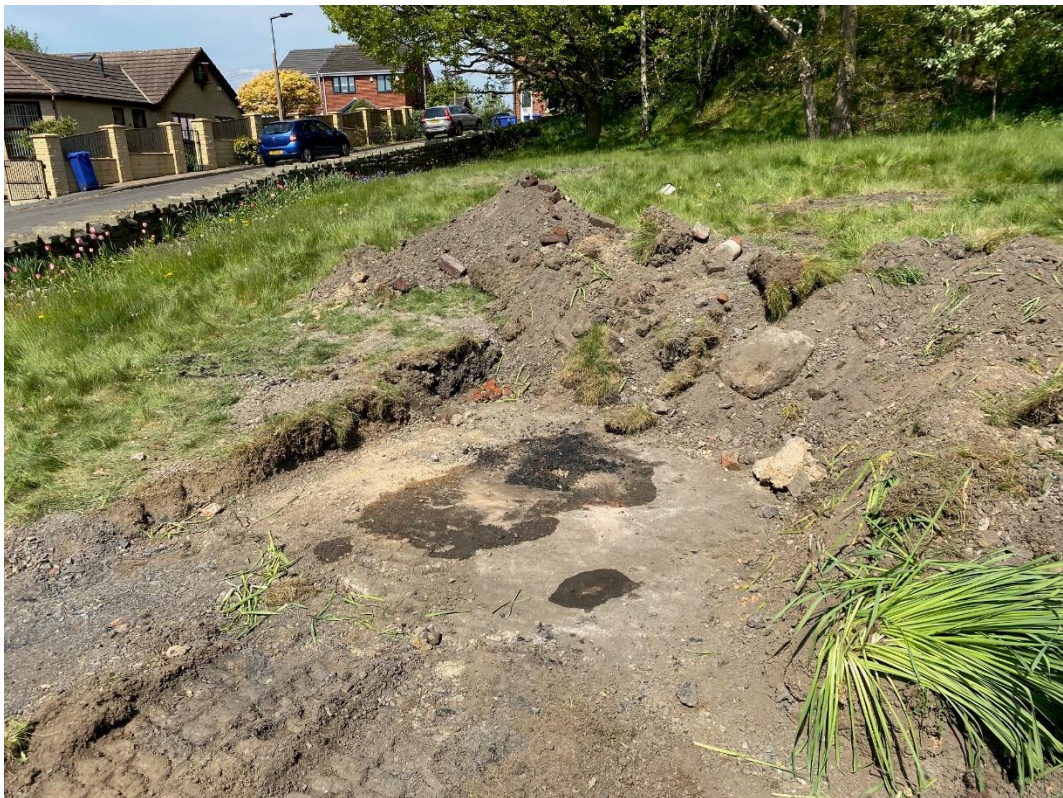
### Appendix 5.5 Site Photographs:

Given the very limited records held by the MRA for this shaft, notably any treatment and/or capping details (and considering the possible presence of a former building foundation from circa 1960), it was felt imperative that we proved the concrete slab was indeed the shaft cap via a probe hole through its centre to check the nature below. A 0.2m diameter core was taken through the slab which proved it to be re-enforced (1 layer of mesh) concrete at the top to circa 0.3m followed by concreted red brick fill to 0.8m which broke up upon follow up probing; proving spoil fill to 7m deep – thus concluding the mine shaft. Gas monitoring equipment was held directly at the hole entrance for a few minutes with no dangerous levels of gases noted. The hole was immediately filled and sealed with bentonite to the surface with concrete re-instated. The shaft cap is illustrated on the attached photographs in appendix 5.5.

- 2) It is usual practice not to build over a mine shaft or to within a line taken at 45° back from where the shaft/cap side intersects rock-head – according to the best practice of CIRIA C758D. Given the proven mine shaft cap of the former ‘Silkstone Main’ mine shaft (MRA ref: 429404-006), and considering depth to competent bedrock around the cap has been determined as 2.5m max., it is recommended that any proposed building foundation should be sited clear of the cap by at least 3m (*of the given OS National Grid References detailed within this report for each corner of the cap*). As the shaft has been proved to be filled, it may be acceptable for soft landscaping (gardens for example) to be maintained (like present) as the use above the cap itself; any other uses, such as hard standings/driveways, over or in close proximity (within 3m), will require the prior design approval from the Mining Remediation Authority (*as owners of the mine shaft and its cap*), who may require other mitigation measures to be carried out to ensure: a) safety for the development from their liabilities; and b) maintain the integrity of their property.
