13<sup>th</sup> December 2019

Ref C359/02/ATS

**Ref: Shallow Mining Investigation on Land Adjacent to 9 Reasbeck Terrace, Barnsley, South Yorkshire.**

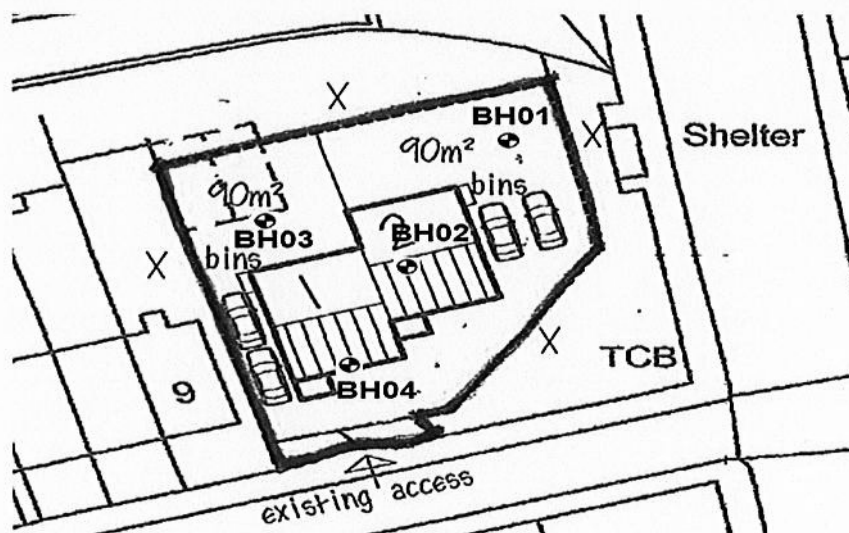
The locations of the exploratory holes are shown below.

Borehole BH4 lost flush between 9.5 m and 10.5 m bgl. The driller noted 'juddering' of the rods on site when the flush was lost, but also resistance to drilling i.e. "solid ground", and has recorded fractures on his logs over this depth range.

While flush was lost within one of the boreholes (BH4 between 9.5m and 10.5m bgl), no evidence of voided strata was noted during the drilling. The driller has recorded the ground as fractured over this depth range

However, given the presence of fractured ground, it is considered prudent to place reinforcement within the foundations such that any zones of weakness can be spanned without any detrimental effect on the property. The foundations should be designed by a suitably qualified structural engineer.

Whilst no mine entries are shown in the immediate area, there is a possibility, although considered to be very low, of a shaft or adit(s) present, as the coal is relatively shallow beneath the site. It is therefore recommended that a watching brief is maintained during the development work, and that all natural surfaces exposed during construction of the foundations are examined by a suitably qualified person, for evidence of such entries.

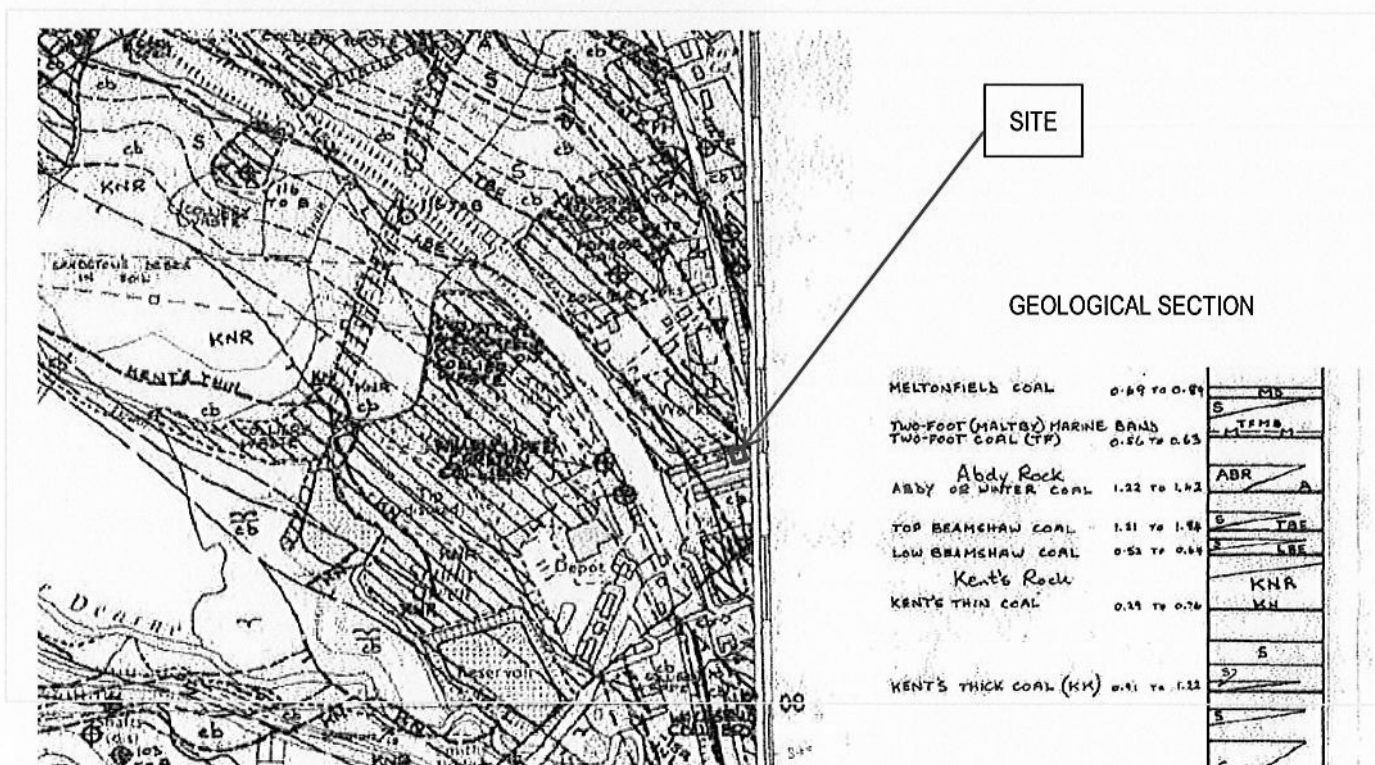
**Figure 4 Geological Map Extract (Sheet SE30NW 1:10,000)**

- 3.5 Both geological sheets show the site is positioned on the vertical section just below the Top Beamshaw coal (TBE), meaning the Low Beamshaw coal (LBE) seam to be outcropping close to the south-west of the site, dipping beneath the site at probable shallow depth. The vertical geological section indicates the LBE to be between 0.52m to 0.64m thick.

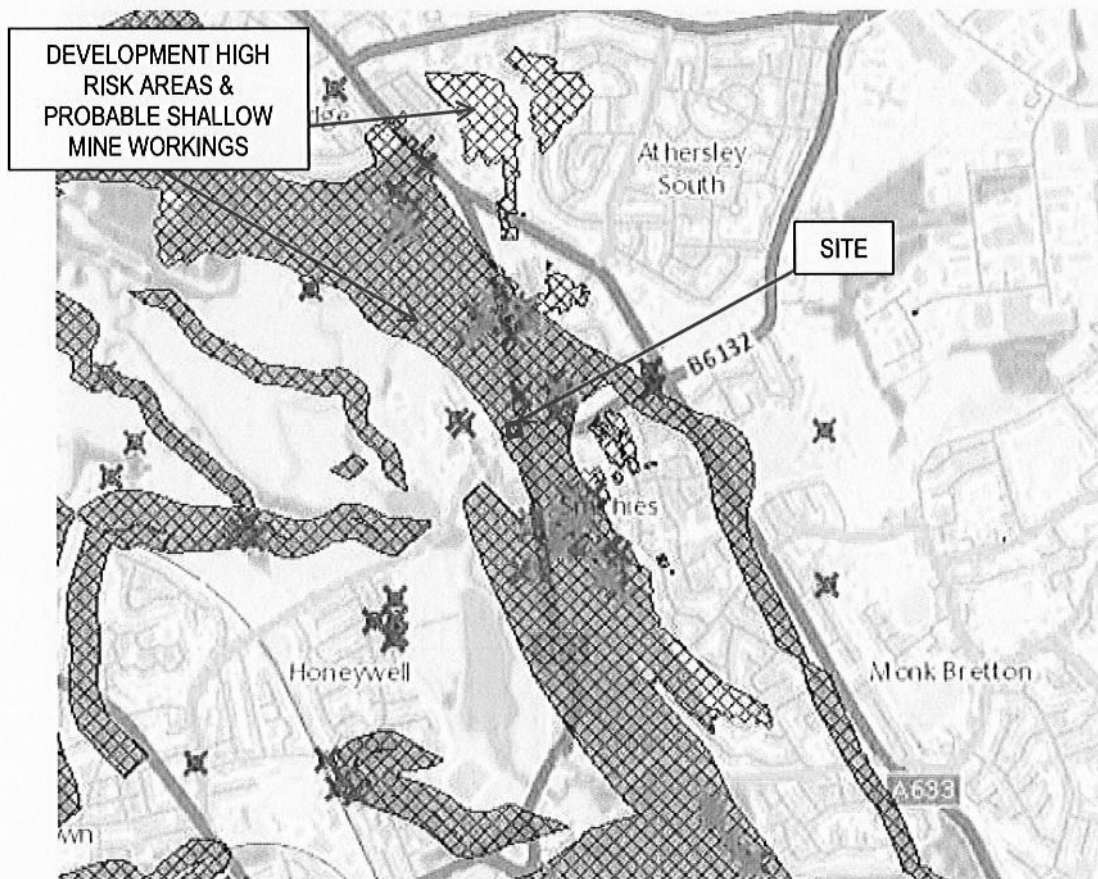
**Figure 5 Development High Risk Area, Past and Probable Shallow Coal Workings**

- 3.18 There is a property within 50m of the site – a house on the south side of Reasbeck Terrace that has a claim for subsidence against the Coal Authority.
- 3.19 There is a one property 331m to the south-east with a mine-gas incident.
- 3.20 The Coal Authority Interactive Map Viewer (Figure 5) shows the site to be located within a Development High Risk Area associated with probable shallow coal mine workings.
