**PROPOSED INTERNAL ALTERATIONS  
TO ATTICS  
TO CREATE  
ADDITIONAL HOTEL ACCOMMODATION  
AT WORTLEY HALL, WORTLEY,  
SHEFFIELD S35 7DB**

**WORTLEY HALL LTD.**

**Fire Compartmentation and Separation Strategy**

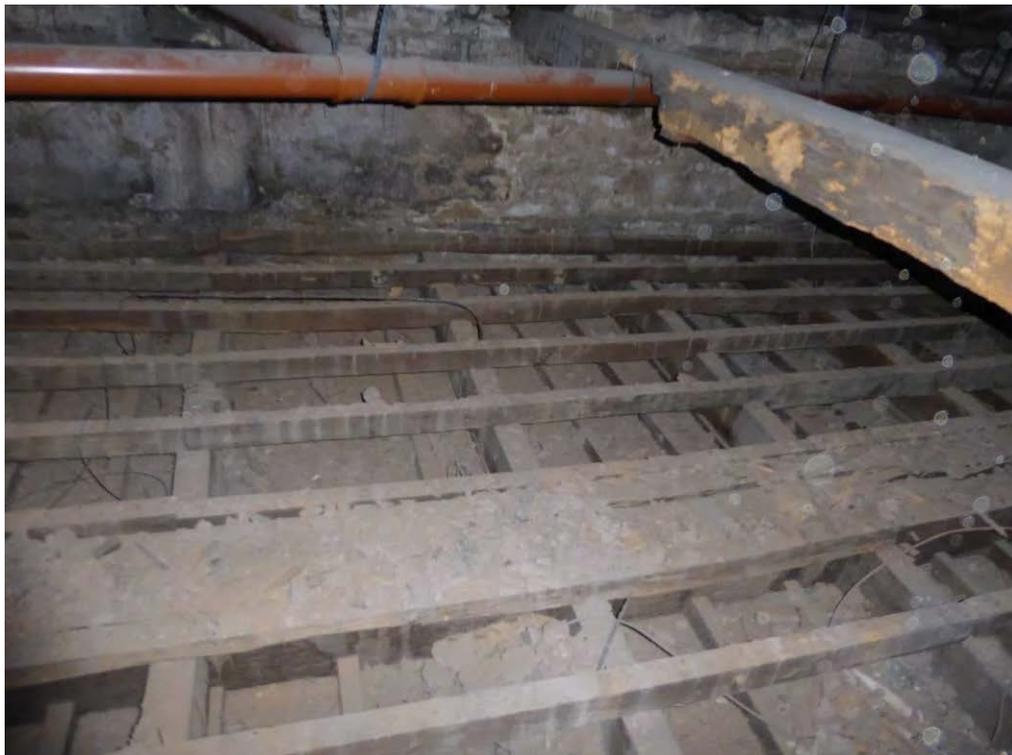
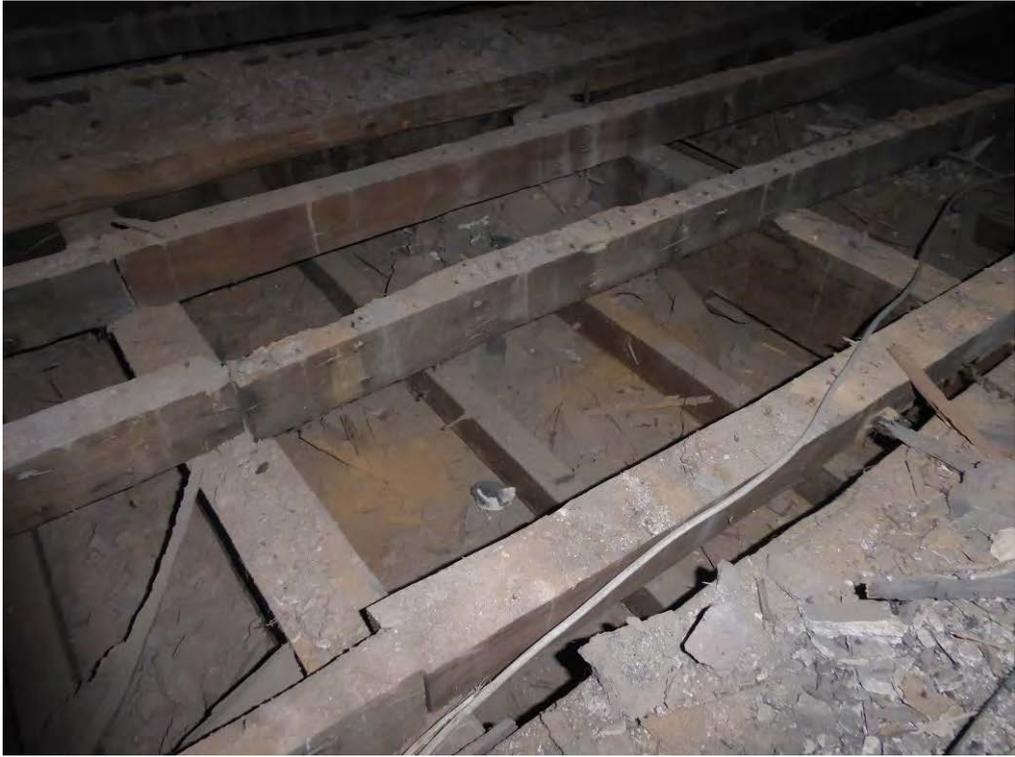
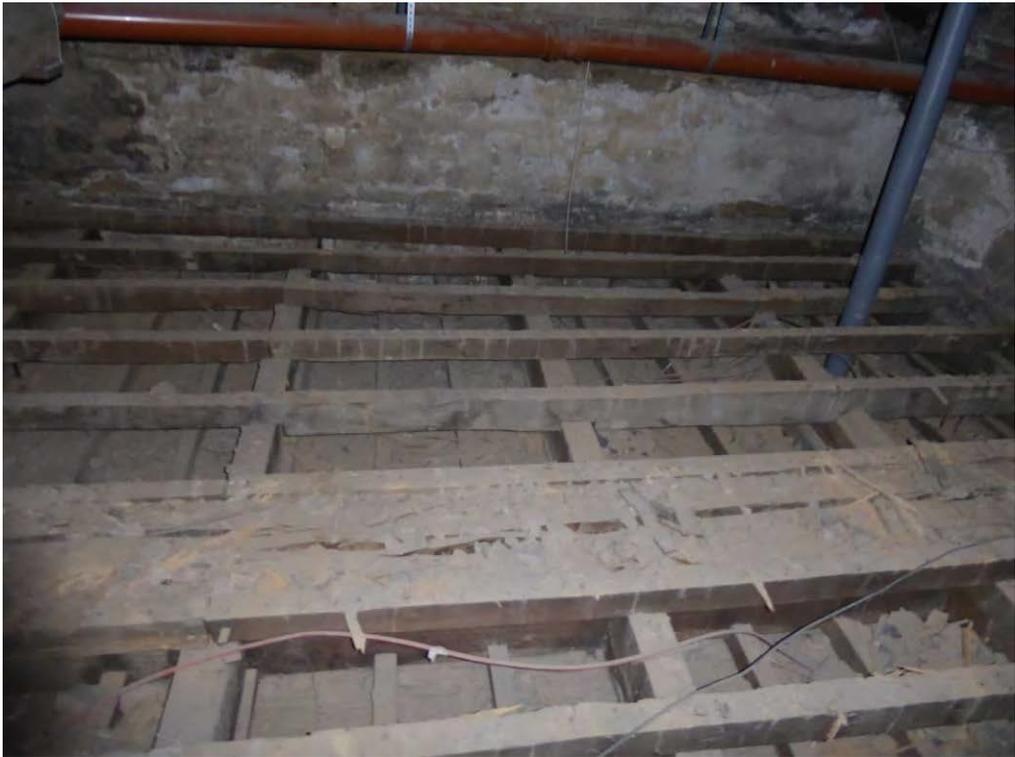
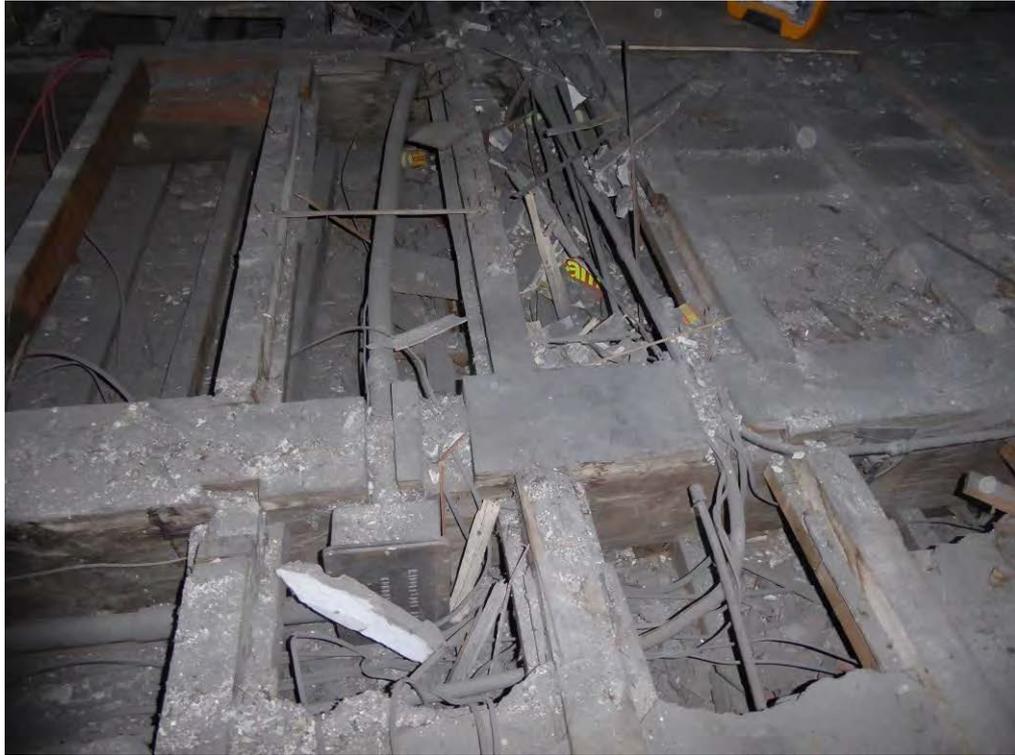
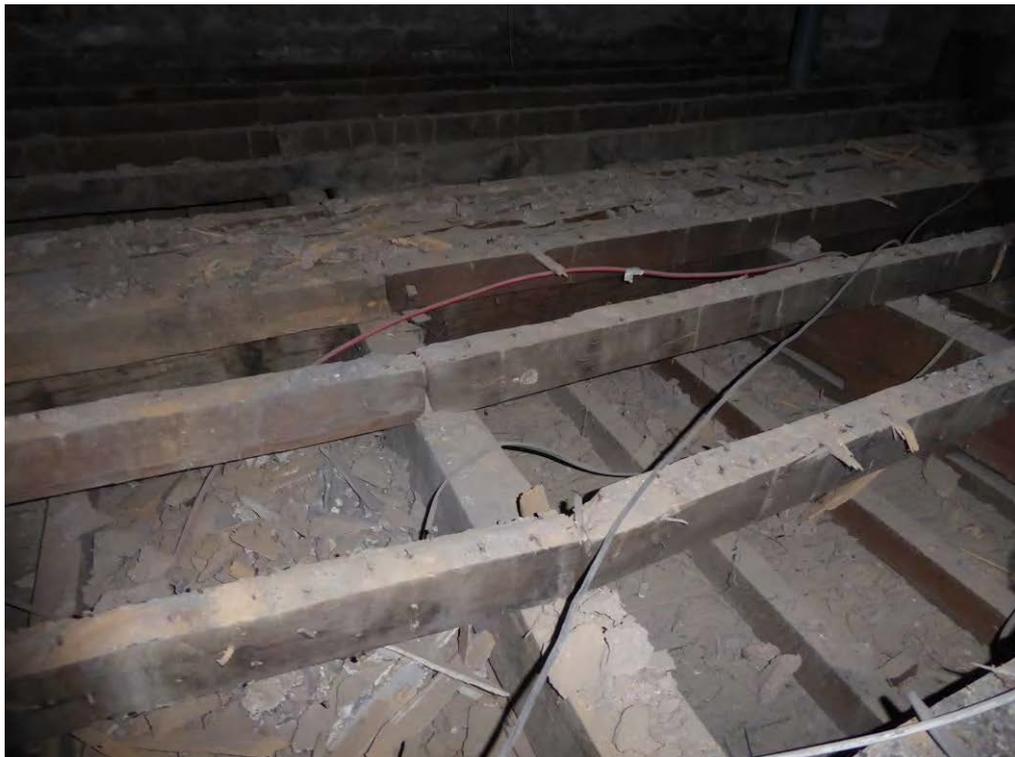
In the **Roof Void** beyond this truss to the West the floor structure (as Detail A, Drawing D/02) comprises **joists** to a lower ceiling being 200mm deep x 100mm wide at approximately 1000mm centres. The **joists** running North South across those are 85 x 75mm at 400mm centres. The **ceiling joists** to below (defining a void from the top of the floor joists to the topside of the plaster of 360mm) are 50 x 75mm at 300mm centres. In the space there is also a section of substantial beam which looks like a composite of some sort about midspan. The **floor joists** are 1 third/2 thirds morticed bearing onto some of the substantial timbers. The principal beams run East/West.

There was originally a lime ash floor to this space, which was regrettably broken out by the Contractor prior to my detailed inspection.

**Pugging existing and in good condition:** Leave, calculating that the combined existing lath and plaster ceiling and the pugging as described will achieve 60 minutes fire resistance – structural and integrity.

**Where pugging is missing/destroyed:** Clear all debris, then relocated existing (or supplement with new) battens supporting pugging down to align with bottom face of floor joists/beams. Over battens, fit Karma TMF70 Stone Fibre Batts (Appendix D), to align flush with the top face of the floor joists/beams, sealing the joists between the batts and sides of the joists/beams (as possible) with Karma EX240 sealant (Appendix D).

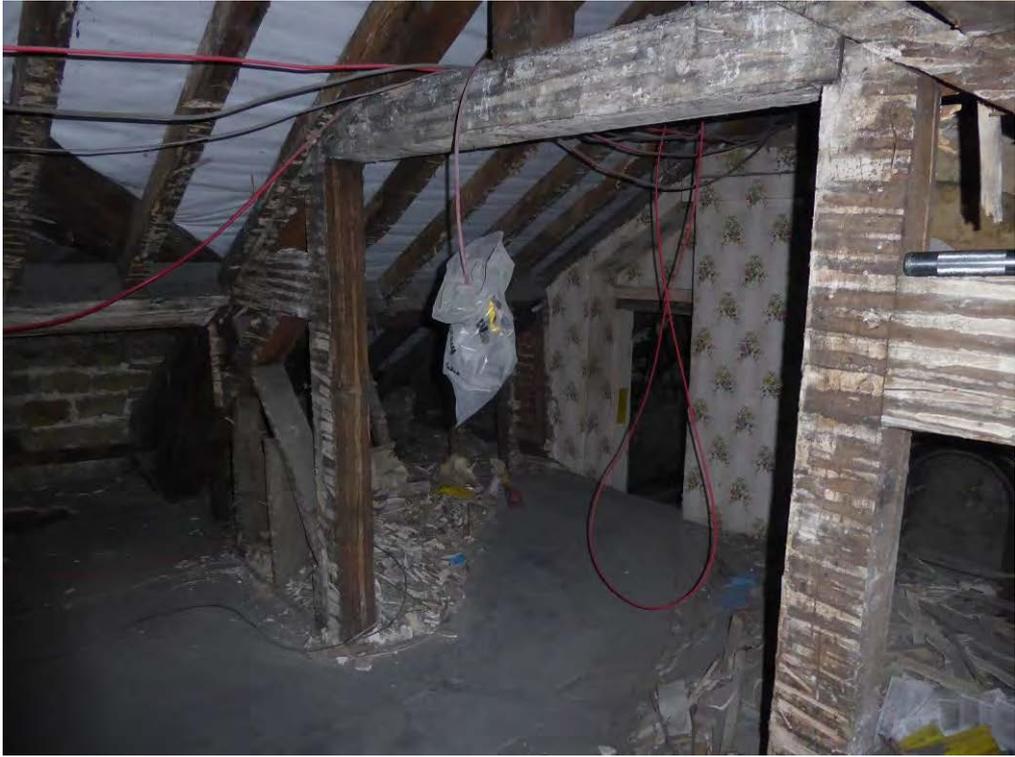
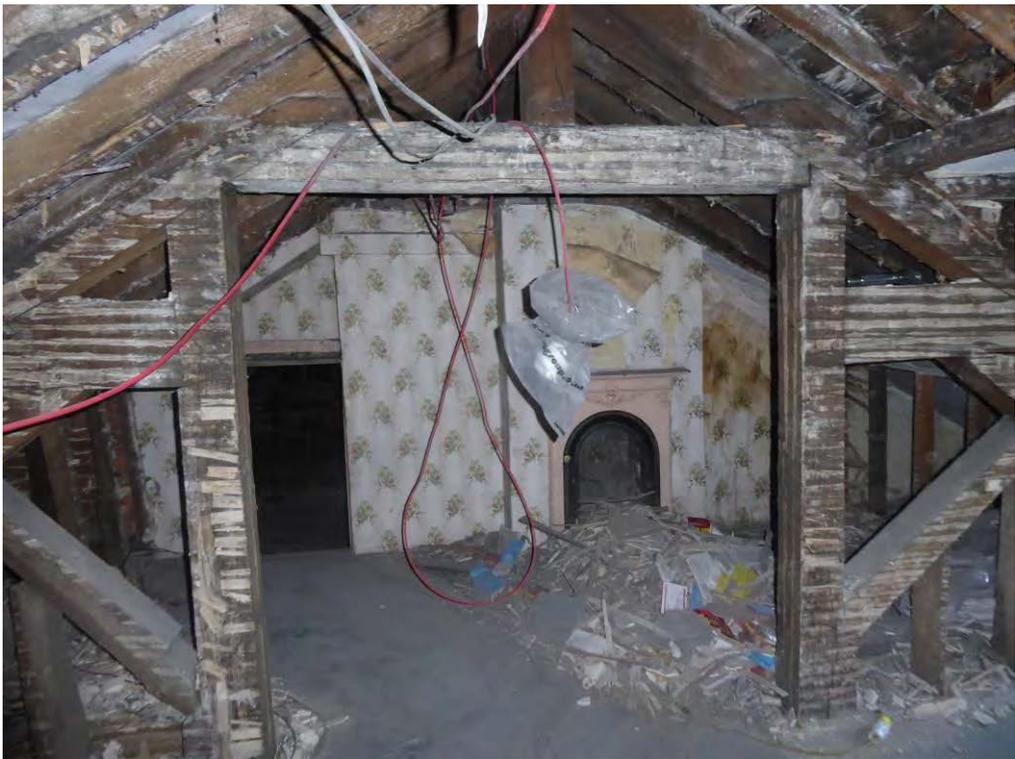
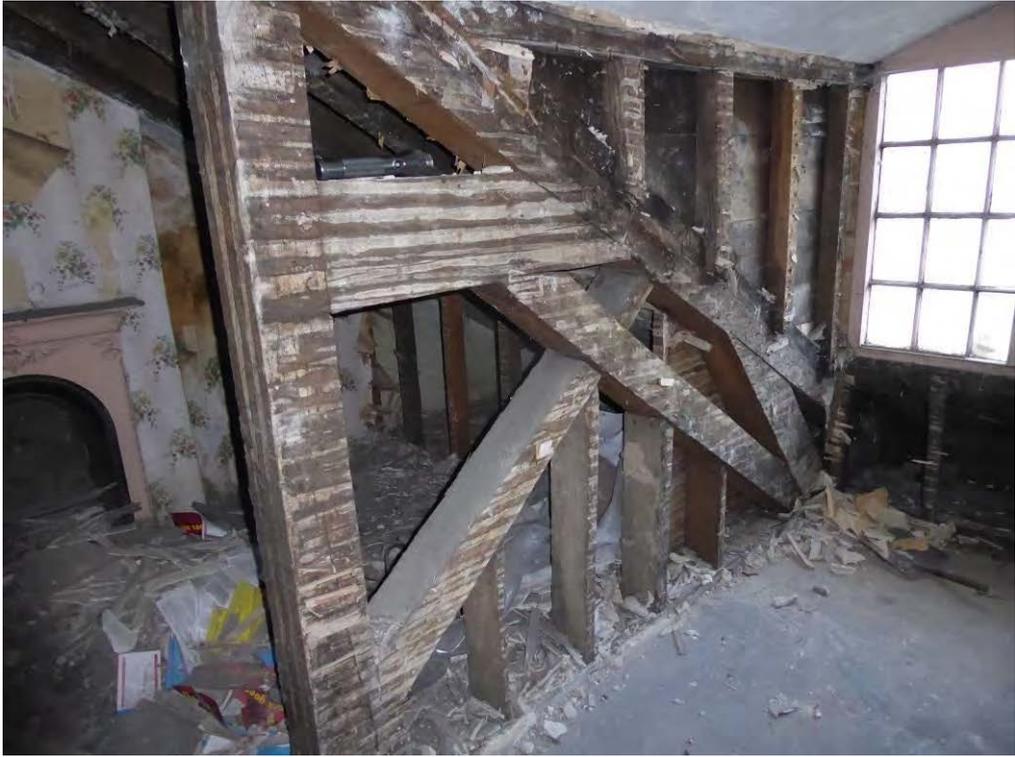
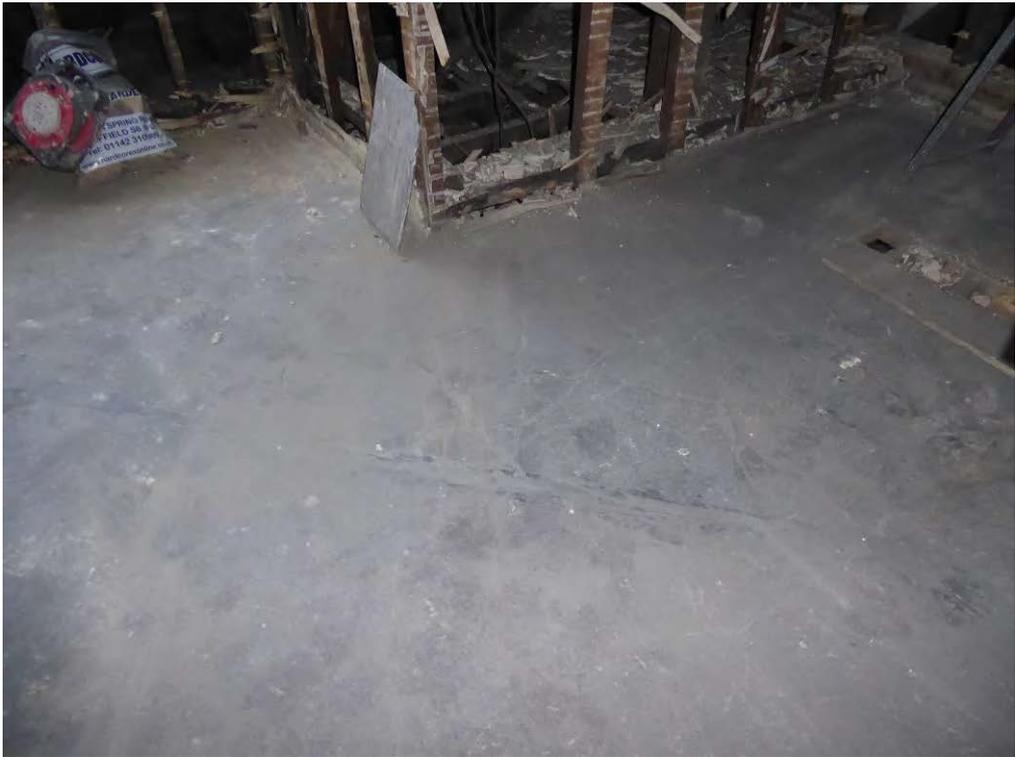
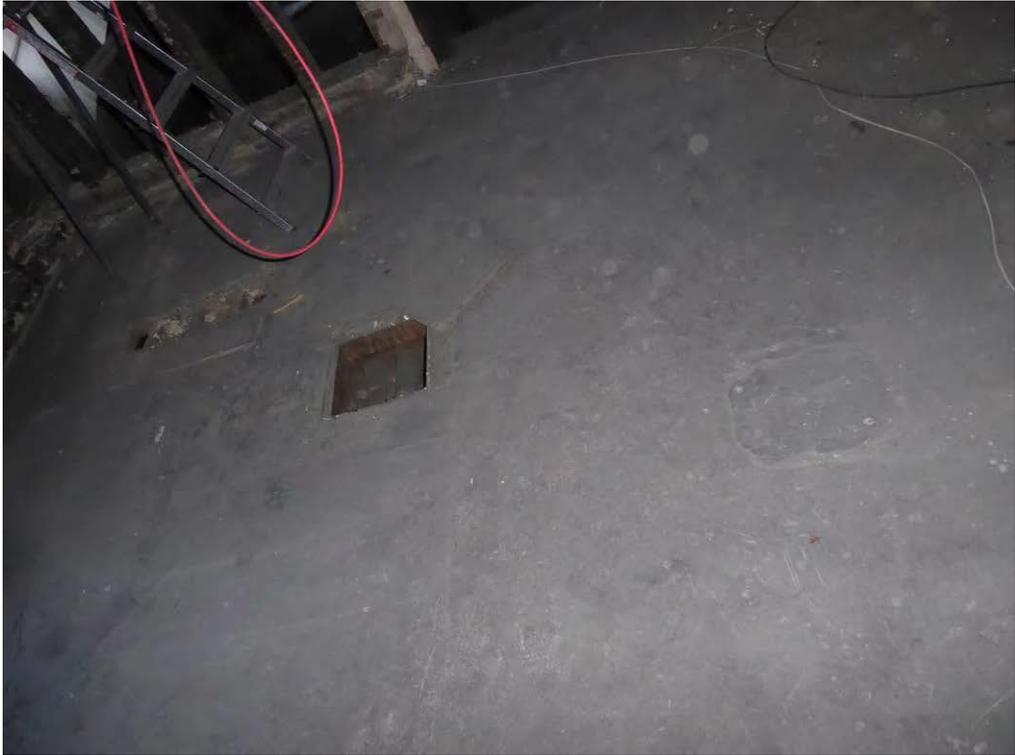
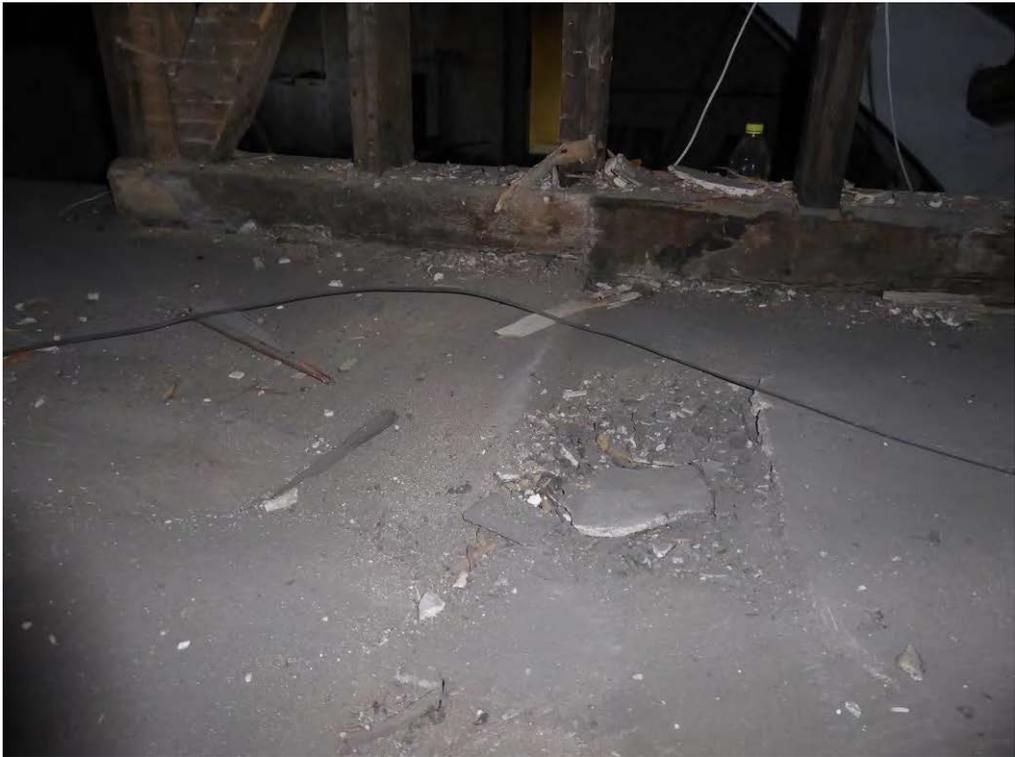
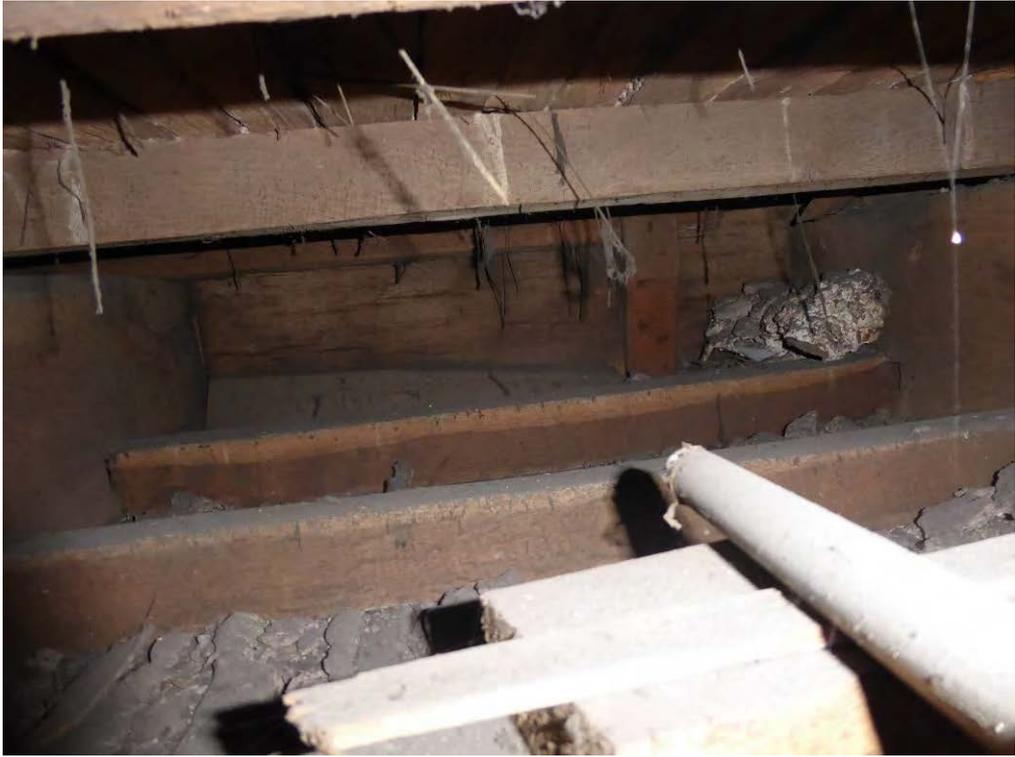
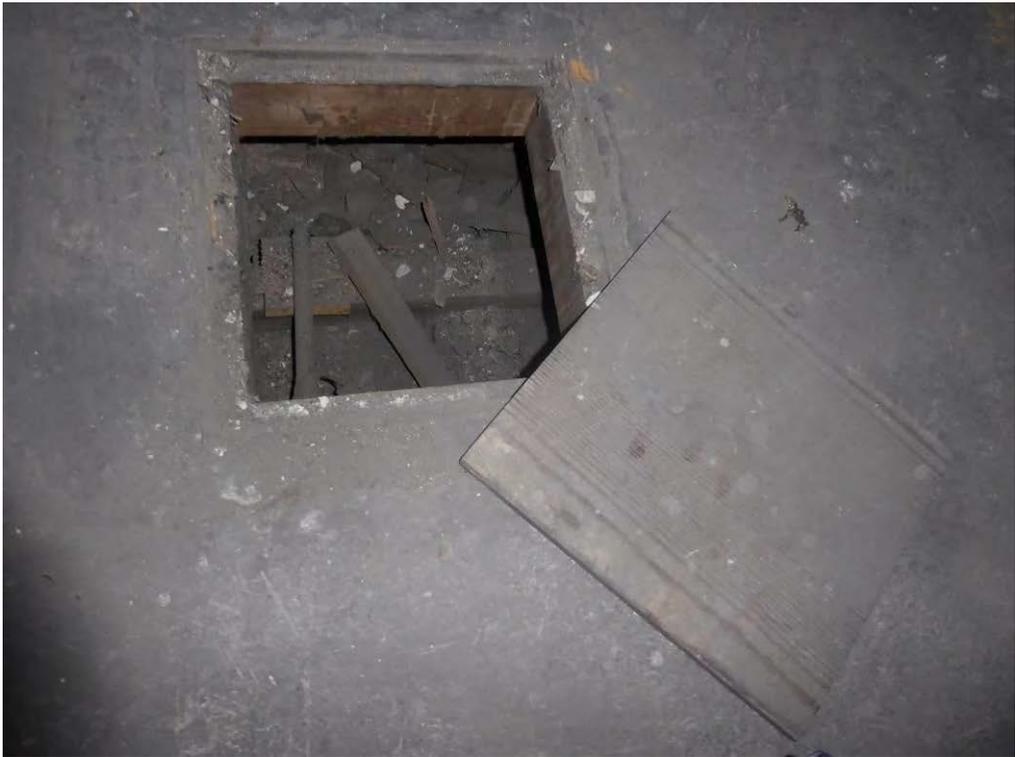
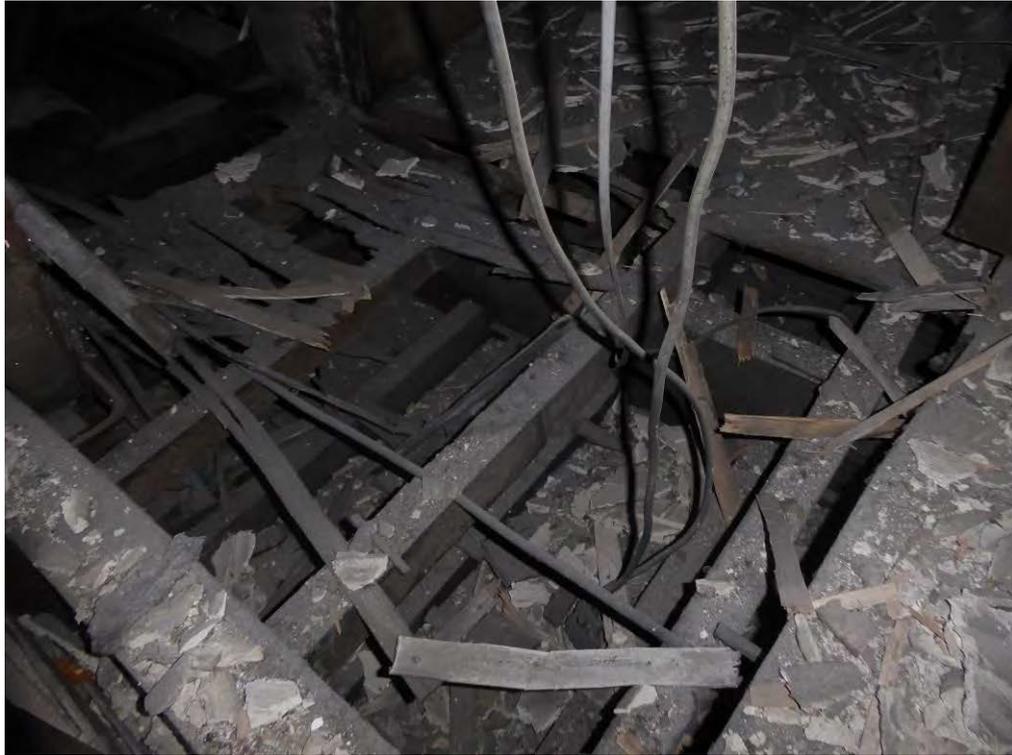
Exposed chimney with stonework built into the brickwork. Some salting. Obviously been water penetration as the plaster below is damaged.

A cupboard broken out in the North East corner of the space shows the **double floor construction** to below. There is another trap in the middle of the floor but this is less instructive. A hole has been broken under the roof void area which shows the same 32 mm lime ash flooring though again it is not possible to see any lath here as yet.

The lime ash floor finish itself does bow and dip about a bit and there is a substantial cracked area which has previously been repaired with cement running from an infilled service trench. This material appears to have been overlaid on the original work below so presumably this is actually some sort of Victorian insertion of sand screed cement very much like that in Bedroom 3. The original work in the South side of the room is broken up where it comes to the wall and presumably there has been damp and when it's been enclosed behind plaster in the modern era.

In the former cupboard space in the North East corner where the cupboards have been broken out and the floor structure is exposed, it can be seen there are substantial **beams** though not collars to the trusses which with a sort of cantilevered detail which seem to be in the order of 300 x 100 mm but it is not possible to see the one next to it, so they will be set out at very large centres.

The **floor joists** above are at approximately 1m centres. The depth of them is indeed 100 x 250mm.

The **ceiling joists** below also spanning East/West as do the floor joists are the same 75 x 100mm at 320 mm centres. Only the top side of the plaster soffits can be seen.

**Where pugging is missing/destroyed:** Clear all debris. Cut back any remaining pugging to centre-line of floor joists to either side and fix stop battens to the top of the beams to the depth of the lime-ash floor/pugging (as shown on Detail F – Alternative). Then relocate existing (or supplement with new) battens supporting pugging as necessary to allow for fitting Karma TMF70 Stone Fibre Batts (Appendix D), to align flush with the top face of the lime-ash floor/pugging, sealing the joists between the batts and sides of the stop-battens (as possible) with Karma EX240 sealant (Appendix D). Over batts, lay new floor boarding on geotextile layer as remainder of room.

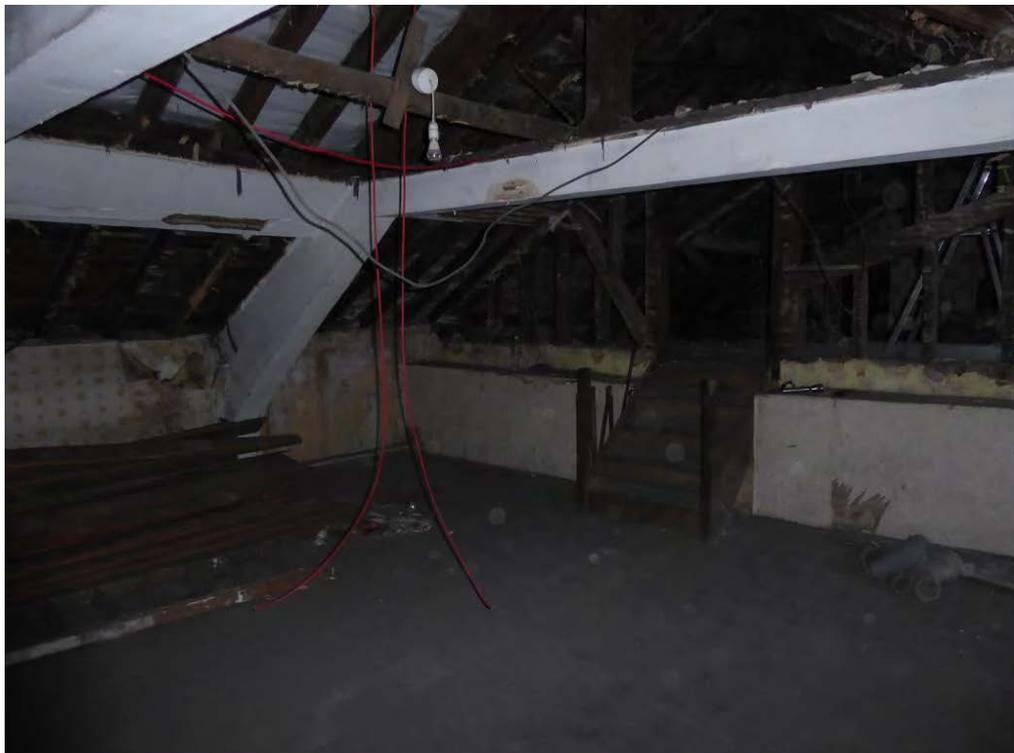
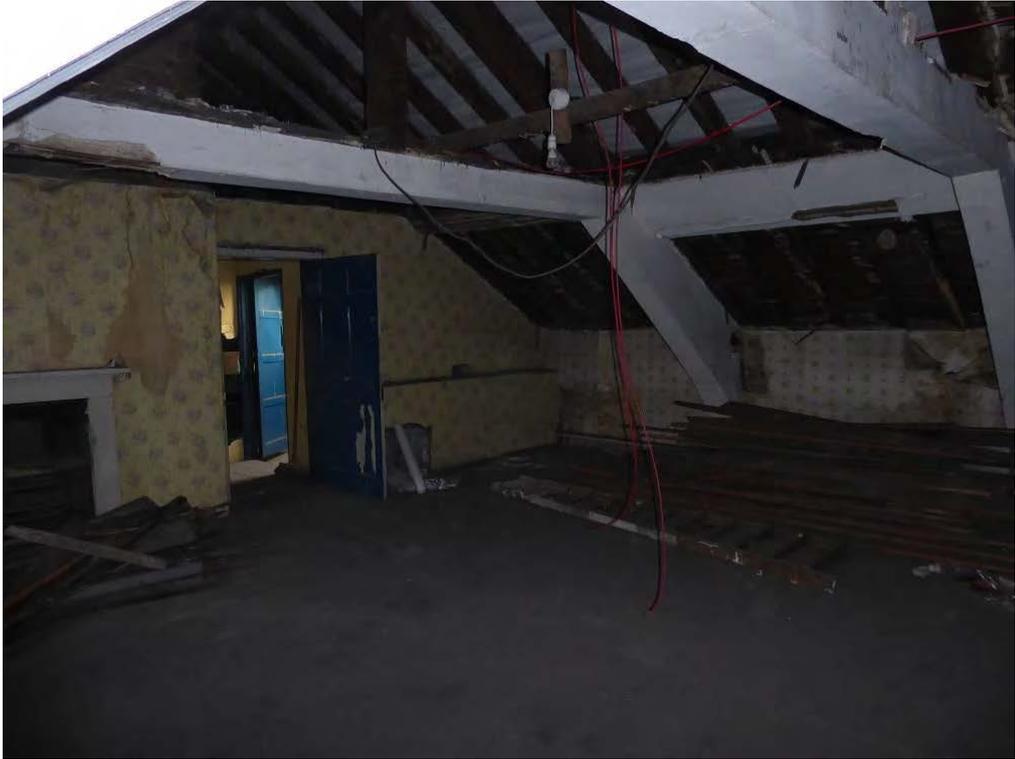
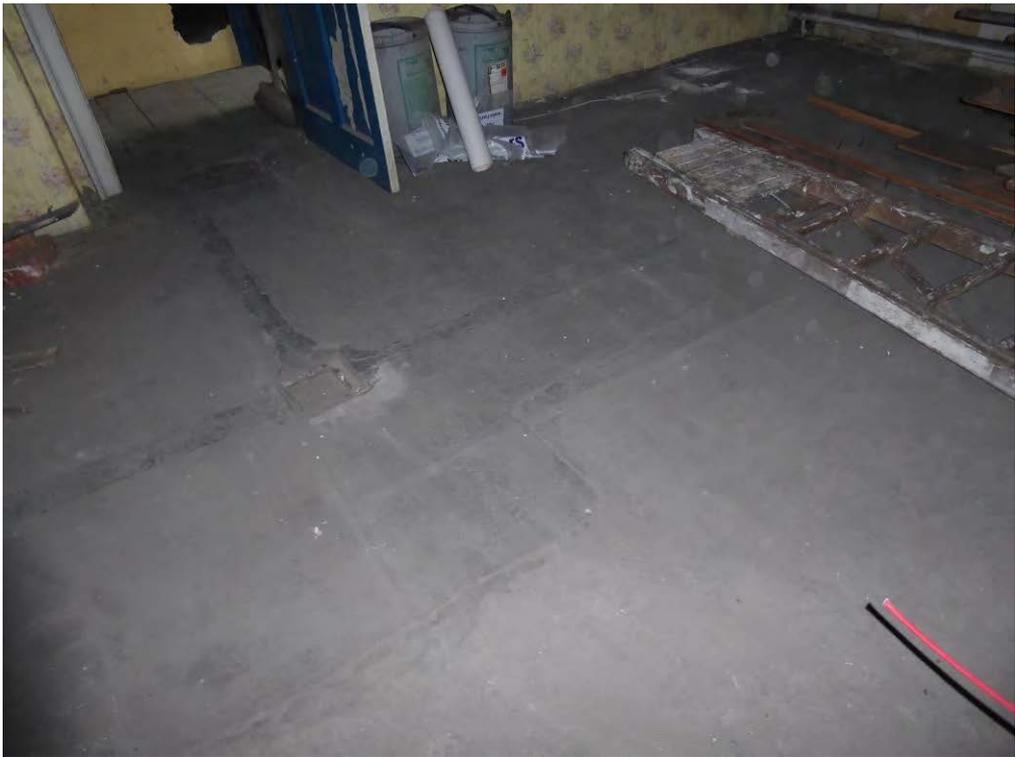
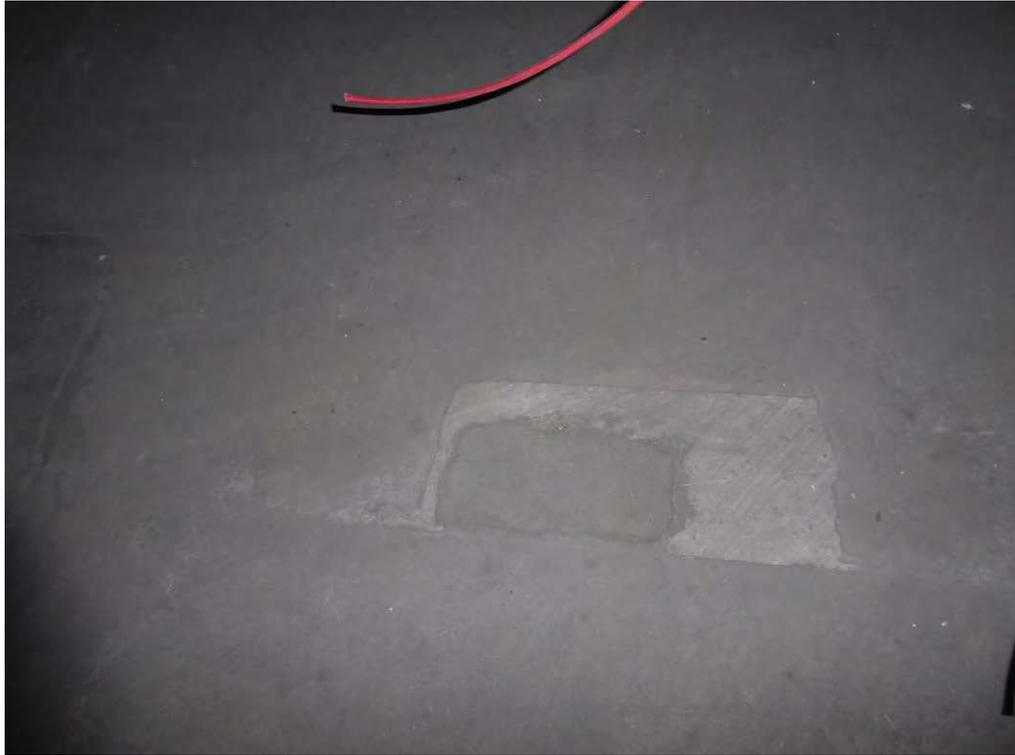
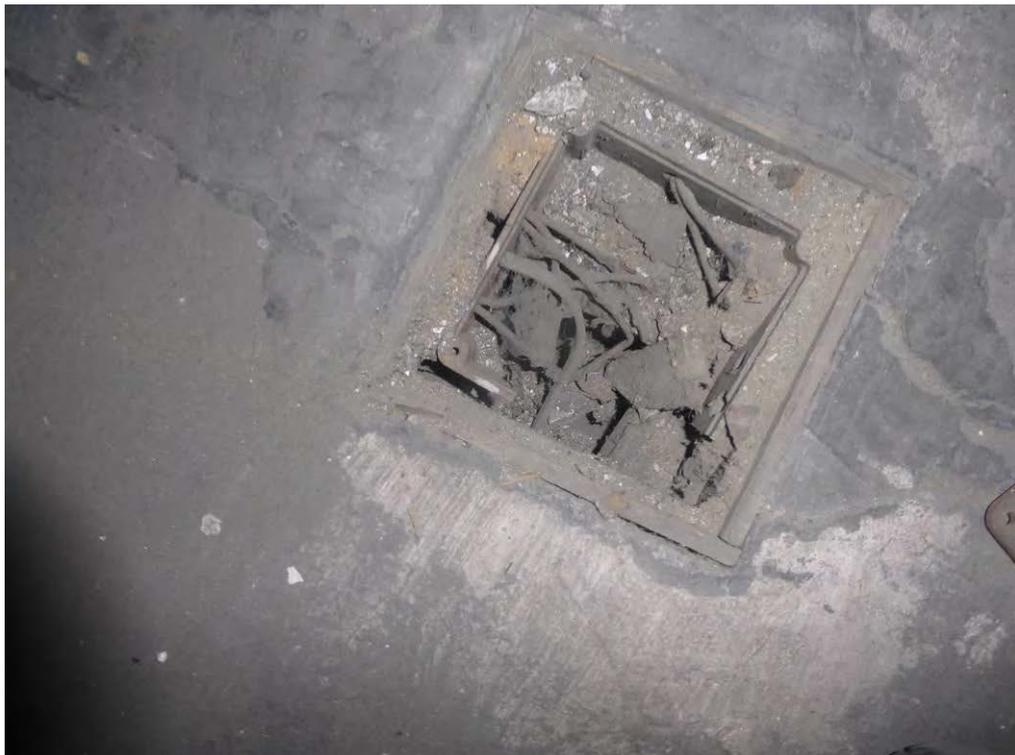
Probably going to be the most problematic to ensure Building Regulations compliance as the lime ash **floor** is in generally adequate condition throughout. I believe in fact it is a Victorian overlaying. No holes in it to be able to find out but there is one service trap and another infilled presumably former service trap hole.

Fireplace to be retained presumably with its hearth which is now integrated at the same floor level as the lime ash.

Floor to ceiling from the underside of the truss collars to the top of the existing lime ash is only 2070 mm. Where the plaster casing has been removed at one end it can be seen that the lath and plaster there is probably of an overall thickness of something like 20 mm, so if that was removed it would give clear height of 2090 mm.

**Upgrading Strategy:**  
(as Detail F, Drawing D/02)

Damaged/missing floor areas: to be repaired and upgraded as described for Bedroom 4.  
Undamaged areas: overboard etc. as Bedroom 4.

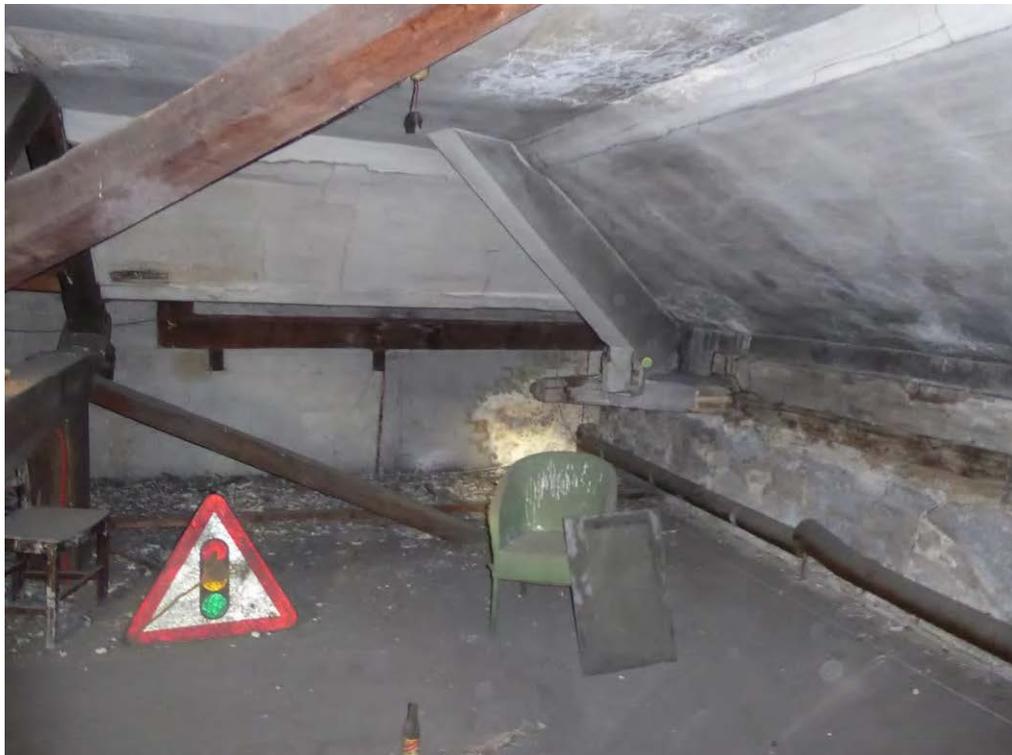
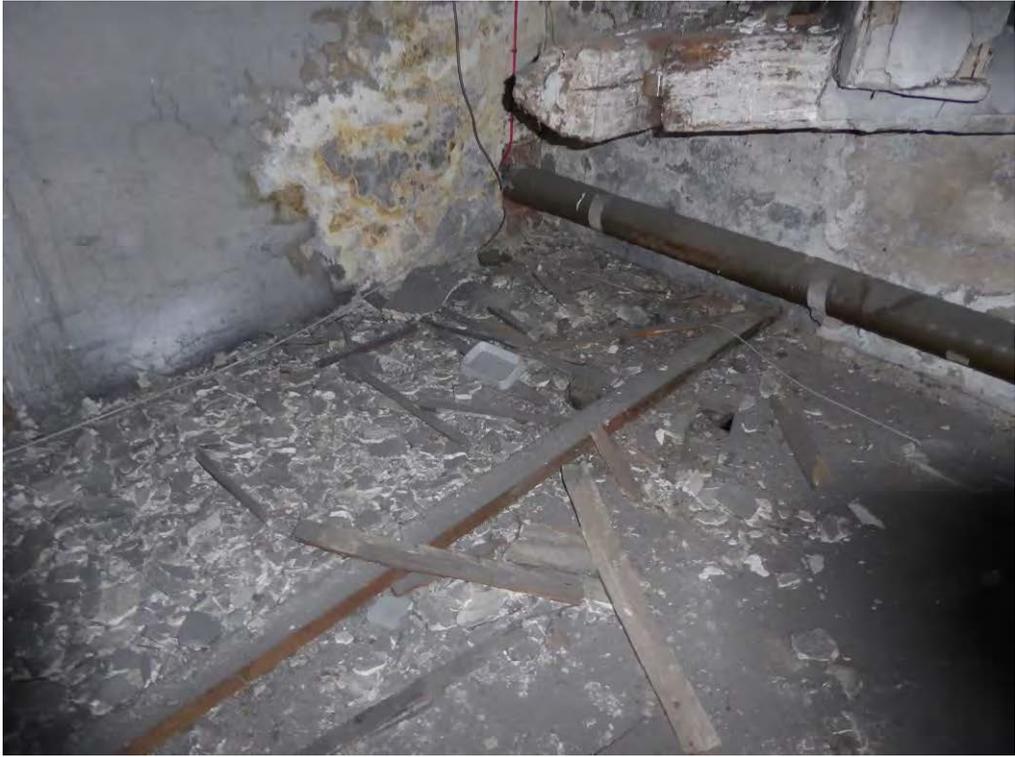
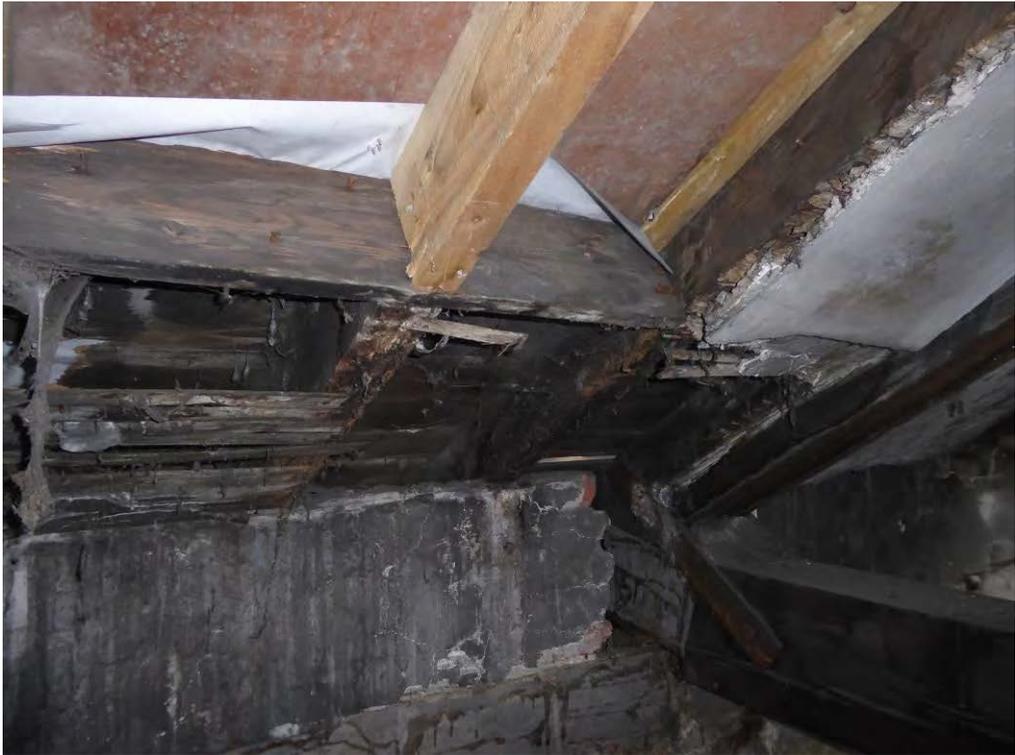
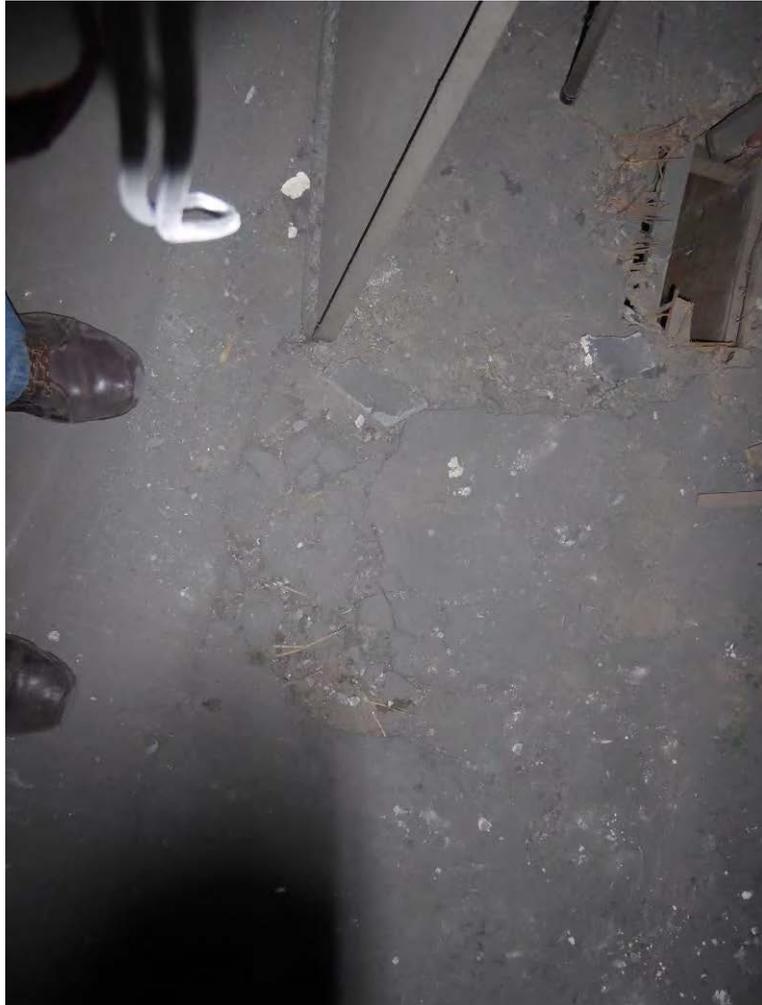
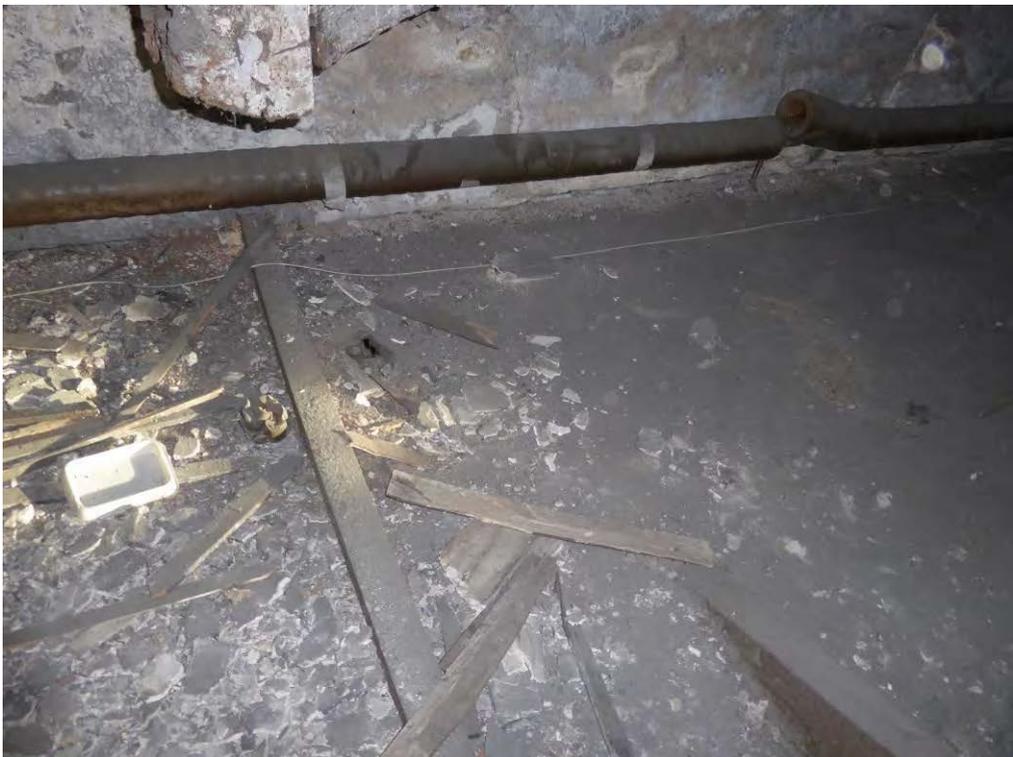
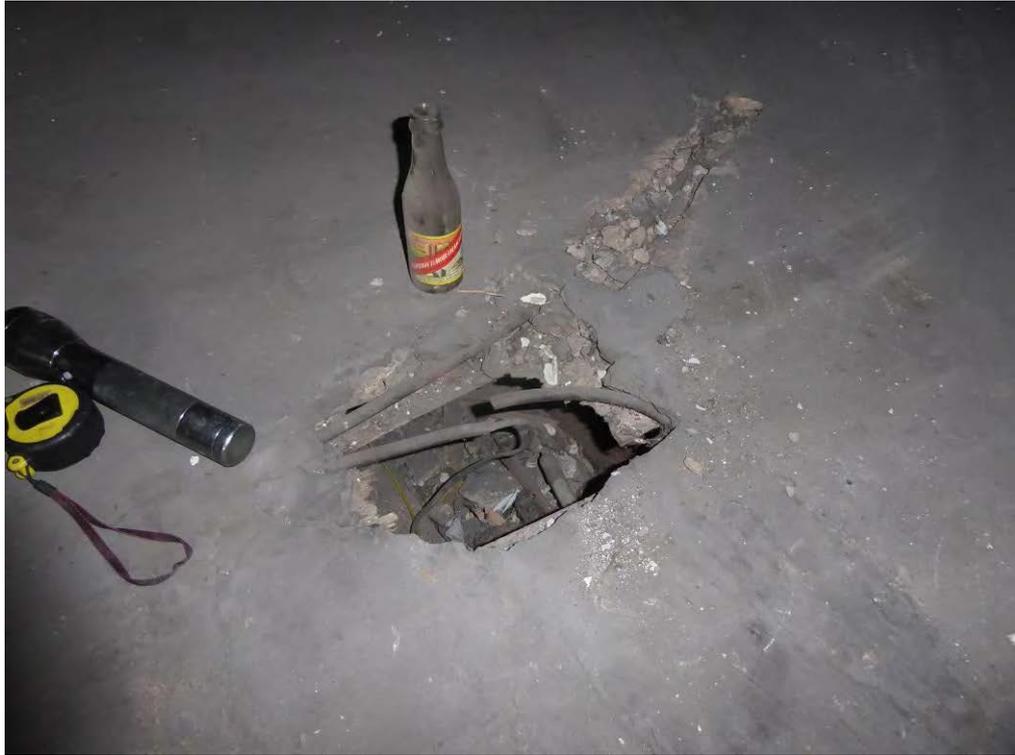
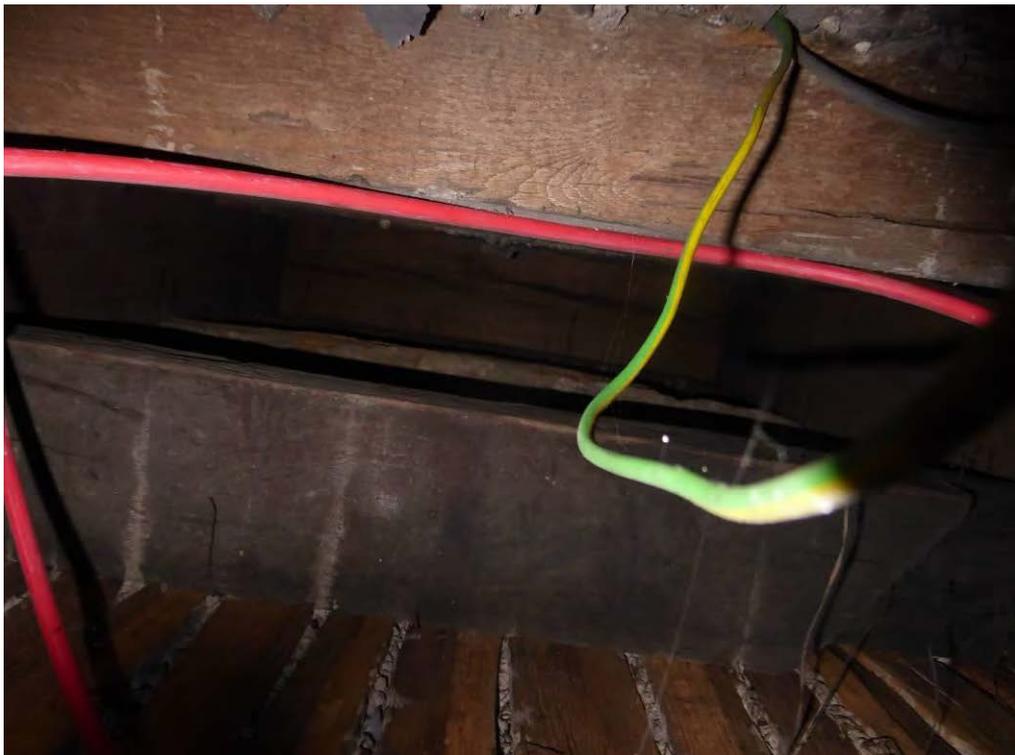
Certainly, part of the original earliest phase of the construction of the house. Fabric in very poor condition following a lot of water penetration in the South East corner leading to deathwatch beetle infestation of the timbers. Decay of the original plaster which had been limewashed. Wallplate in poor condition. Wall directly underneath a gutter. Deathwatch beetle infestation around the existing rooflight. Part of the ceiling is still underdrawn. Sagging ceilings probably need underboarding. New rooflights are to go in.

The **floor** construction is lime ash in actually much better condition than when previously discussed. A lot of debris from reroofing presumably in the North area. Decayed dragon tie now not supported any more. Collar onto a post to come down to create level access and to remove part of the canopy there.

Inspection of the floor void could only be made by "hidden" photographs taken into openings, as the pugging is mostly still in position. Lime ash actually not in bad condition, cracks in it, services installations caused trenches through it.

Large heating pipe around the perimeter to be dealt with.

**Upgrading Strategy:**  
(as Detail F, Drawing D/02)

As for Bedrooms 3 and 4 for undamaged and damaged areas of existing pugging, which is to be retained as possible.
