**PROPOSED INTERNAL ALTERATIONS  
TO ATTICS  
TO CREATE  
ADDITIONAL HOTEL ACCOMMODATION  
AT WORTLEY HALL, WORTLEY,  
SHEFFIELD S35 7DB**

**WORTLEY HALL LTD.**

**Fire Compartmentation and Separation Strategy**

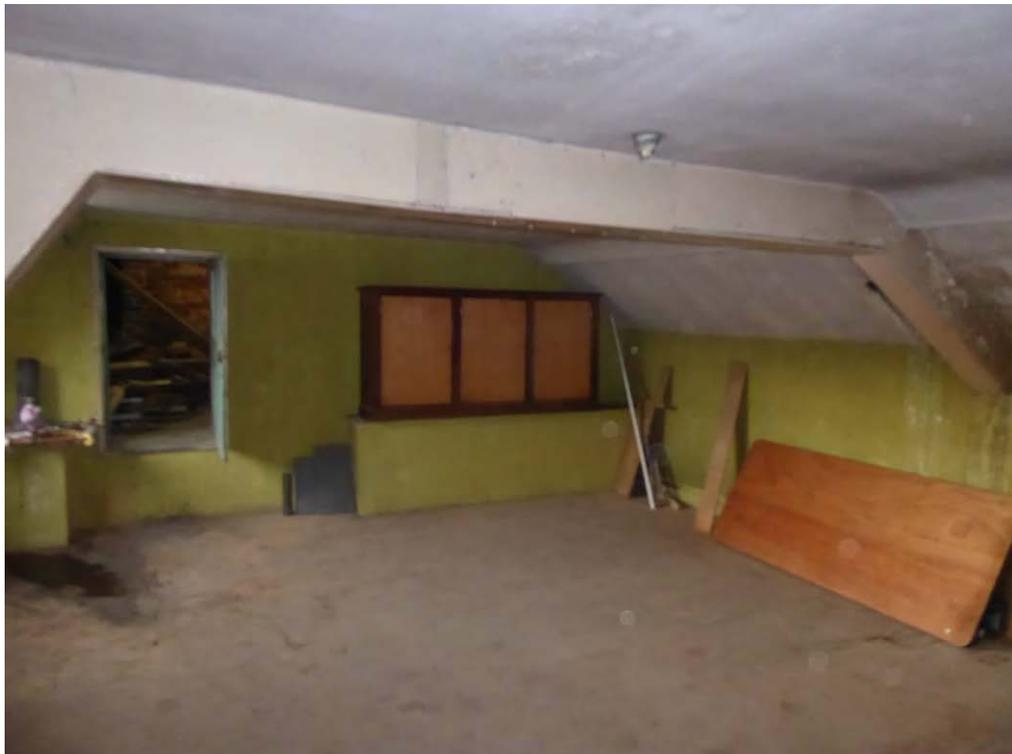
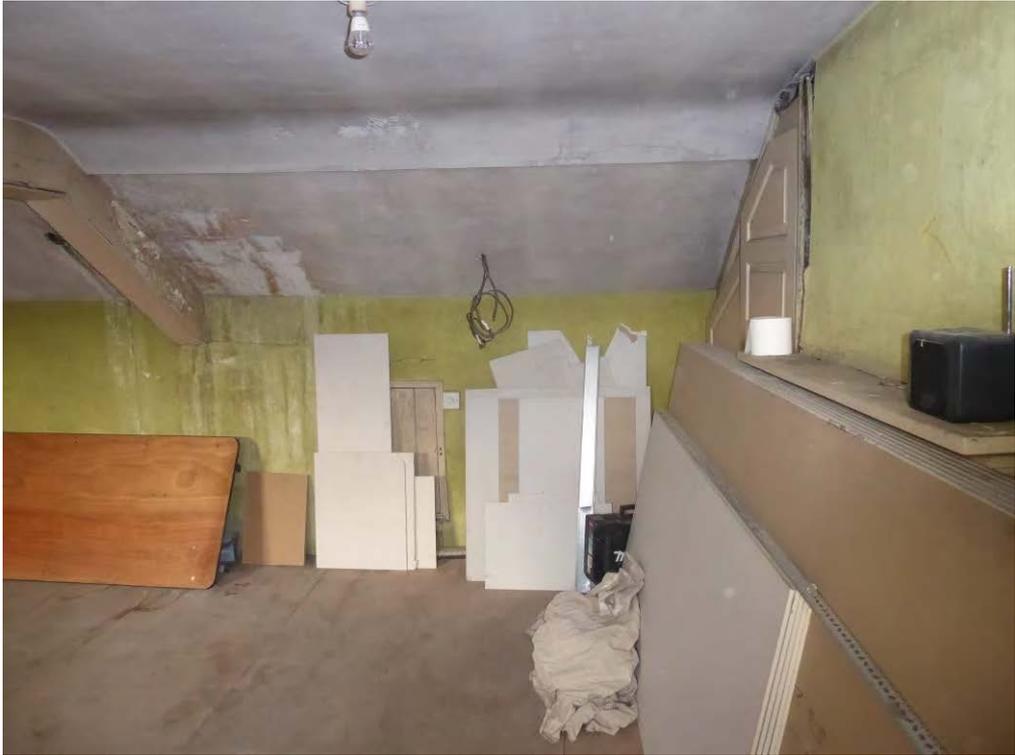
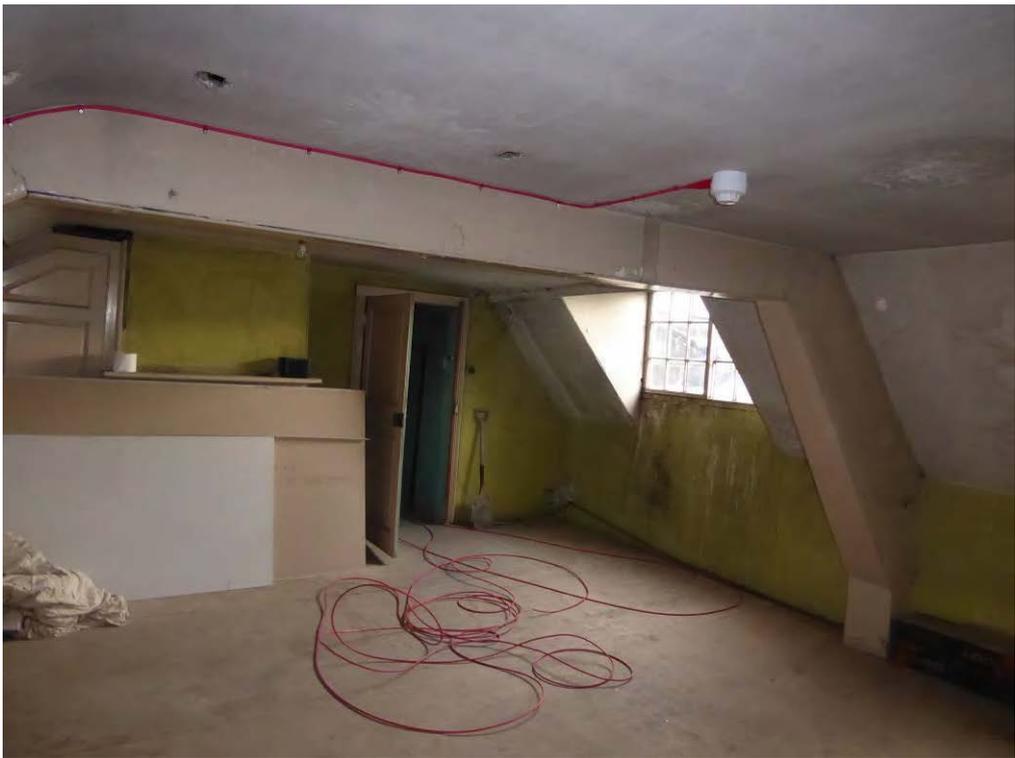
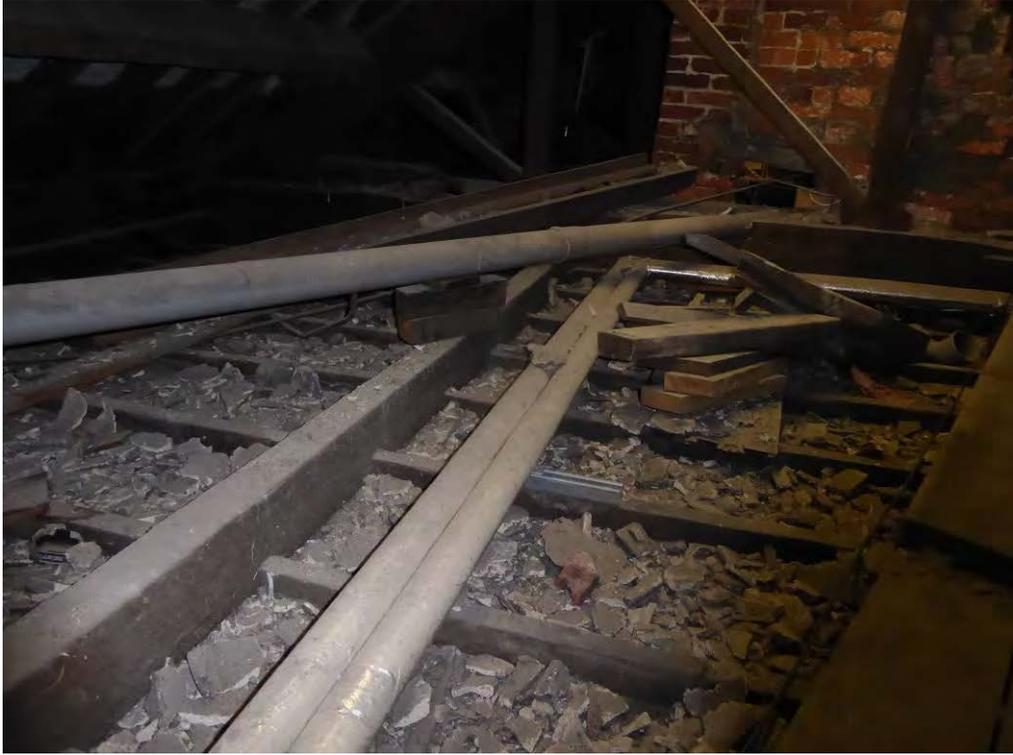
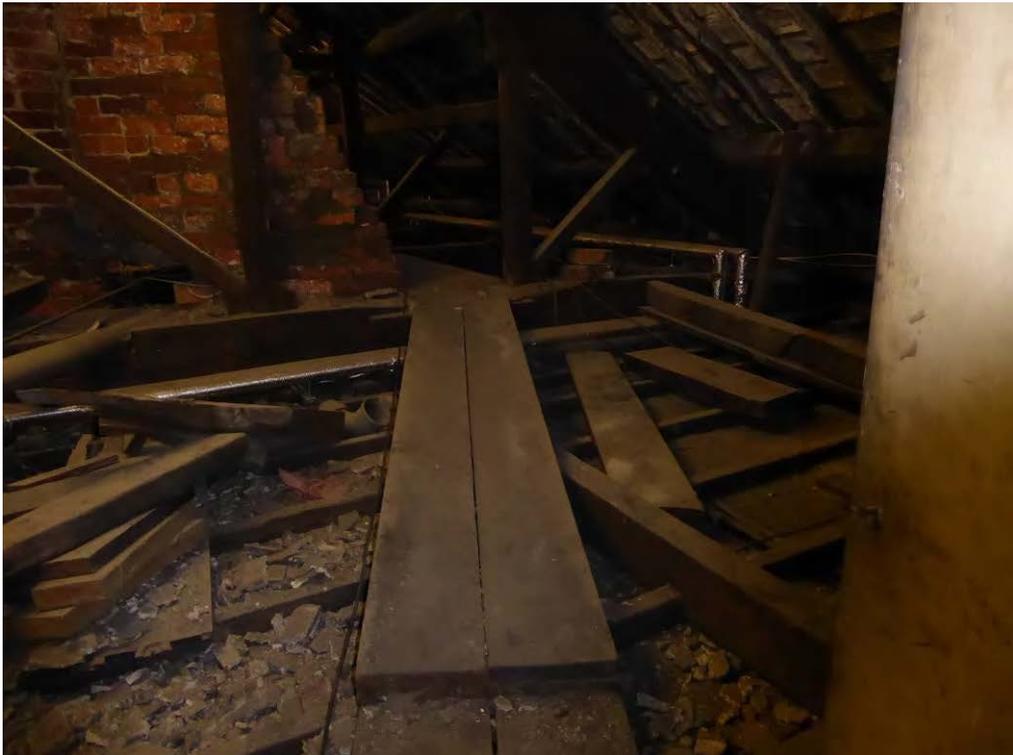
In that present Roof void (proposed Bathroom) there are floor joists running North to South which are 50 x 75 mm at approx. 460 centres. These span something in the order of 1960 mm from beams to beams running East/West, from the solid partition wall to the collar of the first truss around the back of the curved chimney stack, and these are 120 x 200 mm deep. No floor joists, presumably those will go over those larger beams.

The space between the top of the ceiling joists below and the top of the beams/floor joists here at present is 140 mm.

**Upgrading Strategy:**  
(as Details H & J, Drawing D/02)

**Bedroom:** Retain existing plywood overboarding of existing pugging over double floor/ceiling construction, and apply new floor over, as Bedrooms 2, 3 & 4. Feather off ramp in access corridor from stair head.

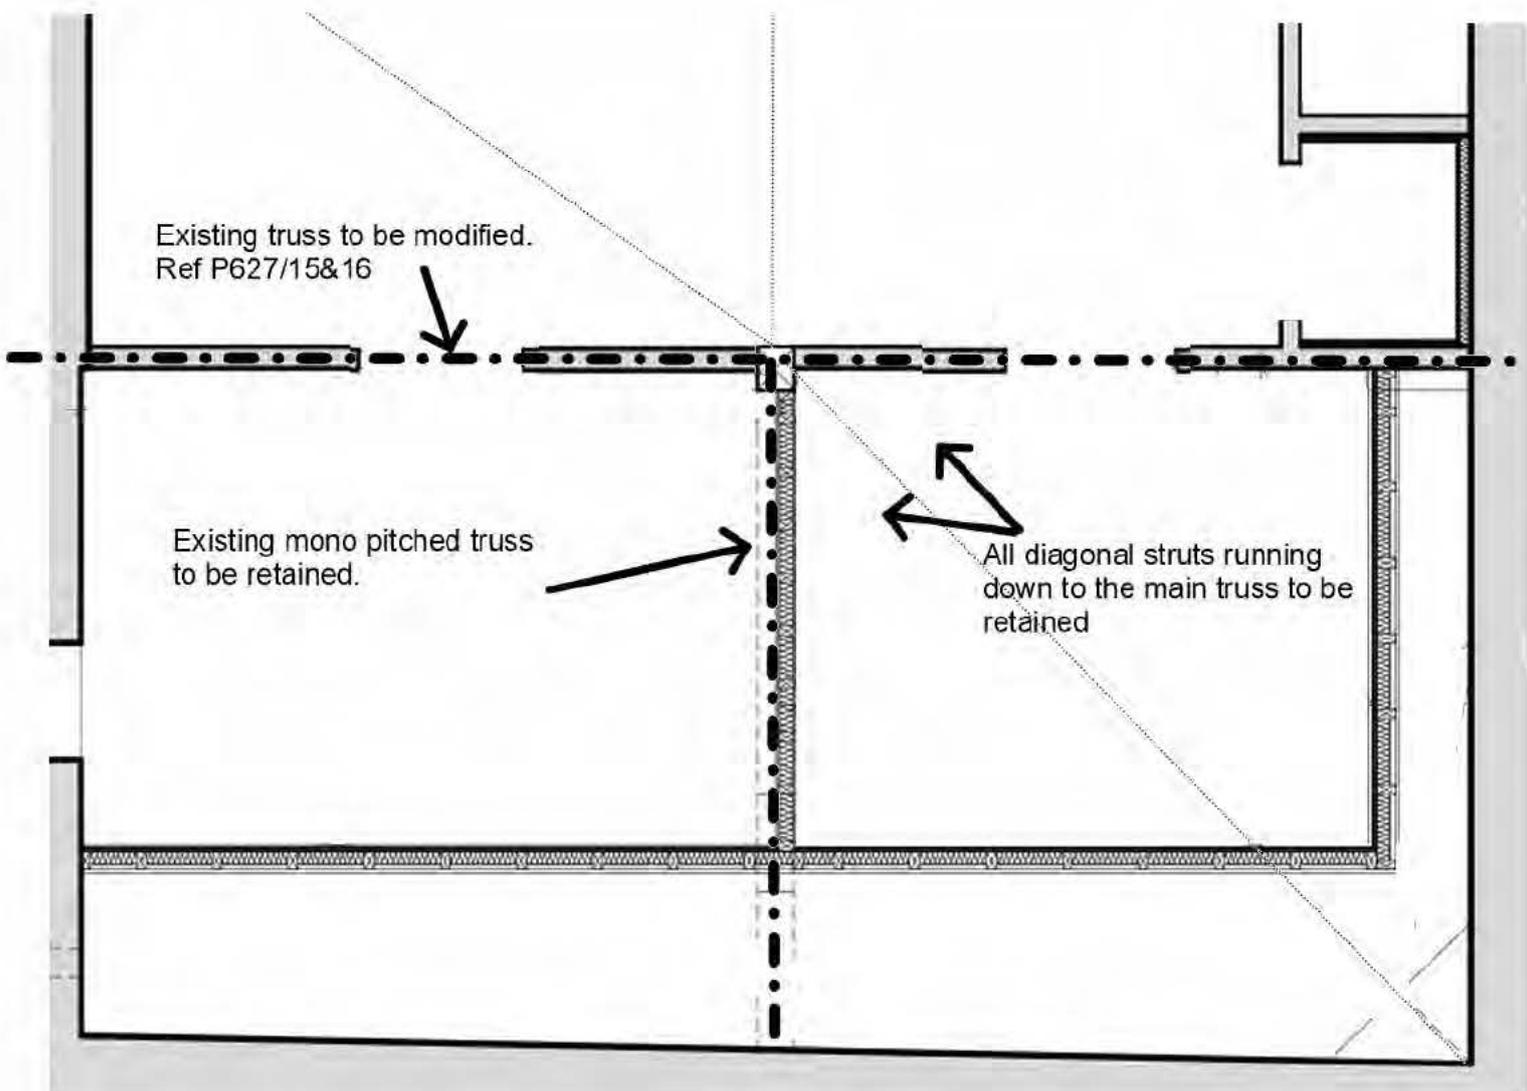
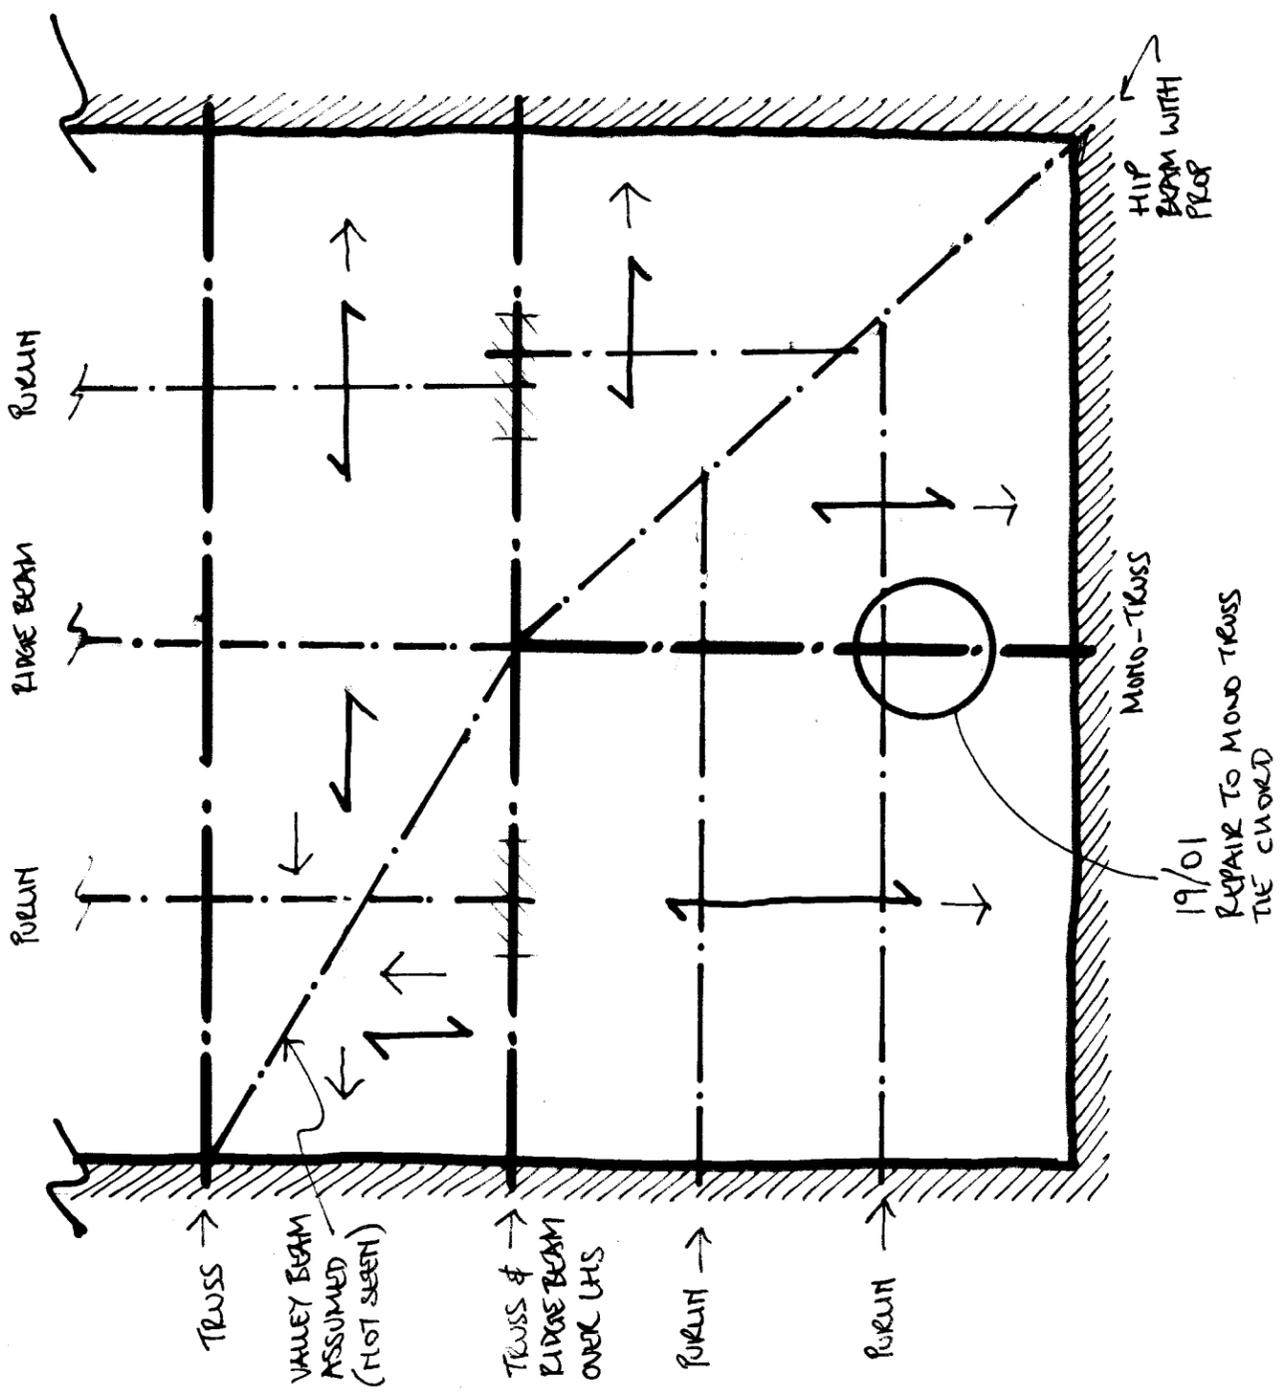
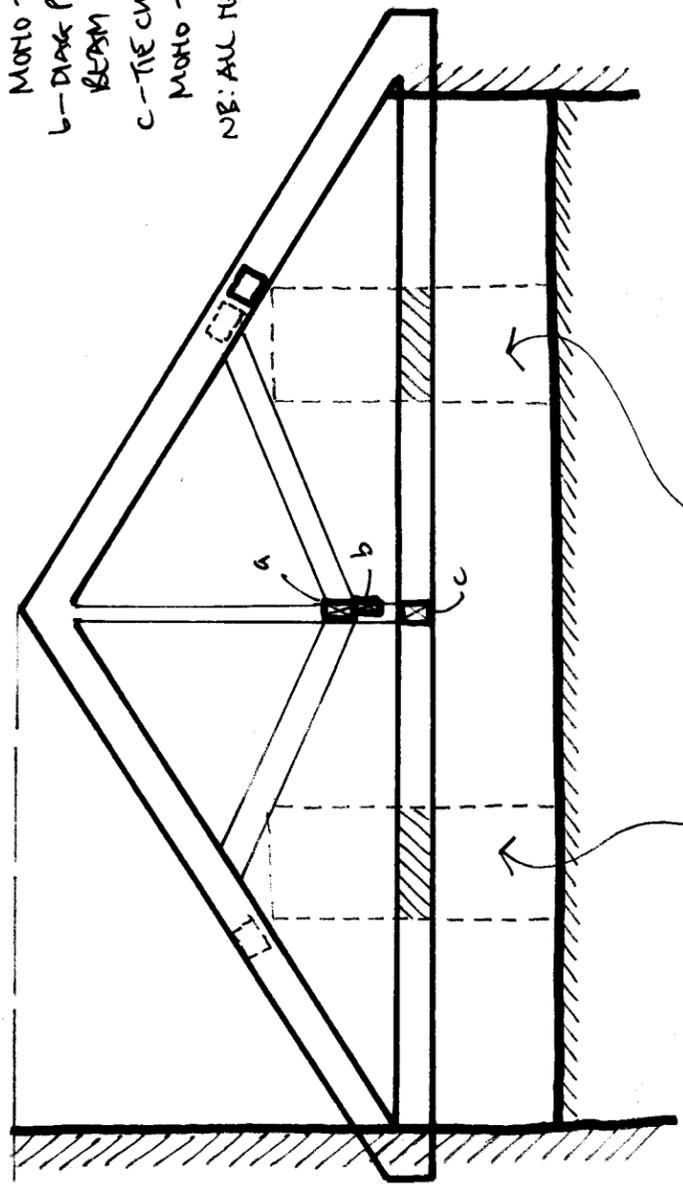
Project		
<b>Wortley Hall Attic Alterations</b>		
Drg. Title		
<b>Bedroom 5 Truss Alteration</b>		
	Date NOV 2017	Drawn JR
Drg. <b>P627/15</b>		Revision

\* Existing timber truss - diagonal strut is missing at this location. Install a new diagonal strut, to be tight fitting, sized to match the existing strut on the left hand side. Grade C24. Hold in place using pair of M10 coach screws, 150 long, to each end, positioned to drive through strut and anchor into the supporting timber beyond.

a - DIAG PROP TO MONO TRUSS  
 b - DIAG PROP TO HIP BEAM  
 c - TIE CHORD TO MONO TRUSS  
 NB: ALL NEED TO REMAIN

PROPOSED PROP OR BRACES MUST BE POSITIONED TO AVOID DIAGONAL STRUTS AS SWOLN. ENSURE ALL STRENGTHENING WORK UNDERTAKEN TO TRUSS/FLOOR PLATE TO CUTTING THROUGH TIE CHORD IS THE 2 LOCATIONS SWOLN. REF THE PROPOSED DRAWINGS.

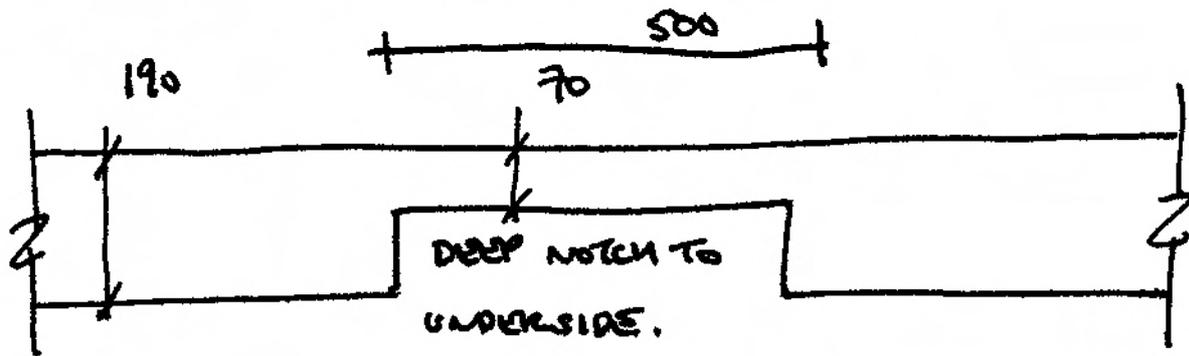
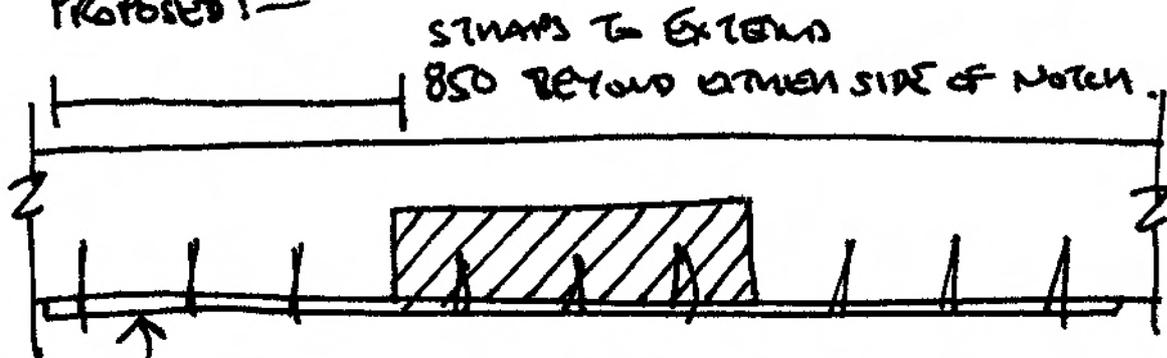
Project -		
Wortley Hall Attic Alterations		
Dwg. Title		
Bedroom 5 Truss Alteration		
	Date NOV 2017	Drawn JR
Dwg. P627/19	Revision

MONO TRUSS TIE CHORD - AS EXISTING :-

GLUED & SCREWED TIGHT FITTING  
HARDWOOD PACKER INSTALLED INTO  
NOTCH

3 no. 30 x 5 GALV. STAYS FIXED UP TO UNDERSIDE,  
GANGED 14 WOODSCREWS, MAX 100CC (STAGGERING  
STAYS). NOTE - AS SHOWN IS INDICATIVE ONLY.  
STAYS TO BE 2.2M LONG & CONTINUOUS.
