**Document No: LACE DP 24-110-DOC001 REV A**

**Structural Appraisal of Barn Building for a Proposed Conversion to a Residential Dwelling at Hill Top Farm, Thurgoland**

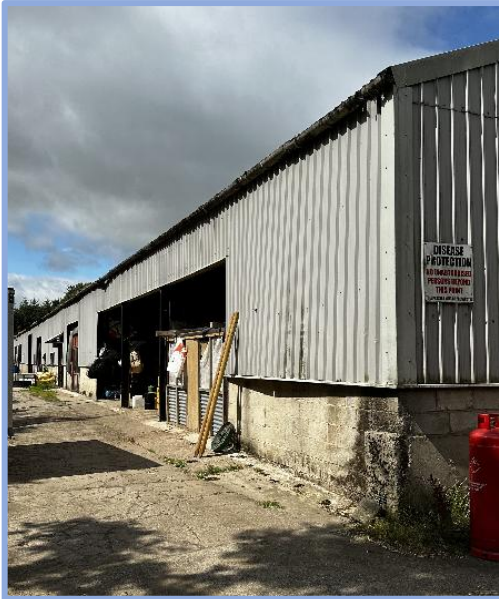
**SOUTH-EAST ELEVATION**

The North-West elevation of the barn has predominantly pedestrian access doors at intervals along the length of the barn. The South-East elevation of the barn has multiple pedestrian and vehicular access doors at very regular intervals along the length of the barn.

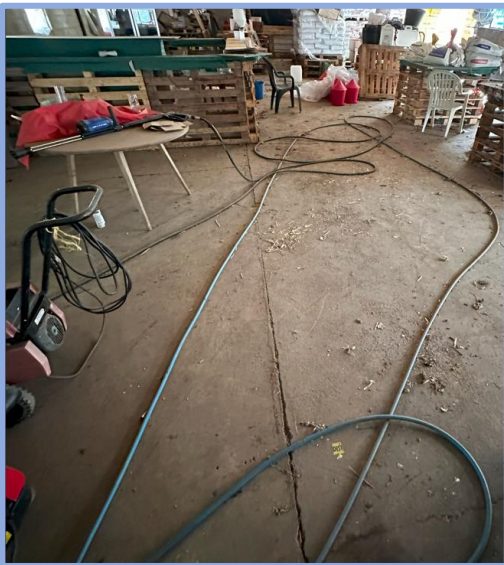
**INTERNAL SLAB**

The ground floor to the barn where visible was seen to be a smooth finished concrete slab.

The ground floor throughout the barn where visible appeared to be a flat concrete slab with a smooth finish, the slab had multiple signs of cracking away from the formed slab joints. The extent of the cracking could not be reviewed on site and some additional investigation would be needed to confirm the slab and sub base make up along with any existing reinforcement that may or may not be present.

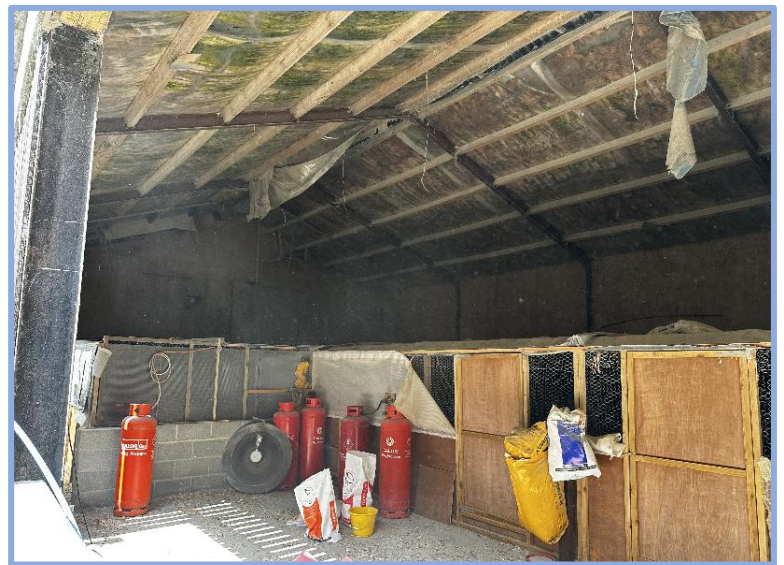
**INTERNAL FRAME VIEW**

The existing barn structure is a detached structure formed by a duopitch steel portal framed structure, the sections of the portal frame appeared to be steel Universal Beam sections throughout.

A laser level or plumb line was not used to check the vertical alignment of the steel frames but visibly the steel frame appeared to be vertically plumb in each direction with no obvious differential movement between adjacent frames. The ridge line of the barn had some very minor undulations in the ridge line, but it was not obvious if this was due to the sheeting, purlin positioning or minor lateral movement of the steel frame.

The steel frame throughout was showing surface rust due to the exposed nature of the frame, there no sections with any visible loss of section.
