**PLOT 4B & 5, ASHROYD BUSINESS PARK, HOYLAND**

**POST COMPLETION HIGHWAY CONDITION INSPECTION**

**11717**

**JUNE 2020**

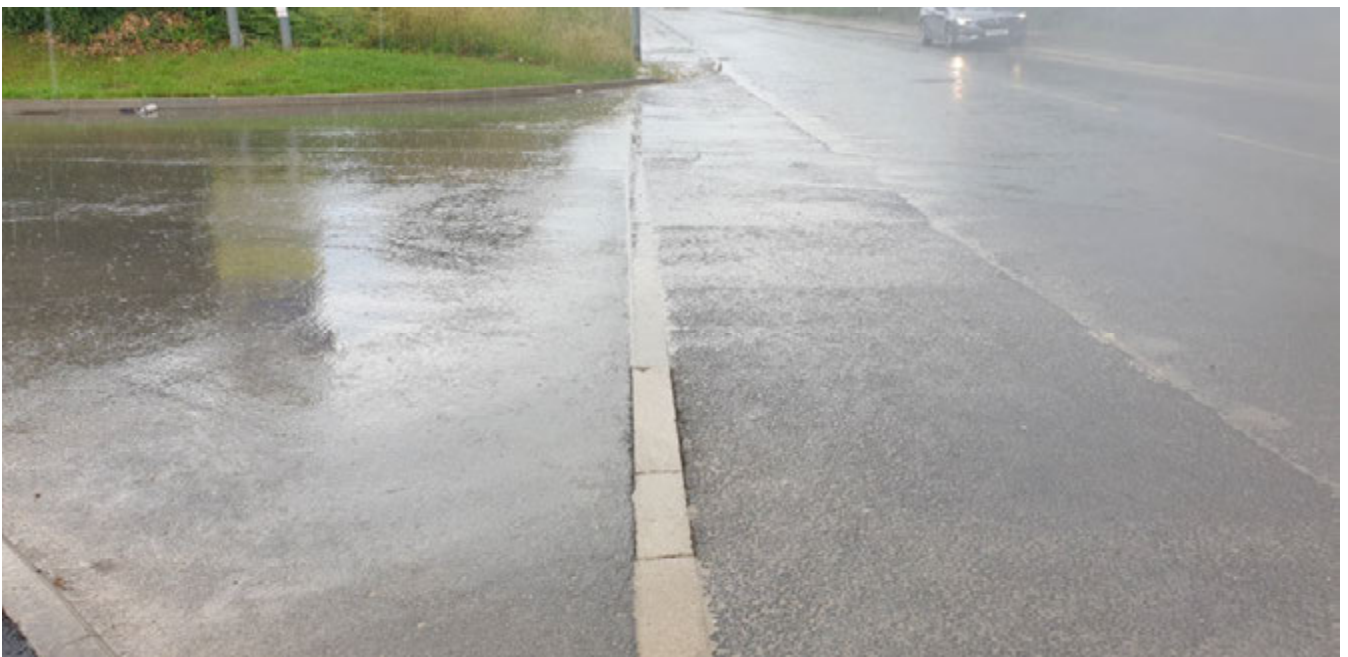
3.1.1 There are two damaged channel blocks to the rear of the public highway on the access to Plot 4B. These will need replacing. These are shown in photos 8 & 9.

*Figure 8 - Loose channel blocks at back of access to Plot 4B - this will need replacing. Identified pre-works refer to Figure 12 Appendix B.*

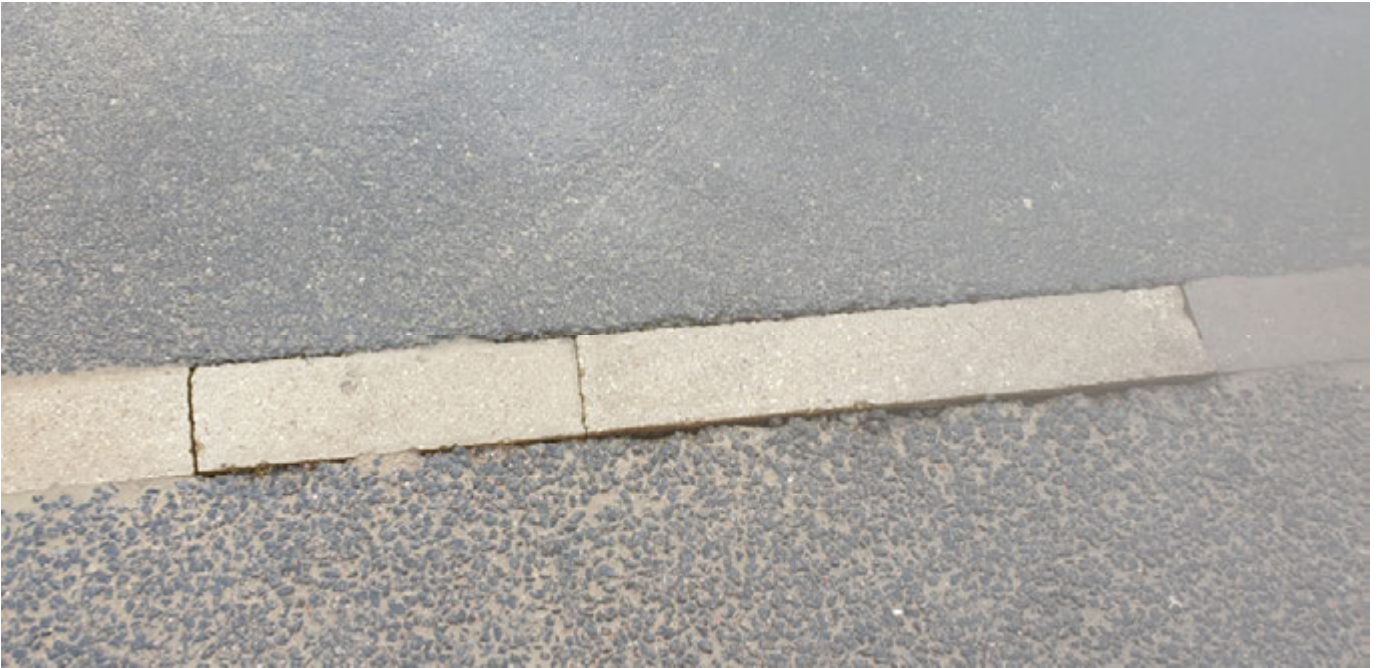
*Figure 9 - Close up of damaged channel blocks. Identified pre-works refer to Figure 12 Appendix B.*

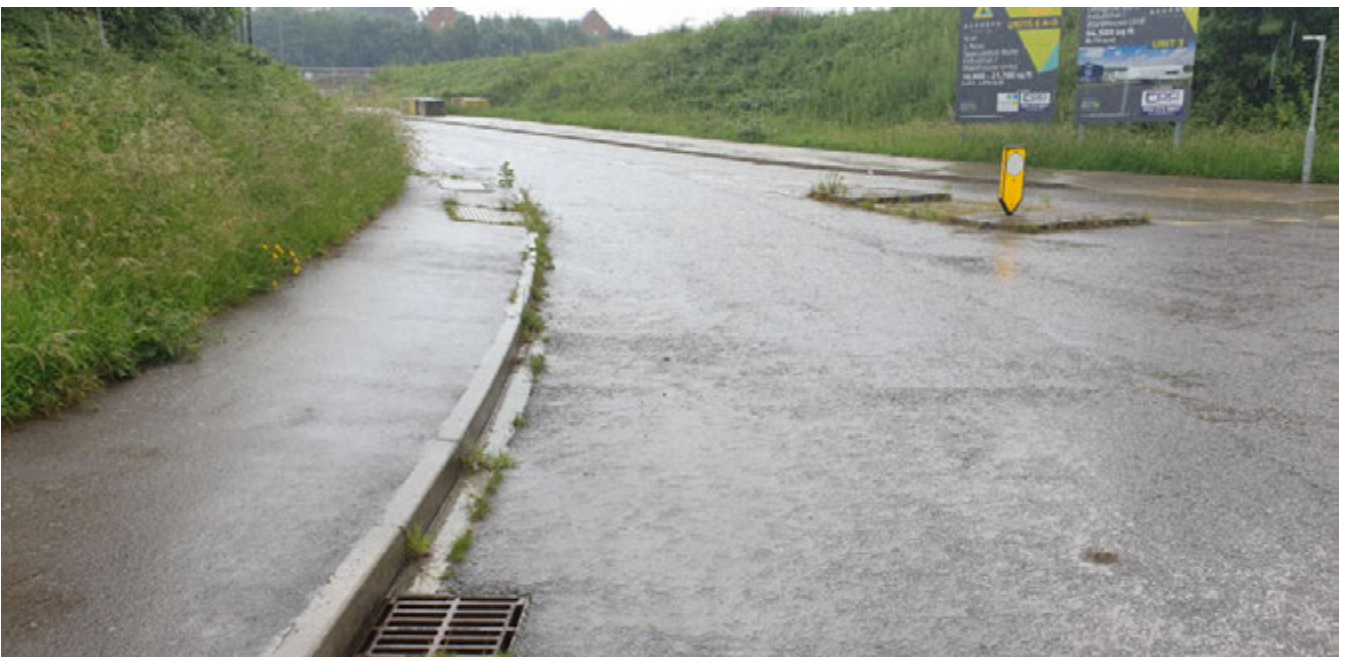
*Figure 14 - View to southern leg from roundabout to Plot 5. Note missing bollard, this was missing prior to the works starting. Refer to Figure 25 Appendix B*

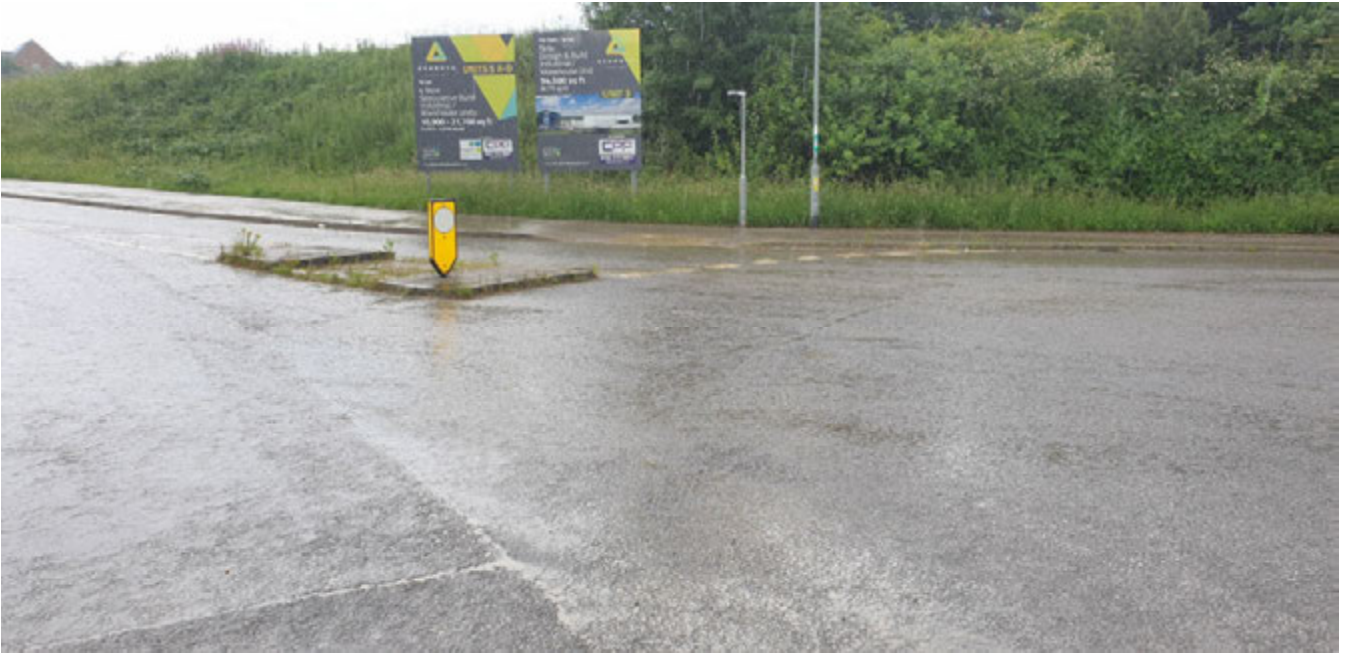
Figure 15 - View to southern leg from roundabout to Plot 5. Note missing bollard, this was missing prior to the works starting. Refer to Figure 25 Appendix B

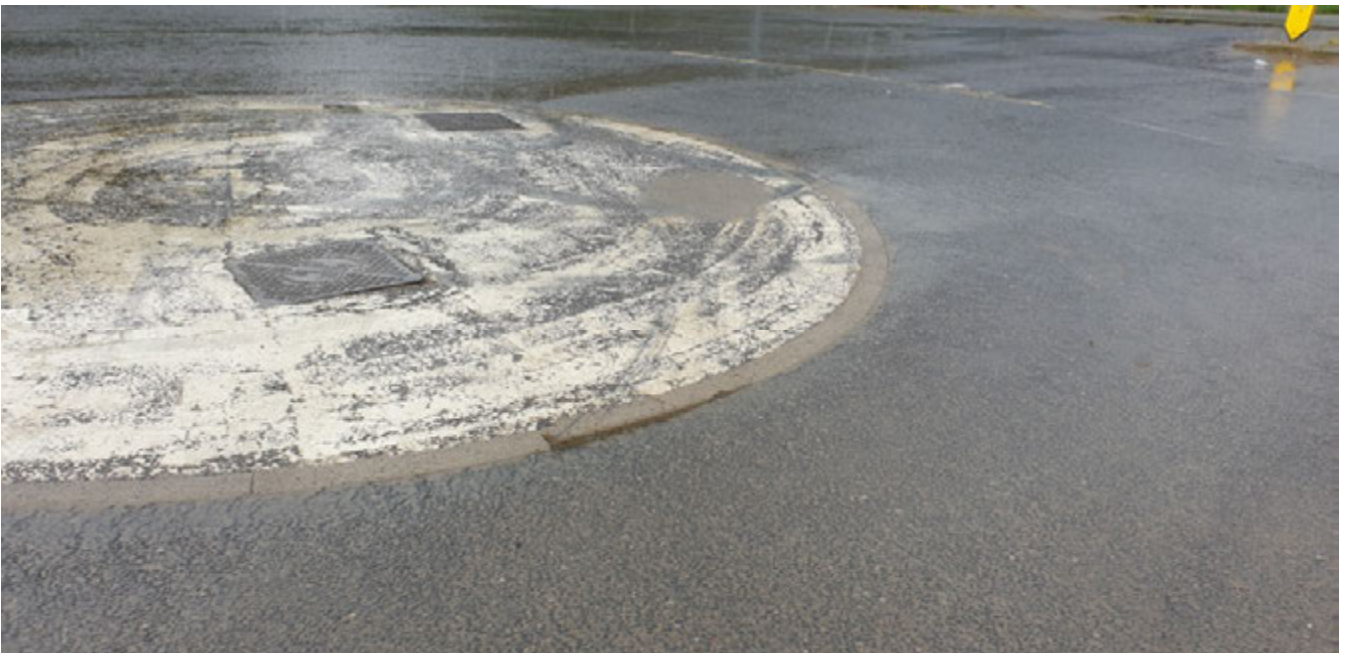
Figure 16 - View of centre island at roundabout. Note the damaged kerbs were present prior to works starting at was noted on the pre-start report. Refer to Figures 21,32,33 – Appendix B.

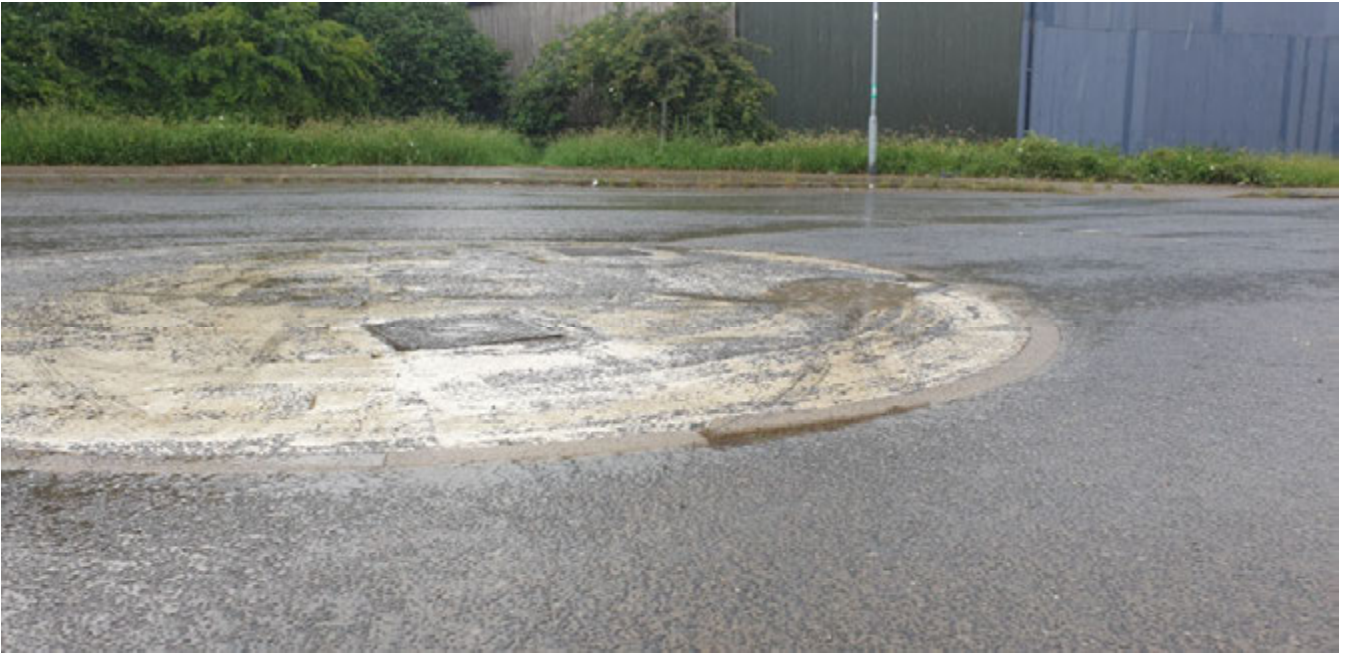
*Figure 17 - View of centre island at roundabout. Note the damaged kerbs were present prior to works starting at was noted on the pre-start report. Refer to Figures 21,32,33 – Appendix B.*

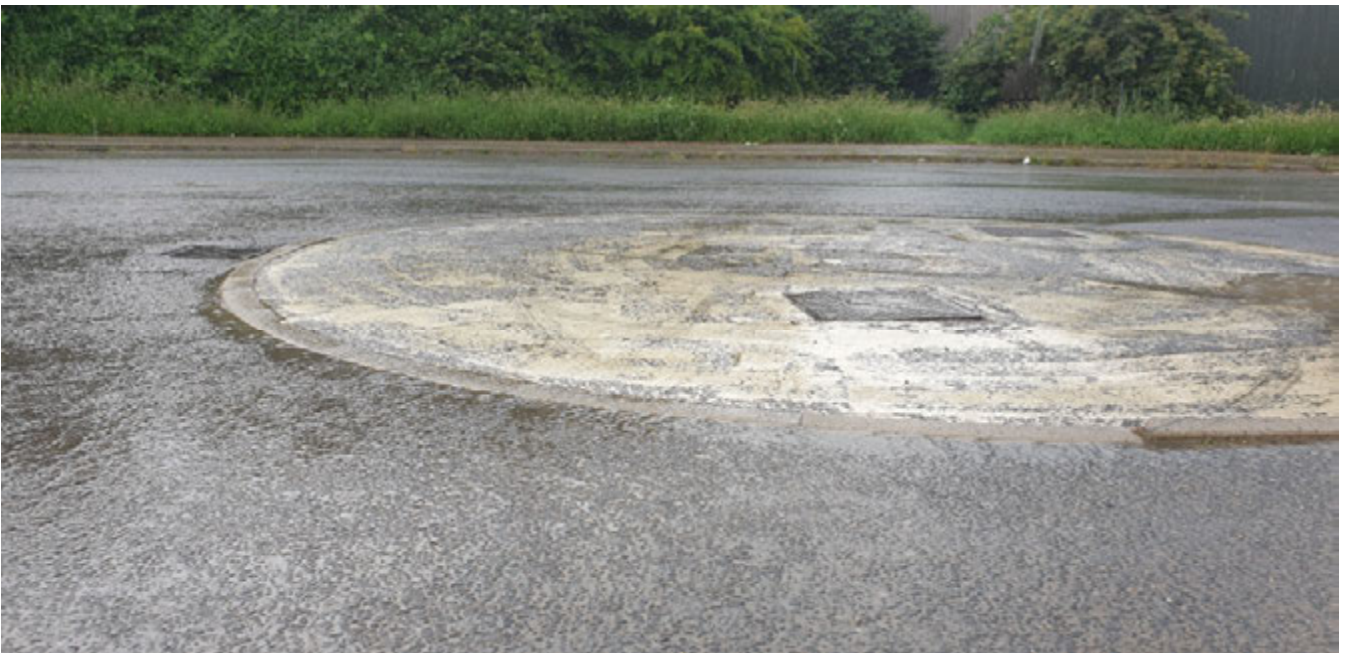
*Figure 18 - View of centre island at roundabout. Note the damaged kerbs were present prior to works starting at was noted on the pre-start report. Refer to Figures 21,32,33 – Appendix B.*

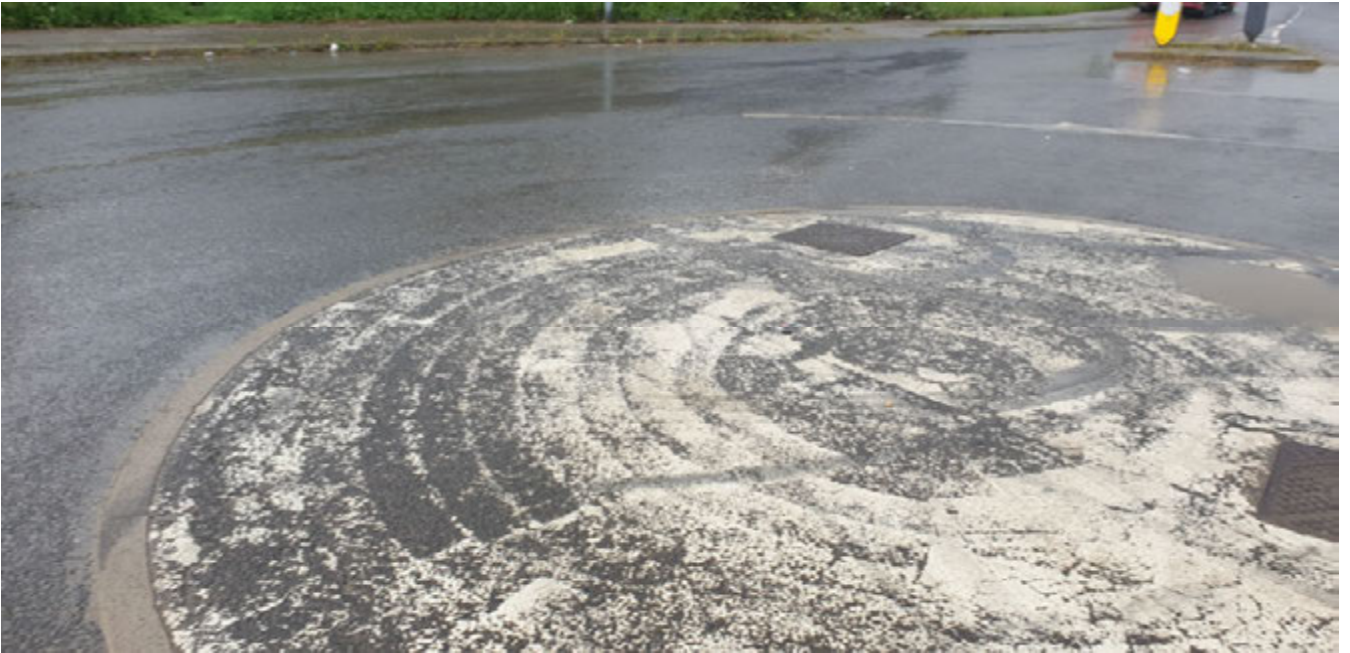
*Figure 19 - View of centre island at roundabout. Note the depression was present prior to works starting at was noted on the pre-start report. Refer to Figures 21,32,33 – Appendix B.*

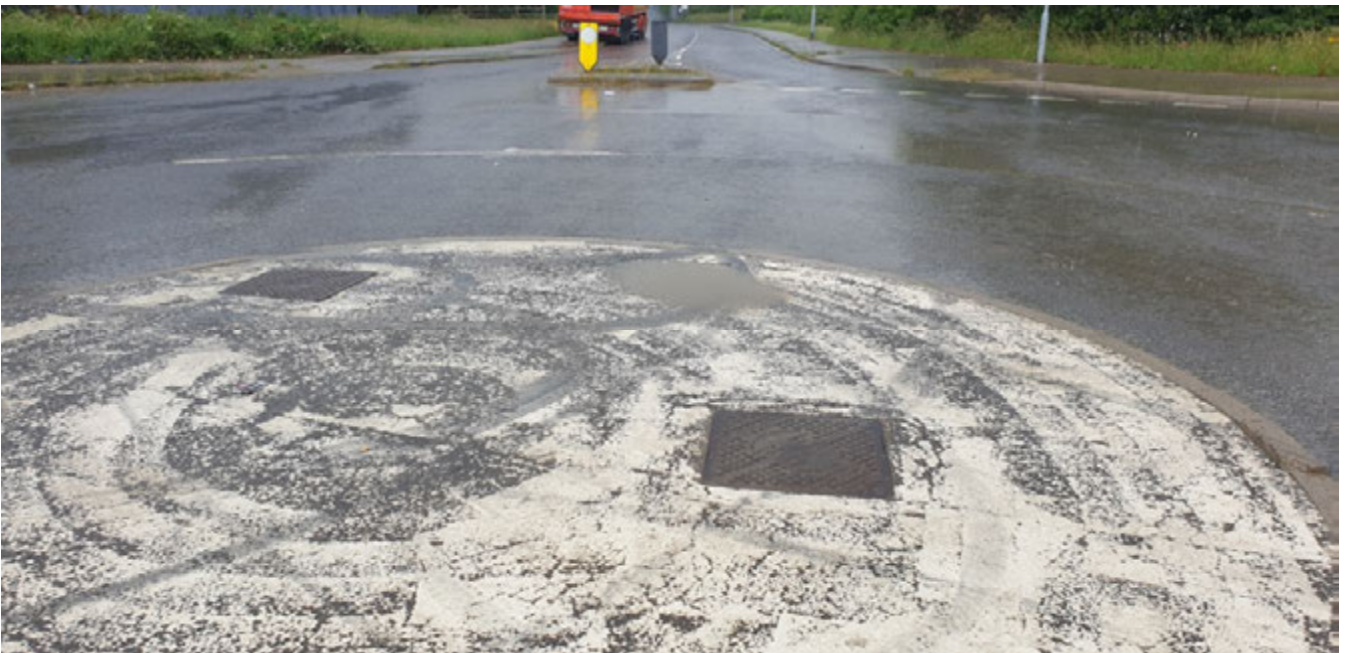
*Figure 20 - View of centre island at roundabout. Note the depression was present prior to works starting at was noted on the pre-start report. Refer to Figures 21,32,33 – Appendix B.*

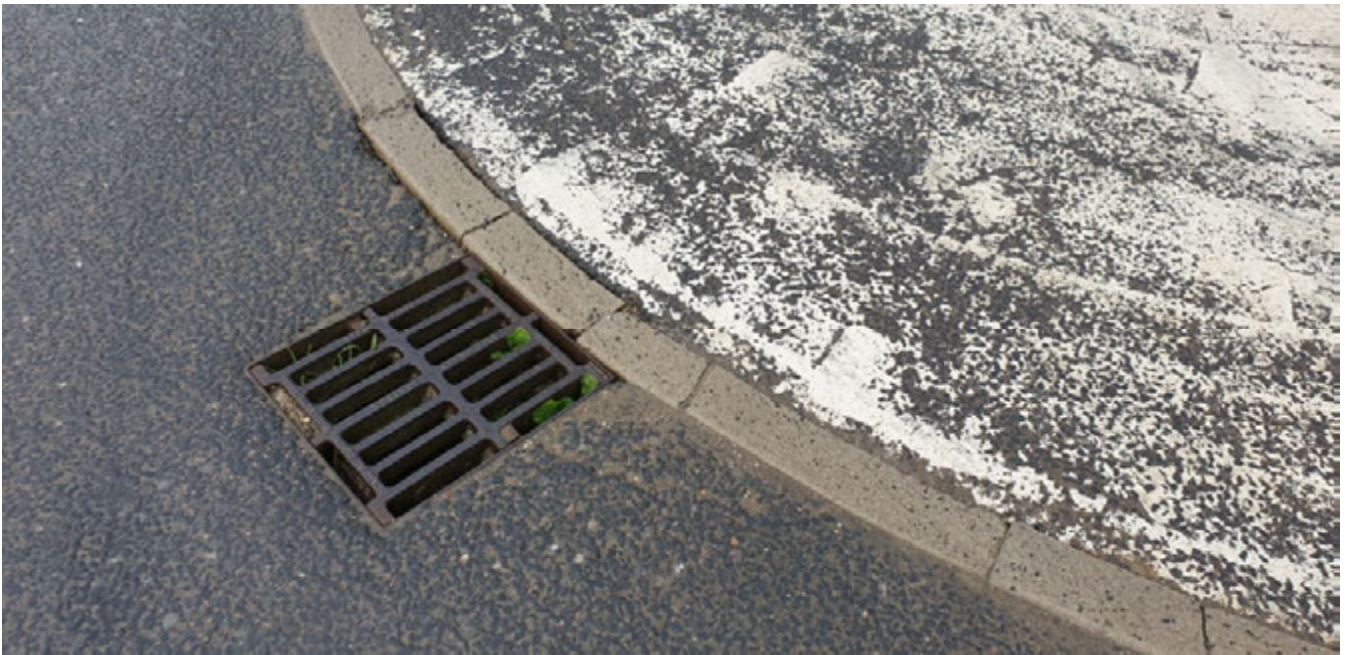
*Figure 21 - View of centre island at roundabout. Note the damaged kerb next to the gully was present prior to works starting at was noted on the pre-start report.*

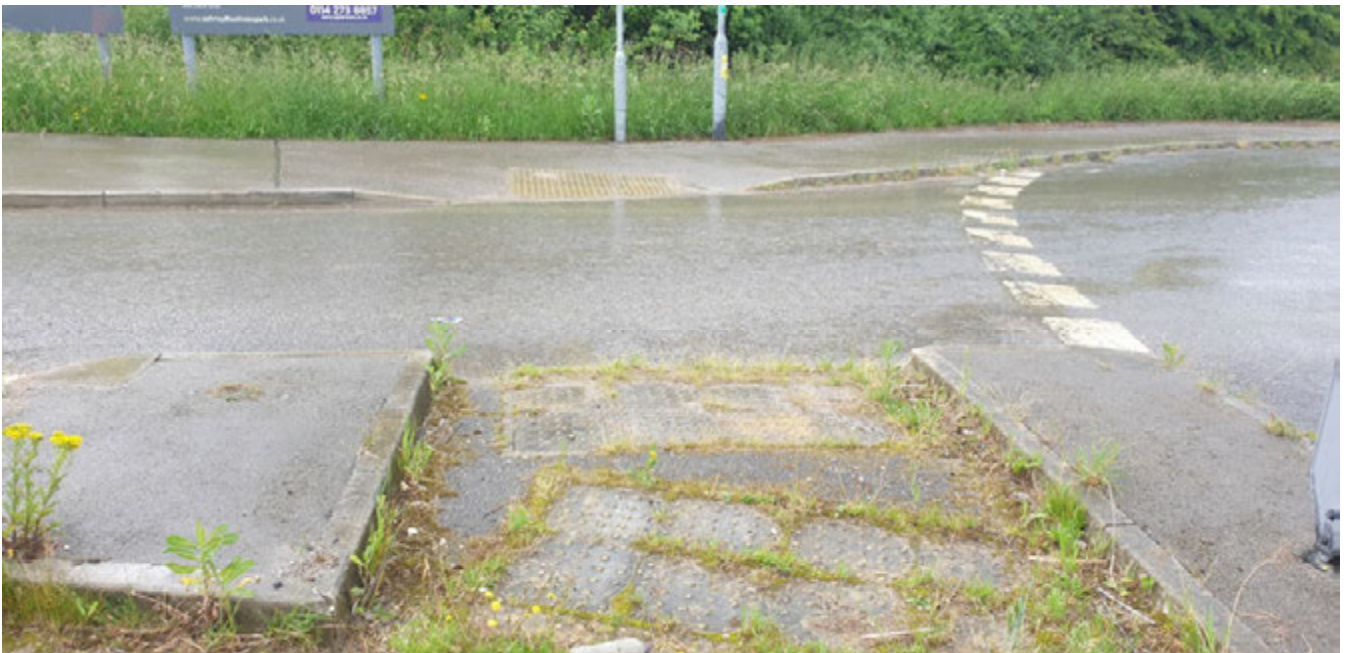
*Figure 22 - View across island on southern leg of roundabout. Paving overgrown with weeds and vegetation.*

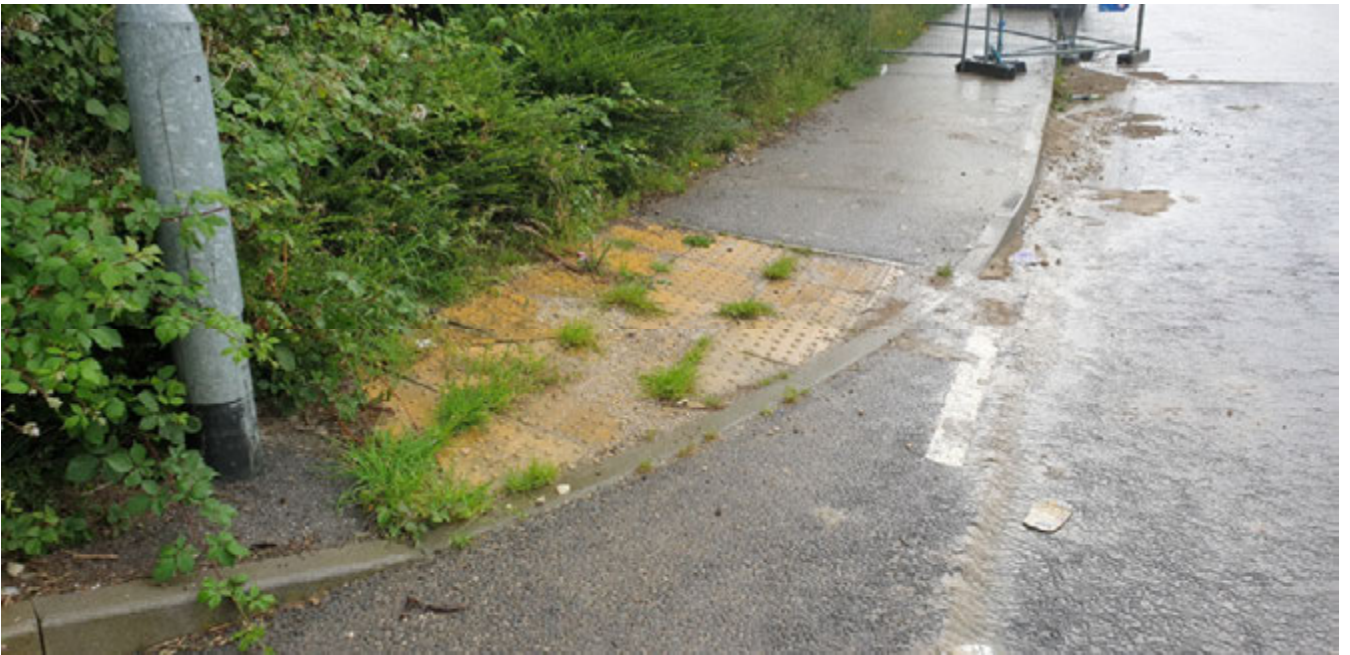
*Figure 25 - View of tactile pavers to north of Storefirst entrance. Some vegetation has been removed. Tactile pavers are uneven, note these are located in the are to be adopted under S38 agreement. Refer to Figure 45 Appendix B.*

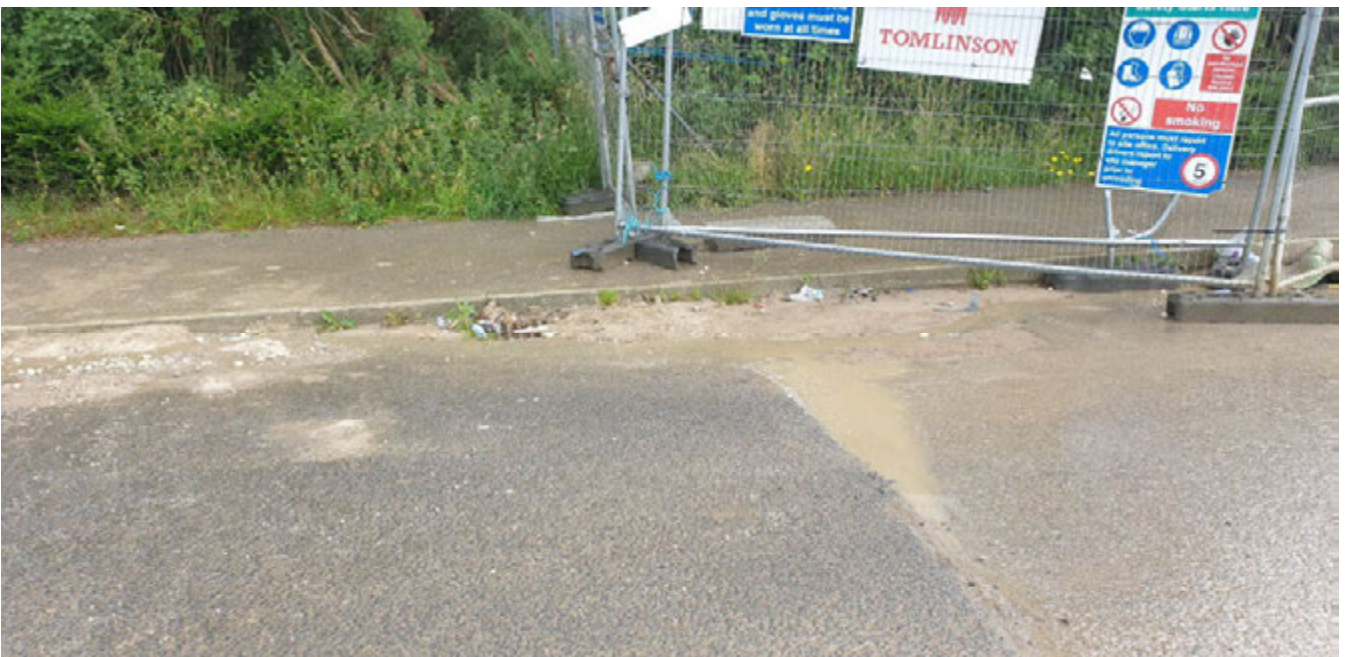
*Figure 28 - Debris in channel adjacent gully. Note this is within the S38 agreement area.*

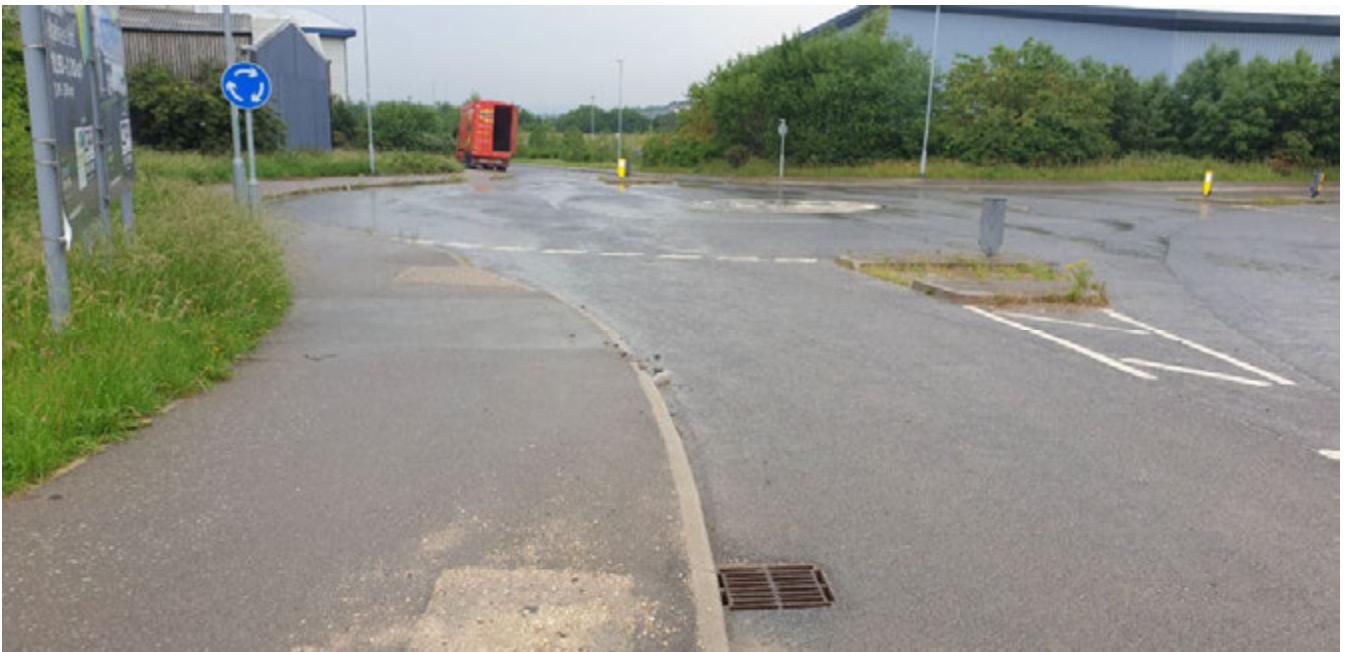
*Figure 30 - View north from southern leg, bollard on island was missing prior to works commencing.*

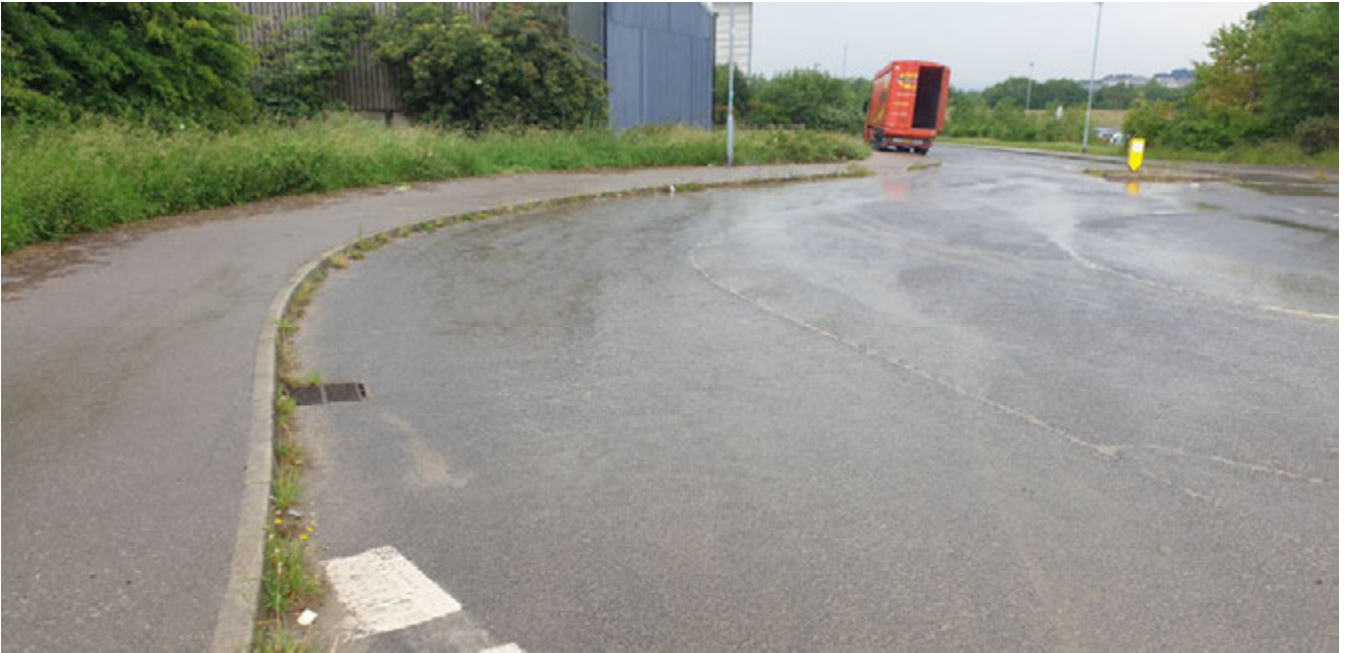
*Figure 31 - View of western side of roundabout - vegetation within channel line.*

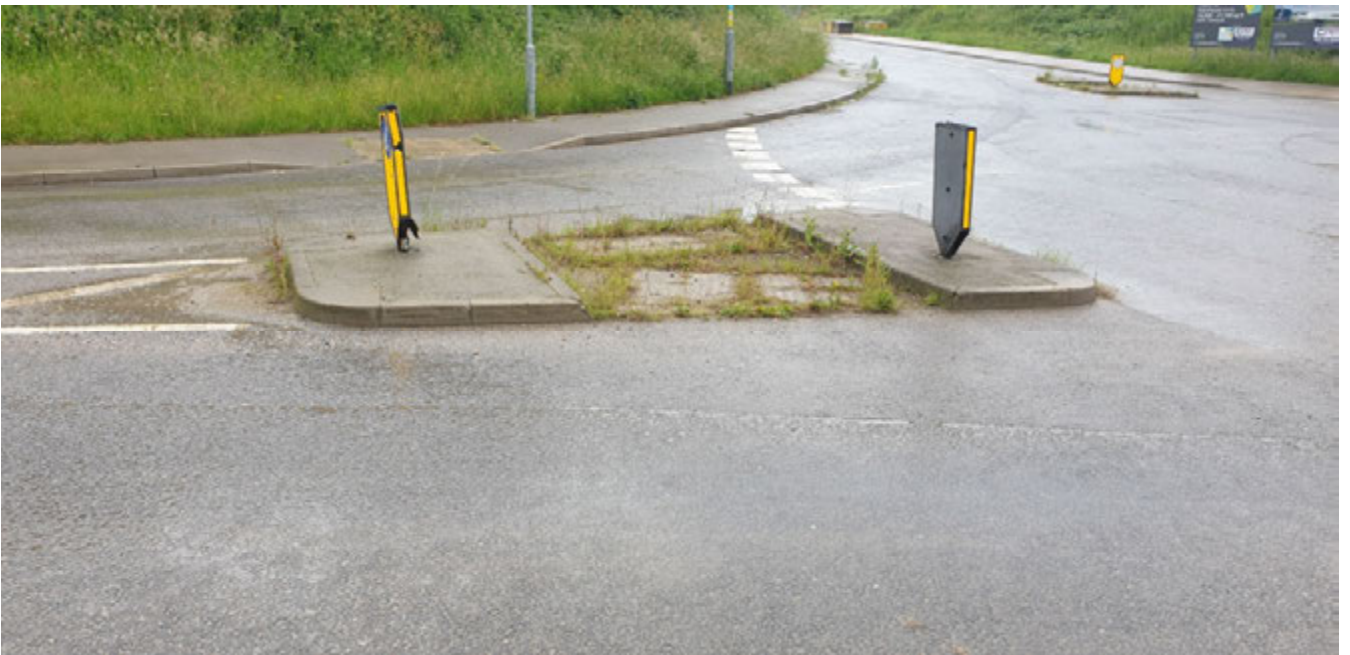
*Figure 36 - Heavy vegetation on tactile crossing on eastern leg.*

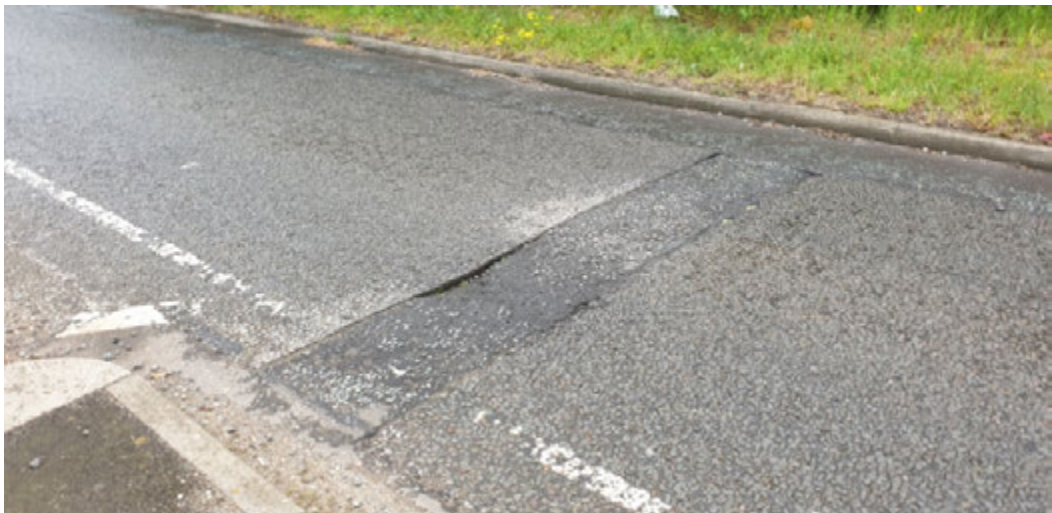
*Figure 239 - Failed reinstatement on Ryecroft Bank to the north of junction with Ashroyds Way.*

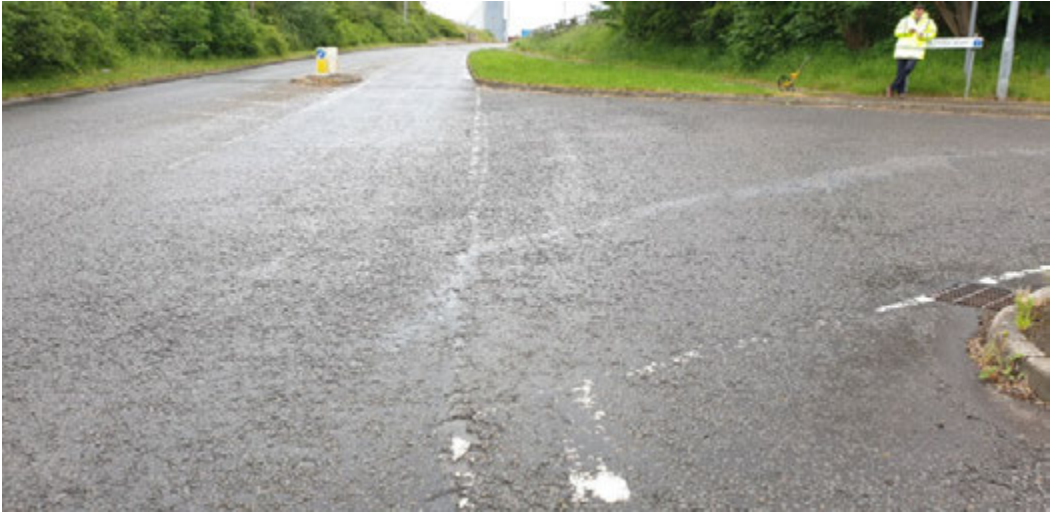
*Figure 40 - View north of westbound lane into Ashroyds Way. Some minor chipping loss in the surface course.  
All junction lining is worn out.*

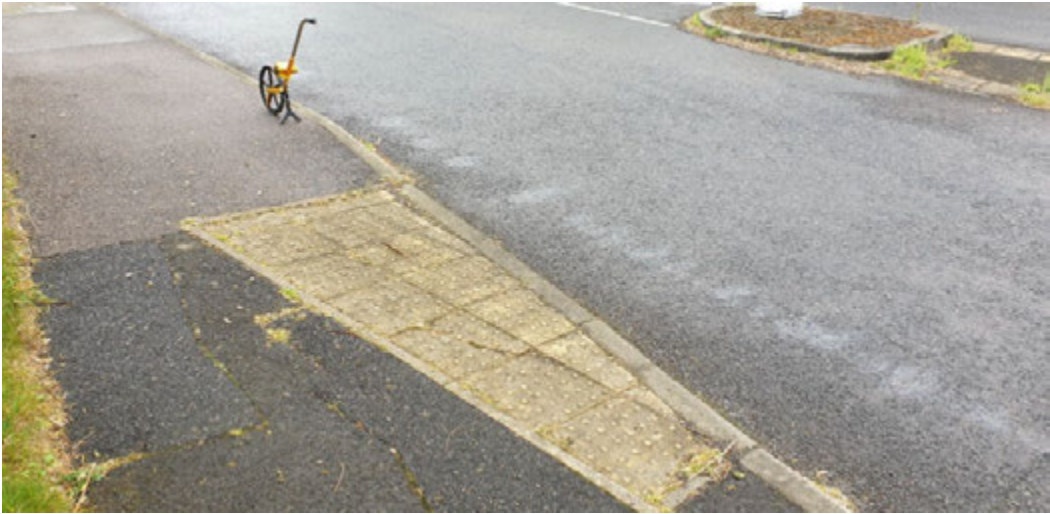
*Figure 6 - Tactile crossing at entrance to site. Pavers cracked but not rocking*

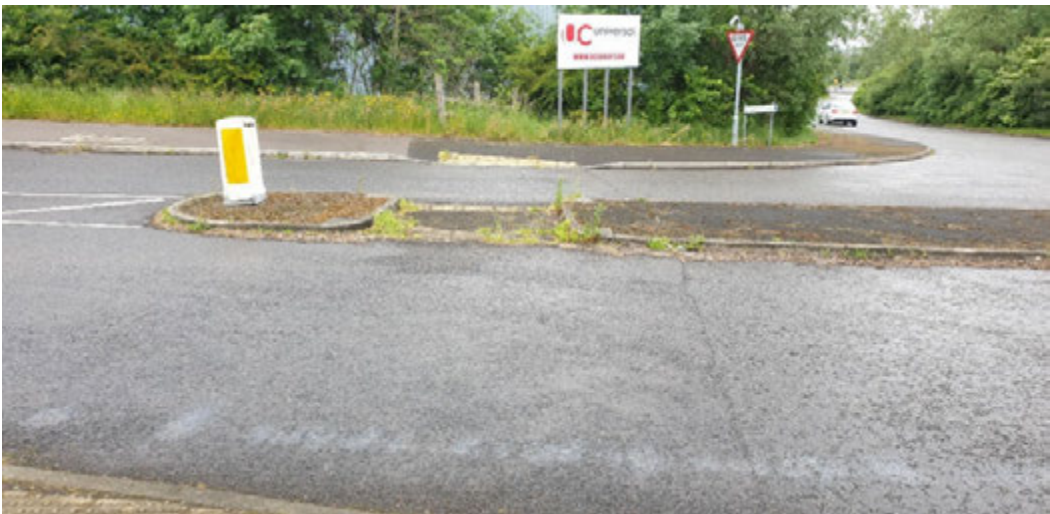
*Figure 7 - View across pedestrian crossing. Heavy vegetation in channels and against kerbs.*

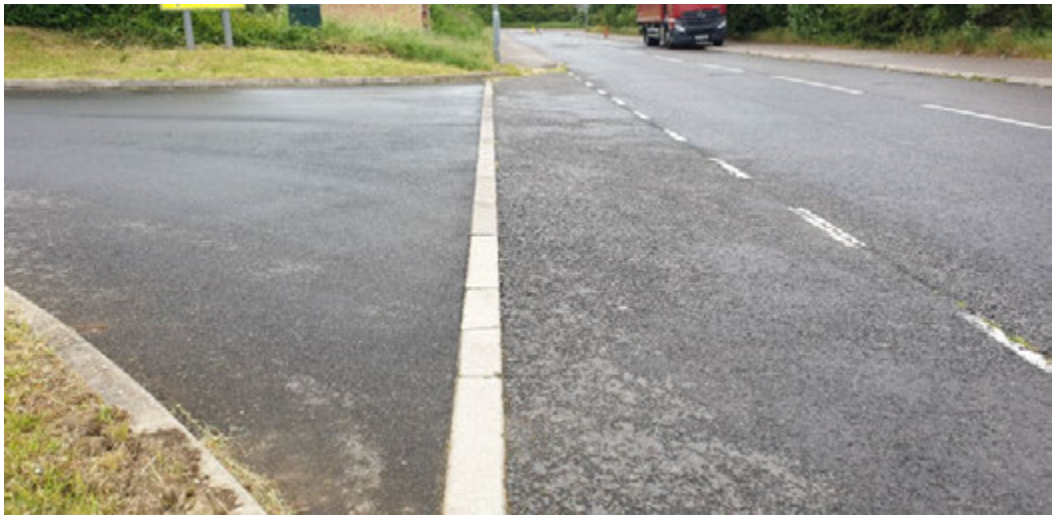
Figure 12 - Existing demarcation channels at rear of Highway boundary. Some channel blocks are loose and rocking.

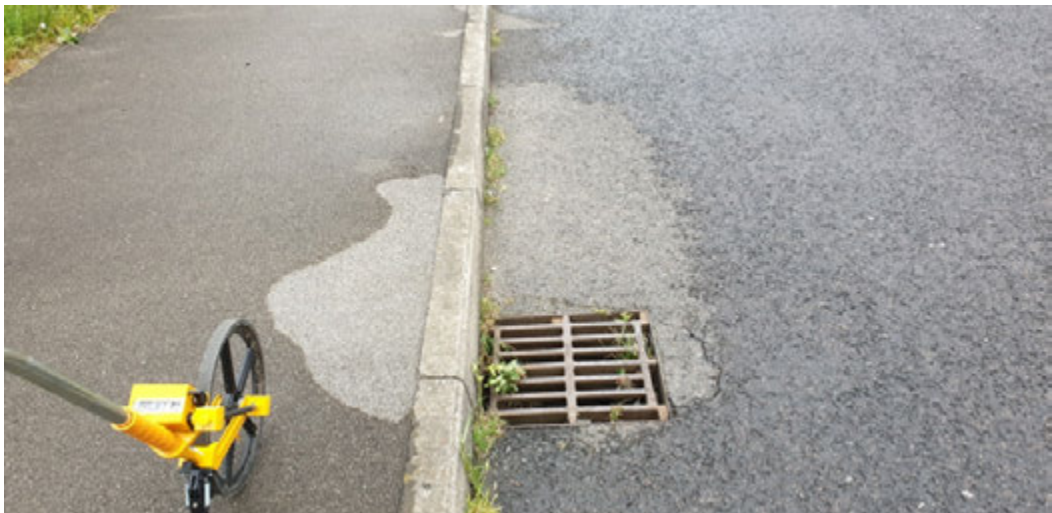
Figure 13 - Some minor cracking in surface course around gully

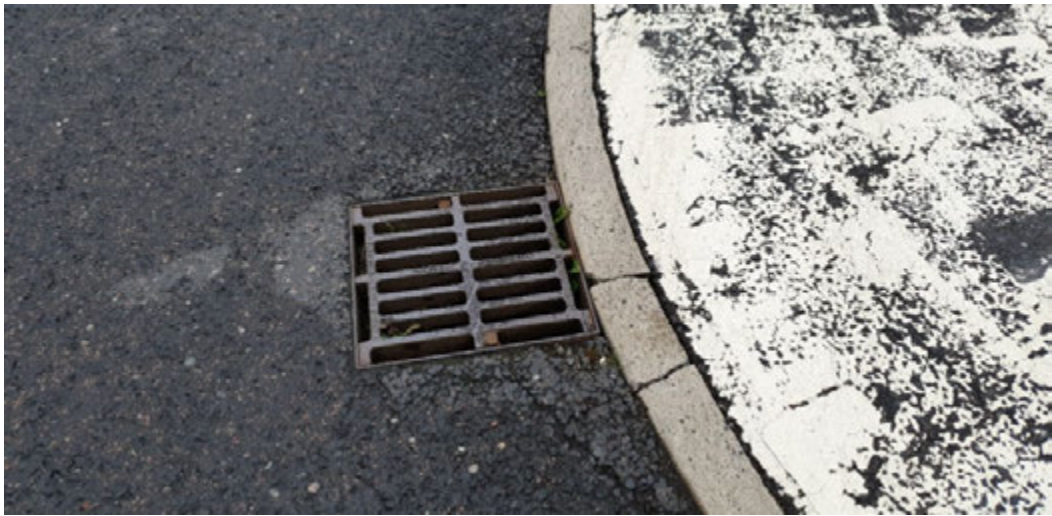
*Figure 21 - Loose kerbing adjacent gully on island.*

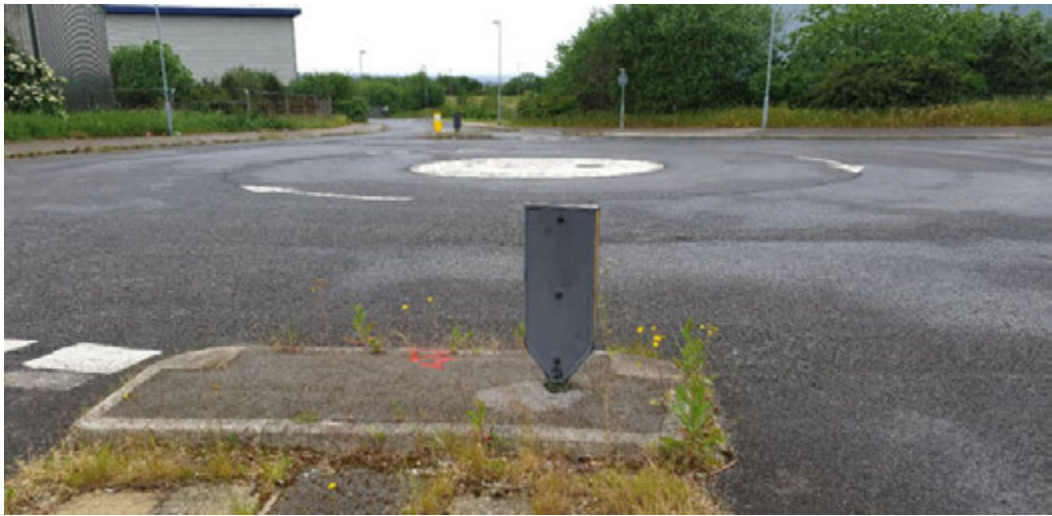
*Figure 24 - View from pedestrian island on southern leg.  
Heavy vegetation in kerb lines/tactile pavers.*

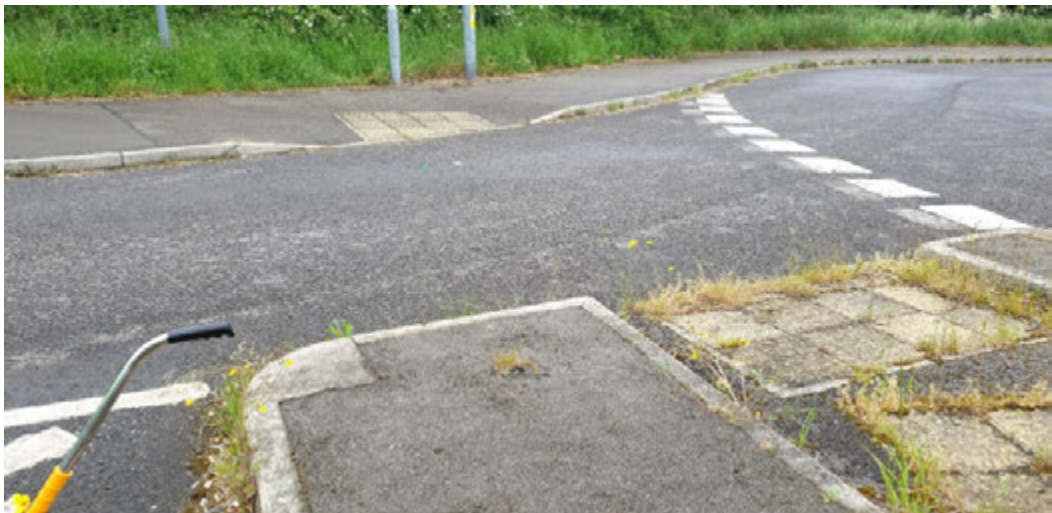
*Figure 25 - Missing reflective bollard on southern side of island on southern leg.*

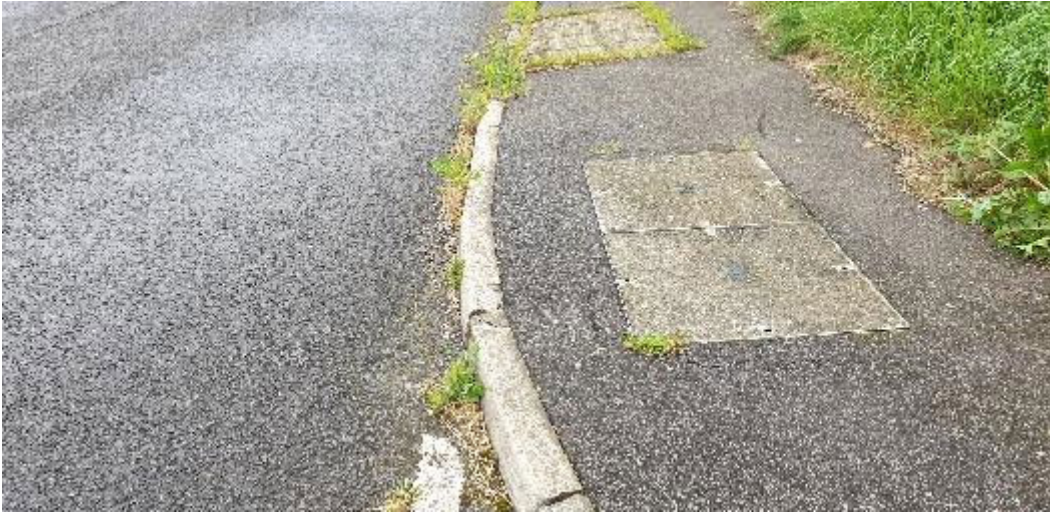
*Figure 27 - Chipped kerbs on western side of southern leg off mini roundabout adjacent BT box.*

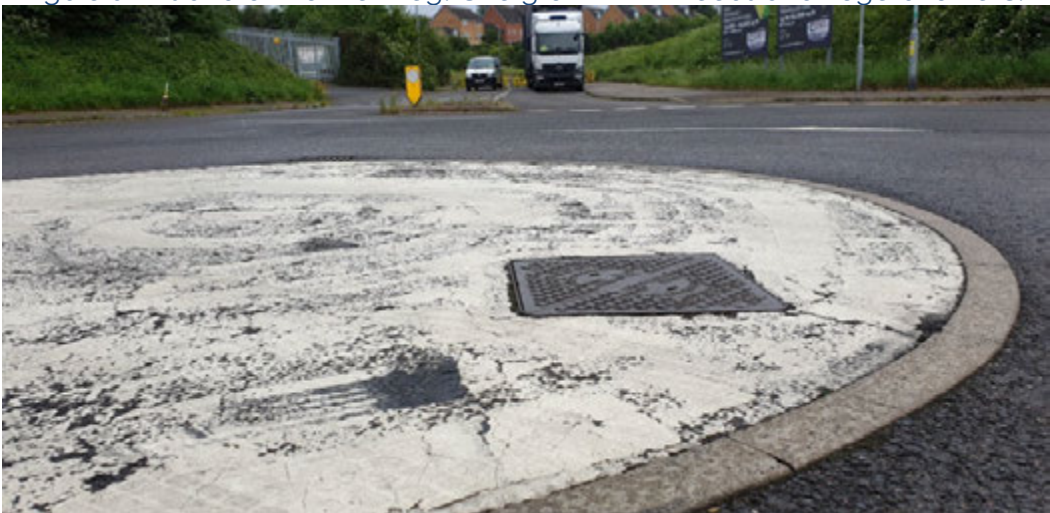
*Figure 32 - Depression in mini-roundabout island from vehicle overrun into the northern leg. Slight breaking up of surfacing around manhole cover.*

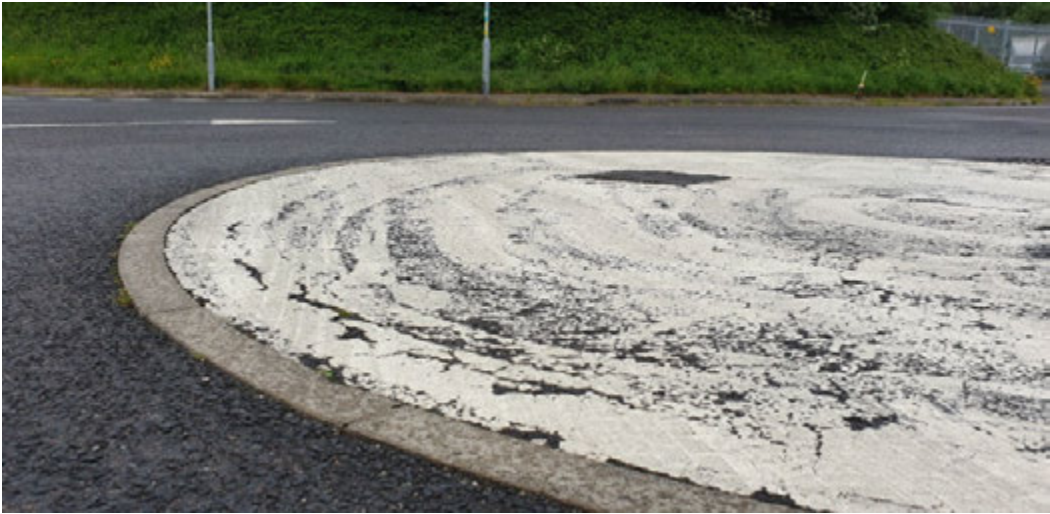
*Figure 33 - Depression in mini-roundabout surfacing.*

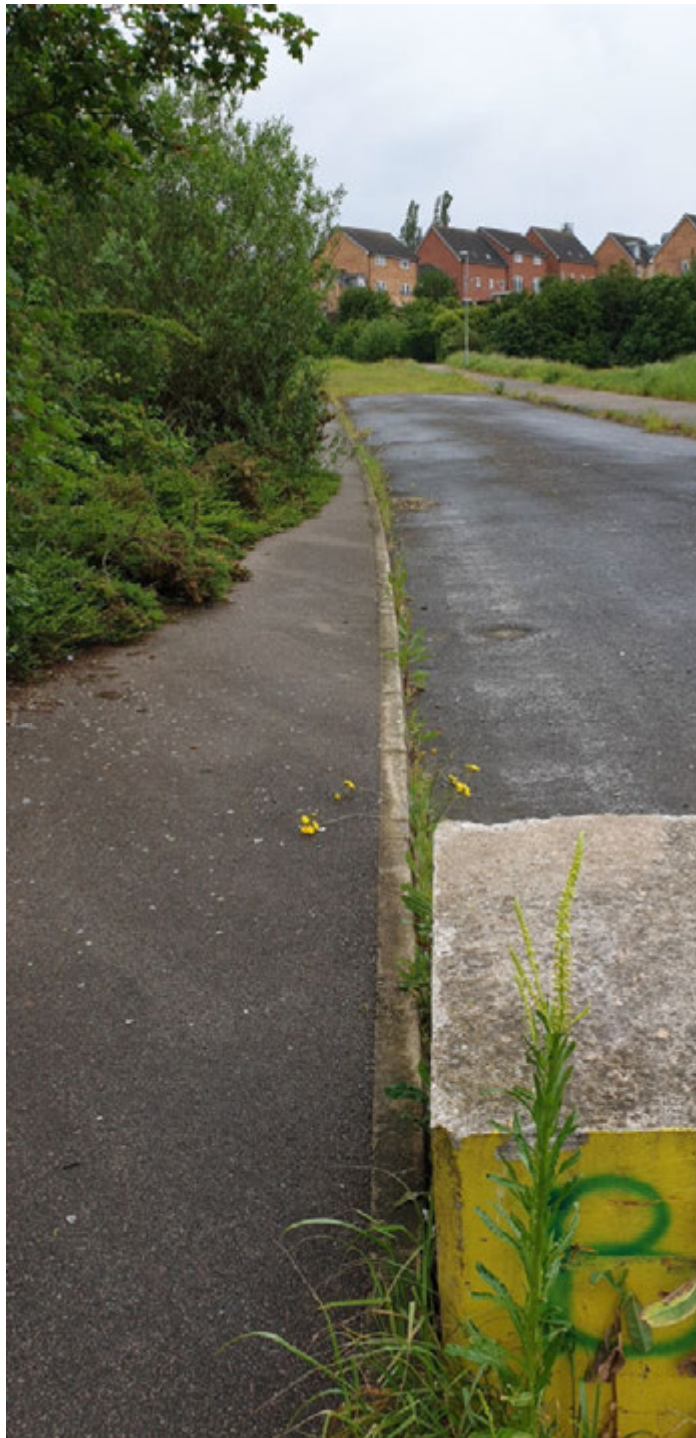
*Figure 44 - Eastern channel looking south from concrete blocks. Vegetation encroaching over footway.*
