**PLOT 4B & 5, ASHROYD BUSINESS PARK, HOYLAND**

**POST COMPLETION HIGHWAY CONDITION INSPECTION**

**11717**

**JUNE 2020**

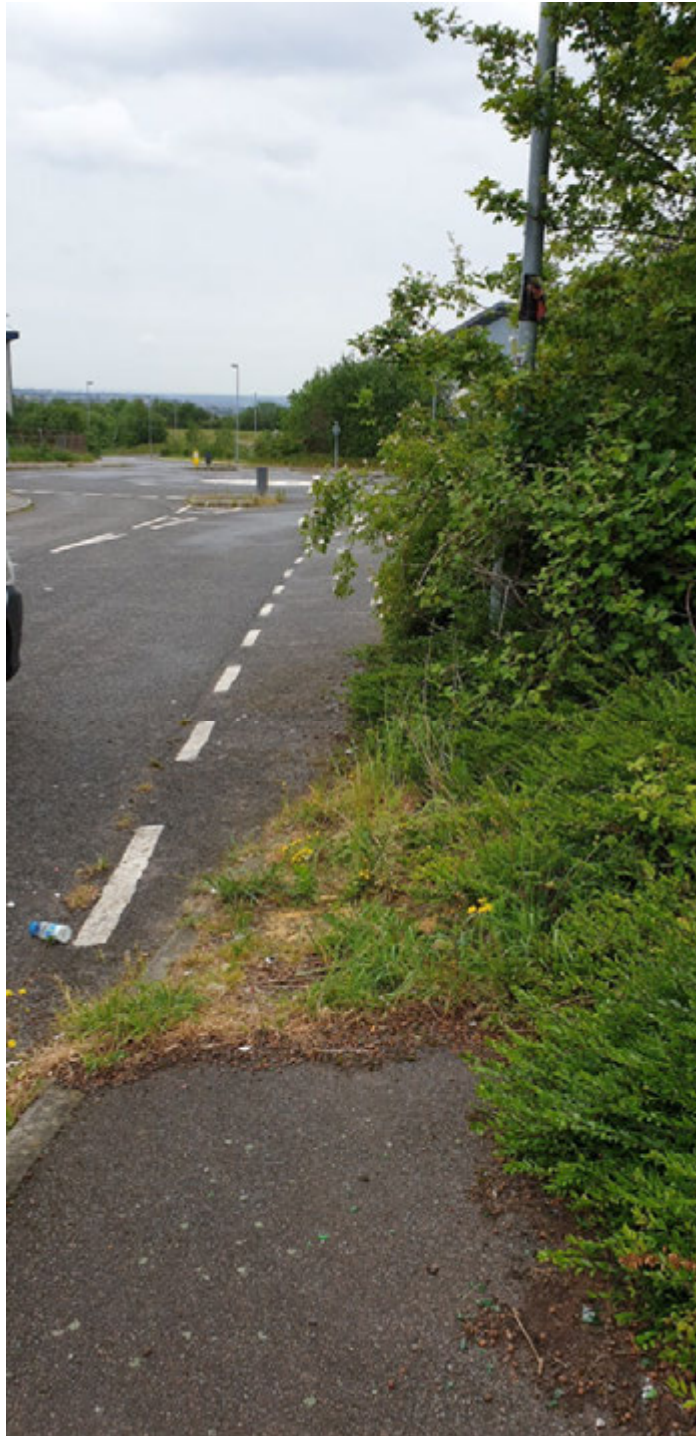
*Figure 45 - Tactile crossing across access. Vegetation encroaching.*
