ARBORICULTURAL REPORT

to **BS5837:2012** at:

***Walled Garden Area,
Cannon Hall,
Cawthorne,
Barnsley
S75 4AT.***

Reference: AWA3590

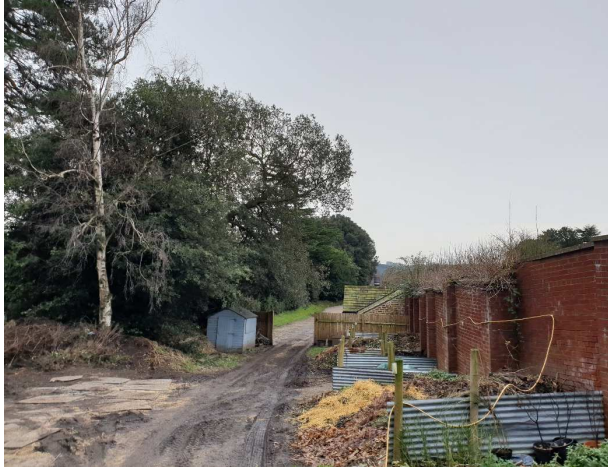
- 3.2.6 To the east of the survey area is a mature Yew T4, with good arboricultural value and good prospects.
- 3.2.7 The Red Horse Chestnut T5 and Holm Oak T1 provide some visual amenity, yet they both have stem defects that are likely to limit their long-term prospects.

Photo 1: Looking south, T1 to T3

- 4.3.3 The design of the new development has considered the trees crown position in relation to the development. While not urgent, it is advised to raise the low hanging crown of T1 to avoid conflict with construction traffic and to give adequate provision for future tree growth.

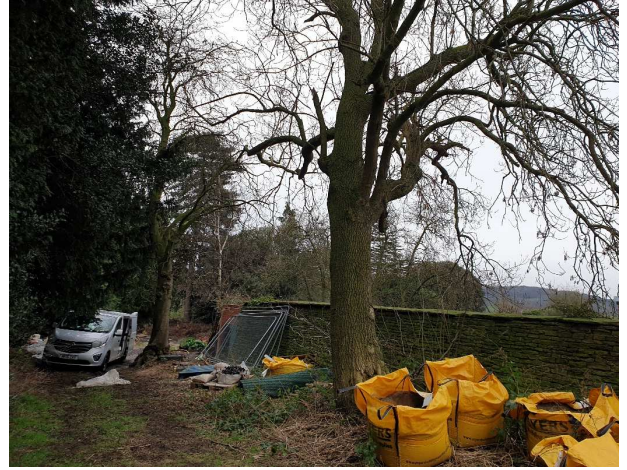
- 3.2.5 Tree T6 is a large imposing Ash, with good landscape value. Many of the Ash trees in the area show symptoms consistent with Chalara or Ash dieback disease. Once a tree is infected, the disease is usually fatal, either directly or indirectly. While the identified Ash trees may continue to provide landscape and wildlife benefits for some time, their long-term prospects are likely to be limited as a result of Ash dieback.

Photo 2: Looking east, T5 and T6

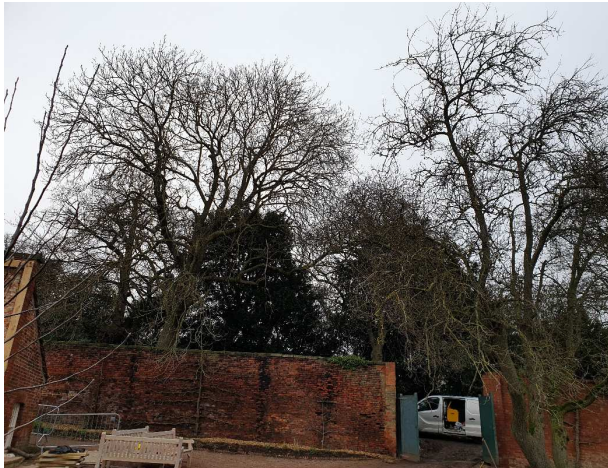
Photo 3: Looking north, T5, T6 & T7

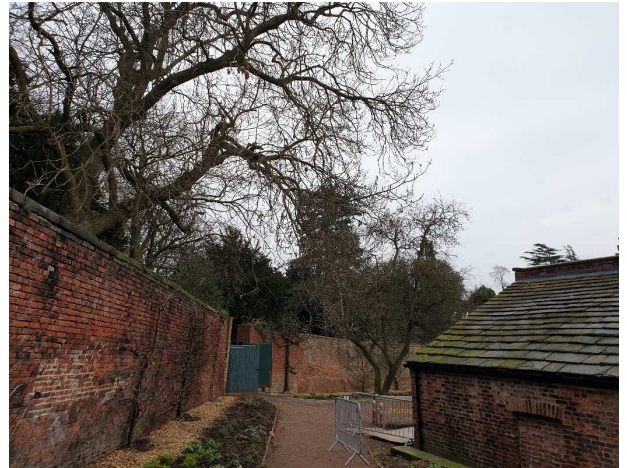
Photo 4: Looking south, T6 & T7

- 4.3.2 Potentially damaging activities are proposed in the vicinity of retained trees. The new drainage encroaches close to and into the edge of the RPA of T6 and T7. Construction within the RPA, can have negative impacts on tree roots. However, the encroachment is very minor, and the detailed RPA for these trees is likely to be a slightly exaggerated representation of the trees actual rooting area. As such, it is unlikely that significant roots will be within these areas and the retained tree should remain largely unaffected by the works, provided care is taken during construction.

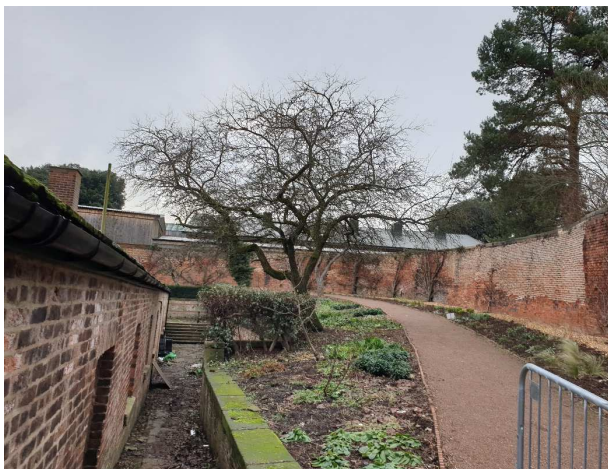
Photo 5: Looking west, T8 & G9

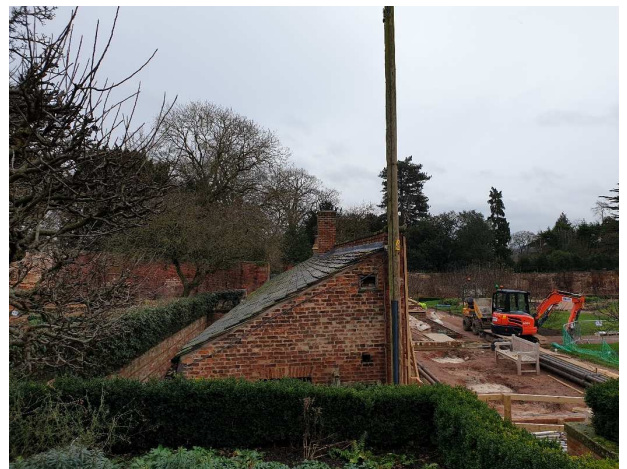
Photo 6: Looking east, T8 & G9
