# **ARBORICULTURAL REPORT** **& Impact Assessment** to **BS5837:2012** at:

*Land at*  
**Pontefract Road**  
**Hoyle Mill**  
**Barnsley**  
**S71 1HF**

Prepared for:  
**Cars 2 Limited**  
Waldorf Way  
Wakefield  
WF2 8DH

Reference: AWA3427

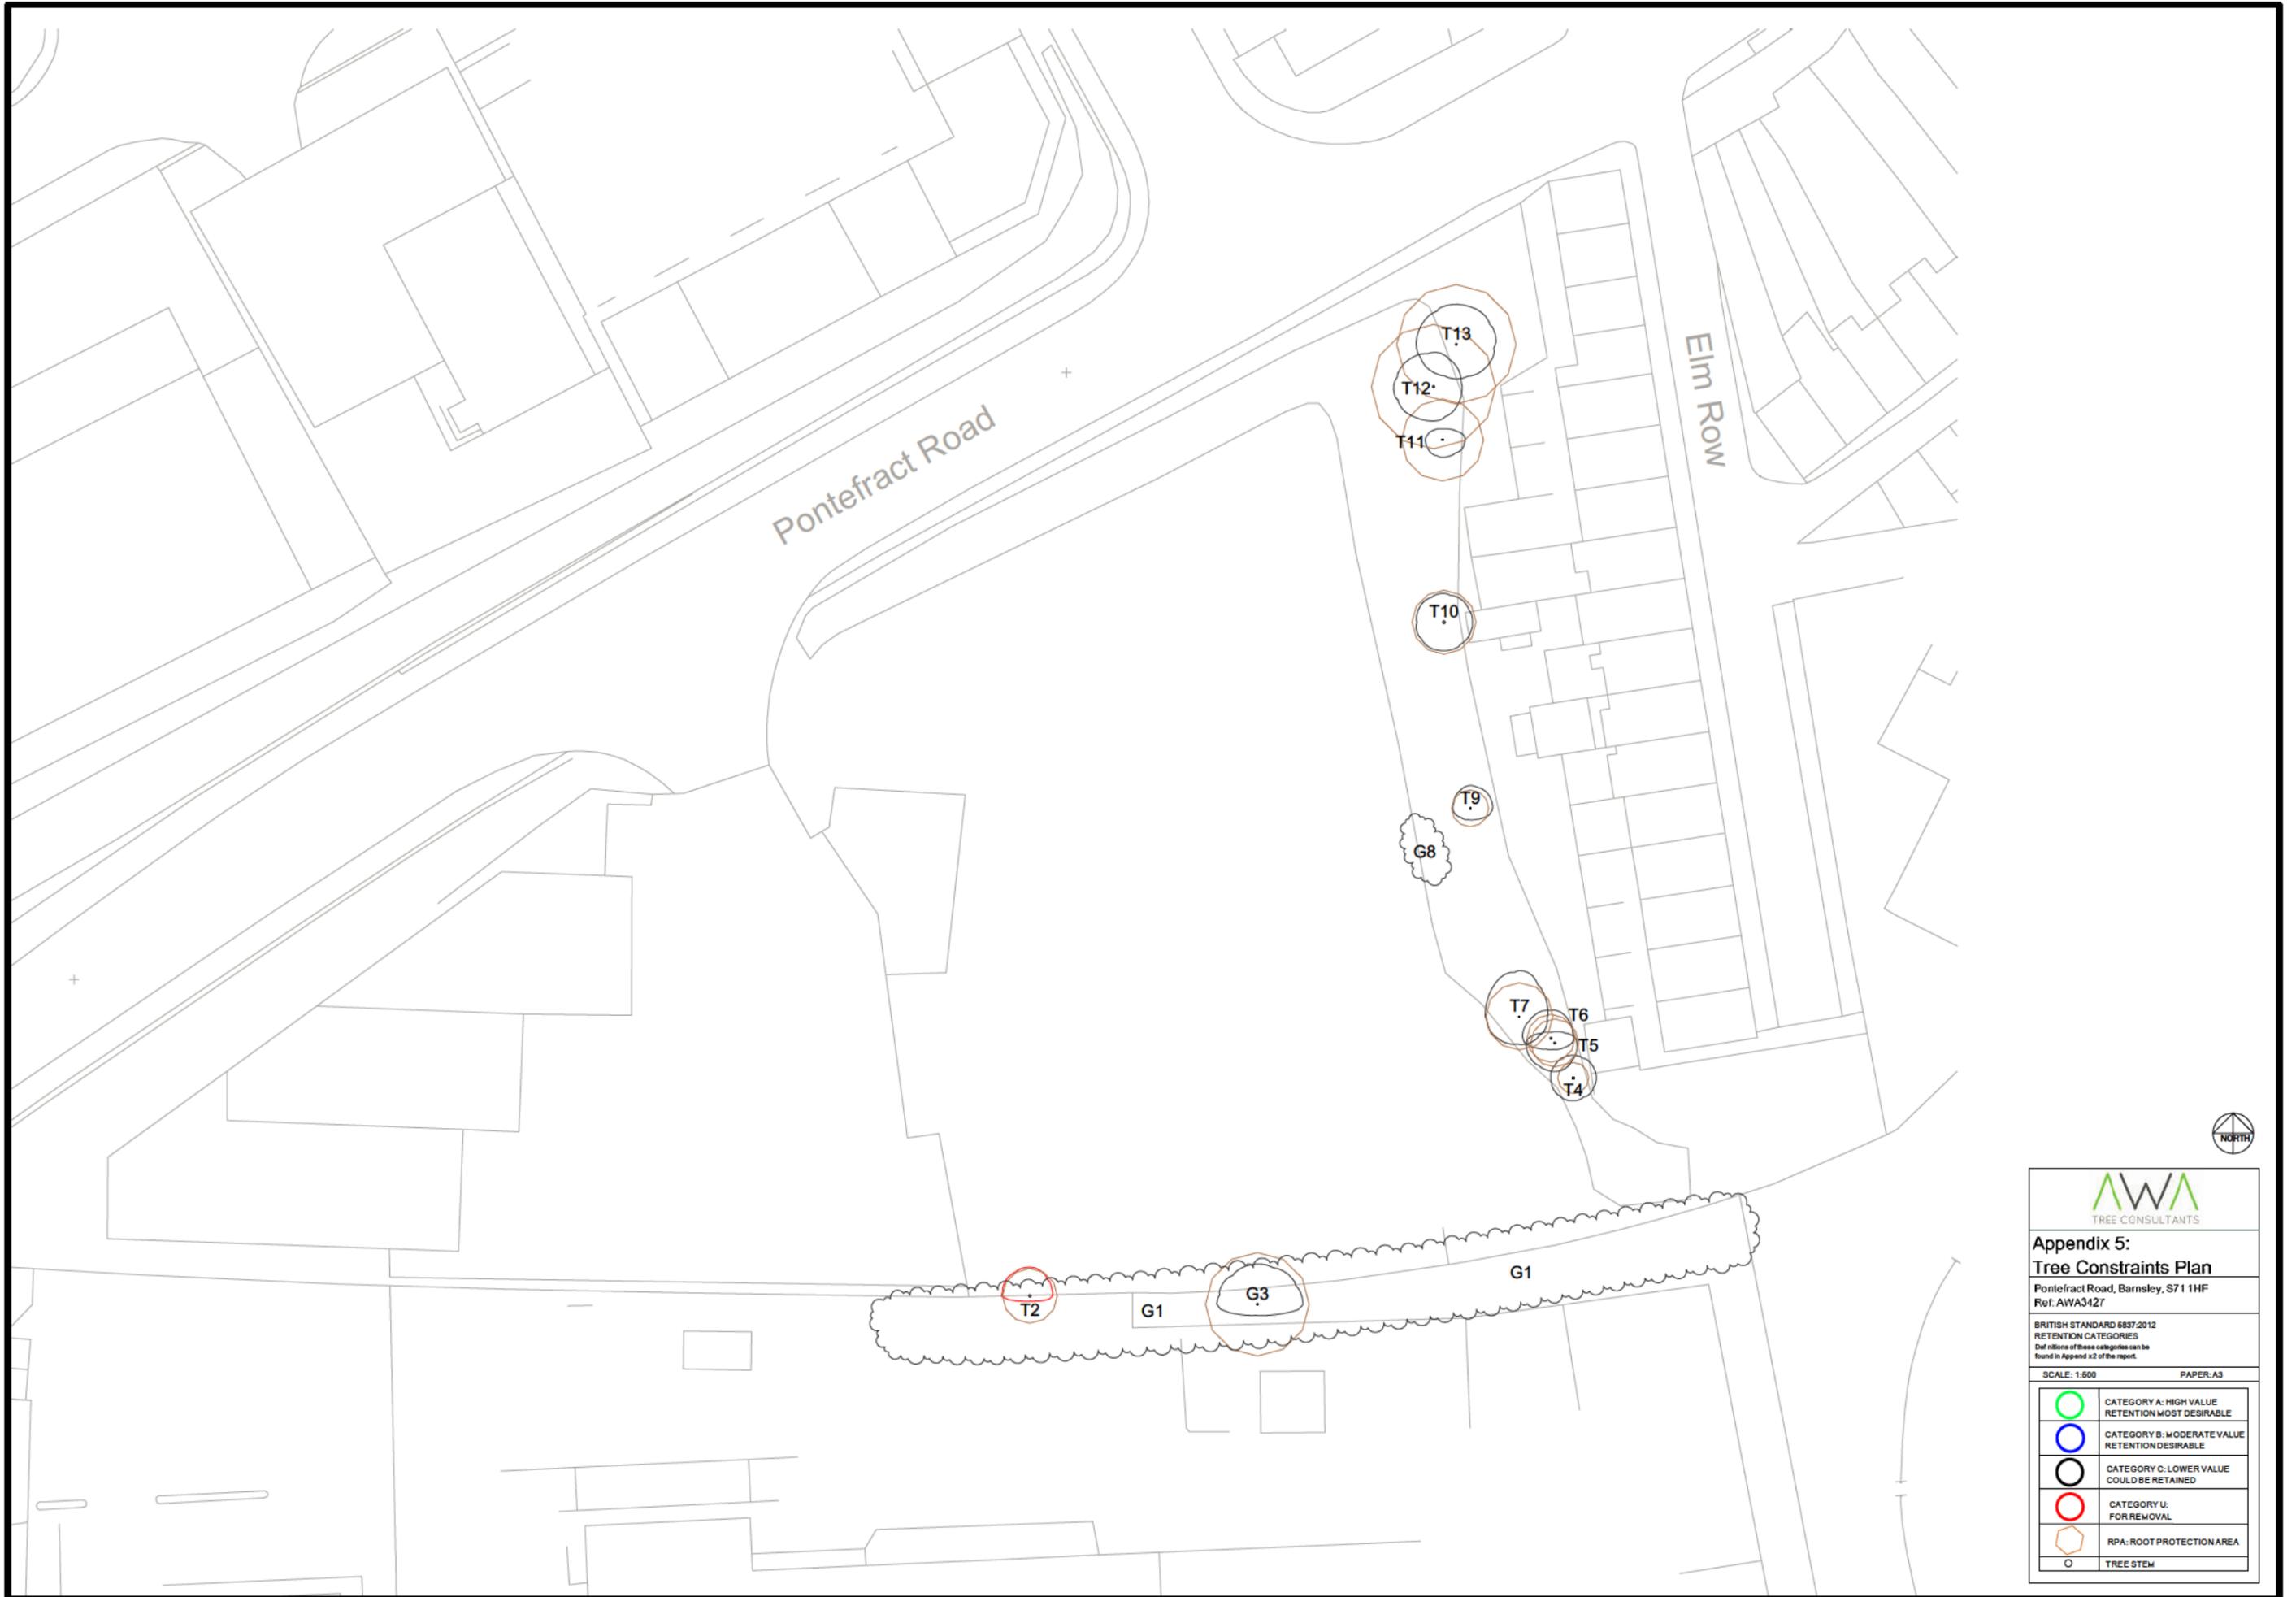
**Appendix 5:  
Tree Constraints Plan**

- 3.2.8 The large linear group of Leyland Cypress trees, G1 are close to the top of a retaining wall at the south of the site, and as such form a prominent feature with some collective value. This species is relatively short-lived, and trees can be prone to unforeseen failure as they mature. It is likely that these trees will need regular management in the future to maintain their suitability for retention. In the longer term it may be more suitable to remove them and replant this area with trees that have better prospects and are more in keeping with the surrounding landscape character.

- 3.2.9 The Sycamore tree, T2 is growing directly at the top of the retaining wall, with clear damage to the wall close to the stem. The tree is in a relatively poor condition and its removal is advised regardless of any future development.

- 3.2.10 Beyond the fence line at the east of the site are the trees and groups T4 to T13. These trees, and the shrubs that surround them, are of low arboricultural value; however, they collectively provide some screening between the site and the residential properties beyond. Large scale removals should be avoided in this area if compatible with development proposals.

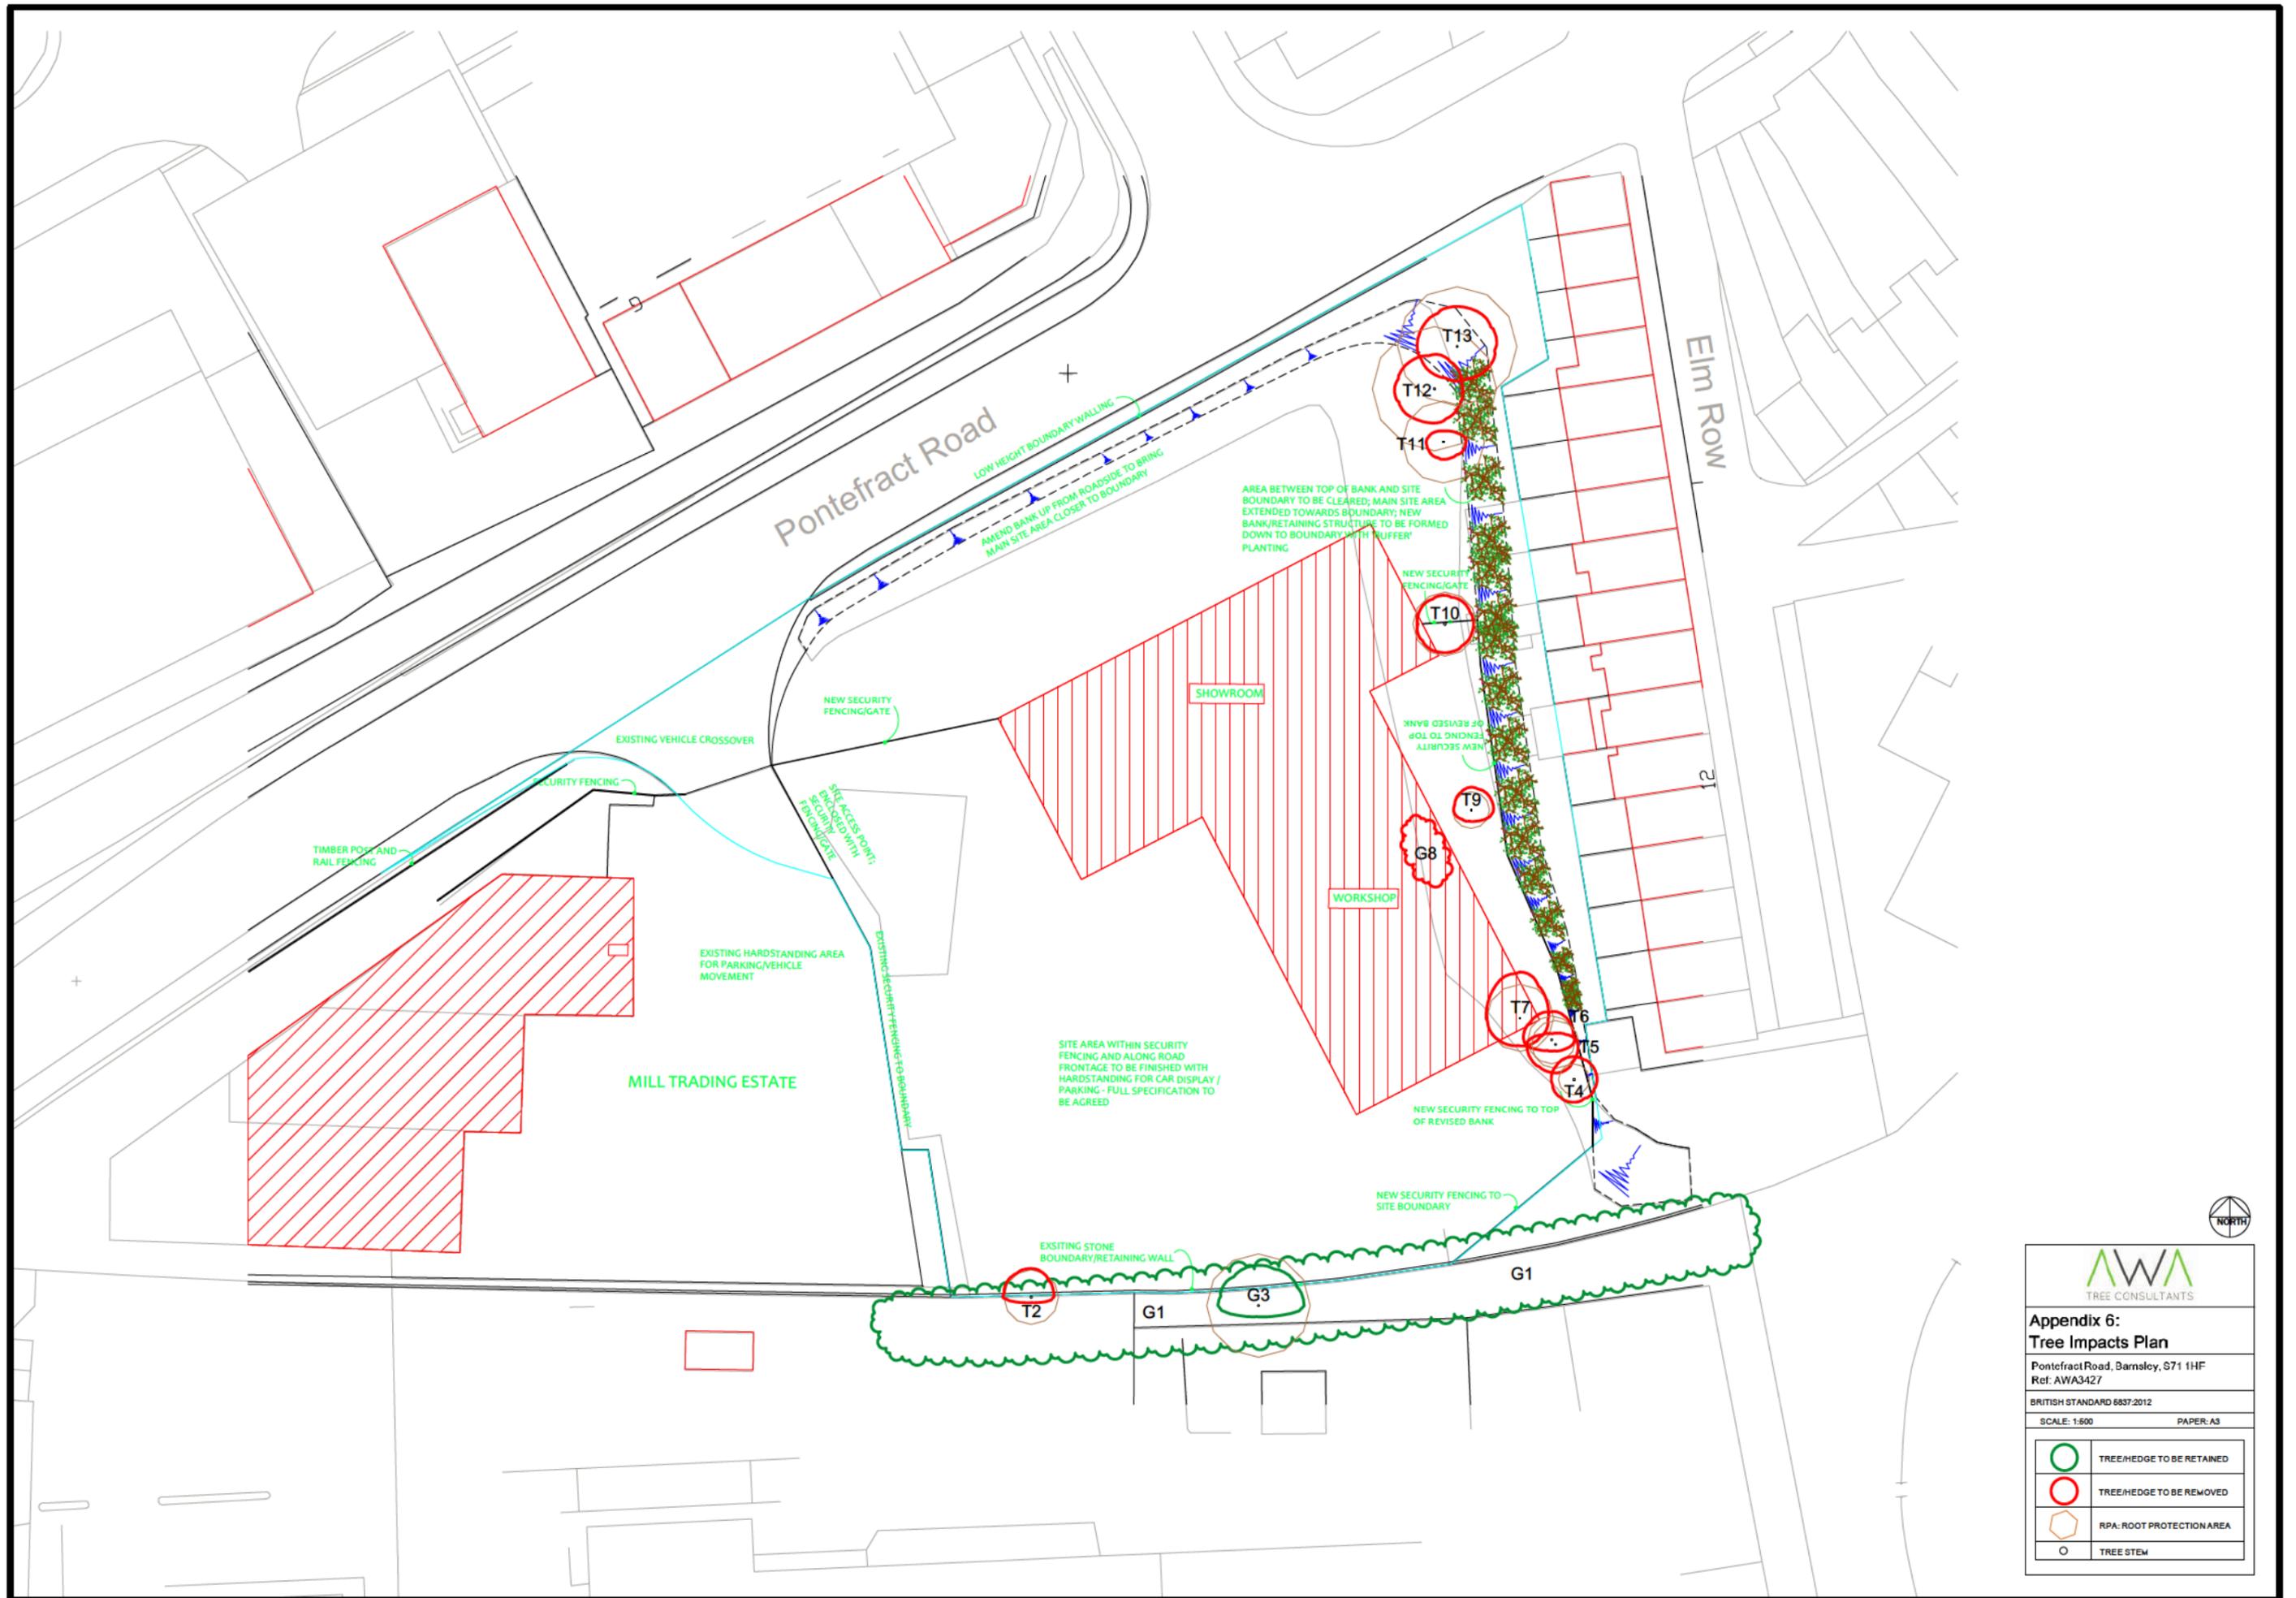
**Appendix 6:  
Tree Impacts Plan**

4.2.1 From assessing the new development proposals, the removal of 9 trees and 1 tree group will be required as they are situated in the footprint of the structure or their retention and protection throughout the development is not suitable.

4.2.2 The trees that are required to be removed are T4 to T13.

4.2.3 All of the trees to be removed are lower value, retention category 'C'. They are all relatively small, some with significant defects that are likely to limit their longer term value.

- 4.4.1 The development of the site provides an excellent opportunity to undertake new tree planting, particularly along the eastern and northern boundaries, as part of a soft landscaping scheme.
- 4.4.2 The planting of suitable new trees, that are in keeping with the surrounding landscape character and tolerant of climate change, can mitigate for the required tree removals and in the longer term improve the sites tree cover.
- 4.4.3 The planting of several larger nursery stock trees would provide trees with established amenity at the outset.
