# **BAT PRELIMINARY ROOST ASSESSMENT**

**Lundwood Social Club,  
Pontefract Road,  
Lundwood,  
Barnsley,  
S71 5PN**

| Date: | 21 <sup>st</sup> May 2026 |
| Reference | WEE0102.01 |

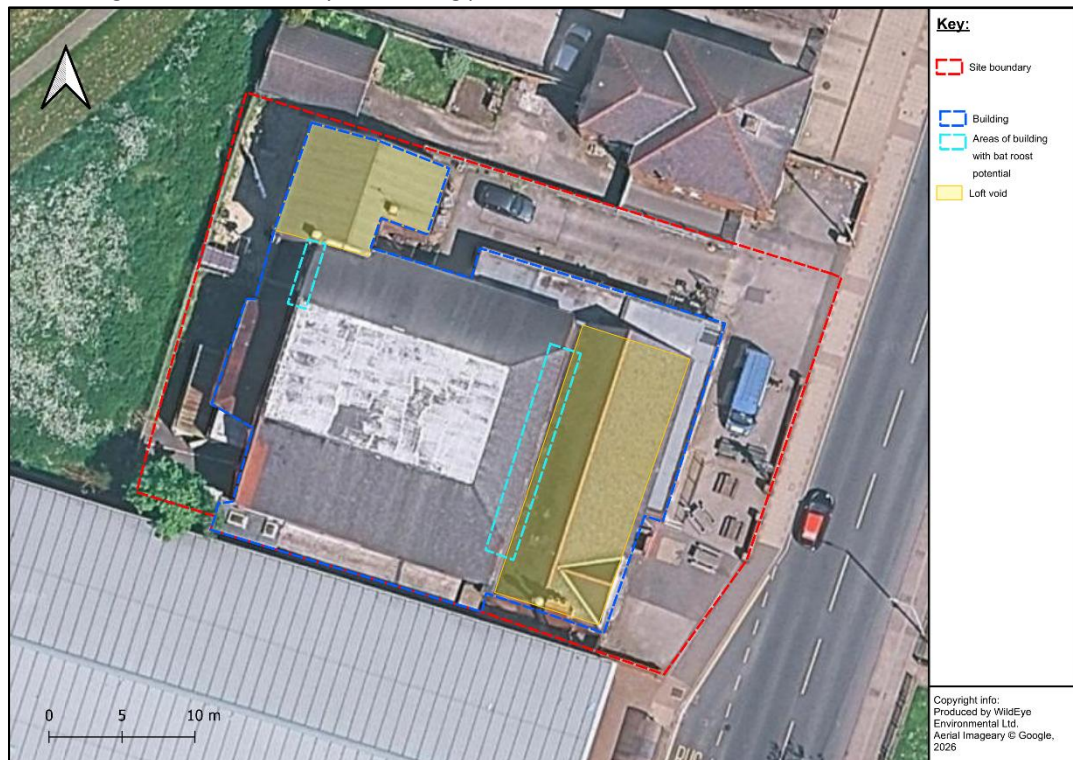
**Figure 1.** Showing the red line boundary and building present on site

**No evidence of bats was identified during the external inspection. Two areas were identified that may present opportunities for roosting bats (as highlighted in Figure 1).**

There are two separate loft voids within the building (highlighted in Figure 1):

However, if the proposals change to include works to (or with proximity of) the areas highlighted, further survey or mitigation works may be required.

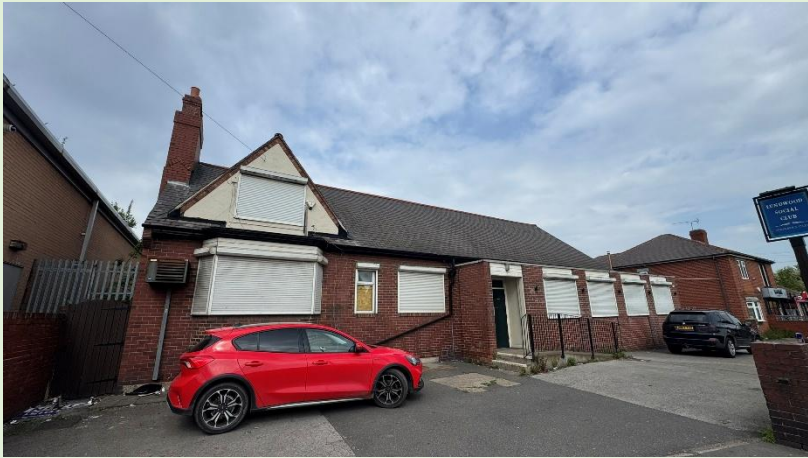
| | Photograph | Description |
|---|---|---|
| 1. | A photograph showing the front elevation of a red brick building with a gabled roof and a chimney. A red car is parked in front of the building. The sky is overcast. | The front elevation of the former social club; east facing |

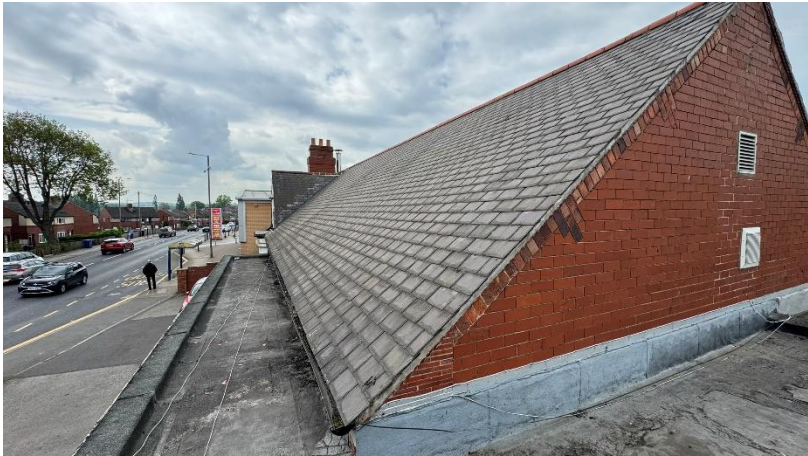
The roof of the building is mostly in excellent condition, with very few PRFs present. There are no suitable gaps between the roof or ridge tiles; some minor gaps are visible beneath the ridge tiles, but when inspected with torch and binoculars, these were found to be superficial and unsuitable for access by bats. The felt roof of the former annex accommodation is also in excellent condition, presenting no opportunities for roosting bats. Due to the complex roof structure, there are various areas of lead (and non-lead) flashing used; however these are well-sealed, presenting no opportunities for bats. A low-level flat roof wraps around the northern, eastern and southern aspects, which is externally lined with bitumen; this is in excellent condition, with no opportunities for bats.

| | Photograph | Description |
|---|---|---|
| 2. | A photograph showing the roof of the eastern elevation of the building, which is covered in grey tiles. The roof is in good condition. A street with cars and a person is visible in the background. | The roof of the eastern elevation; in good condition |

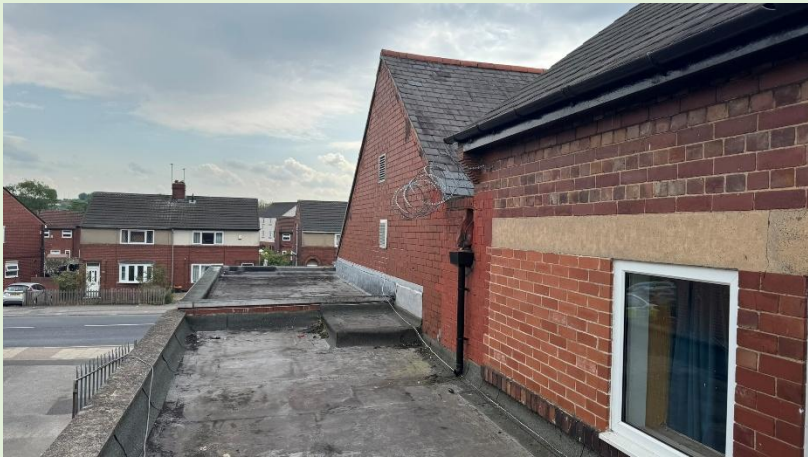
| | Photograph | Description |
|---|---|---|
| 3. | A photograph showing the eastern section of the northern elevation of the building, viewed from the flat roof. The building is made of red brick and has a white-framed window. A street with other buildings is visible in the background. | The eastern section of the northern elevation from the flat roof. |

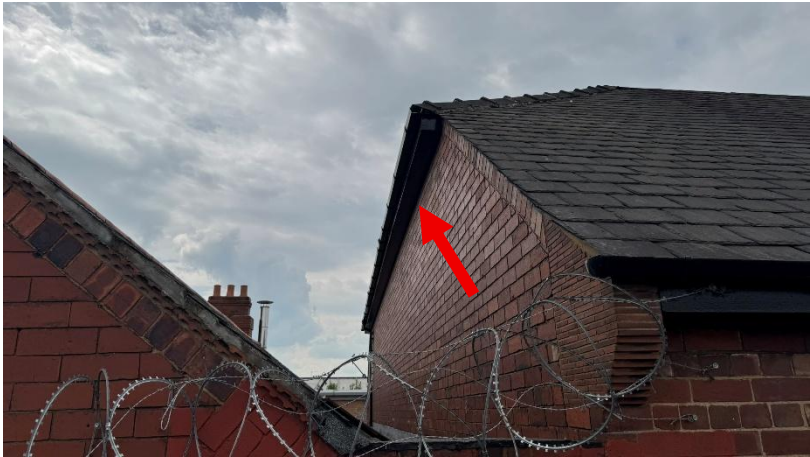
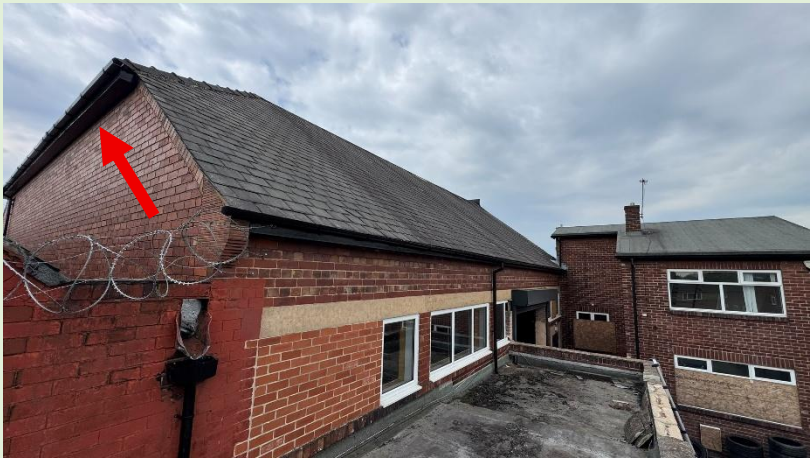
The eaves and soffits of the building are mostly well-sealed with gaps too narrow for access by bats. The exception is an eastern facing soffit (Photos 4 and 5, and highlighted in Figure 1), where a gap of 1-2cm is present. This feature could not be accessed to complete an endoscope inspection; however no droppings were visible by viewing with torch and binoculars.

| 4. | | <p>An eastern facing elevation adjacent to the easternmost part of the building; soffit is visible where a gap is present; suitable for use by bats, but not accessible to fully inspect. No evidence of bats was visible through binoculars and torch.</p> |
| 5. | | <p>Another photo showing the east-facing soffit with suitability for bats.</p> |

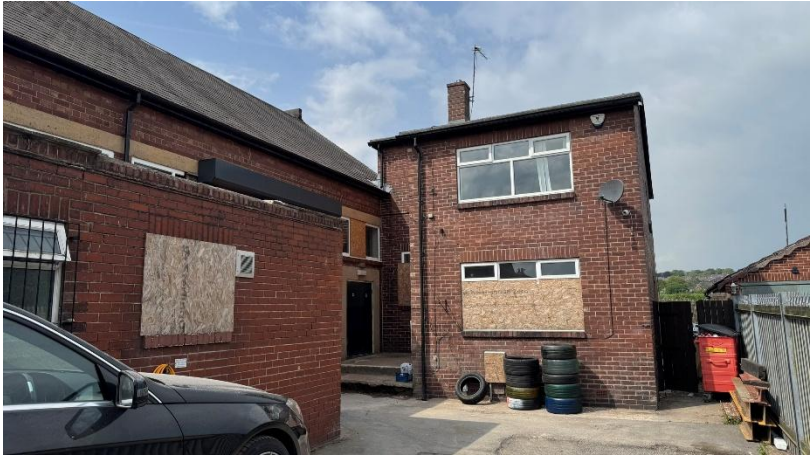
| 6. | | <p>The northern elevation; showing the former annex accommodation.</p> |

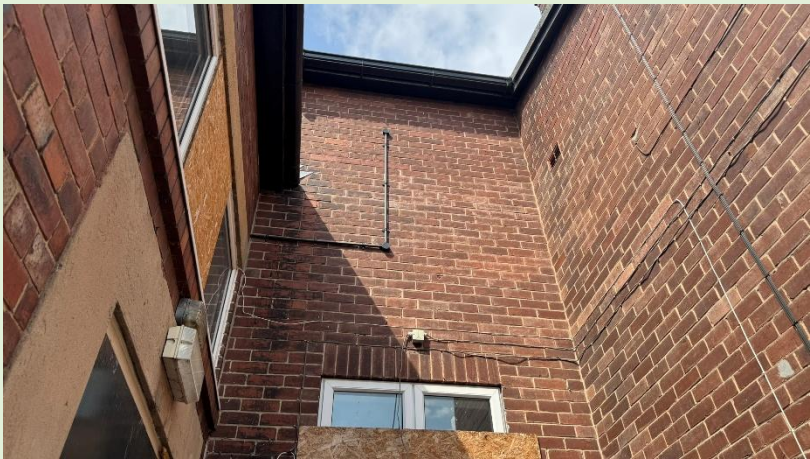
| 7. | | <p>The eaves of the annex accommodation; these were tightly sealed.</p> |

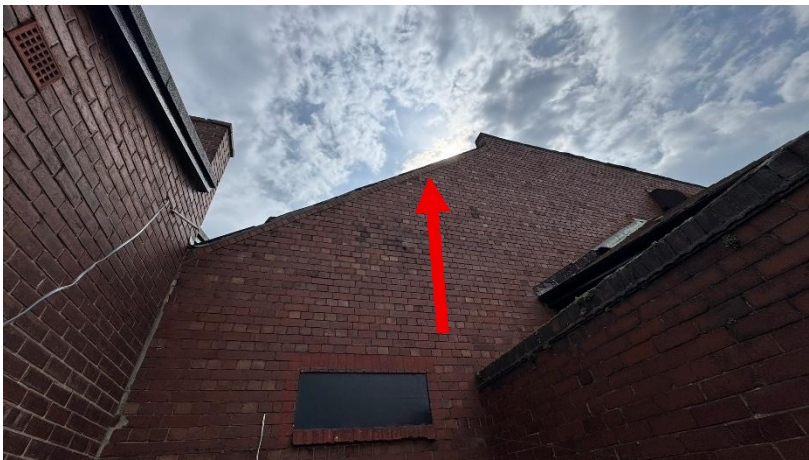
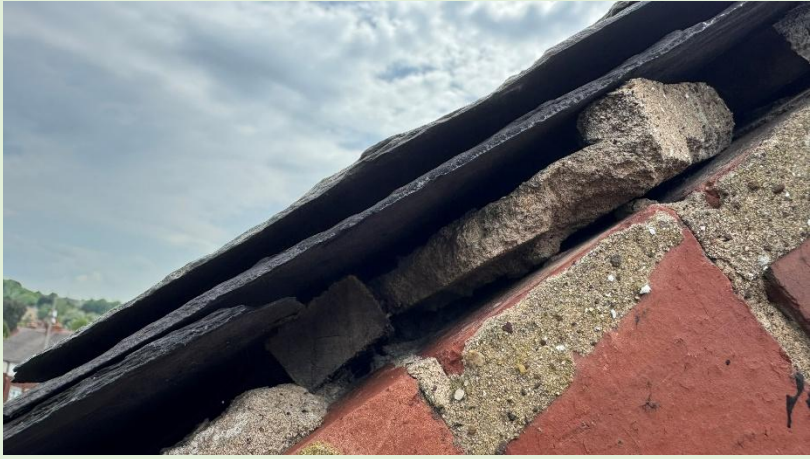
There is a small section of missing mortar at the gable apex of the eastern aspect (facing Pontefract Road), however upon inspection by torch and binoculars, this is found to be superficial and unsuitable for use by bats. Another area of missing mortar is present at the verge pointing on the western aspect (north-facing pitch): This feature leads into a cavity between the roof tiles and bitumen lining creating a suitable cavity for roosting bats (see Photos 8 and 9, highlighted at Figure 1). The feature was inspected with a ladder and endoscope and found to be moderately cobwebbed, with no evidence

of bats. The feature extended beyond the length of the endoscope though and could not be fully inspected.

| 8. | | <p>The western elevation; the verge pointing at the roof line is partly missing mortar, providing potential access points for bats.</p> |
| 9. | | <p>A close up of the missing mortar on the western elevation roof line (accessed by ladders and endoscoped); the feature extends into the gap between roof slates and internal lining, beyond the length of the endoscope, however no evidence of bats was identified.</p> |

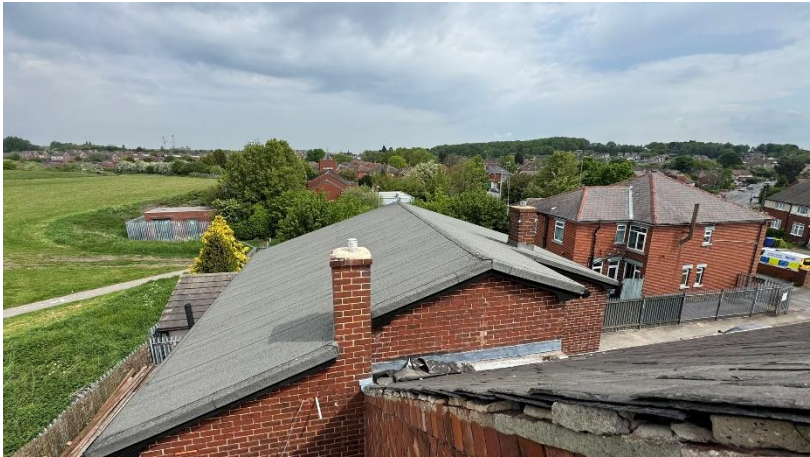
| 10. | | Showing the roof of the former annex accommodation (western elevation) |

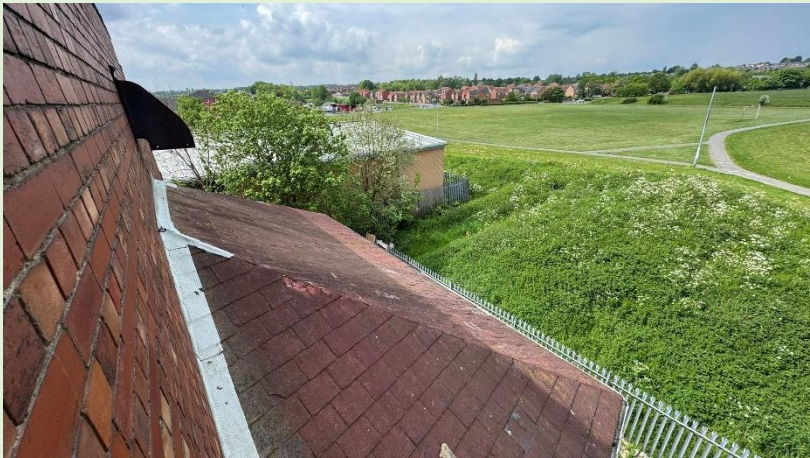
| 11. | | Western elevation; facing onto the amenity playing fields to the west. |

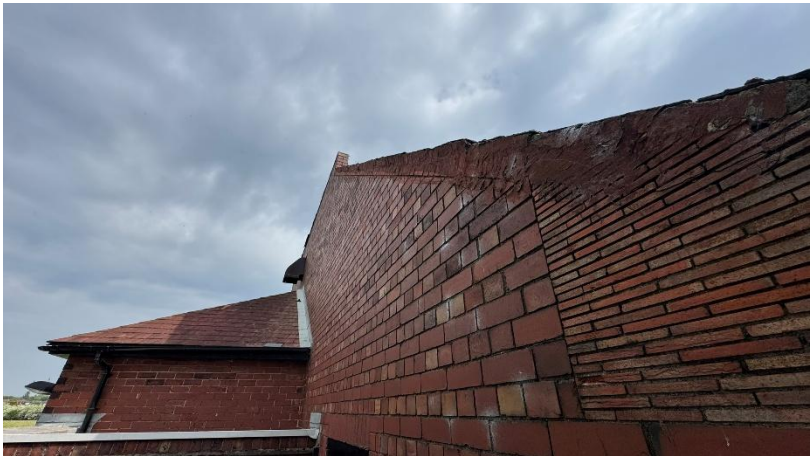
| 12. | | Southern section of the western elevation |

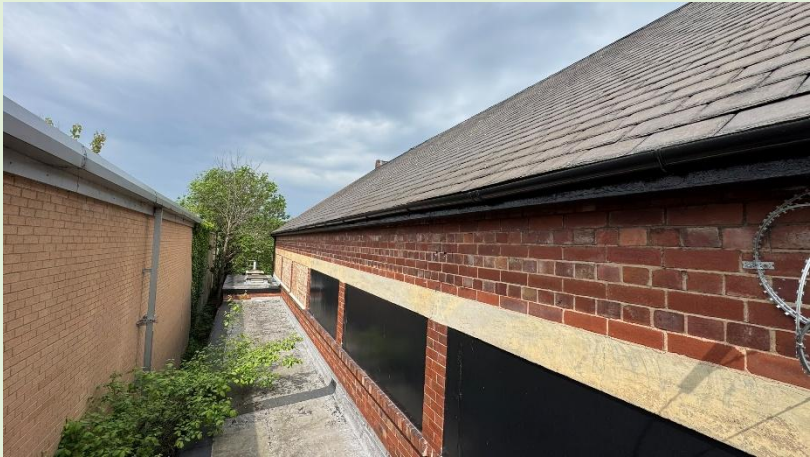
| 13. | A photograph showing the southern elevation of a brick building, viewed from a flat roof. The building has a red brick wall with a light-colored stone or concrete band running horizontally. The roof is dark and appears to be made of slate or tiles. The soffits are well sealed. | Southern elevation, viewed from the flat roof; the soffits are well sealed. |

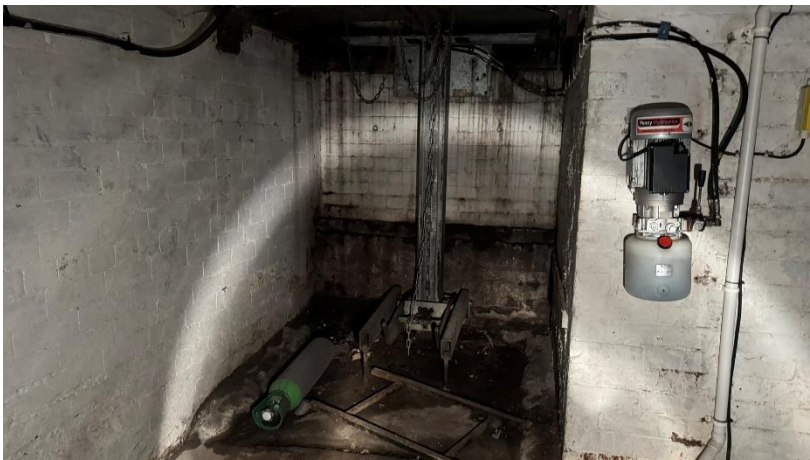
There is a cellar present beneath the eastern section of the building (former use for drinks storage). As discussed above, there is access to this cellar through an access hatch at ground level on the eastern aspect, however this is tightly sealed with no access opportunities for bats. No other access opportunities were identified.

| 14. | A photograph of a cellar interior. The walls are made of concrete blocks. A former access point for barrel delivery is visible, which was tightly sealed, presenting no access for bats. A green gas cylinder and some equipment are on the floor. | The cellar; showing the former access point for barrel delivery; this was tightly sealed, presenting no access for bats. |

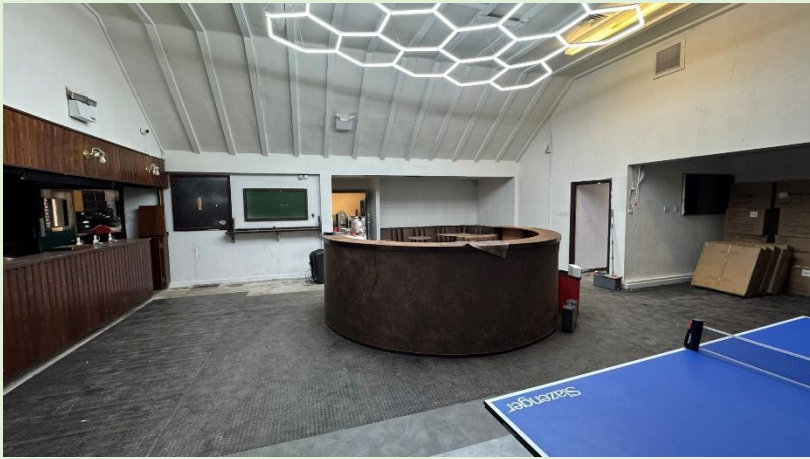
| 15. | A photograph of the interior of a former social club. The room has a high ceiling with exposed wooden beams and a large, curved wooden bar in the center. A blue ping pong table is visible in the foreground. The walls are white, and there are some shelves and equipment in the background. | The internal view of the former social club. |

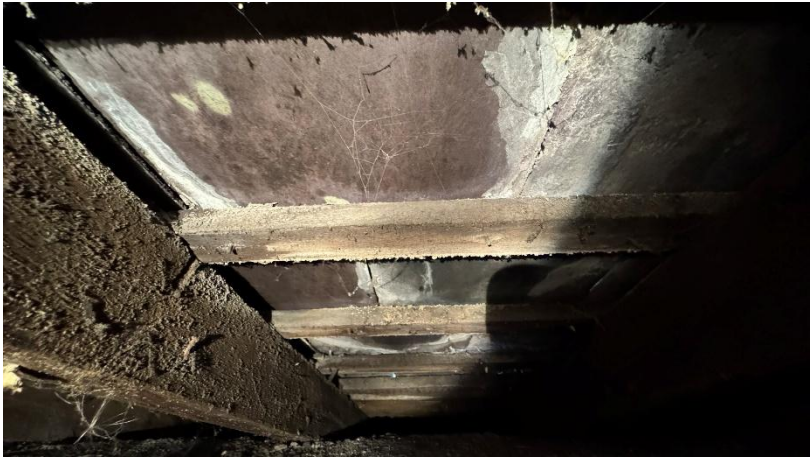
| 16. | | Unlined section of the loft of the former social club. |

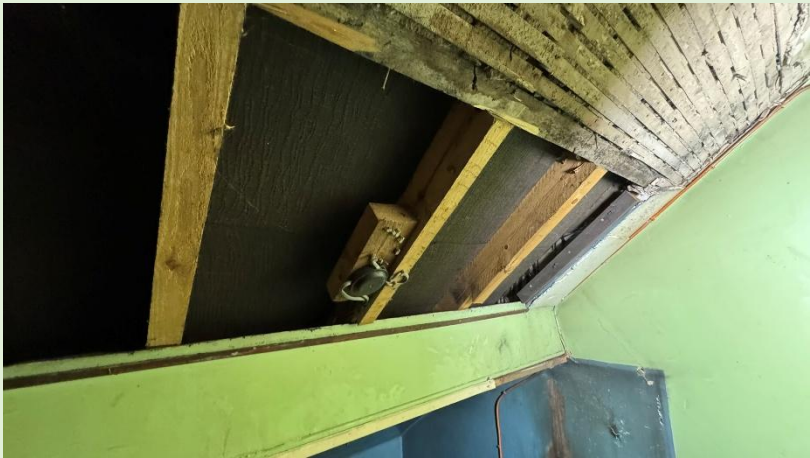
| 17. | | Bitumen felt lined section of the former social club. |

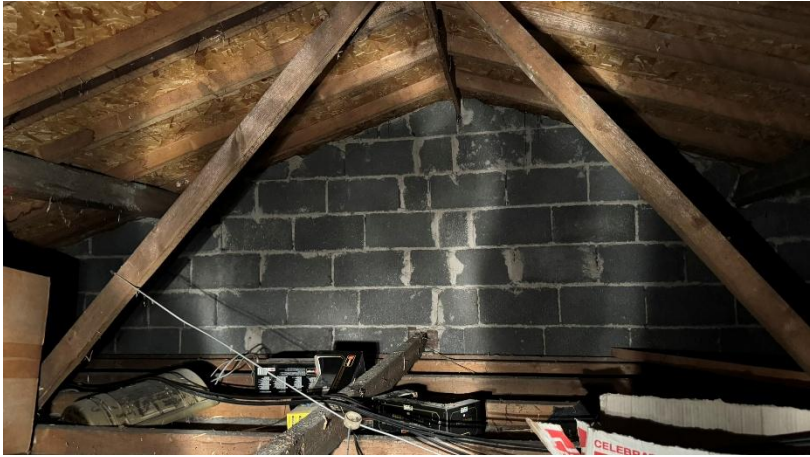
| 18. | | Chipboard lined section of the former annex accommodation (facing north). |

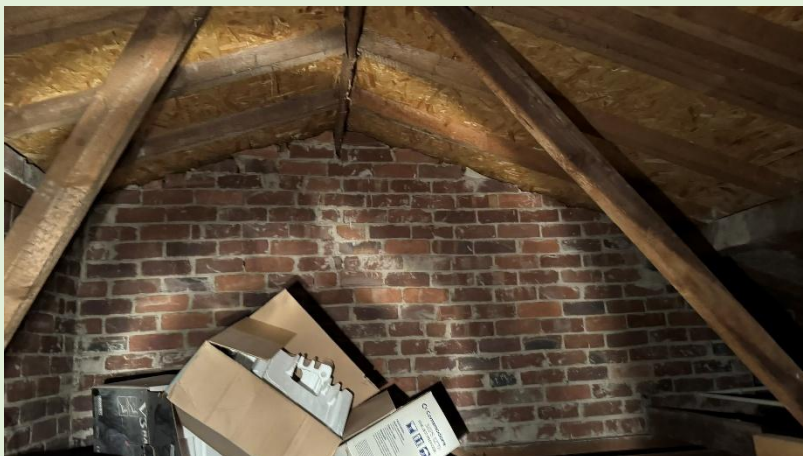
19.

Chipboard lined section of the former annex accommodation (facing south).
