**Land North of Keresforth Road, Dodworth,
Barnsley**

Road Safety Audit Combined Stage 1 & 2

TMS reference no: 18507
Date: 5th June 2024
Revision: 0

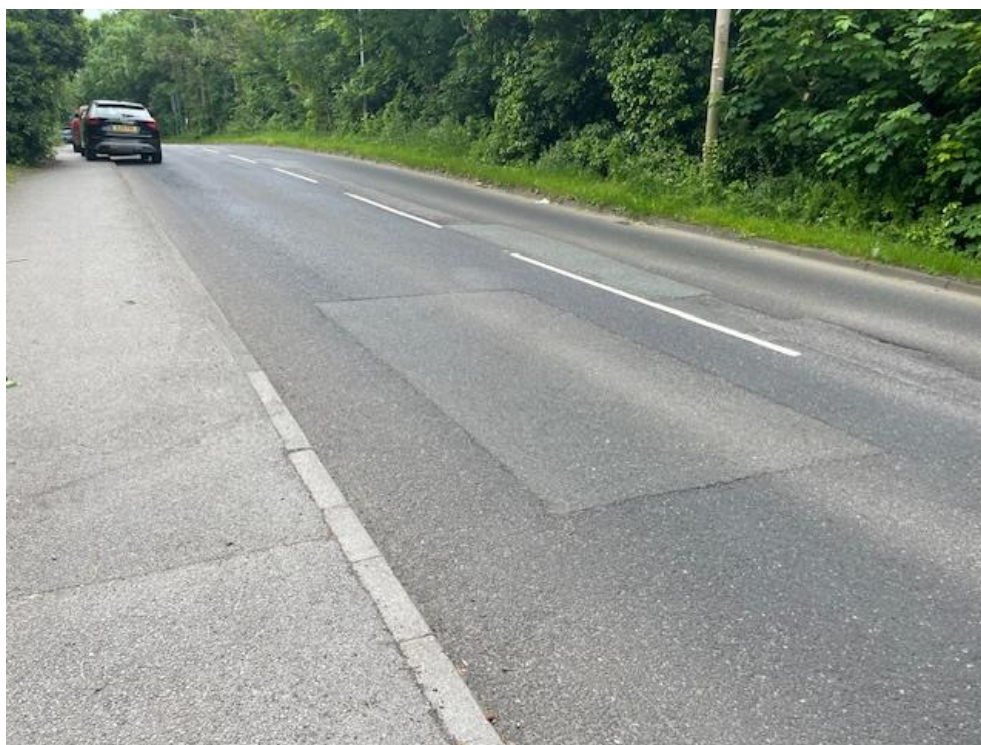
Summary: Poor carriageway condition may increase the risk of braking, skid and loss of control type vehicle collisions

The existing carriageway condition on Keresford Road at the proposed site access junction is poor, with patches from previous works and some surface cracks. This may result in differential skid resistance across the junction. The development will introduce a significant number of braking and turning manoeuvres into the site and as such the poor carriageway condition may increase the risk of braking, skid and loss of control type vehicle collisions.

Keresford Road should be resurfaced for the extent of the new junction.

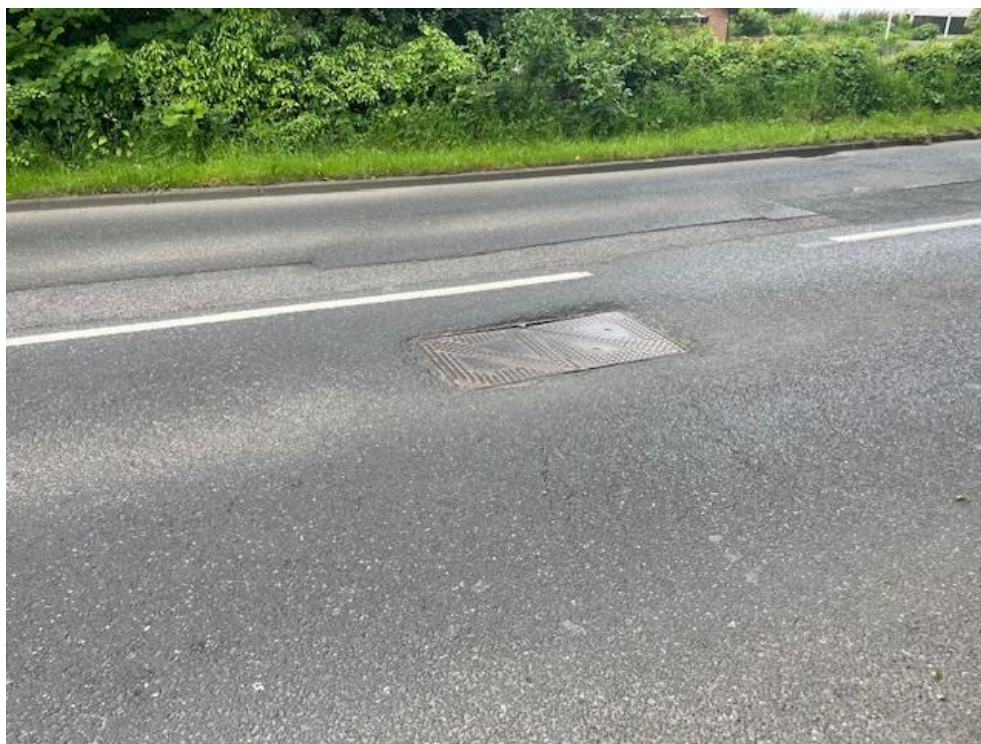
Summary: Sunken utility may be a loss of control hazard to turning vehicles

There is a sunken utility cover within the southbound running lane on Keresford Road at the site access junction. The manhole cover may be a potential loss of control hazard to vehicles making turning manoeuvres to and from the site access. This may be a particular issue for two wheeled vehicles.

In addition, the polished nature of the utility cover may present a potential skid hazard to vehicles, exacerbated during wet or icy conditions.

The utility cover should be reset flush with the carriageway and treated with a suitable non-slip surface with similar skid resistance to the surrounding carriageway.

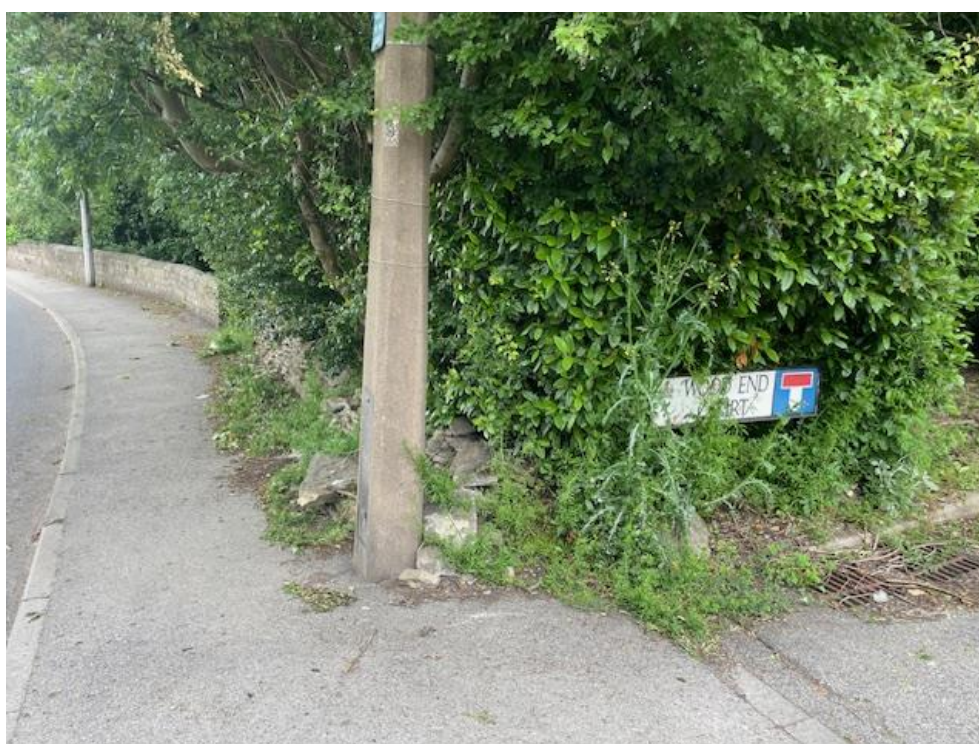
Summary: Poor illumination of the junction may increase the risk of darkness related vehicle collisions

There is an existing lighting column that will be within the extents of the widened access junction and will therefore require removal. No details have been provided to show if and where the lighting column will be relocated. A lack of illumination at the junction may increase the risk of darkness related vehicle collisions.

The junction of Keresford Road and the site access road should be appropriately illuminated.
