**SITE INVESTIGATION/**  
**CCTV REPORT**  
**AT**  
**STONECROFT**  
**HALL ROYD LANE**

**Insured**                      Mr Firth  
**Client's Ref**                SU1200023  
**Auger's Ref:**               29033.1.USI  
**Visit Date:**               27-Jan-12  
**Report Date:**             10 Feb. 12  
**Author:**                    LC  
**Checked By:**               H.E

Risk Address: Stonecroft, Hall Royd Lane,  
Barnsley S75 4PP

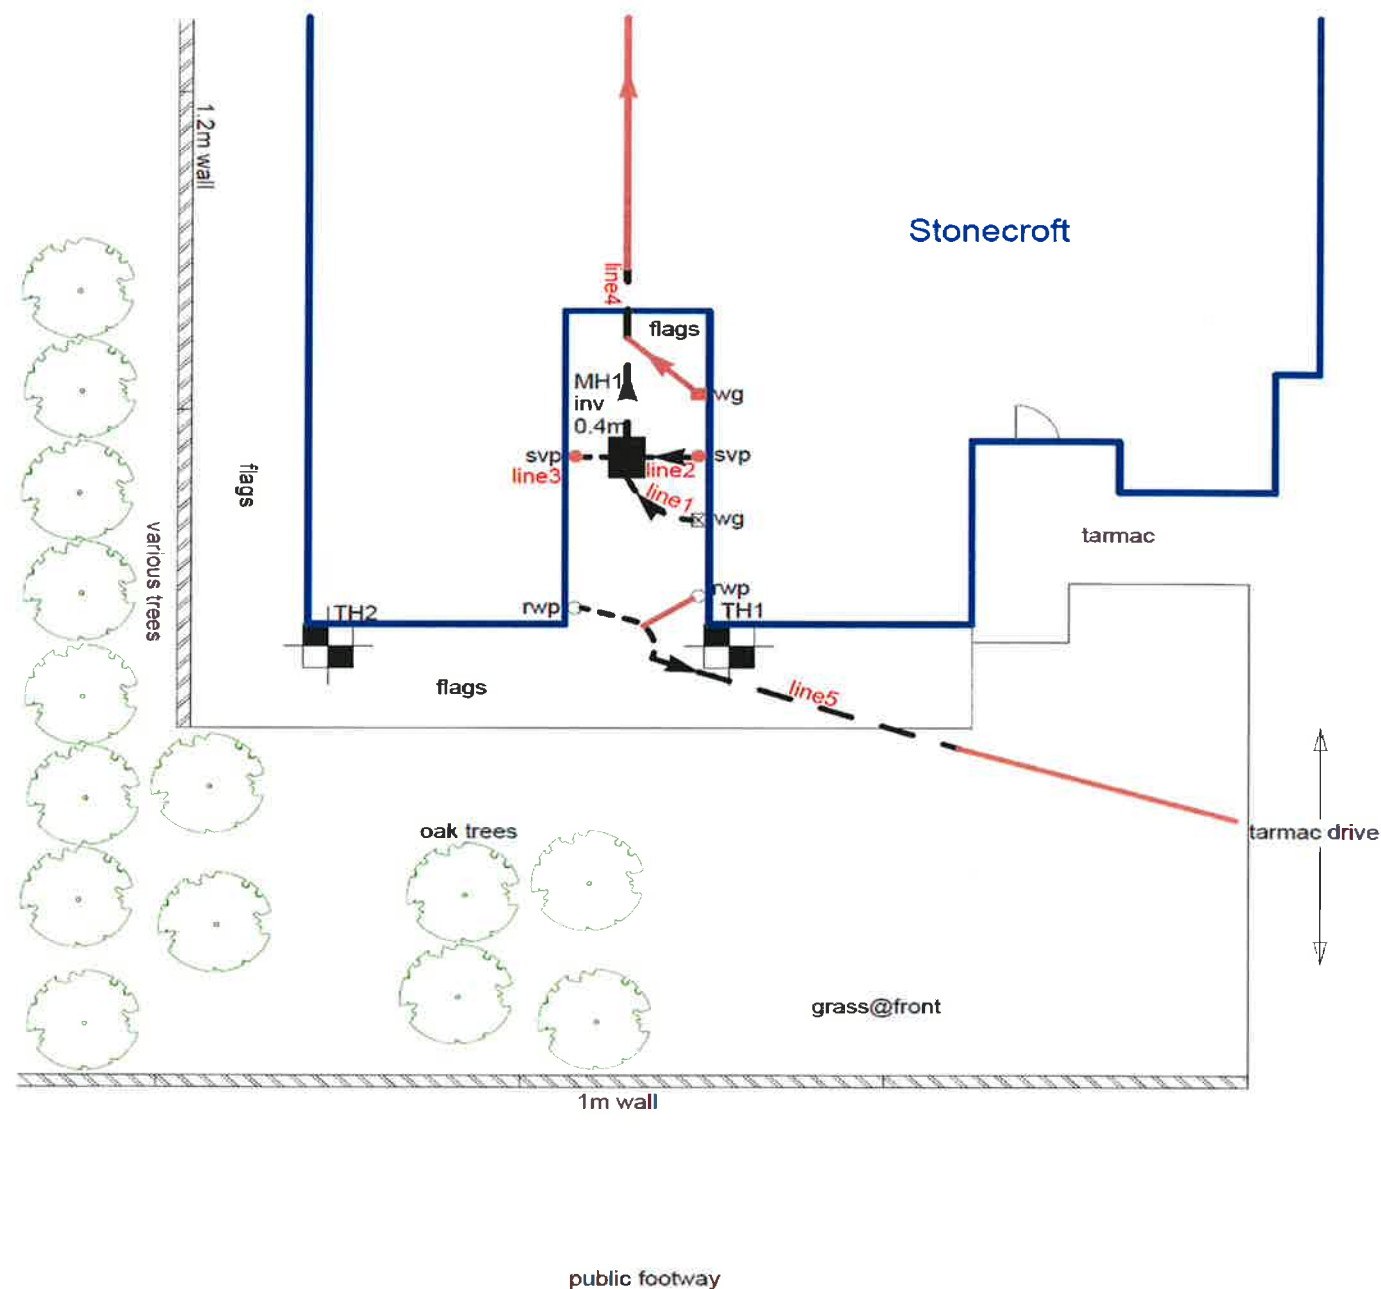
# EXISTING DRAINAGE LAYOUT

This drawing assumes the layout of the drainage system shown below. The conformation of the pipework location can only be determined by excavation and detailed technical survey.

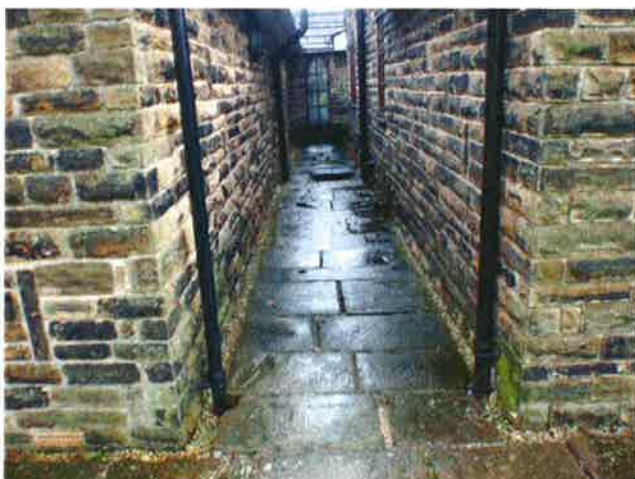
| <b>Visual Summary:</b> | A visual survey of the above address revealed no obvious signs of any significant defects to the drainage system. |

*Fig 1.1 – Area Of Surveyed Drainage*

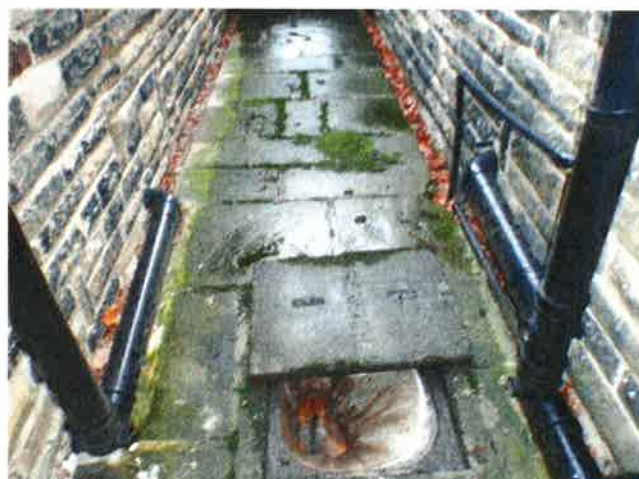
*Fig 1.2 – Manhole 1*
