## **STRUCTURAL REPORT - EXISTING BARN (BUILDING 1)**

### **RESIDENTIAL CONVERSION**

Hill End Farm, Hill End Road, Mapplewell, Barnsley, S75 6DU

**Report Ref:** TH/Hill End/Bldng1/ClassQ/Struct/01/June2022/v01

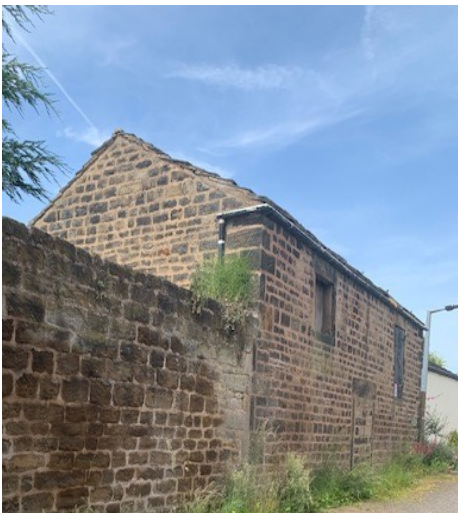
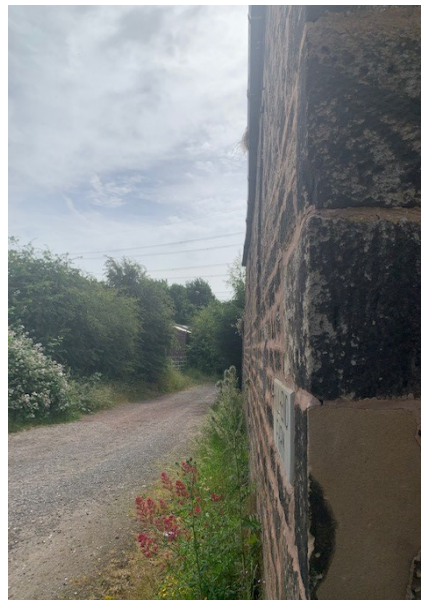
## 2.1 NORTH ELEVATION (FRONT)

*On the north elevation at the (main) front of the building facing the track onto Hill End Road the general structure of the building is plumb and exhibits no signs of substantial (or any) movement and/or significant damage.*

*The structural fabric requires some notional minor repairs and alterations but is capable of full retention with no major (or any) areas of deflection and no requirement to remove and/or replace large sections*

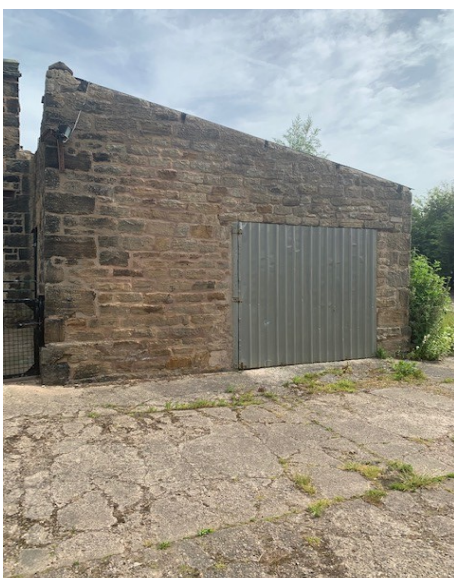
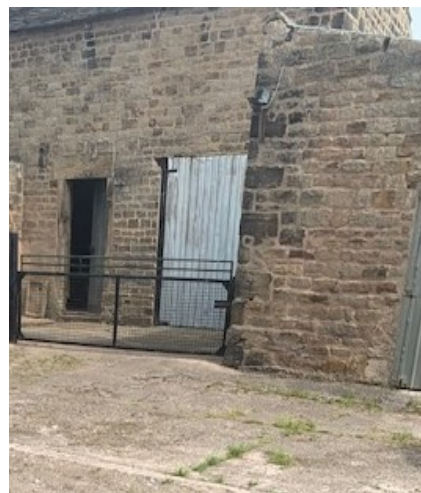
*The adjoining leant-to sides at the rear of the building is also in good general structural order, with the main elements all very plumb and exhibiting no serious signs of movement, deflection and/or significant damage.*

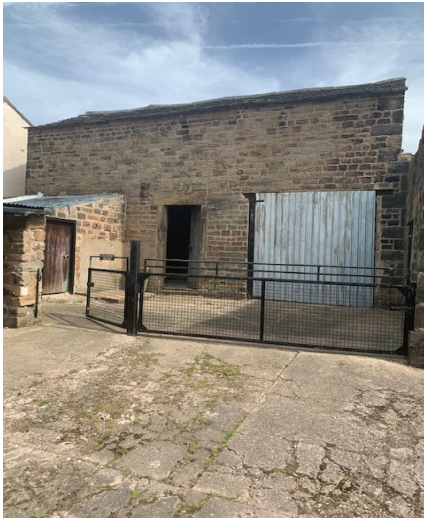
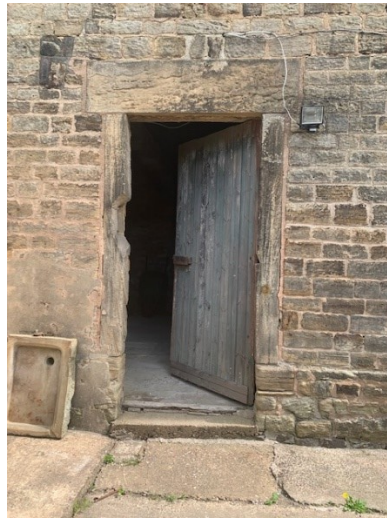
## 2.2 SOUTH ELEVATION (REAR)

*On the south elevation at the (main) rear of the building facing the courtyard area the general structure of the building is plumb and exhibits no signs of substantial (or any) movement and/or significant damage.*

*The structural fabric requires some notional minor repairs and alterations but is capable of full retention with no major (or any) areas of deflection and no requirement to remove and/or replace large sections*

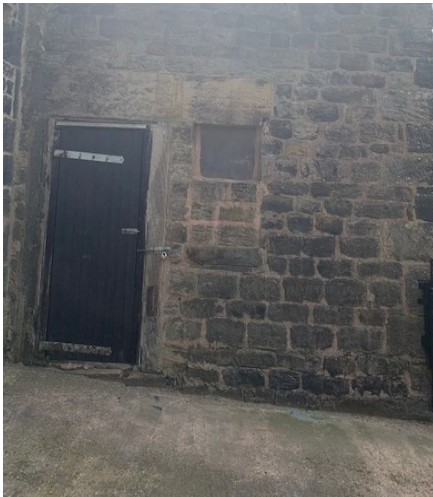
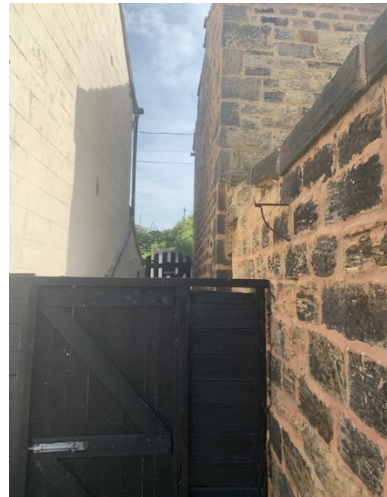
*The adjoining leant-too side at the north-west elevation is also in good general structural order, with the main elements all very plumb and exhibiting no serious signs of movement, deflection and/or significant damage.*

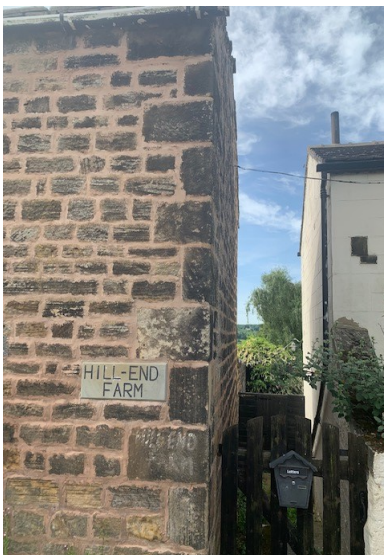
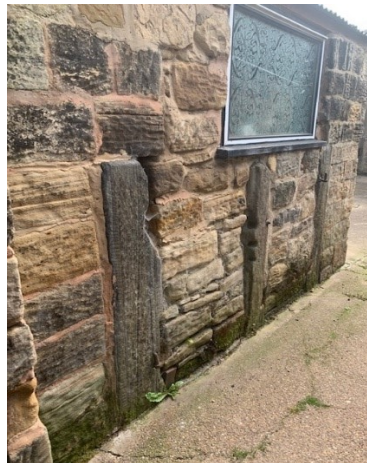
## 2.3 WEST ELEVATION

*The main building west elevation + lean-too is also in good general structural order, with the main elements all very plumb and exhibiting no serious signs of movement, deflection and/or significant damage.*

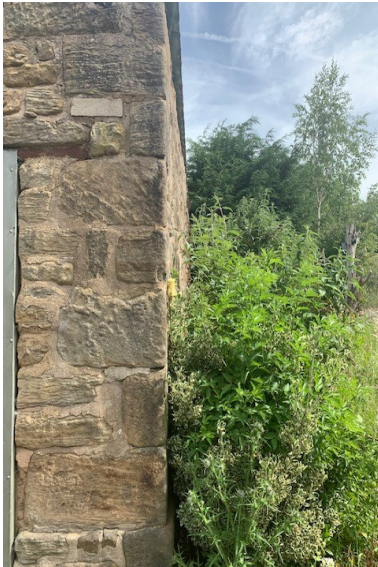
## 2.4 EAST ELEVATION

*The main building east elevation is also in good general structural order, with the main elements all very plumb and exhibiting no serious signs of movement, deflection and/or significant damage.*

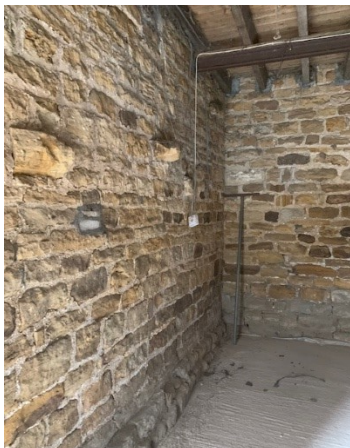
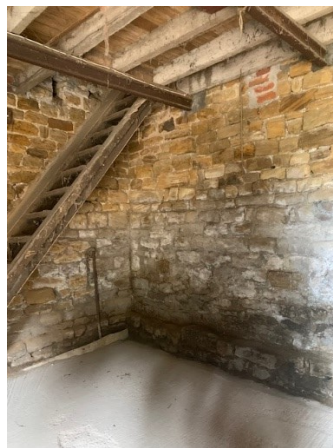
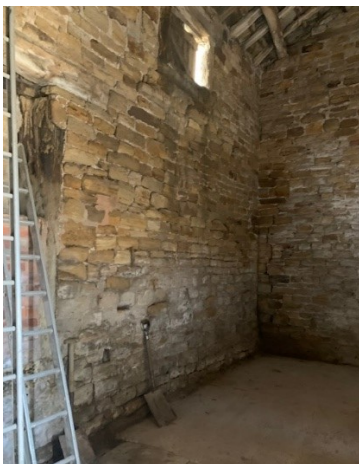
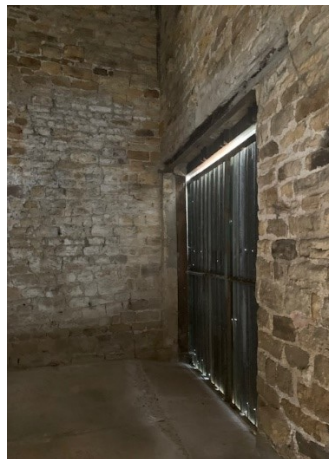
## 2.5 INTERNAL

*Internally, the main building (all elevations) are also in good general structural order, with the main elements all observed to be very plumb and exhibiting no serious signs of movement, deflection and/or significant damage.*

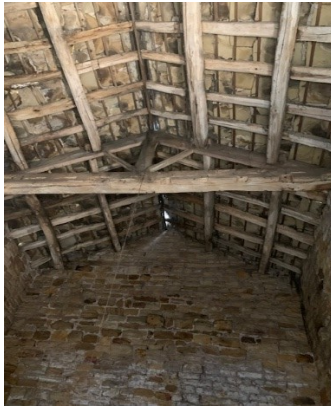
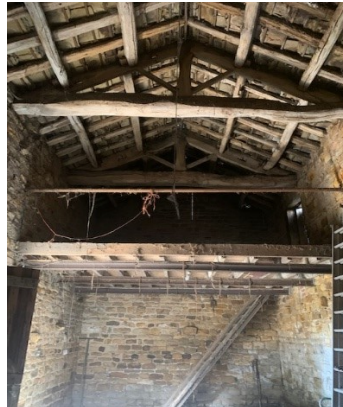
## 2.6 ROOF

*The roof structure is intact and stable, and whilst there may be some fabric repairs and infilling etc., it should be capable of retention with no requirement to remove and/or replace large structural sections*

*Some alterations will be required but in general the fabric is fully capable of retention with no areas of bulging/deflection and no requirement to repair by any means of disruptive dismantling or rebuilding.*
