# **STRUCTURAL REPORT**

## **98 - 102 WATH ROAD, ELSECAR**

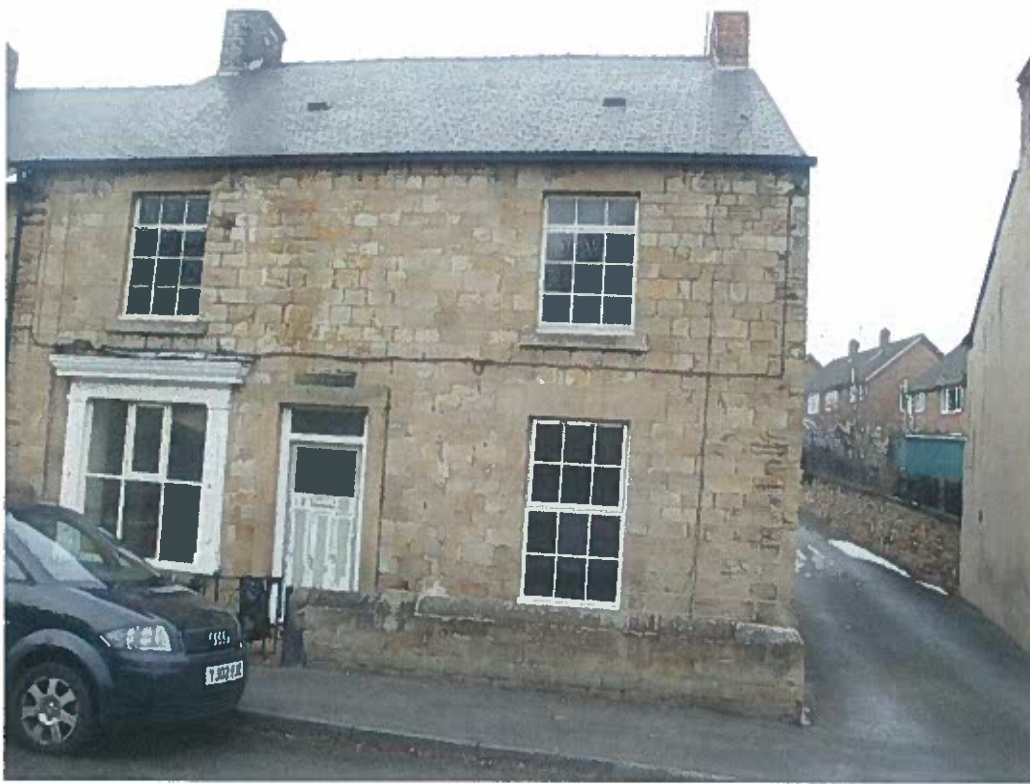
Photo 1 –Front Elevation 102 Wath Road

Number 102 Wath Road has a front elevation in coursed ashlar honey coloured sandstone and a shop front type window as illustrated on photo 1. The gable to 102 consists of rendered brickwork shown in photo 5.

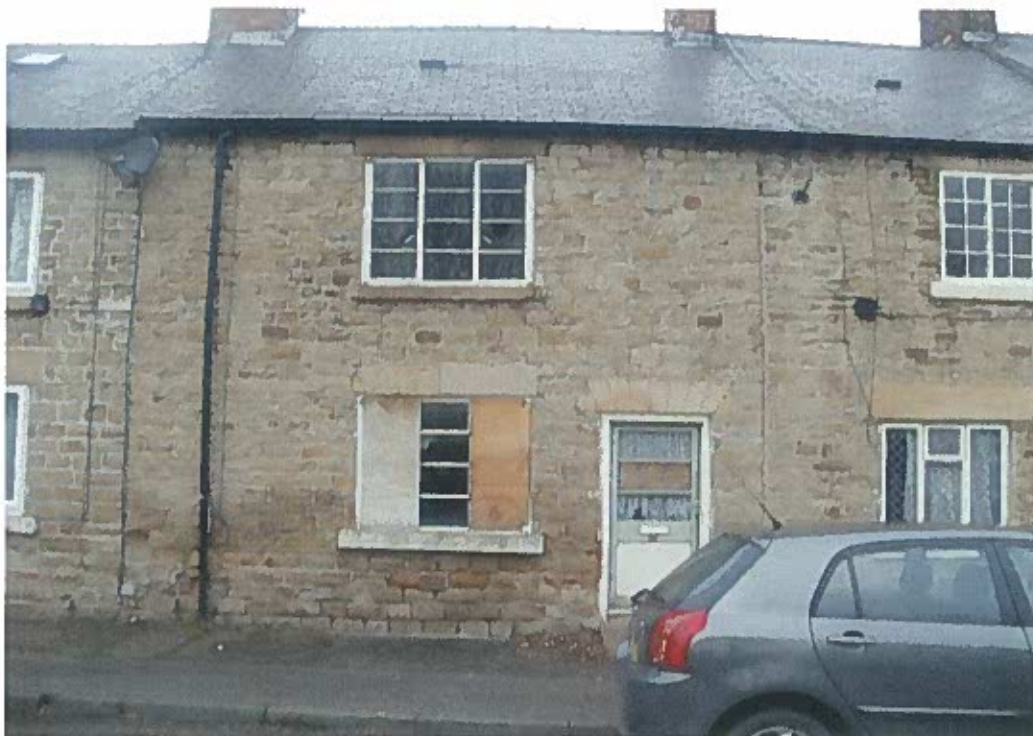
Photo 2 – Front Elevation 98+100 Wath Road

Number 98 and 100 Wath Road have a front elevation in coursed honey coloured soft local sandstone shown in photos 2, 3 and 4. The roofs to all properties are covered with welsh thin slate. The chimney stacks are of brickwork.

To the front elevation of 98, 100 and 102 Wath Road only local and isolated stones have as a result of weathering in the formerly industrial polluted environment undergone erosion and have perished at the locations indication on drawing SL(2)05. The top courses of stone to areas of the wall appears loose and will be re-bedded or repointed as necessary. Over the lounge windows to number 98 the stone lintel has a cementitious render repair. Half of the render is missing, exposing the underlying eroded sandstone lintel. It is proposed to replace or repair this lintel and similarly the cracked cill.

Following the local removal of stones from the front elevation it will be determined whether any loss or settlement of the rubble to the core of the wall has occurred. If it has it is proposed to rectify this with pumped low pressure cementitious grout, following repointing of the walls to avoid grout loss. If only local loss of the rubble occurs during stone replacement this will be made good as work proceeds. It is proposed to provide stainless steel resin fixed remedial wall ties to avoid any wall spread which is known to have occurred on similar nearby properties.

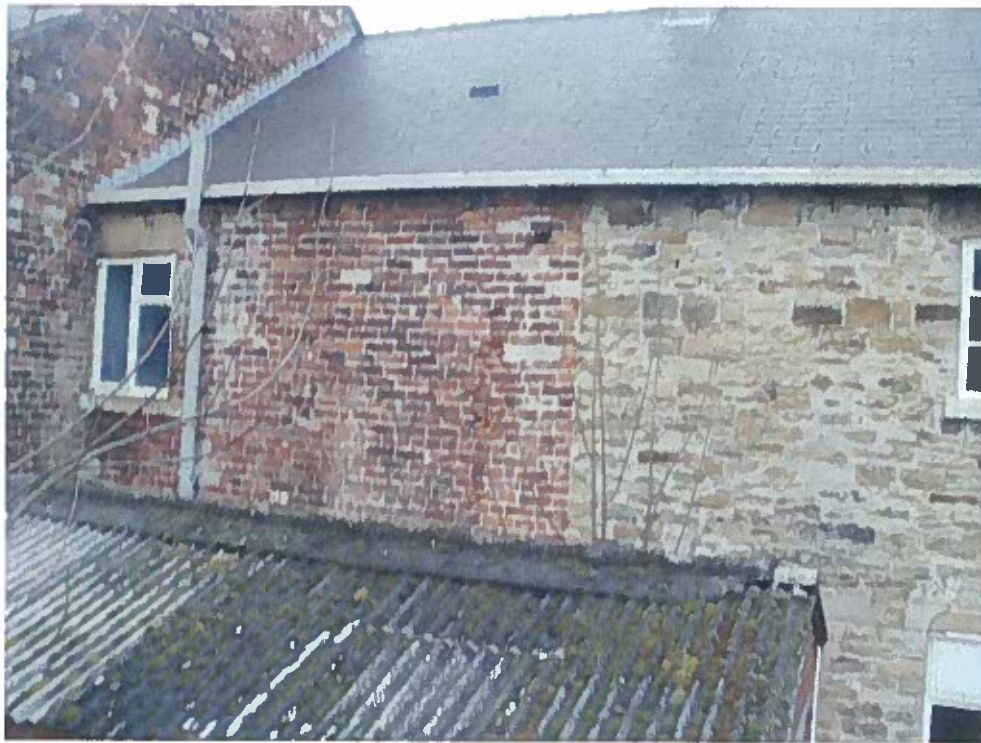
Photo 6- Rear Elevation 98+100 Wath Road

The rear elevations to 100 and 102 Wath Road including a part gable is in solid brickwork shown in photos 6, 9, 10, 11 and 12. There is a mix of stone and concrete lintels in various states of disrepair to the rear elevation.

As previously noted the rear elevations to 100 and 102 Wath Road consist of solid brickwork construction. The brickwork surface has perished and the face has spalled to a number of bricks. In a number of instances mortar has been used to make up the face of the brickwork. Most pointing is weathered and in poor condition other areas have been repointed with hard cementitious pointing which is now brittle and loose. The rear brick walls have a number of distinctive and prominent bulges and tilts to such an extent that they are not considered to be within the scope of local repair. It is therefore recommended that they should be rebuilt. It remains to be determined whether any suitable or adequate foundation is present. A new strip footing has been provisionally allowed for if required.

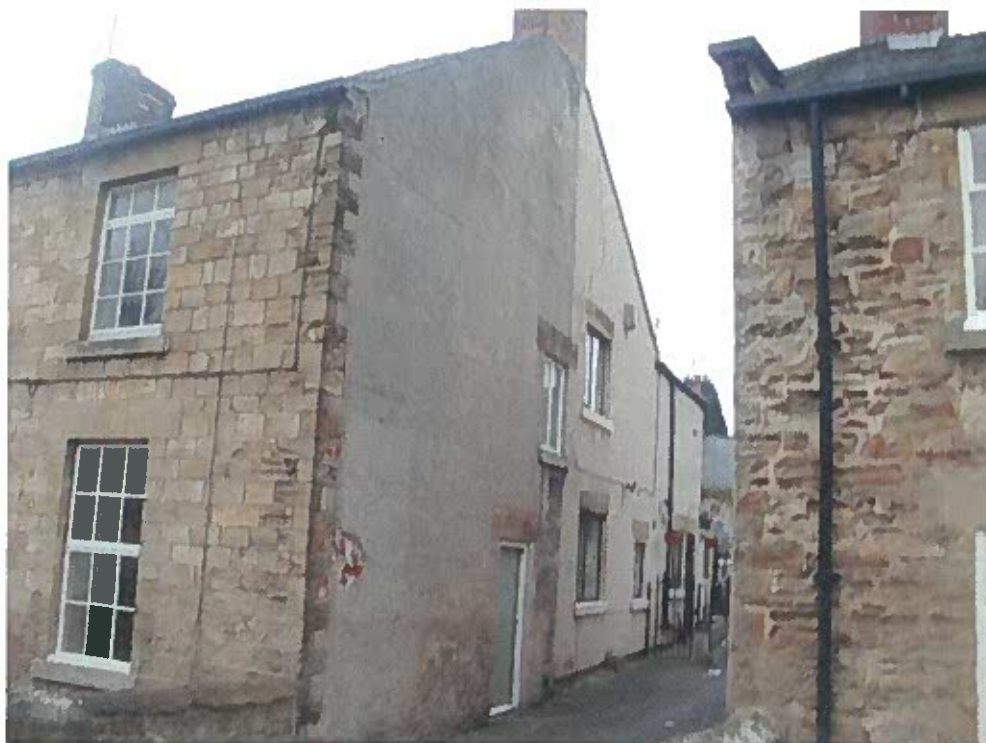
Photo 5- Gable to 102 Wath Road

The gable wall to 102 Wath Road consists of solid rendered brickwork shown on photo 5, where a local area of render is missing adjacent the front corner, the underlying brickwork can be seen to have perished. It is proposed to remove the render, examine the underlying brickwork and make local repairs as necessary prior to re-rendering. Since the first floor joists span parallel to the gable wall it is proposed to provide lateral restraint straps.
