LILEY FARM LILEY LANE MILL HOUSE GREEN SHEFFIELD S36 9NG

1.0 About the Inspection

- 1.3 The survey and report (ref L2/3240) have been carried out for Mr B Marsden on behalf of Marsden's Farms Ltd care of Townsend Planning Consultants, PO Box 788, Wakefield, WF1 9UX. Our instructions are to undertake a survey of the barn and attached building at Liley Farm, Liley Lane, Mill House Green, Sheffield, S36 9NG.

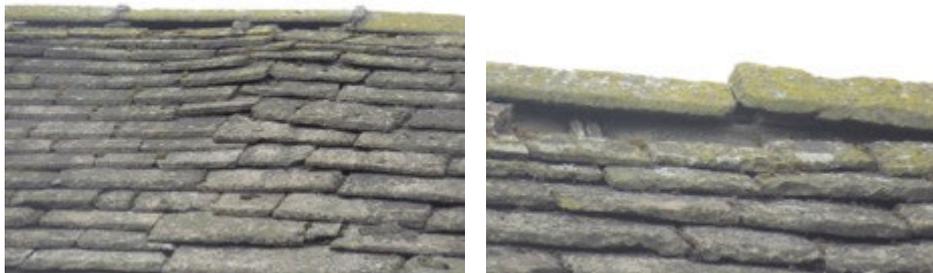
3.7.1 The roof was inspected from ground level, with the aid of binoculars. Ridge tiles across the roof are reasonably level with no significant deflection noted. Mortar bed joints to the underside of the tiles are in poor condition or have been eroded completely. It is apparent that some capping’s are loose.

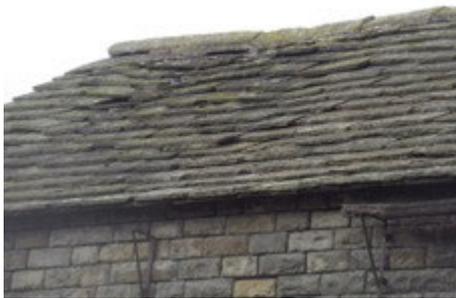
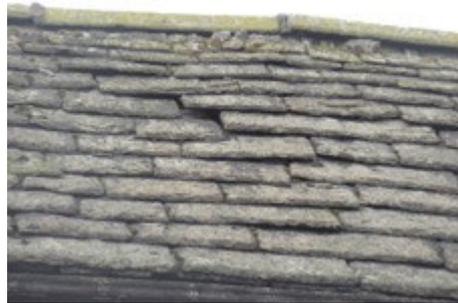
- 3.7.2 There is sagging and unevenness to the roof slopes and covering, particularly about the position of the supporting timber trusses. The stone flags in these areas do not lie flush and could be more easily displaced in storm conditions.

- 3.7.3 The flags are held in place by means of a hardwood peg driven through a hole in the top edge, and then hung over the supporting battens. Over the years, the weight of the slate drags on the peg to such an extent that this gives way, allowing slippage to occur. Regular re-fixing of slipped and damaged flags becomes necessary as part of a programme of routine maintenance.

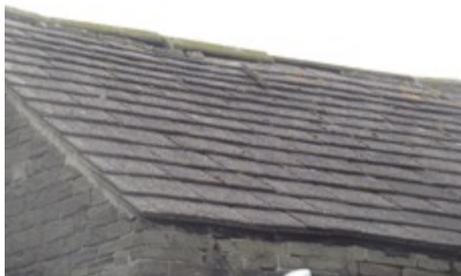
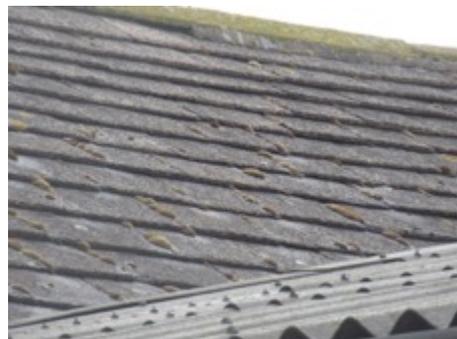
- 3.7.5 The original rear roof covering, at some time in the past, had the stone flags stolen. The rear slope covering has been replaced with a "Hardrow" style plain concrete tile. These tiles are in serviceable condition with very little damage being noted across the slope.

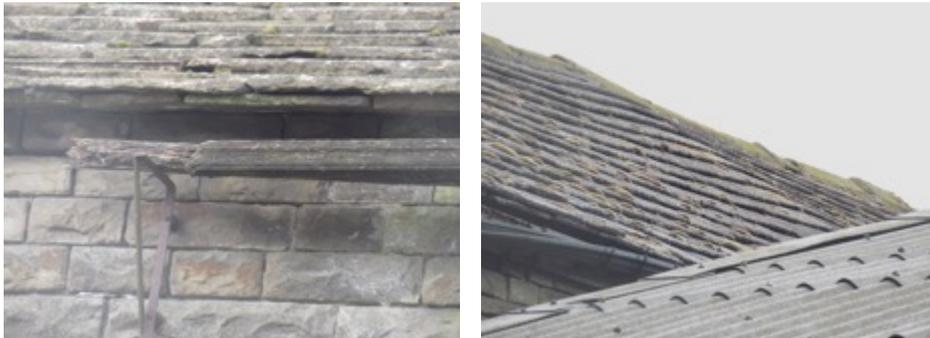
3.7.6 Timber gutters at the front eaves have essentially rotted away and require renewing. Plastic gutters at the rear are in a state of partial collapse.

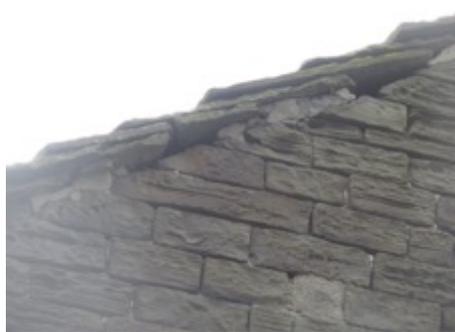
3.7.7 Verge pointing at the gable has fallen away and requires renewing.

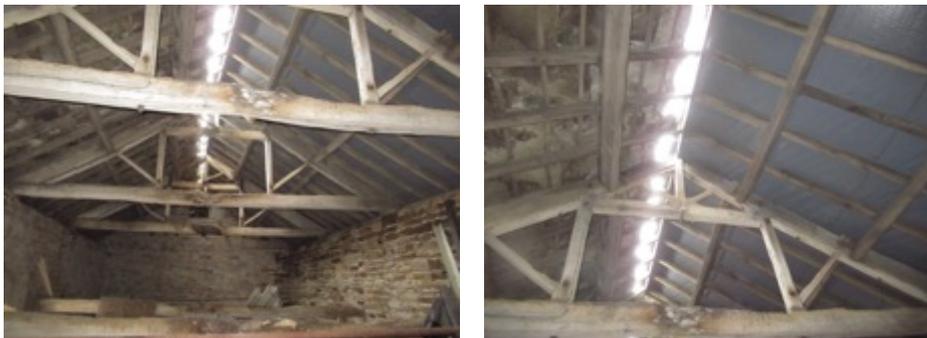
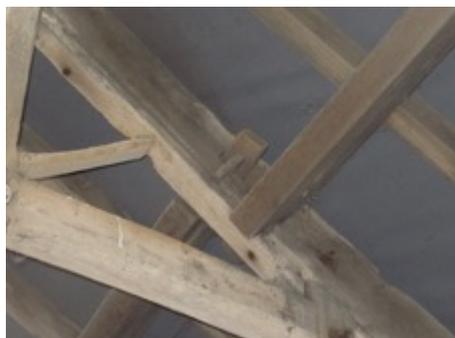
3.7.8 The supporting structure to the right-hand side barn take the form of twin timber purlins (the horizontal beams) spanning side to side with intermediate support from three timber Queen post truss rafters spanning front to rear. The purlins are tenon jointed and pegged into the top cord of each truss.

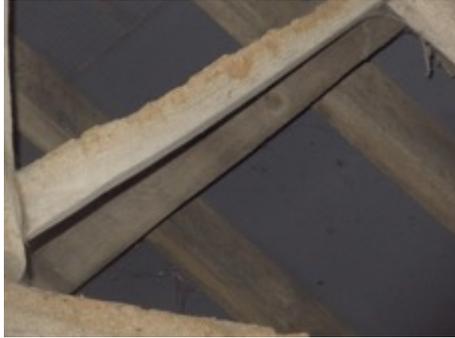
- 3.7.9 Active insect attack was noted in the timbers; there is a need for an application of an insecticide to address the infestation. It is likely that during maintenance work there will be a need to replace badly affected timbers.

- 3.7.10 Several rafters show a degree of loss of cross section. Replacement of the defective sections of timber may be required. Repairs of this type and magnitude are typically encountered in farm buildings and are usually made good during the course of routine maintenance.

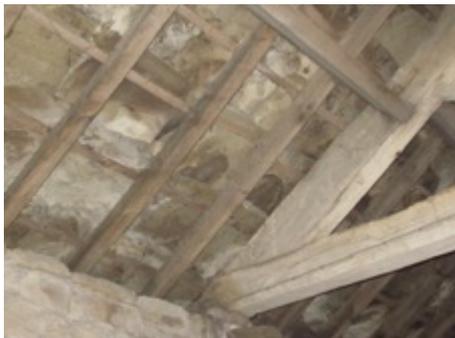
- 3.7.11 The purlins support the rafters that run from the eaves to the ridge, timber laths and flags. No sarking felt is laid beneath the flags to the front roof slope. The back edge of the flag covering was pointed along the battens, as is typical of a building of this age. Over the years most of the pointing has fallen away. Attempts to renew the pointing are seldom successful or cost effective.

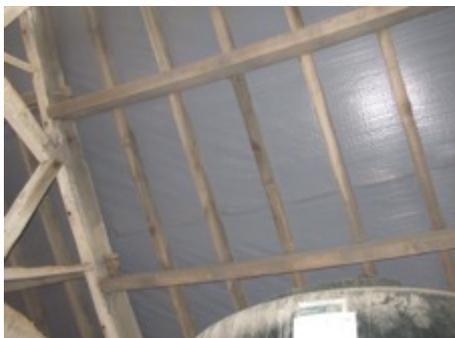
- 3.7.12 The rear roof slope tile covering is laid over a plastic membrane; this appears intact with no indications of water penetration.

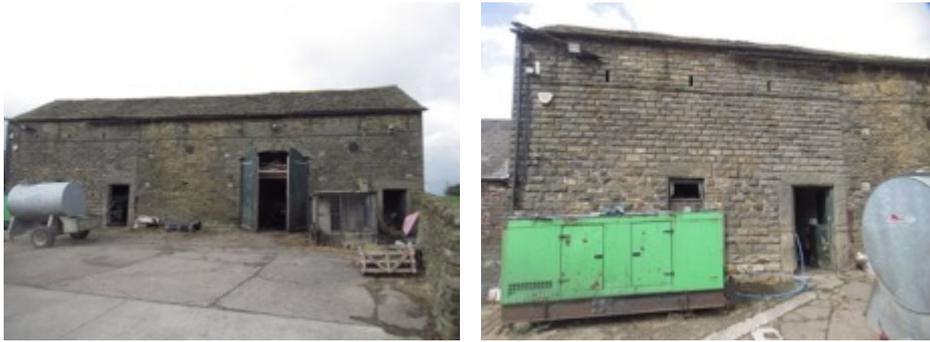
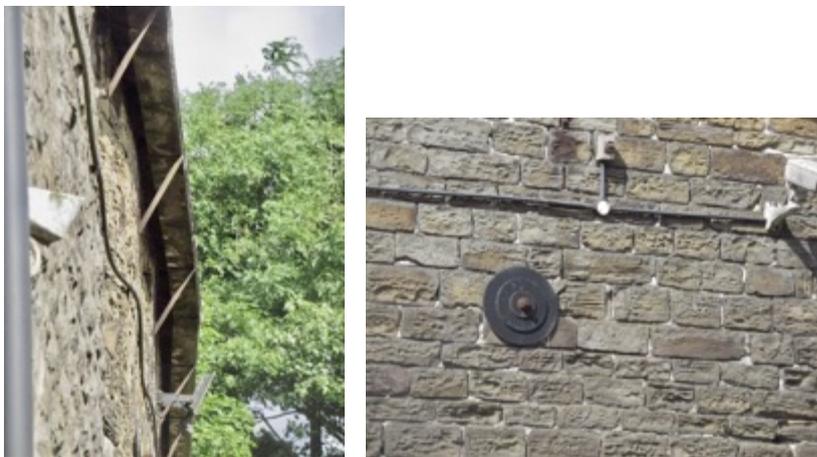
- 3.9.1 It appears that there has been a degree of roof spread at the eaves, which has caused the wall to move outward and bulge slightly. Distortion of stonework of this nature is frequently encountered and can readily be restrained. Tie bars and pattress plates have been installed to restrain the walls in the past. The bulging is of some considerable age; no indications of recent movement was noted.

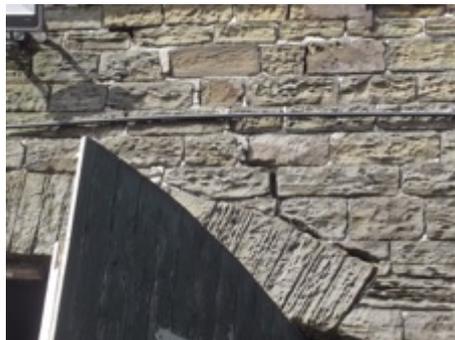
- 3.9.2 The arch over the barn door has settled slightly; this damage appears to be longstanding in nature. Cutting out and resetting the disturbed section and re-bonding the stone will address the movement. The stone can be further restrained by using metal fixings should the need arise.

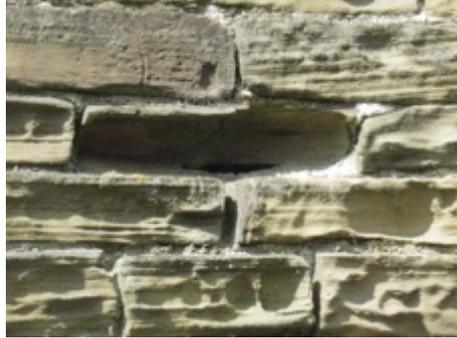
- 3.9.3 Several stones have eroded across the face of the wall a result of hard mortar pointing. The face can easily be restored using specialist mortar.

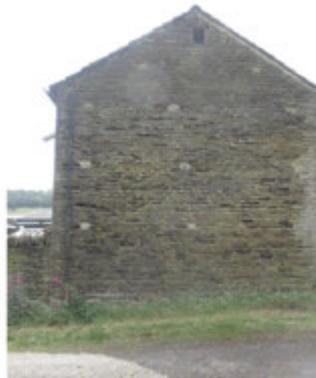
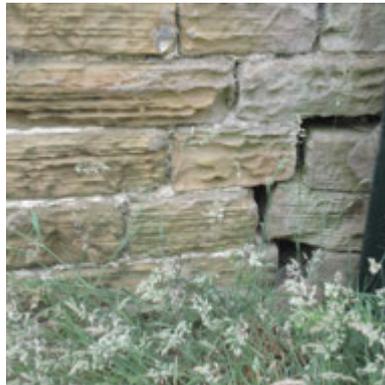
- 3.10.1 An area of disturbed stone requires re-bonding; this damage appears to be the result of vehicle impact. The damage has not impaired the stability of the wall.

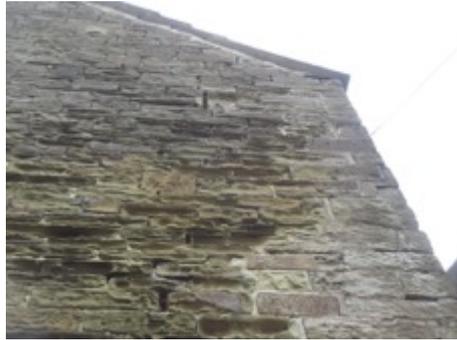
3.10.2 Several stones have eroded a result of hard pointing. The face can easily be restored using specialist mortar

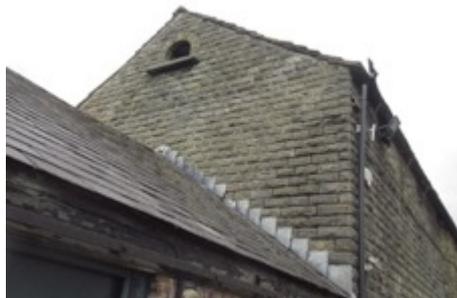
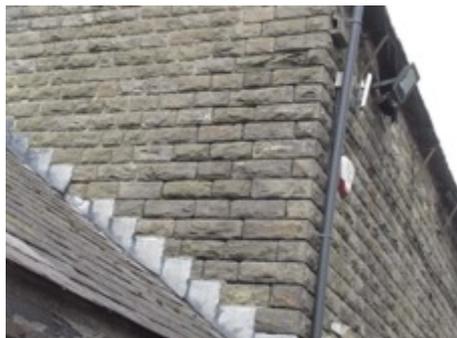
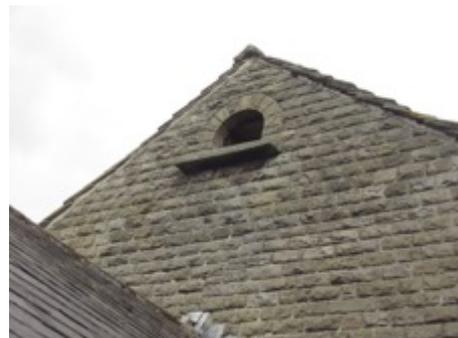
3.12.1 The upper section of the gable is acceptably vertical with no significant issues noted. Routine pointing in due course will be required.

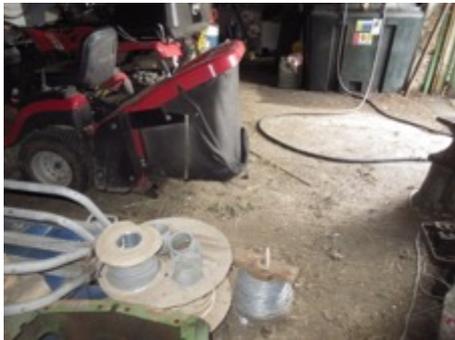
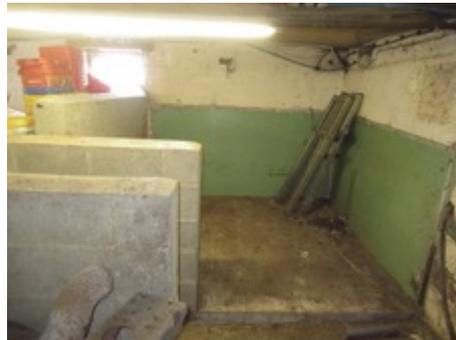
3.14.1 The first floor to the right-hand side section of the building is suspended timber construction comprising of joists and floorboards. The floor is badly affected by insect attack and has been deemed unsafe to walk over. The floor in any event would be renewed as part of a maintenance programme or any renovation of the building.

3.14.2 The ground floors are concrete. The floors are satisfactory for the building's current use. In any refurbishment of the building there will be a requirement to replace the floor to comply with the requirements of the Building Regulations.
