# **ARBORICULTURAL REPORT & Impact Assessment to BS 5837:2012 at:**

*Land at  
Shaw Lane,  
Carlton,  
Barnsley,  
S71 3HG*

Prepared for: *White Agus Ltd*

Reference: *AWA7534*

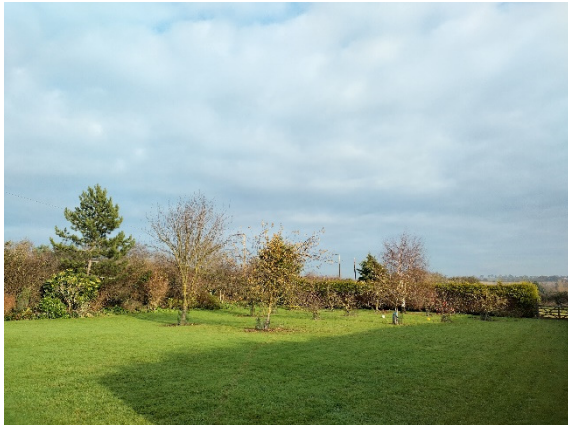
- 3.2.7 Trees T3, T4, T5, T6, T7, T9, T10, T11, T12, T13, T14, T16, T17, and T18 form the significant tree cover within the garden of the site. All are semi-mature with only T9 being early-mature. These trees are all planted specimens, most being fruit trees forming a small orchard within the site. These trees provide the site with some tree cover, however individually most feature defects likely to limit their long-term prospects. As such these trees are retention category 'C'.

Photo 1: G2, T4-T7, G8, and T9-T14 looking north east

- 4.2.8 Trees T9, T10, T11, T12, T13, T14, T16, T17, and T18 are lower value semi-mature trees with defects that limit their value and prospects, or they are of insignificant stature.

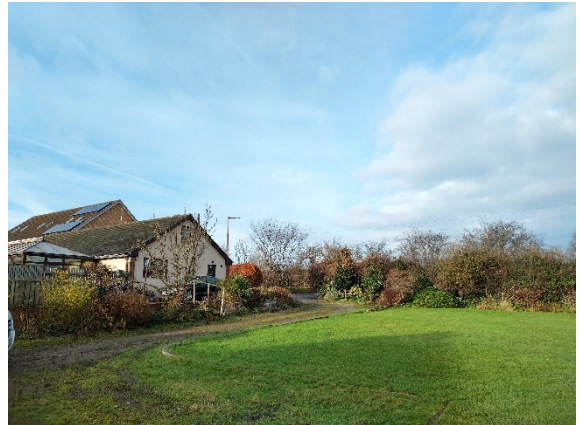
- 3.2.6 Hedges G1, G2, G8, and G15 are all semi-mature and managed, providing some screening value. Hedges G1 and G2 provide a moderate amenity value as they provide an effective screen from Shaw Lane. Tree group G19 is an adjacent group of mature Elder at the north eastern boundary of the site. All have reduced vitality featuring dieback, deadwood, or decay, limiting their long-term prospects. As such these hedges and tree groups are retention category 'C'.

Photo 2: G1, G2, T3, and T16 looking north west

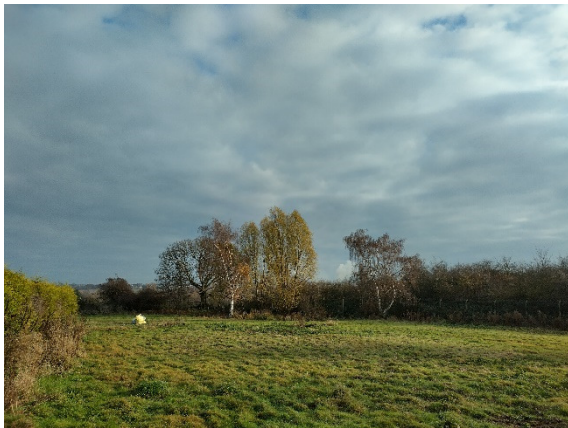
- 3.2.8 Trees T20, T21, T23, T25, T26, T27, and T28 form the significant tree cover within the south eastern corner of the site, surrounding an existing pond. These trees are prominent within the site but provide only a limited amenity value. They are predominantly early-mature Willows and Birch, with the occasional semi-mature Beech, and feature weak unions, poor form, or wounds which limit their long-term prospects. As such they are retention

Photo 3: G15 and T20-T28 looking east

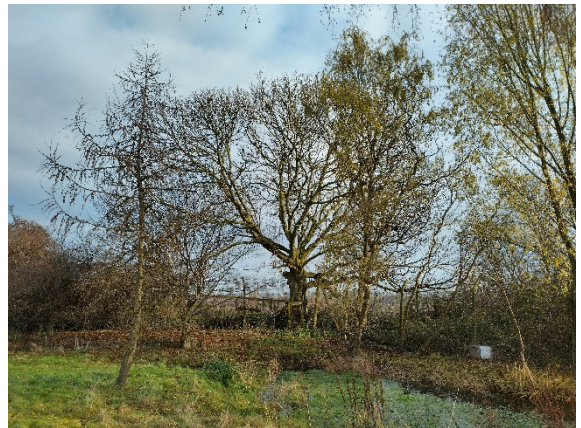
- 3.2.5 The sites most significant tree is T24, an adjacent mature Ash. The tree is situated at the south eastern corner of the site. This tree is prominent throughout the entire site and surrounding area and provides a moderate level of amenity value. Whilst the tree does not currently suffer from Ash Dieback Disease, its long-term prospects are likely limited as a result. As such the tree is retention category 'C'.

- 3.2.11 Many Ash trees in the wider region are being impacted by Chalara or Ash dieback disease. Once a tree is infected, the disease is usually fatal, either directly or indirectly. While the identified Ash trees may continue to provide landscape and wildlife benefits for some time, their long-term prospects are likely to be limited as a result of Ash dieback.

Photo 4: T21, T22, T24, T25, and T26 looking east

- 3.2.12 T22 is dead and requires felling regardless of any new development at the site (as detailed in Appendix 4).
- 3.2.13 Some trees were covered in dense Ivy or were inaccessible (as detailed in Appendix 4). In such cases measurements were estimated and the condition values are indicative only.

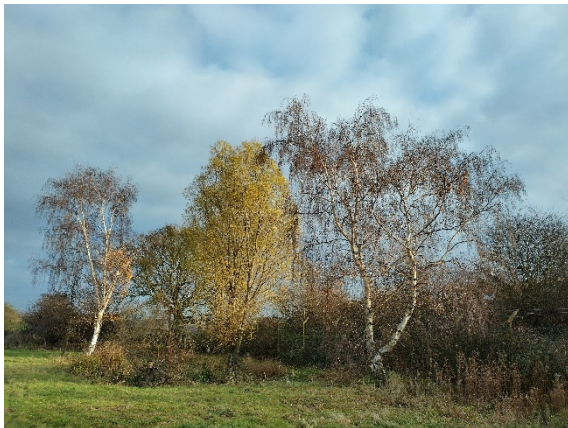
Photo 5: T20 to T28 looking east

- 4.3.3 Potentially damaging activities are proposed in the vicinity of retained trees. The existing pond is to be filled in close to and into the edge of the RPA of T21, T25, T26, and T28. The proposed infilling of the existing pond within the RPA of retained trees has the potential to result in indirect impacts through changes to local soil moisture conditions and drainage characteristics. The pond may have influenced the existing rooting environment, and its removal could alter soil aeration and moisture availability within parts of the RPAs, potentially affecting root function and tree vitality over time. The significance of this impact will depend on the relationship between the pond and the surrounding soil environment.

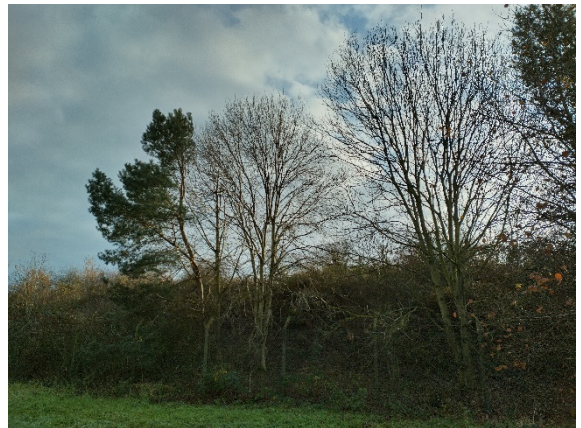
- 3.2.9 Tree groups G29 and G30 are situated at the southern boundary of the site. G29 is an adjacent shelter-belt screening group predominantly composed of semi-mature and early-mature Pine and Ash. The group provides a moderate amenity value due to its position in the landscape and screening value, however, individually the trees are of little arboricultural significance. Tree group G30 is an insignificant semi-mature group of self-set Willows. As such these trees are retention category 'C'.

Photo 6: G29 looking south east
