## Tree

| Tag Number: | T2 |
| Common Name: | Lombardy poplar |

| Address: | 59 High Street |

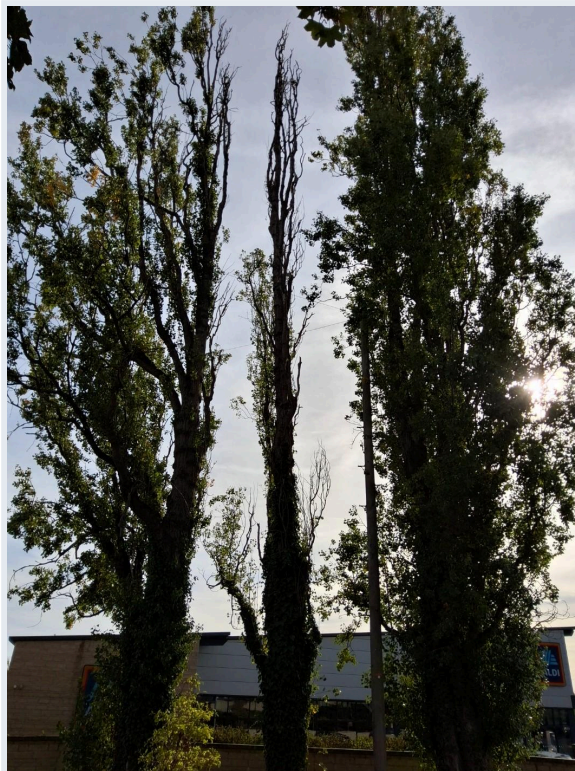
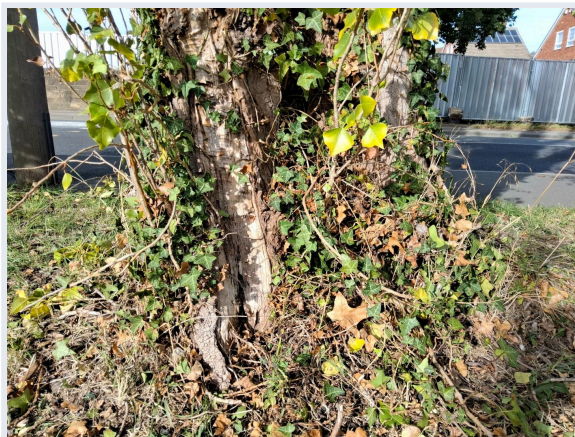
| Structural Condition: | Poor |
| Percent Dieback (%): | >75% |

| Tree Comments: | Structurally unsound, does have the energy to produce epicormic growth on stem, but this is not particularly vigorous and any resulting branches may be poorly attached. |

| Tree Inspections | | | | | |
|---|---|---|---|---|---|
| 7268 | Recommend felling and stump grinding. All parts of the tree appear to be in decline and it is unlikely to recover sufficiently to make removal of deadwood only a viable option. Pruning is also unlikely to lengthen it's lifespan. High target Location as noted for T3 | katherinechurch | 23/09/2026 | 14 | Poor |

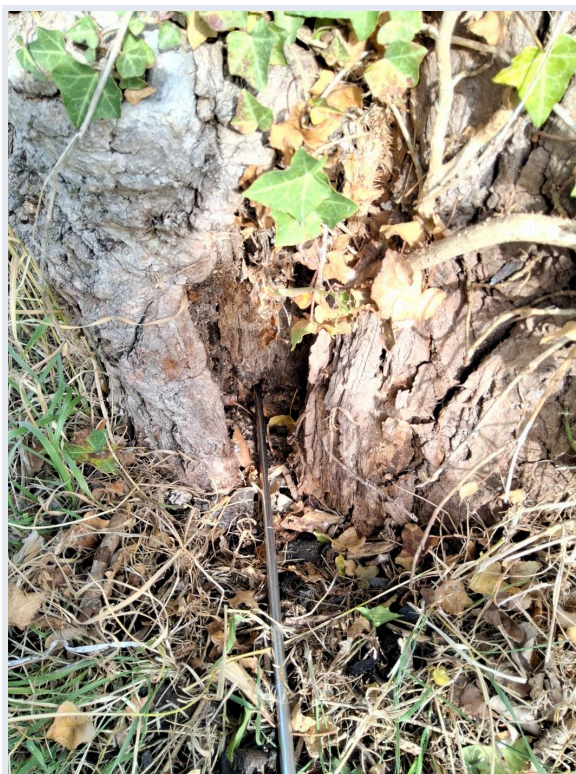
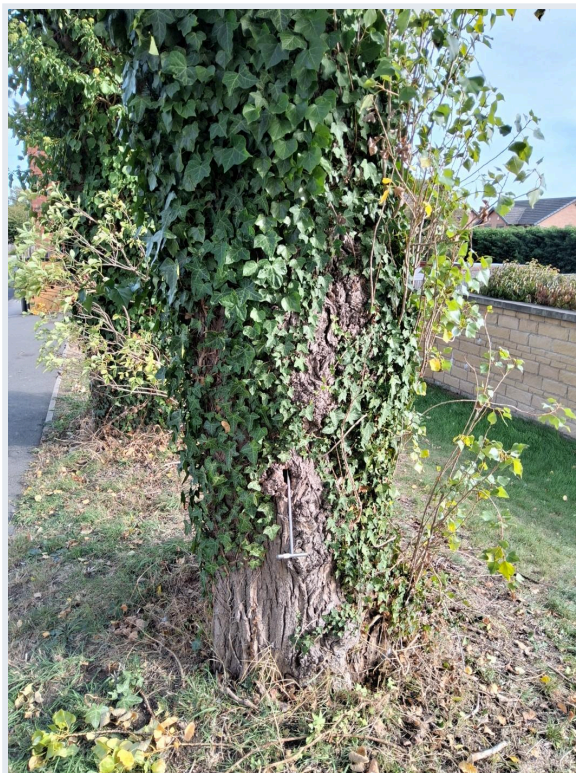
| Crown Observations: | Bark Necrosis / Damage, Major deadwood |

| Crown Comments: | Top is completely dead, bark flaking and falling from the many dead branches throughout the canopy |
| Trunk Observations: | Decay on Stem, Cavity, Climber Restricting Inspection |
| Trunk Comments: | Cavity and decay to west extending from base to at least 1m with extensive dysfunctional cambium column affecting half of circumference |
| Root Comments: | Buttress and Root to south exposed and decayec |
| PPD Comments: | Was completely defoliated by a satin moth infestation in 2025 and never recovered |
