## **MANAGEMENT ASBESTOS SURVEY**

High Street Dodworth  
88 High Street, Dodworth, Barnsley,, S75 3RQ

REPORT No: R-00010  
Survey Date: 23/05/2013 to 06/03/2014

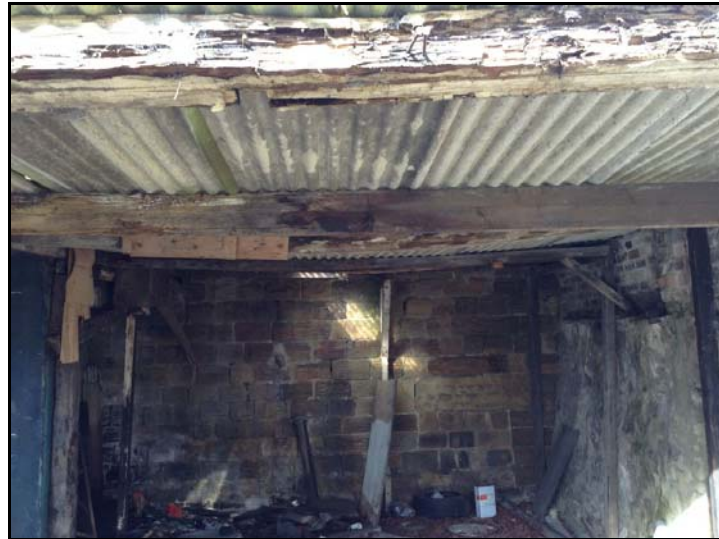
Lead Surveyor	Dan Ancliff	Building	
Survey Type	Demolition	Floor	
Survey Date		Room/Area	001 - Lean to
Next Inspection	23/05/2014	Sample No.	S001
Level of Identification	Sampled	Laboratory Ref	001

**Description:** Photo Reference 433 Roof - Pitched, profiled cement sheet

Score
<b>Product Type</b>	Asbestos reinforced composites etc.	1
<b>Extent of Damage</b>	High Damage	3
<b>Surface Treatment</b>	Self Sealed	0
<b>Asbestos Type</b>	Chrysotile	1
<b>Amount</b>	10m <sup>2</sup>	
<b>Accessibility</b>	Inaccessible or unlikely to be disturbed	5
<b>Algorithm Score</b>

<b>Recommendation</b>	Remove
-----------------------	--------

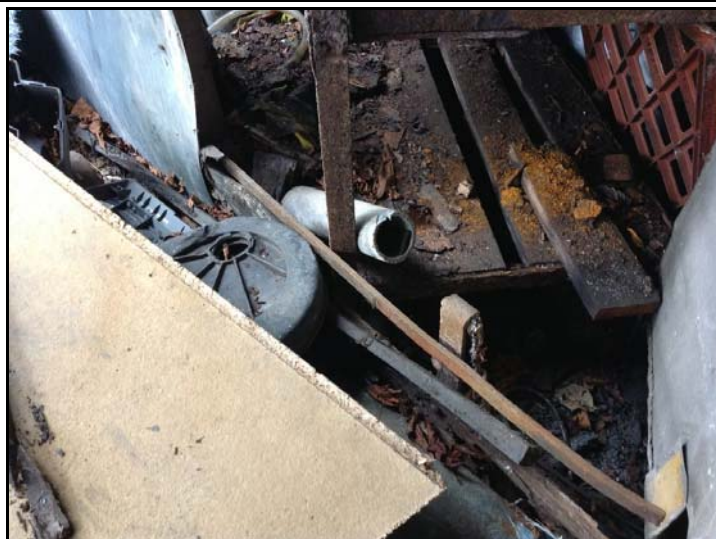
Lead Surveyor	Dan Ancliff	Building	
Survey Type	Demolition	Floor	
Survey Date		Room/Area	001 - Lean to
Next Inspection	23/05/2014	Sample No.	S003
Level of Identification	Sampled	Laboratory Ref	003

**Description:** Photo Reference 522 Cement rainwater goods - Debris

Score
<b>Product Type</b>	Asbestos reinforced composites etc.	1
<b>Extent of Damage</b>	High Damage	3
<b>Surface Treatment</b>	Self Sealed	0
<b>Asbestos Type</b>	Chrysotile	1
<b>Amount</b>	3lm	
<b>Accessibility</b>	Inaccessible or unlikely to be disturbed	5
<b>Algorithm Score</b>

<b>Recommendation</b>	Restrict Access and Remove
-----------------------	----------------------------

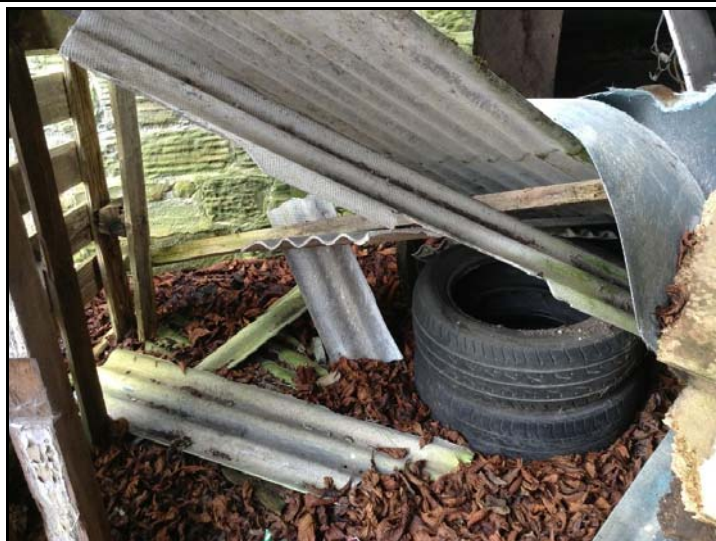
Lead Surveyor	Dan Ancliff	Building	
Survey Type	Demolition	Floor	
Survey Date		Room/Area	001 - Lean to
Next Inspection	23/05/2014	Sample No.	S002
Level of Identification	Sampled	Laboratory Ref	002

**Description:** Photo Reference 545 Cement debris - Debris

Score
<b>Product Type</b>	Thermal insulation, sprayed asbestos, loose asbestos etc.	3
<b>Extent of Damage</b>	High Damage	3
<b>Surface Treatment</b>	Self Sealed	0
<b>Asbestos Type</b>	Chrysotile	1
<b>Amount</b>	10m <sup>2</sup>	
<b>Accessibility</b>	Inaccessible or unlikely to be disturbed	7
<b>Algorithm Score</b>

<b>Recommendation</b>	Restrict Access and Remove
-----------------------	----------------------------

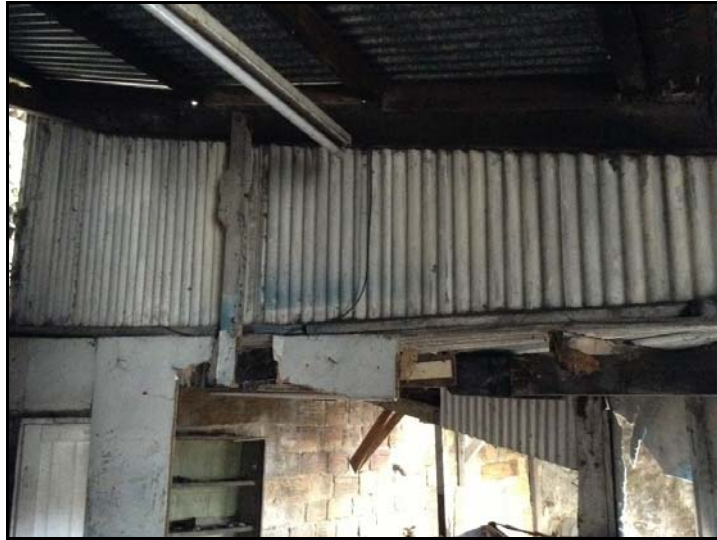
Lead Surveyor	Dan Ancliff	Building	
Survey Type	Demolition	Floor	
Survey Date		Room/Area	002 - Workshop
Next Inspection	23/05/2014	Sample No.	As Sample 001
Level of Identification	Sampled	Laboratory Ref	001

**Description:** Photo Reference 470 Wall - Sloped, profiled cement sheet

Score
<b>Product Type</b>	Asbestos reinforced composites etc.	1
<b>Extent of Damage</b>	High Damage	3
<b>Surface Treatment</b>	Self Sealed	0
<b>Asbestos Type</b>	Chrysotile	1
<b>Amount</b>	4m <sup>2</sup>	
<b>Accessibility</b>	Inaccessible or unlikely to be disturbed	5
<b>Algorithm Score</b>

<b>Recommendation</b>	Remove
-----------------------	--------

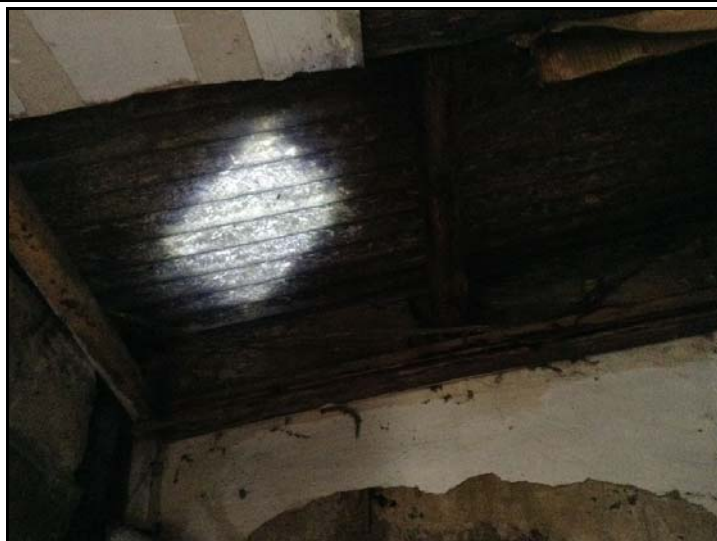
Lead Surveyor	Dan Ancliff	Building	
Survey Type	Demolition	Floor	
Survey Date		Room/Area	004 - Garage 2
Next Inspection	23/05/2014	Sample No.	As Sample 001
Level of Identification	Sampled	Laboratory Ref

**Description:** Photo Reference 404 Ceiling - Sloped, profiled metal sheet

Score
<b>Product Type</b>	Asbestos reinforced composites etc.	1
<b>Extent of Damage</b>	High Damage	3
<b>Surface Treatment</b>	Self Sealed	0
<b>Asbestos Type</b>	Chrysotile	1
<b>Amount</b>	30m <sup>2</sup>	
<b>Accessibility</b>	Inaccessible or unlikely to be disturbed	5
<b>Algorithm Score</b>

<b>Recommendation</b>	Remove
-----------------------	--------

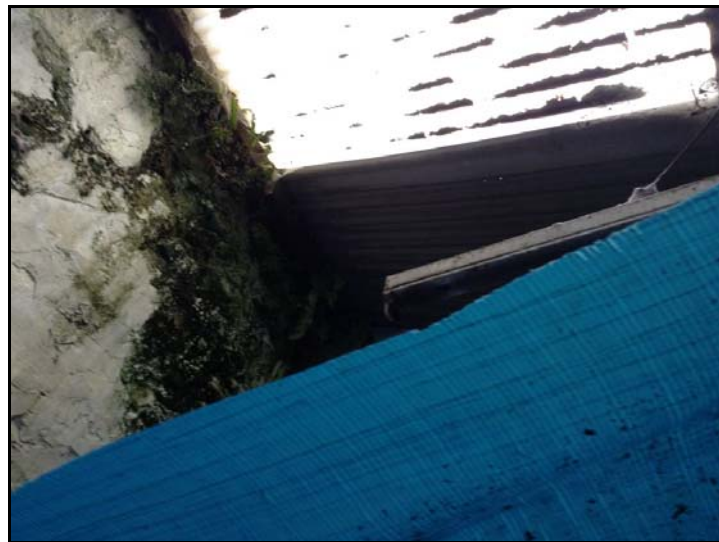
Lead Surveyor	Dan Ancliff	Building	
Survey Type	Demolition	Floor	
Survey Date		Room/Area	005 - Stores
Next Inspection	23/05/2014	Sample No.	As Sample 001
Level of Identification	Sampled	Laboratory Ref

**Description:** Photo Reference 436 Ceiling - Pitched, profiled cement sheet

Score
<b>Product Type</b>	Asbestos reinforced composites etc.	1
<b>Extent of Damage</b>	High Damage	3
<b>Surface Treatment</b>	Self Sealed	0
<b>Asbestos Type</b>	Chrysotile	1
<b>Amount</b>	8m <sup>2</sup>	
<b>Accessibility</b>	Inaccessible or unlikely to be disturbed	5
<b>Algorithm Score</b>

<b>Recommendation</b>	Remove
-----------------------	--------

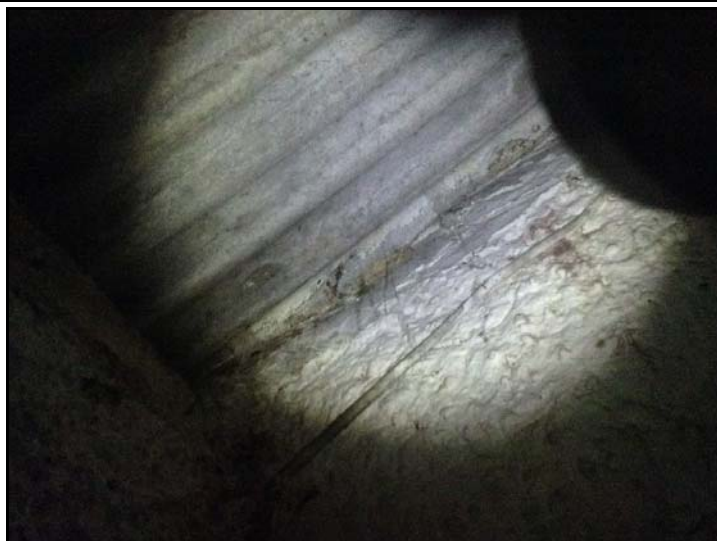
Lead Surveyor	Dan Ancliff	Building	
Survey Type	Demolition	Floor	
Survey Date		Room/Area	006 - WC
Next Inspection	23/05/2014	Sample No.	As Sample 001
Level of Identification	Sampled	Laboratory Ref

**Description:** Photo Reference 460 Ceiling - Sloped, profiled cement sheet

Score
<b>Product Type</b>	Asbestos reinforced composites etc.	1
<b>Extent of Damage</b>	High Damage	3
<b>Surface Treatment</b>	Self Sealed	0
<b>Asbestos Type</b>	Chrysotile	1
<b>Amount</b>	3m <sup>2</sup>	
<b>Accessibility</b>	Inaccessible or unlikely to be disturbed	5
<b>Algorithm Score</b>

<b>Recommendation</b>	Remove
-----------------------	--------

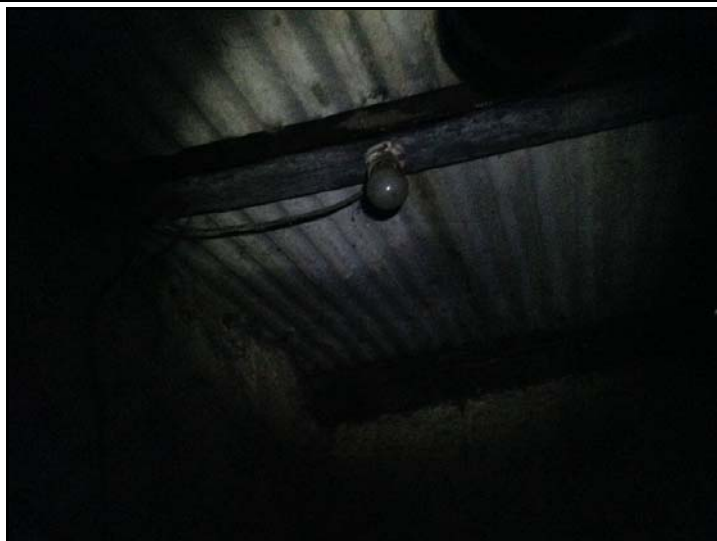
Lead Surveyor	Dan Ancliff	Building	
Survey Type	Demolition	Floor	
Survey Date		Room/Area	007 - WC
Next Inspection	23/05/2014	Sample No.	As Sample 001
Level of Identification	Sampled	Laboratory Ref

**Description:** Photo Reference 503 Ceiling - Sloped, profiled cement sheet

Score
<b>Product Type</b>	Asbestos reinforced composites etc.	1
<b>Extent of Damage</b>	High Damage	3
<b>Surface Treatment</b>	Self Sealed	0
<b>Asbestos Type</b>	Chrysotile	1
<b>Amount</b>	3m <sup>2</sup>	
<b>Accessibility</b>	Inaccessible or unlikely to be disturbed	5
<b>Algorithm Score</b>

<b>Recommendation</b>	Remove
-----------------------	--------

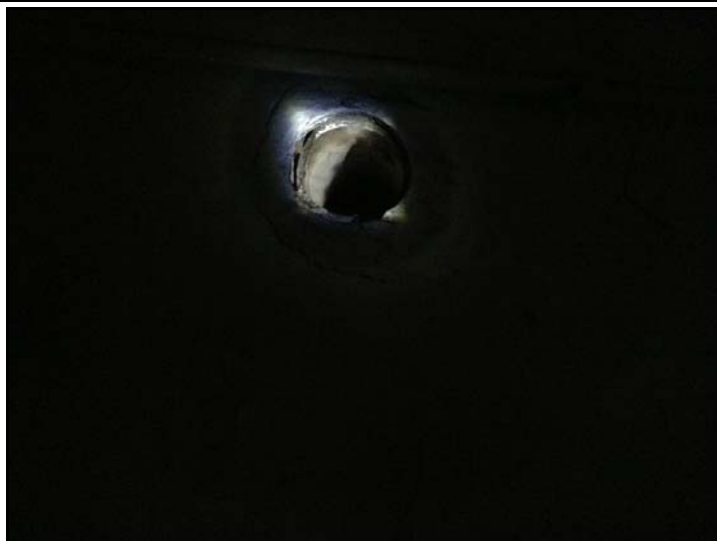
Lead Surveyor	Dan Ancliff	Building	
Survey Type	Demolition	Floor	
Survey Date		Room/Area	010 - Stores
Next Inspection	23/05/2014	Sample No.	S004
Level of Identification	Sampled	Laboratory Ref

**Description:** Photo Reference 389 Cement rainwater goods - Debris

Score
<b>Product Type</b>	Asbestos reinforced composites etc.	1
<b>Extent of Damage</b>	High Damage	3
<b>Surface Treatment</b>	Self Sealed	0
<b>Asbestos Type</b>	Chrysotile	1
<b>Amount</b>	1m <sup>2</sup>	
<b>Accessibility</b>	Inaccessible or unlikely to be disturbed	5
<b>Algorithm Score</b>

<b>Recommendation</b>	Restrict Access and Remove
-----------------------	----------------------------

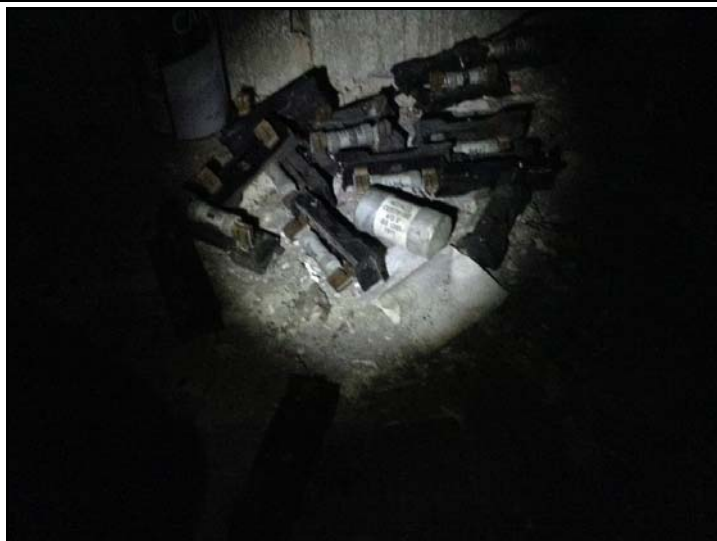
Lead Surveyor	Dan Ancliff	Building	
Survey Type	Demolition	Floor	
Survey Date		Room/Area	010 - Stores
Next Inspection	23/05/2014	Sample No.	S006
Level of Identification	Sampled	Laboratory Ref

**Description:** Photo Reference 546 Fuses - Woven Product

<b>Recommendation</b>	No Asbestos Detected
-----------------------	----------------------

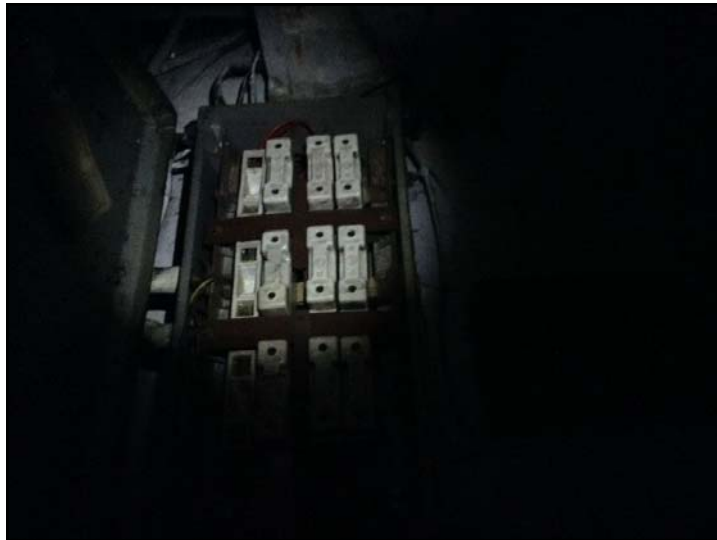
Lead Surveyor	Dan Ancliff	Building	
Survey Type	Demolition	Floor	
Survey Date		Room/Area	010 - Stores
Next Inspection	23/05/2014	Sample No.	S005
Level of Identification	Sampled	Laboratory Ref

**Description:** Photo Reference 570 Flash guards - Woven Product

Score
<b>Product Type</b>	Asbestos insulating board, millboards, gaskets & ropes etc.	2
<b>Extent of Damage</b>	Low Damage	1
<b>Surface Treatment</b>	Sealed	1
<b>Asbestos Type</b>	Chrysotile	1
<b>Amount</b>	X16	
<b>Accessibility</b>	Inaccessible or unlikely to be disturbed	5
<b>Algorithm Score</b>		
<b>Recommendation</b>	Remove

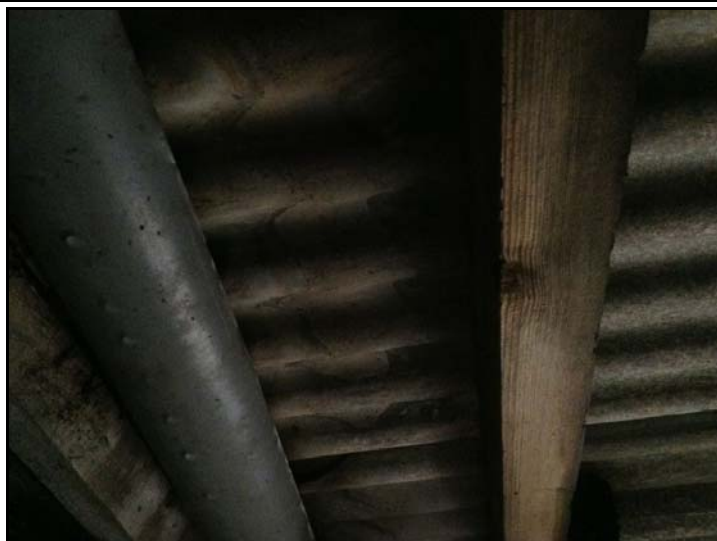
Lead Surveyor	Dan Ancliff	Building	
Survey Type	Demolition	Floor	
Survey Date		Room/Area	017 - Workshop
Next Inspection	23/05/2014	Sample No.	S009
Level of Identification	Sampled	Laboratory Ref

**Description:** Photo Reference 399 Ceiling - Pitched, profiled cement sheet

Score
<b>Product Type</b>	Asbestos reinforced composites etc.	1
<b>Extent of Damage</b>	High Damage	3
<b>Surface Treatment</b>	Self Sealed	0
<b>Asbestos Type</b>	Chrysotile	1
<b>Amount</b>	10m <sup>2</sup>	
<b>Accessibility</b>	Inaccessible or unlikely to be disturbed	5
<b>Algorithm Score</b>

<b>Recommendation</b>	Remove
-----------------------	--------

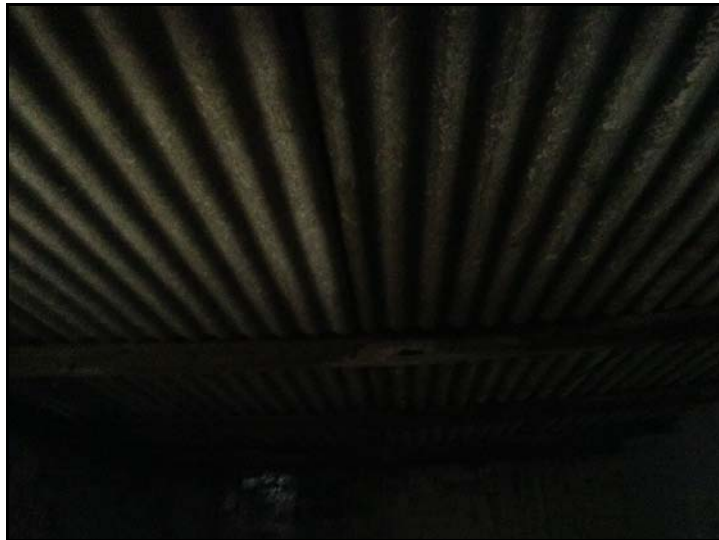
Lead Surveyor	Dan Ancliff	Building	
Survey Type	Demolition	Floor	
Survey Date		Room/Area	018 - Workshop
Next Inspection	23/05/2014	Sample No.	As Sample 009
Level of Identification	Sampled	Laboratory Ref

**Description:** Photo Reference 384 Ceiling - Pitched, profiled cement sheet

Score
<b>Product Type</b>	Asbestos reinforced composites etc.	1
<b>Extent of Damage</b>	High Damage	3
<b>Surface Treatment</b>	Self Sealed	0
<b>Asbestos Type</b>	Chrysotile	1
<b>Amount</b>	8m <sup>2</sup>	
<b>Accessibility</b>	Inaccessible or unlikely to be disturbed	5
<b>Algorithm Score</b>

<b>Recommendation</b>	Remove
-----------------------	--------

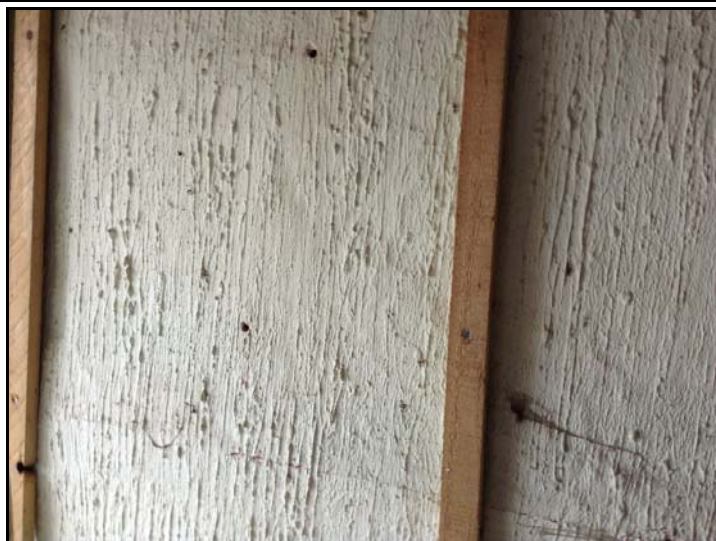
Lead Surveyor	Dan Ancliff	Building	
Survey Type	Demolition	Floor	
Survey Date		Room/Area	025 - Lounge
Next Inspection	23/05/2014	Sample No.	S013
Level of Identification	Sampled	Laboratory Ref

**Description:** Photo Reference 432 Walls - Textured Coating

Score
Product Type		
Extent of Damage		
Surface Treatment		
Asbestos Type		
Amount		
Accessibility	Inaccessible or unlikely to be disturbed	
Algorithm Score		
<b>Recommendation</b>	No Asbestos Detected

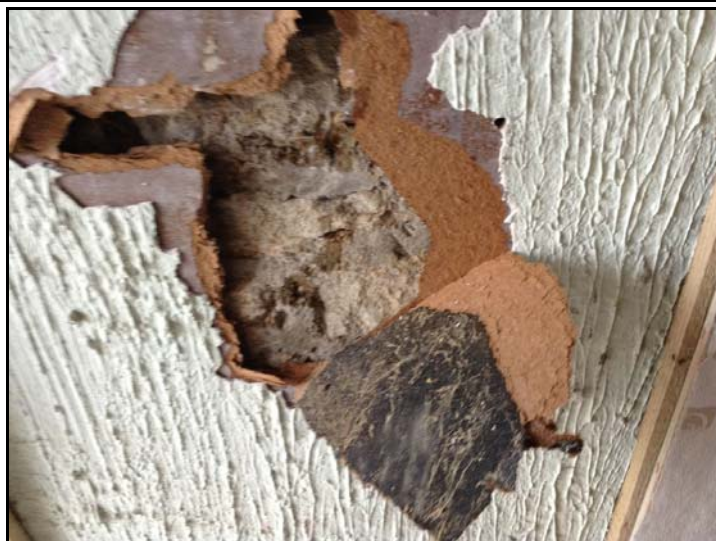
Lead Surveyor	Dan Ancliff	Building	
Survey Type	Demolition	Floor	
Survey Date		Room/Area	025 - Lounge
Next Inspection	23/05/2014	Sample No.	S014
Level of Identification	Sampled	Laboratory Ref

**Description:** Photo Reference 492 Walls - Insulating Board

Score
Product Type		
Extent of Damage		
Surface Treatment		
Asbestos Type		
Amount		
Accessibility	Inaccessible or unlikely to be disturbed	
Algorithm Score		
<b>Recommendation</b>	No Asbestos Detected

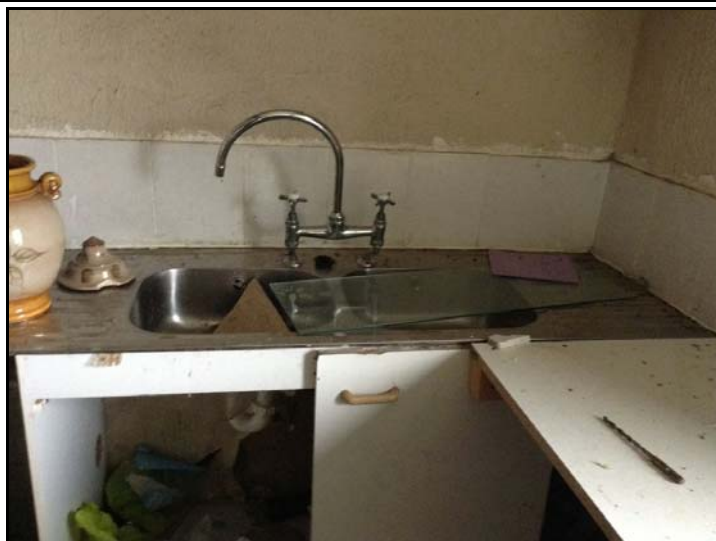
Lead Surveyor	Dan Ancliff	Building	
Survey Type	Demolition	Floor	
Survey Date		Room/Area	027 - Kitchen
Next Inspection	23/05/2014	Sample No.	S016
Level of Identification	Sampled	Laboratory Ref

**Description:** Photo Reference 509 Sink pad - Bituminous Product

<b>Recommendation</b>	No Asbestos Detected
-----------------------	----------------------
