BAT SURVEY REPORT

Fitzwilliam Arms, Hill Street, Elsecar, Barnsley

Produced by: Protected Species Surveys
Contact: Email: protectedpsurveys17@gmail.com
Client: Mr M Monfredi
Location: Fitzwilliam Arms, Hill Street, Elsecar, Barnsley
Date: January 2025

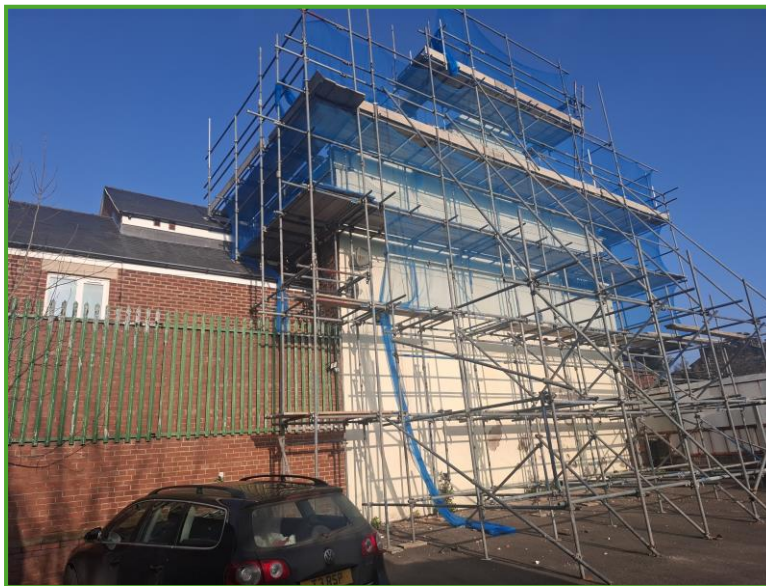
- 3.1 Building 1 (B1) was a three-storey former public house (Fitzwilliam Arms) with a slate clay tiles roof (Photo 1). As a result of partial remediation works the brick chimney has been removed along with a large section of roof tiles. A two-storey, brick-built extension adjoined the wester aspect of the building with a slate tiled roof. The exterior of the building was whitewashed. All windows were boarded to prevent vandalism of the building.

Photo 1: View of southern gable end of Building B1 (former Fitzwilliam Public House)

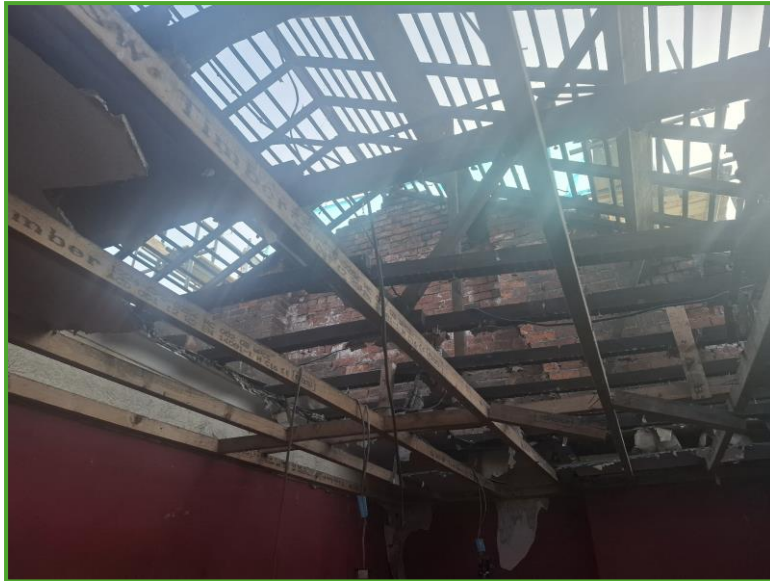
- 3.2 Internally no roof void was present with the ridge beam visible from the second-floor landing. The two southern gable end brick chimneys had been removed along with a large section of slate roof tiles (Photo 2). From the remaining section of roof remaining no underfelt was present with the wooden batons visible. The remaining roof appeared excessively cobwebbed with a heavy lining of detritus on exposed roof timbers.

Photo 2: View of Building B1 southern gable wall with both chimneys removed and clay roof tiles.

- 3.3 No internal / external evidence of use by bats was identified during the survey. The building was considered to offer negligible potential to support roosting bats.
- 3.4 Building 2 (B2) was a modern two-storey, brick-built building with a pitched slate tiled roof adjoining the western aspect of B1. The building appeared well maintained. Potential bat access points were limited to occasional gaps in missing mortar at the verge. No internal access was possible at the time of the survey.

- 4.3 The results of the 2025 PRA survey considered the partial remediation works carried out to date on B1 to make the building safe has rendered the building as offering negligible potential to support roosting bats. The only likely bat roosting opportunities would have been beneath the ridge tiles following the PRA survey. However, the ridge and roof tiles removed to facilitate the remediation works have opened the roof to varying weather conditions likely to result in the remaining area of roof unsuitable to support bats if present due to the open nature of roof with water ingress and wind and temperature fluctuations, as such any further works to the building are unlikely to impact on roosting bats. Therefore, it is considered that remaining remediation works proceed. However, as a precautionary approach all remaining ridge tiles should be carefully removed and checked underneath before removal. In the event a bat is discovered, all works must immediately stop and further advice sought from Natural England.

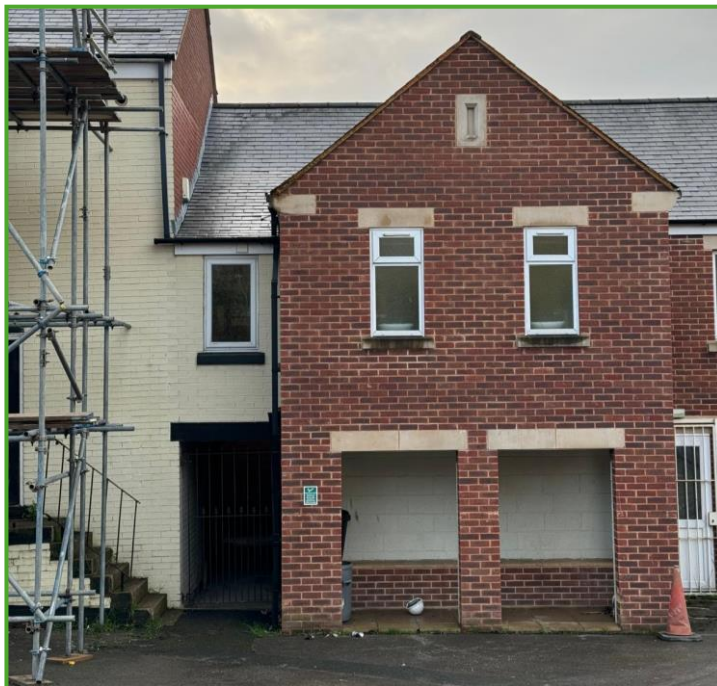
Photo 3: View of Building B2

- 3.5 No external evidence of use by bats was identified during the survey. The building was considered to offer negligible / low potential to support roosting bats.
- 3.6 Building 3 (B3) comprised a two-storey, brick-built storage building with a pitched clay tiled roof with clay ridge tiles. No other structural features of note were recorded. Potential bat access points were observed within the slate tiles and beneath the ridge tiles and around the widen door. No roof void was present with the roof open to the ridge. The roof was not lined with the timber batons visible from within the building which was also heavily cobwebbed.

- 4.4 Building B2 and B4 are considered to offer negligible potential to support roosting bats. Therefore, no further surveys are required, and bats are not considered a statutory constraint to the proposed conversion work.

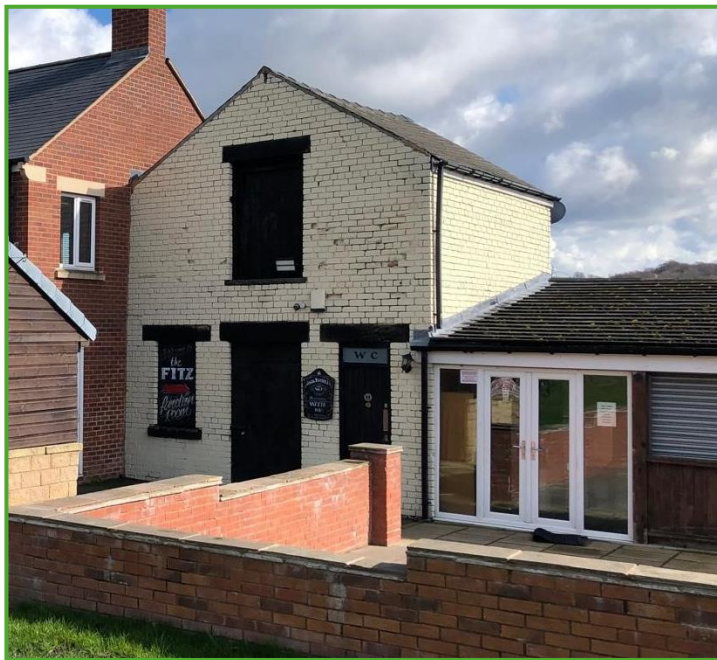
Photo 3: View of Building B3

- 3.7 No external evidence of use by bats was identified during the survey. The building was considered to offer low potential to support roosting bats.
- 3.8 Building 4 (B4) was a single-storey, brick-sided and slate tiled mono-pitched roof. The building appeared to be a former restaurant room with a timber front and glazed front. No external evidence of use by bats was identified during the survey. The building was considered to offer negligible potential to support roosting bats.

- 4.5 Building B3 provided limited bat roosting opportunities beneath the ridge tiles and fabric of the building. Therefore, due to the low potential of building to support roosting bats and in accordance with industry guidance (BCT, 2023), a single nocturnal survey is required during the optimal survey season (May – August, inclusive) to

determine the presence / likely absence of roosting bats from the buildings.

- 4.6 If during the nocturnal survey confirms a bat roost as being present, additional nocturnal survey effort will be required in support of a Natural England Licence to facilitate the works.

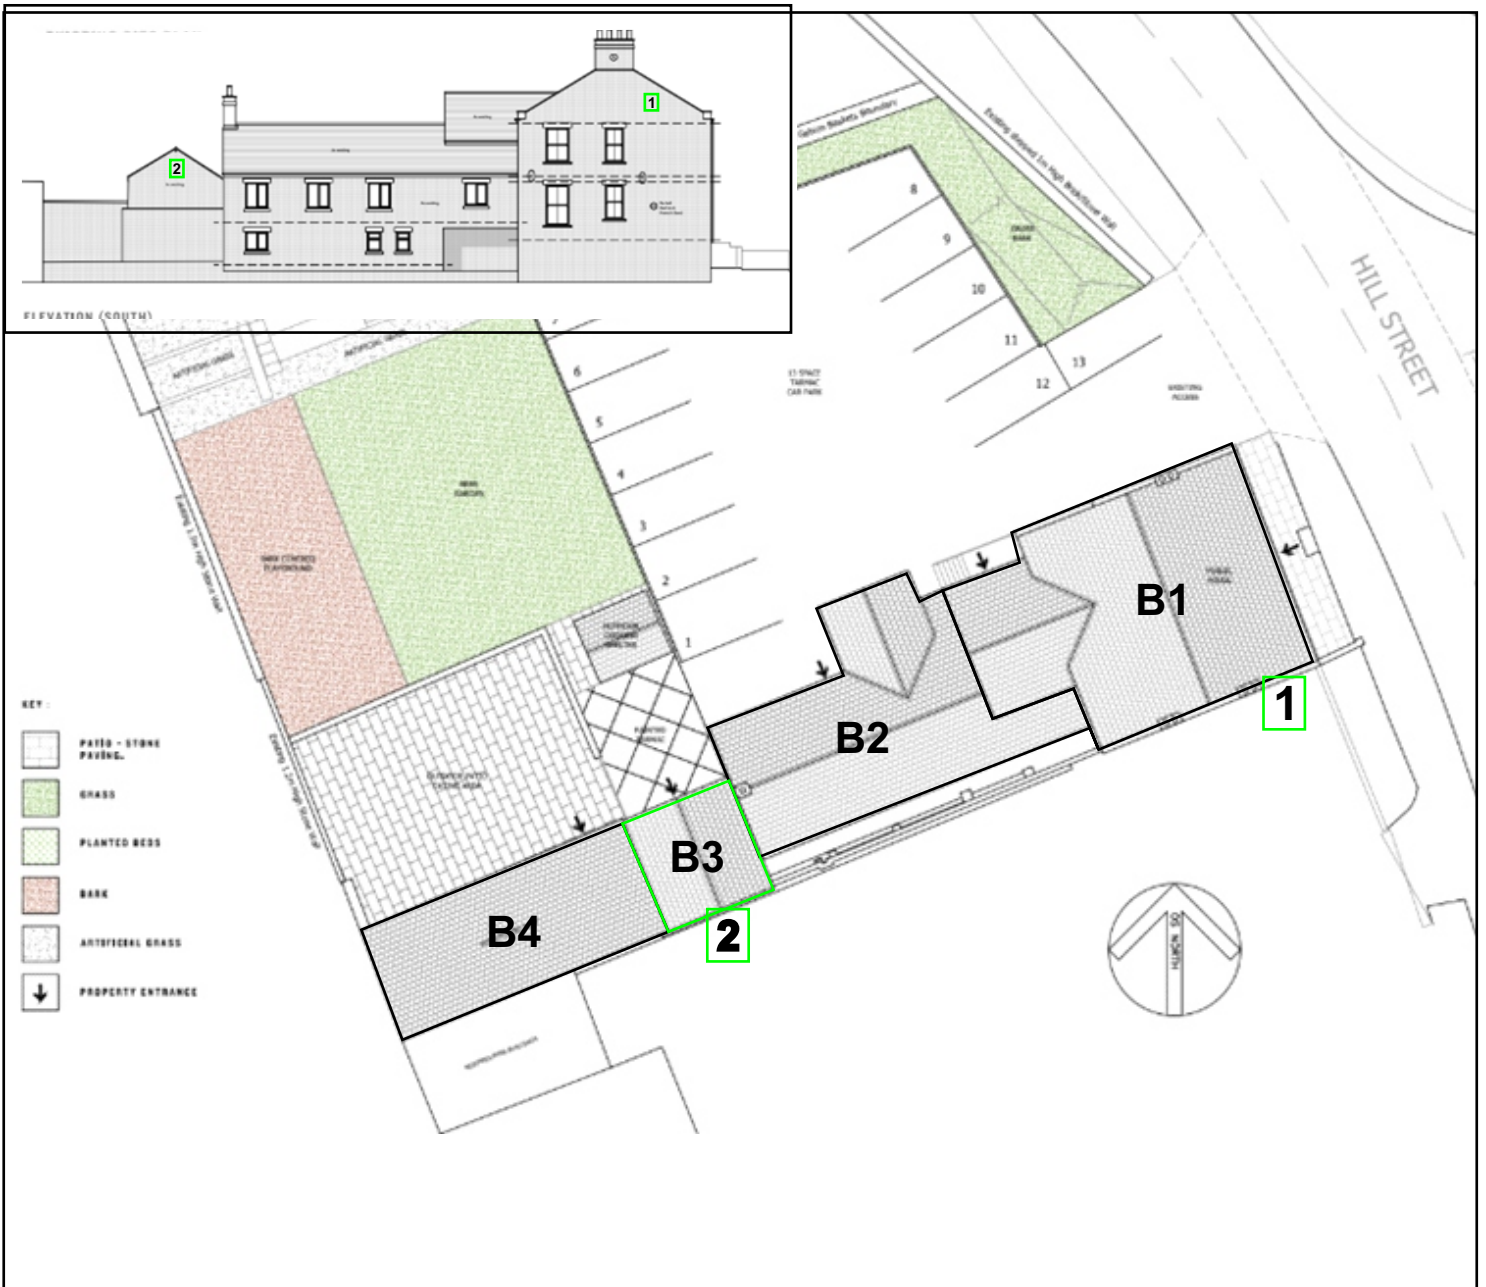
Figure 2: Building Reference Plan

- Building with negligible bat roosting potential
- Building with low bat roosting potential
- 1 Possible bat tube locations

- 4.7 Post development enhancements will comprise a bat tube incorporated in the southern gable end of building B1 or B3 (see Figure 2). The Build-in WoodStone Bat Box is designed to fit into the cavity of house walls, with the entrance sitting flush with the outside bricks and provides an excellent insulation for roosting bats.
- 4.8 The sloping entrance allow any bat droppings to fall out of the box, creating a maintenance-free habitat for a variety of bat species. Position the box at least 3.5m above ground level and away from artificial light sources facing a southerly direction.
