Arboricultural Implication Assessment  
Of Trees At

The Countryman Public House,  
Park Hollow, Wombwell, Barnsley

(Layout ST/17080016/201)

For  
Premier Construction North

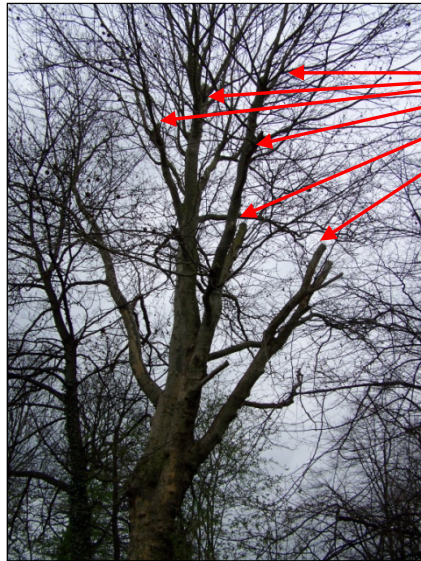
The trunk divides at 3.6m to form 2x codominant stems which further divide resulting in 5x stems that carry the crown. The tree has been crudely reduced in the past at 11m and there are multiple re-growth stems emanating from the reduction heads which appear to be in a decaying state.

A climbing inspection would be beneficial to evaluate the extent of the decay. An understanding of tree biology and mechanics leads to the prognosis that the attachment points of the stems onto the decaying reduction heads will be significantly compromised and will inevitably result in the failure of the limbs especially during adverse weather conditions. It would be prudent to monitor the condition of these reduction heads annually by a qualified arboriculturalist, who may advise a further reduction in the future and the tree to be routinely managed as a pollard.

Reduction heads which contain some decay and numerous adventitious shoots

There is some deadwood retained in the crown and there is a woodpecker hole on a decaying stub on the northern flank.

The south western stem is growing into and making contact with a sycamore which is located on the neighbouring property the stems are rubbing resulting in some cambial damage.

- It would be prudent to carry out an aerial inspection to determine to extent of the decay within the reduction heads.
- Crown clean to remove the deadwood and prune to clear the adjacent sycamore tree so there is no contact between trees.

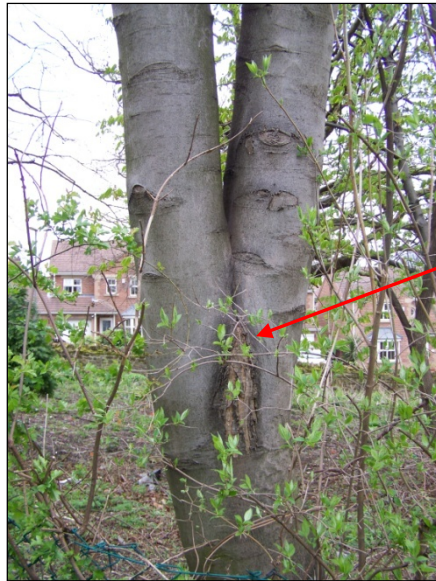
The tree has good outline form however the trunk divides at 1.6m to form 2x codominant stems. The resulting fork is acutely angled with included or trapped bark present between the stems. This type of formation is a potential structural weakness which is prone to failure in strong winds.

The problem occurs when the wood fibres meet at a shallow angle in a symmetrical plane and can therefore be parted with much less force than is required to tear a normal branch formation from the tree which has a much superior interlocked mechanism of attachment. This means that the plane of weakness and line of splitting will follow the forks downwards into the main trunk structure.

V crotch with included bark and cross sectional reaction growth present on either side of the union

It would be prudent for the tree owner to have the tree inspected by a qualified arboriculturalist regularly or following the event of adverse winds or storm conditions.

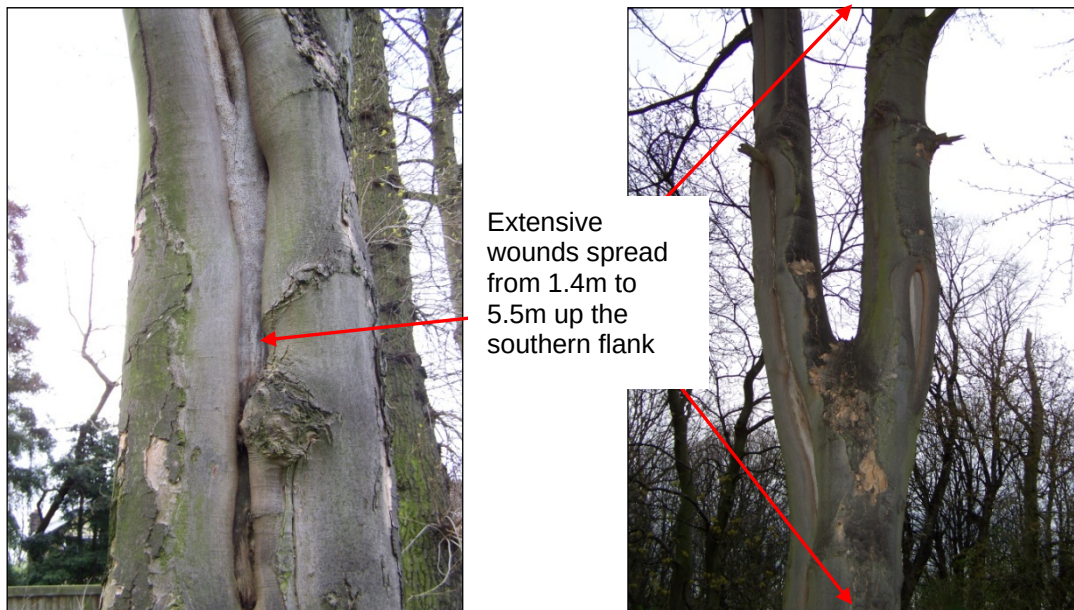
The southern flank of the trunk has previously sustained a considerable amount of damage which is characteristic of heat damage from a bonfire. The wound extends from ground level to 1.4m on the northern flank and from 1.4m to 5.5m up the southern flank and onto the western stem.

It is assumed that this damage has been caused post designation of the TPO as the damage is so significant that it detracts the amenity value of the tree and the structural integrity is also questionable.

Generally this is a poor specimen and should be removed in the interest of safety and as part of establishing a higher level of arboricultural management for the site replacing it with a new specimen elsewhere. The tree will also need to be removed to facilitate the construction of the parking for plot 13.

- Remove the tree to facilitate the development
- Replace tree as part of a replanting scheme

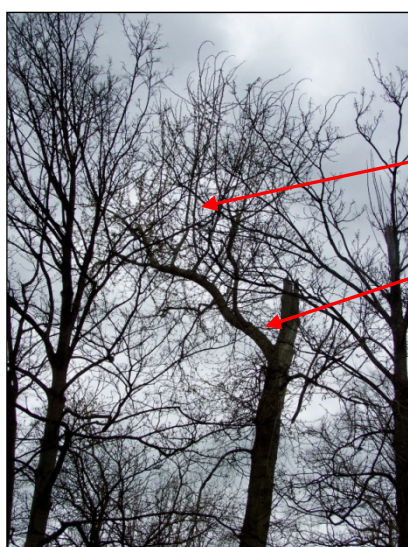
A subdominant stem emanates at approximately 10m on the western flank. This subdominant stem has produced numerous vertical adventitious shoots which are developing as the new leaders. As these establish and grow they will increase the weighting and sail area of the limb thus increasing the load bearing stress on the limb attachment at the stem. The prognosis is the likely failure of the limb.

Adventitious shoots with increase loading on limb attachment

It would be appropriate to remove the tree as part of the site management replacing it with a new specimen elsewhere on site. The tree will need to be removed to facilitate the construction of the building on plot 13.

- Remove the tree to facilitate the development
- Replace tree as part of a replanting scheme

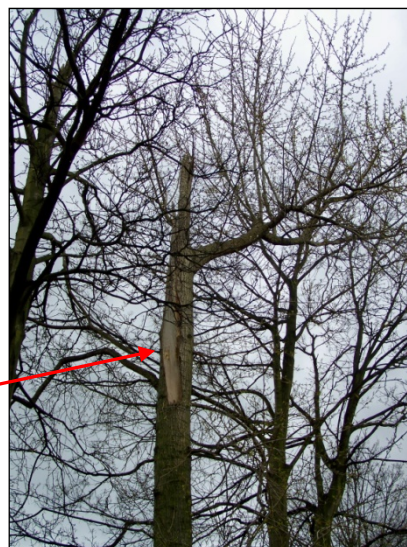
The top of the main leader has previously snapped out resulting in a large tear wound down the northern flank of the stem. The wound appears to be fairly recent as the wood has not yet discoloured with weathering.

Torn wound (photo taken from the northeast)
