Project Name: Gleeson - Off Wakefield Road	Project number:	Date: 17/12/2024	Contact:	
---	-----------------	---------------------	----------	--

Profile Report	1
Inspection: 1	
Project Information	2
Section: 1, S1 --- Outfall	5
Section: 2, F1 --- F2	6
Section: 3, F2 --- F3	11
Section: 4, F3 --- F4	16
Section: 5, F4 --- F5	20
Section: 6, F4 --- Boundary	24
Section: 7, F6 --- F3	26
Section: 8, F7 --- F5	31
Section: 9, F7 --- F5	38
Section: 10, F7 --- F5	41
Section: 11, F5 --- F8	45
Section: 12, F8 --- F9	50
Section: 13, F8 --- F9	58
Section: 14, F9 --- F10	62

Project name :
Gleeson - Off Wakefield Road - Ather

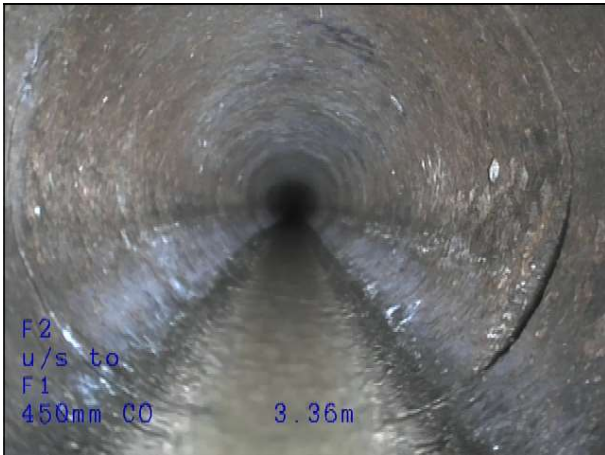
Photo: 2_3A
 3.36m, Surface damage, spalling, from 3 to 5 o'clock
 Remarks: At joint

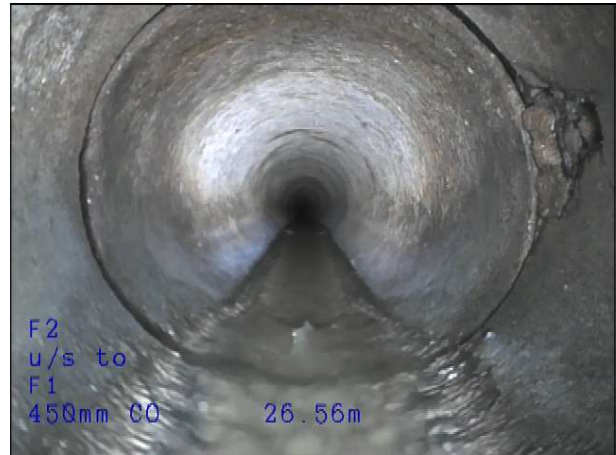
Photo: 2_4A
 26.56m, Hole in drain/sewer at joint, from 2 to 3 o'clock
 Remarks: Backfill visible

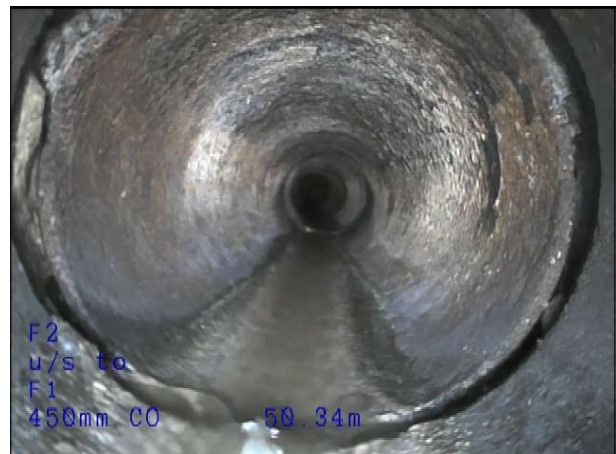
Photo: 2_6A
 50.34m, Open joint, medium
 Remarks: Backfill visible

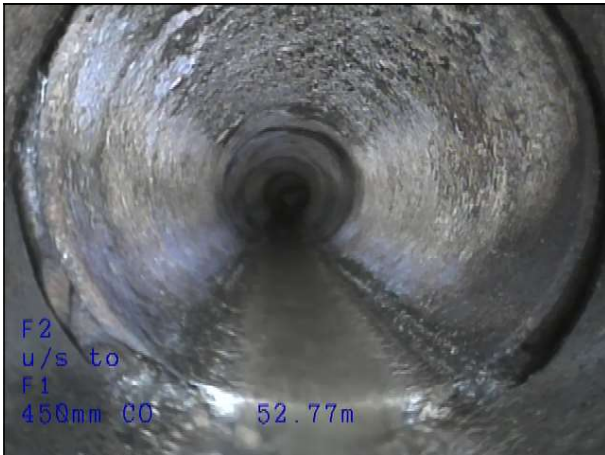
Photo: 2_7A
 52.77m, Open joint, medium

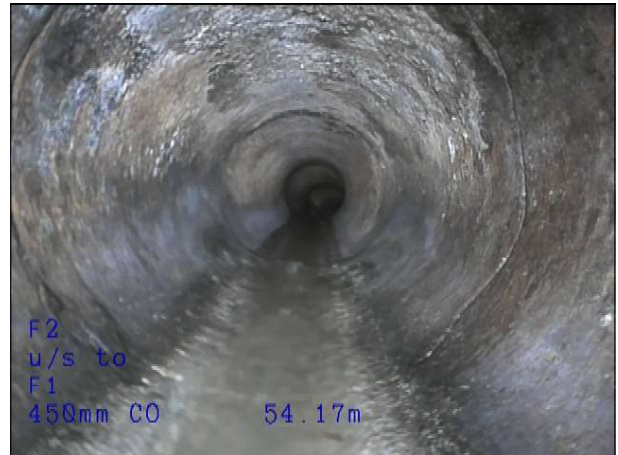
Photo: 2_8A
 54.17m, Fracture, circumferential, from 12 to 12 o'clock

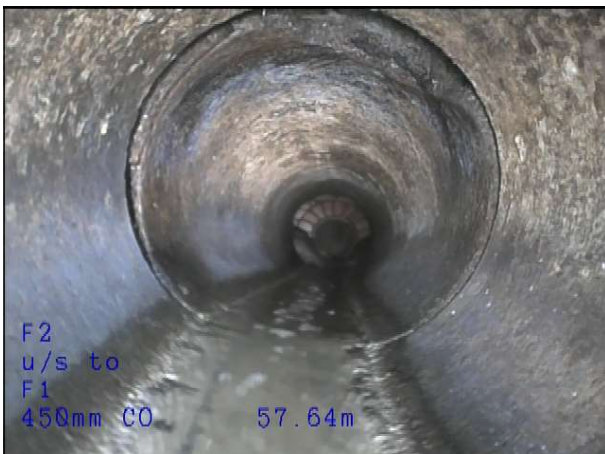
57.67	Hole in drain/sewer at joint, from 11 to 2 o'clock Remarks: Pipework missing	(Struct) 5	
60.30	Finish node type, manhole reference number: F1 (Constr) 0		<p style="font-size: small;">F2 U/S to F1 450mm CO 60.30m</p> <p style="text-align: center;">60.30 m //</p>

Photo: 2_9A
 57.67m, Hole in drain/ sewer at joint, from 11 to 2 o'clock
 Remarks: Pipework missing

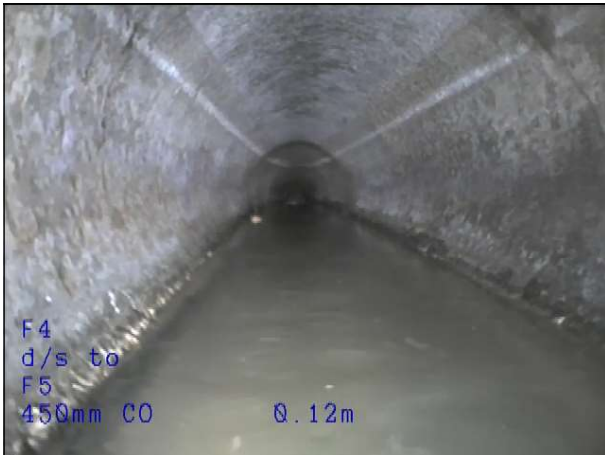
Photo: 5_3A, 00:00:10
 0.12m, Crack, circumferential, from 9 to 4 o'clock

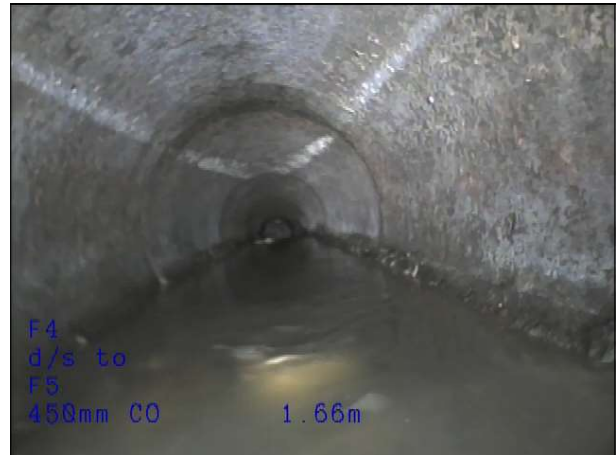
Photo: 5_4A
 1.67m, Settled deposits, coarse, 10% cross-sectional area loss, Start

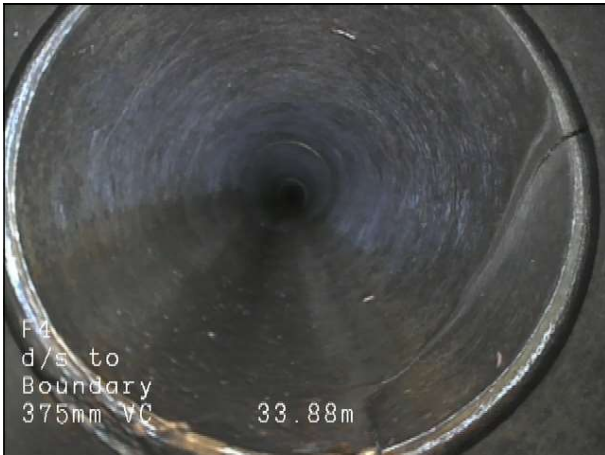
Photo: 6_3A
 33.88m, Fracture, circumferential at joint, from 2 to 5 o'clock

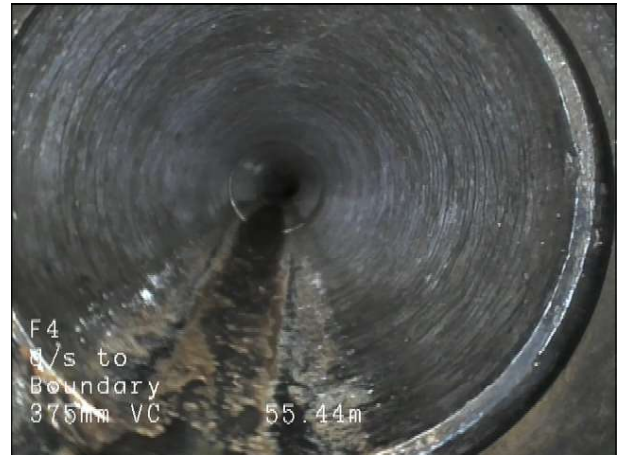
Photo: 6_4A
 55.44m, Open joint, medium

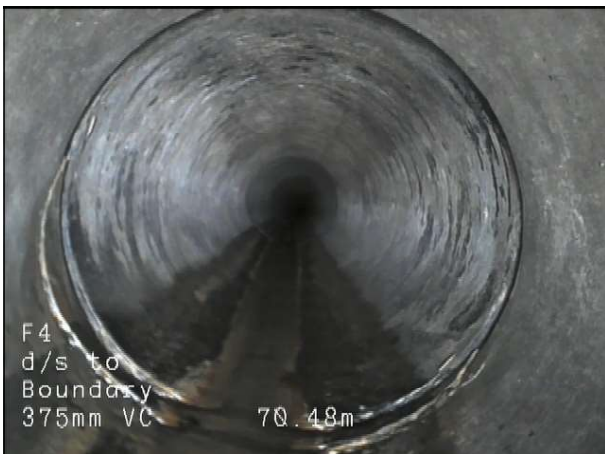
Photo: 6_6A
 70.48m, Fracture, circumferential at joint, from 4 to 9 o'clock

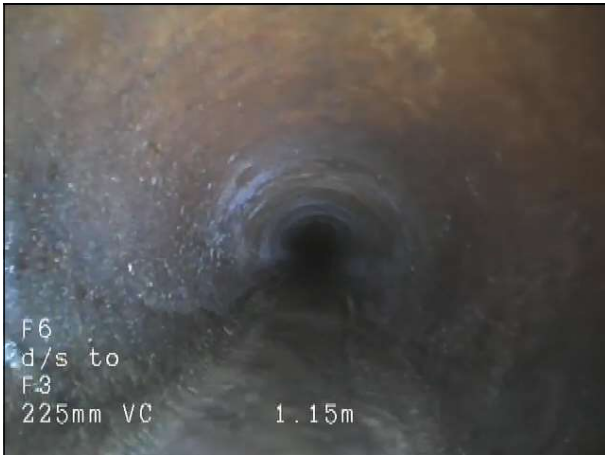
Photo: 7_4A
 0m, Point repair, localised lining, from 12 to 12 o'clock, Start
 Remarks: Cured in place lining installed

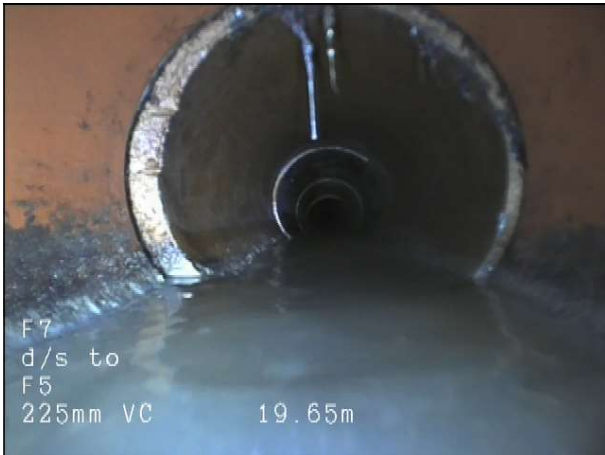
Photo: 8_5A
 19.65m, Roots, fine at joint

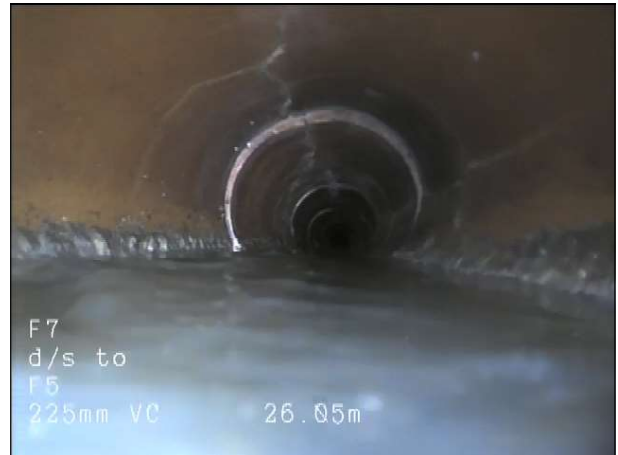
Photo: 8_10A
 26.05m, Fracture, longitudinal, at 11 o'clock, Start

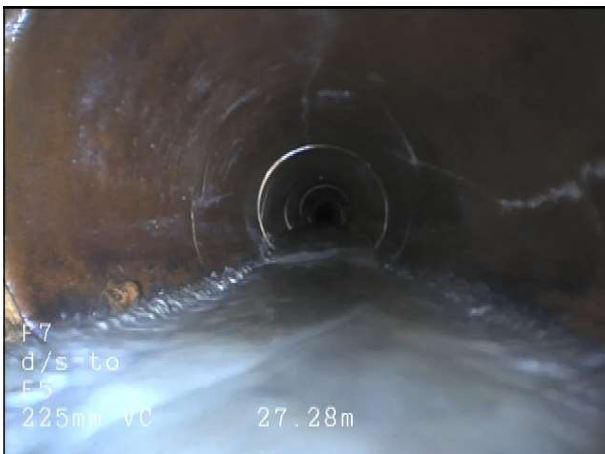
Photo: 8_12A
 27.27m, Crack, longitudinal, at 3 o'clock

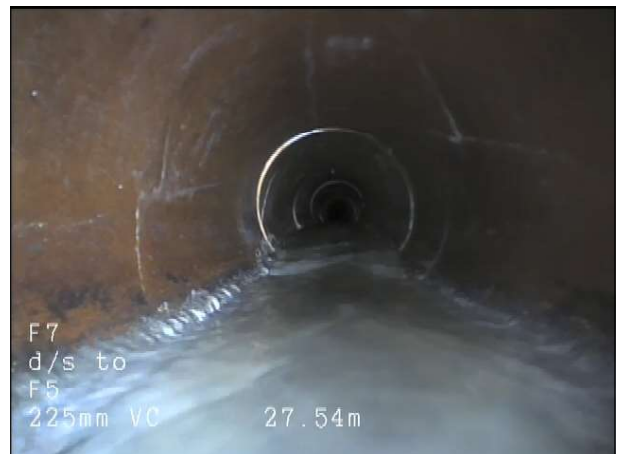
Photo: 8_13A
 27.55m, Crack, circumferential, from 7 to 3 o'clock

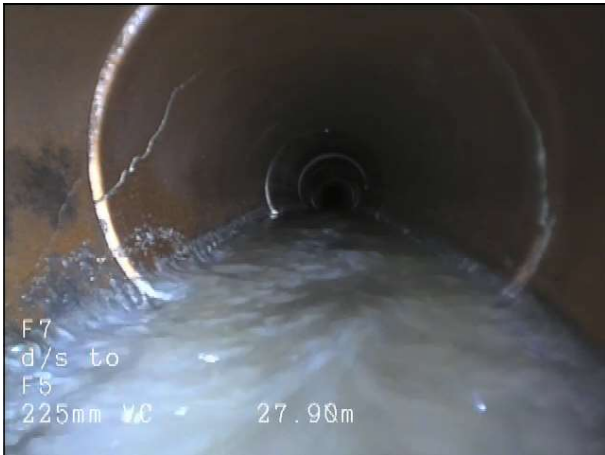
Photo: 8_14A
27.9m, Fracture, longitudinal, at 11 o'clock, End

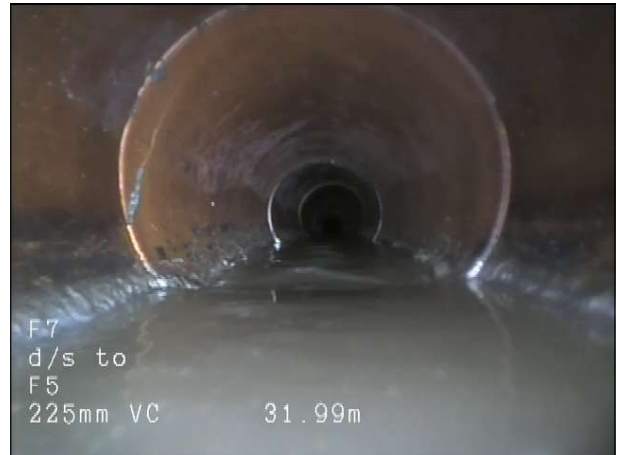
Photo: 8_18A
31.99m, Crack, circumferential at joint, from 8 to 11 o'clock

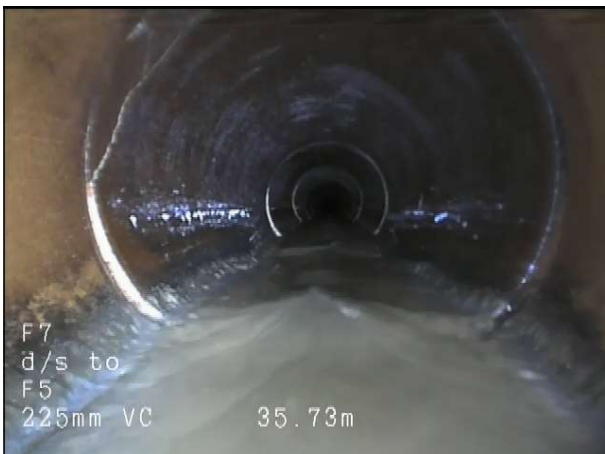
Photo: 8_20A
35.73m, Fracture, circumferential at joint, from 9 to 11 o'clock

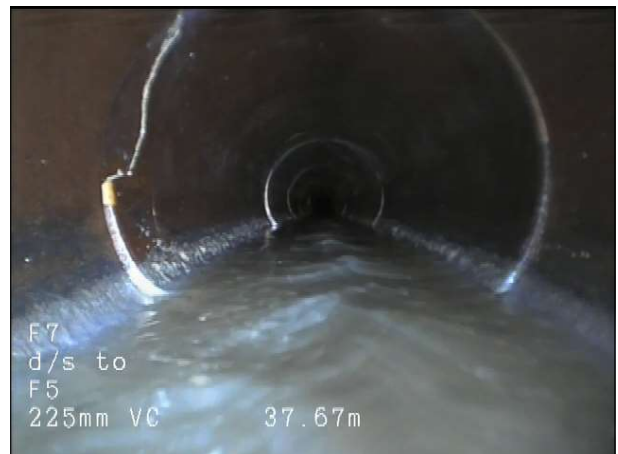
Photo: 8_21A
37.67m, Fracture, circumferential at joint, from 9 to 11 o'clock

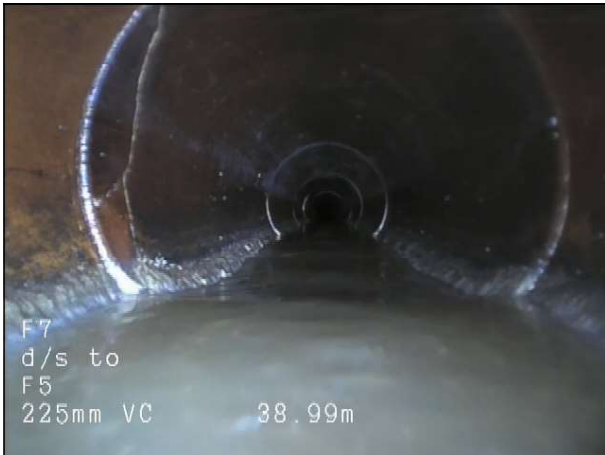
Photo: 8_22A
 38.99m, Fracture, circumferential at joint, from 7 to 11 o'clock

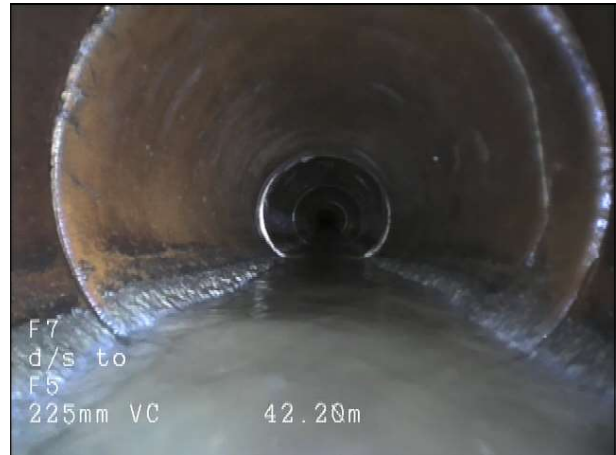
Photo: 8_23A
 42.2m, Fracture, circumferential at joint, from 1 to 5 o'clock

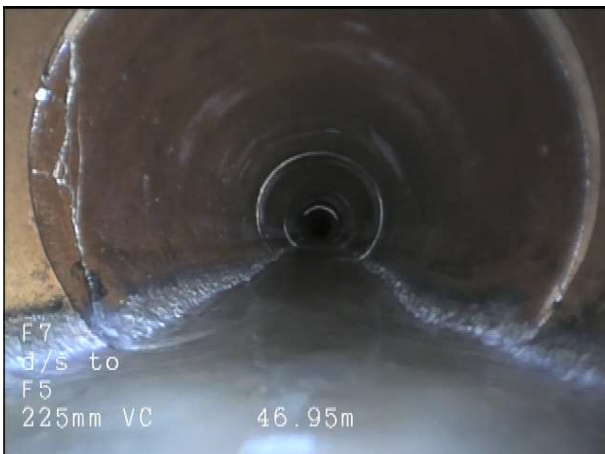
Photo: 8_24A
 46.95m, Fracture, circumferential at joint, from 7 to 10 o'clock

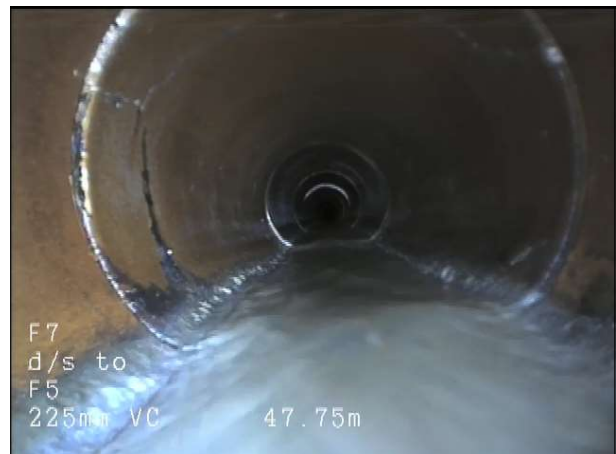
Photo: 8_25A
 47.75m, Fracture, circumferential at joint, from 10 to 2 o'clock

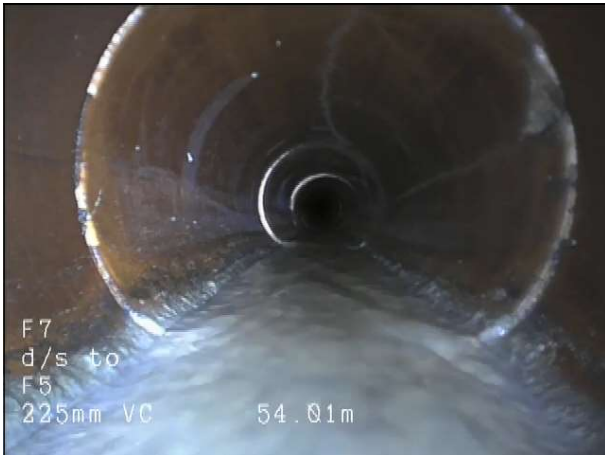
Photo: 8_26A
 54.01m, Crack, longitudinal, at 12 o'clock

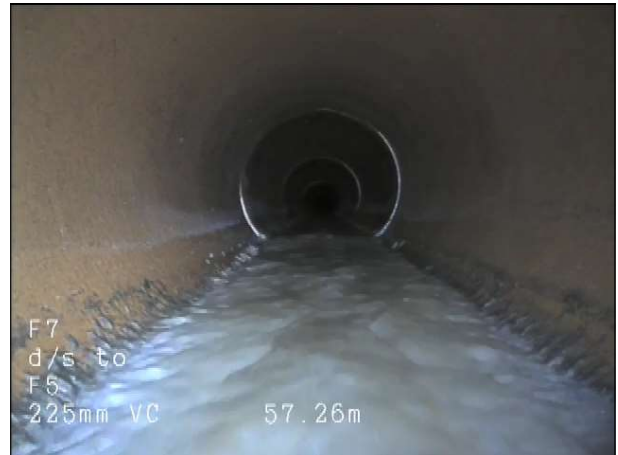
Photo: 8_28A
 56.57m, Crack, circumferential at joint, from 1 to 5 o'clock

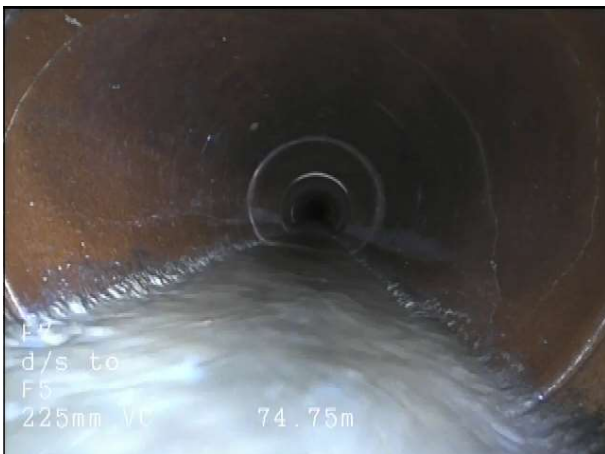
Photo: 8_31A
 74.75m, Crack, circumferential, from 7 to 5 o'clock

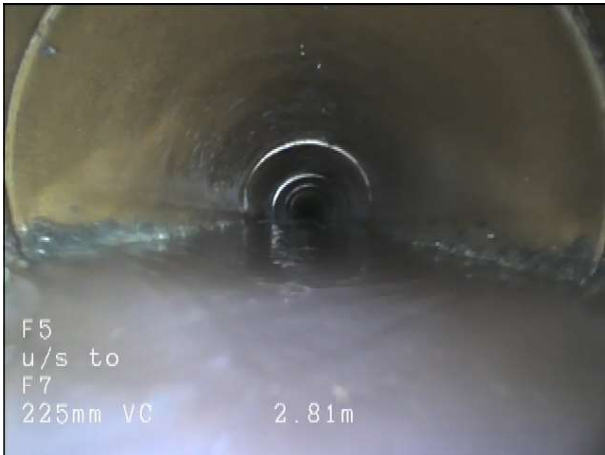
Photo: 10_3A
2.82m, Water level, 20% of the vertical dimension

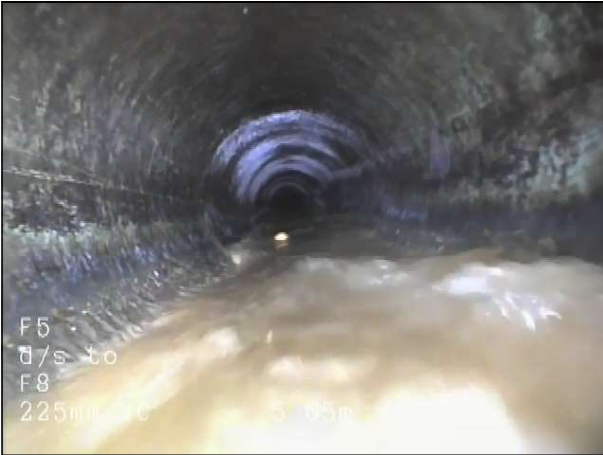
Photo: 11_3A

0m, Point repair, localised lining, from 12 to 12 o'clock, Start
Remarks: Cured in place lining installed

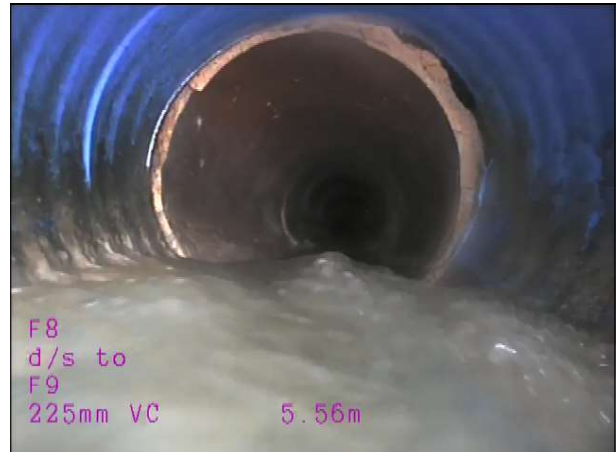
Photo: 12_5A
 5.63m, Material changes, vitrified clay

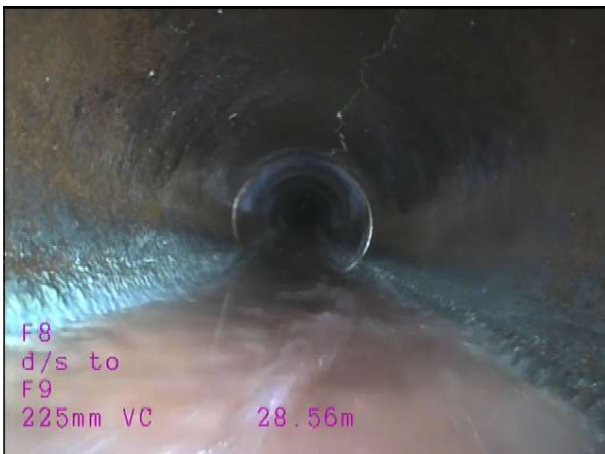
Photo: 12_6A
 28.56m, Crack, longitudinal, at 1 o'clock

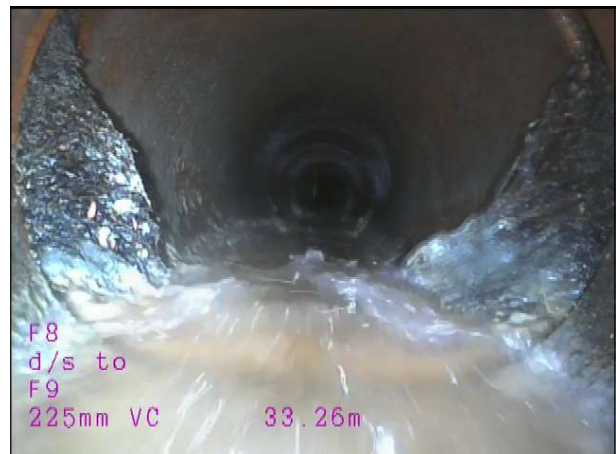
Photo: 12_7A
 33.26m, Roots, mass at joint, 20% cross-sectional area loss

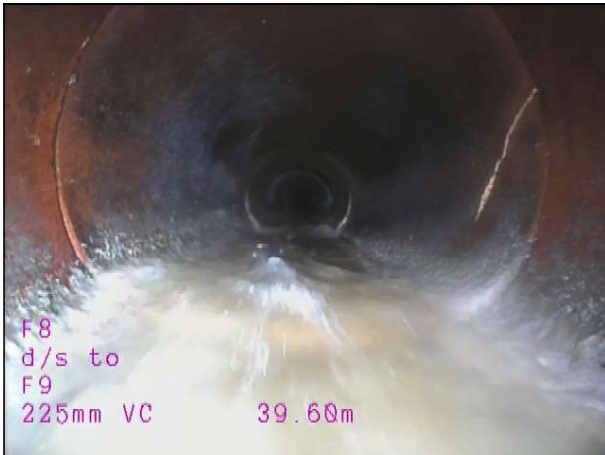
Photo: 12_10A
 39.6m, Crack, circumferential at joint, from 2 to 4 o'clock

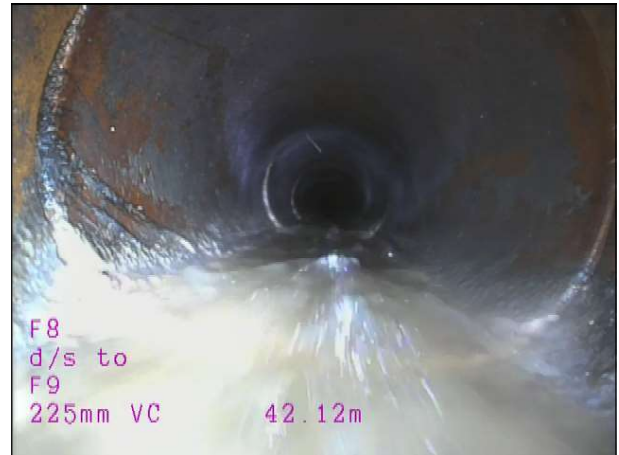
Photo: 12_11A
 42m, Roots, fine at joint, Start

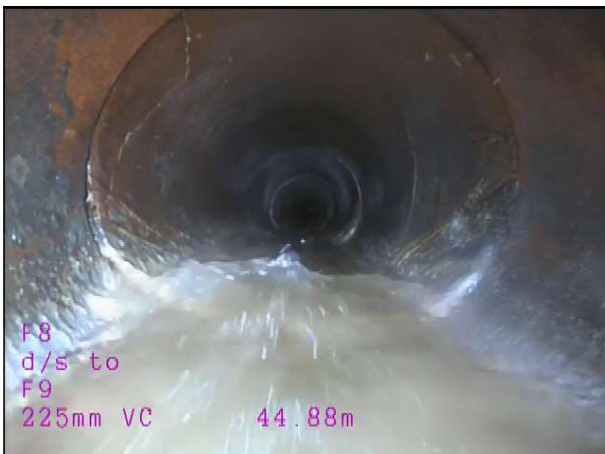
Photo: 12_12A
 44.79m, Crack, longitudinal, at 12 o'clock

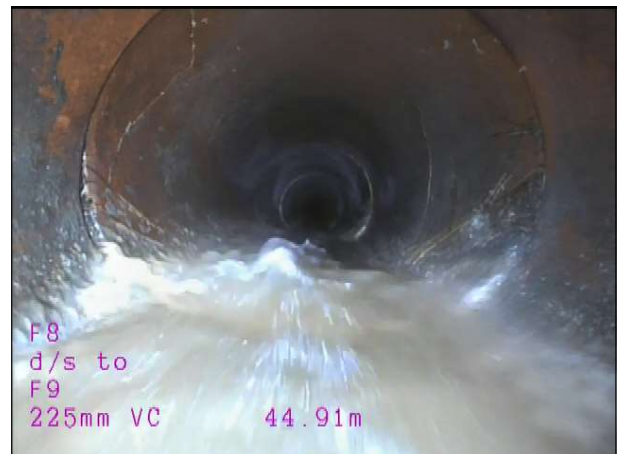
Photo: 12_13A
 44.91m, Fracture, circumferential at joint, from 8 to 11 o'clock

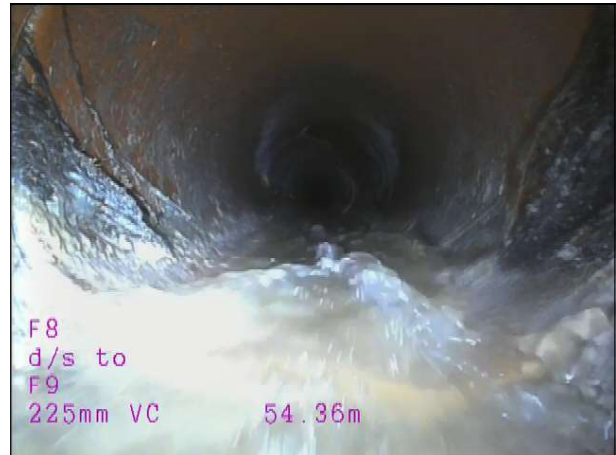
Photo: 12_15A
 54.36m, Roots, mass at joint, 10% cross-sectional area loss

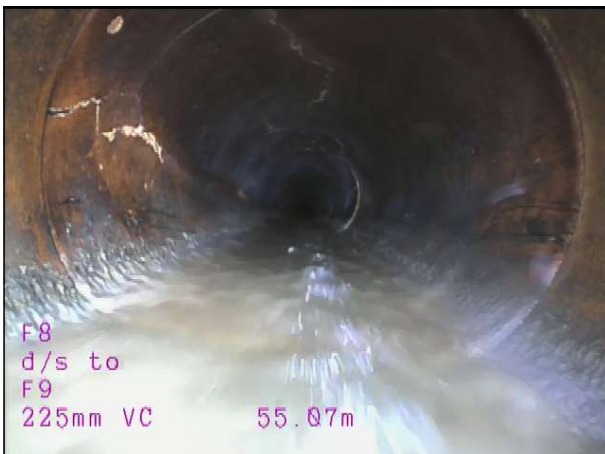
Photo: 12_16A
 55.07m, Fracture, longitudinal, at 9 o'clock

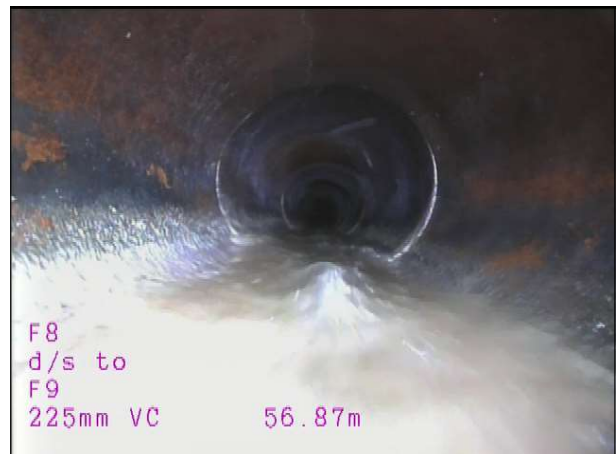
Photo: 12_18A
 56.87m, Crack, longitudinal, at 12 o'clock

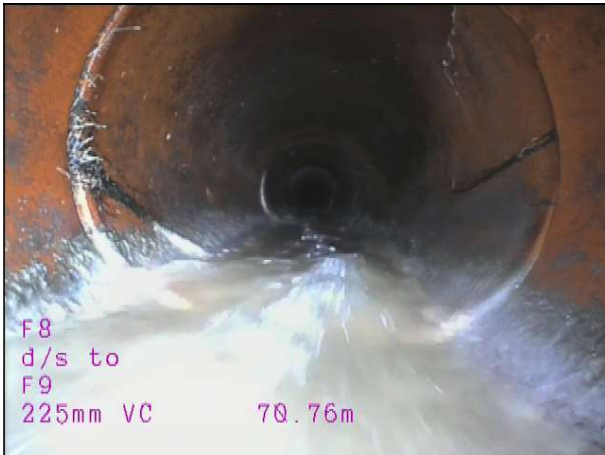
Photo: 12_19A
 70.76m, Fracture, longitudinal at joint, at 2 o'clock

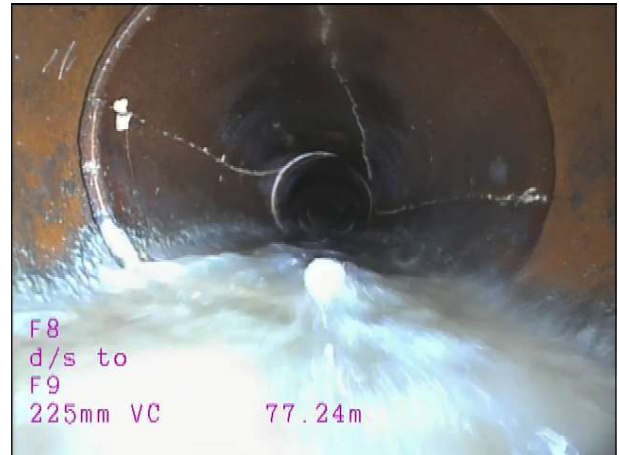
Photo: 12_20A
 77.24m, Fracture, longitudinal, at 3 o'clock

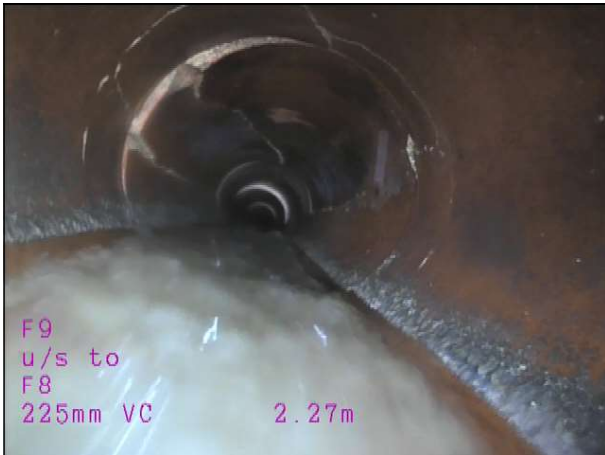
Photo: 13_3A
2.27m, Fracture, multiple, from 8 to 4 o'clock, Start

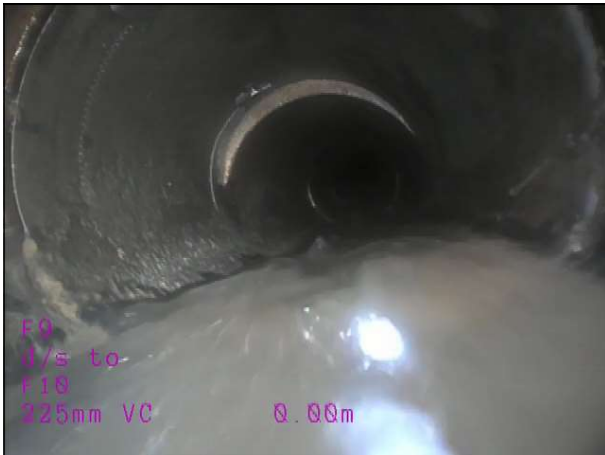
Photo: 14_3A
 0m, General remark Remarks: Re-rounding clip installed

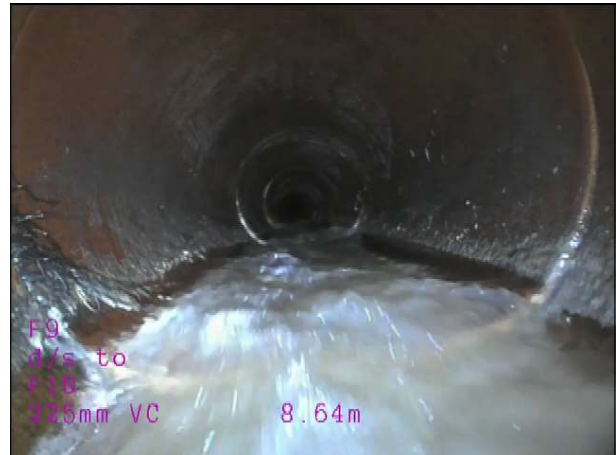
Photo: 14_5A
 8.64m, Roots, fine at joint, Start

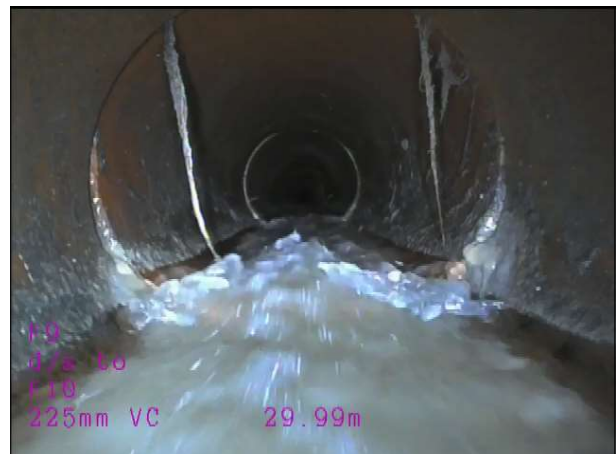
Photo: 14_7A
 29.99m, Roots, mass at joint, 5% cross-sectional area loss

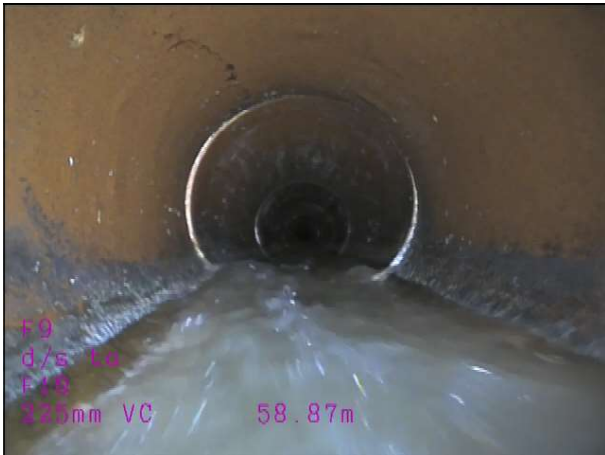
Photo: 14_9A
 58.87m, Crack, longitudinal, at 11 o'clock

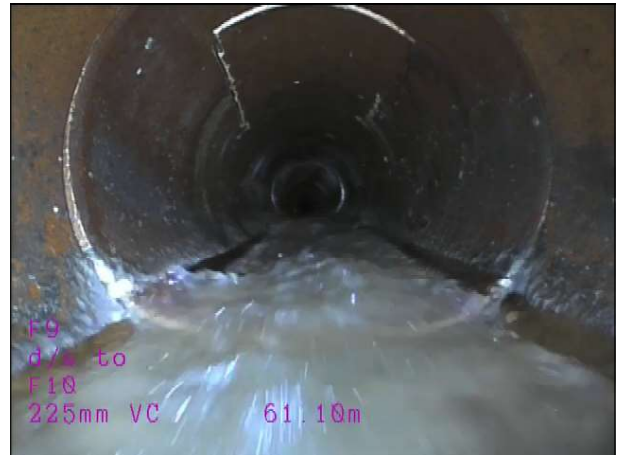
Photo: 14_10A
 61.1m, Point repair, hole repaired, from 11 to 1 o'clock

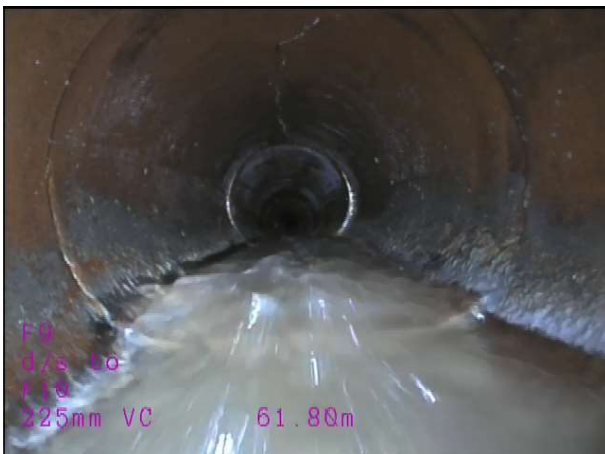
Photo: 14_11A
 61.8m, Crack, longitudinal at joint, at 12 o'clock

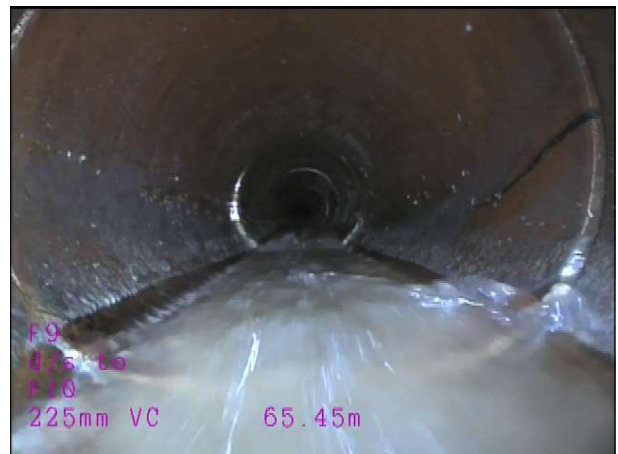
Photo: 14_12A
 65.45m, Roots, fine at joint

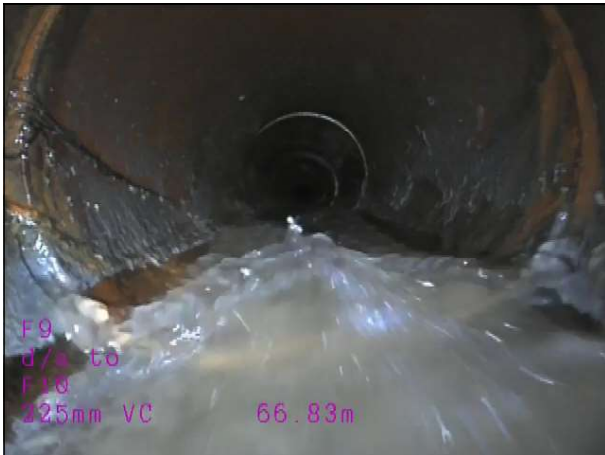
Photo: 14_14A
 66.83m, Roots, fine at joint, Start

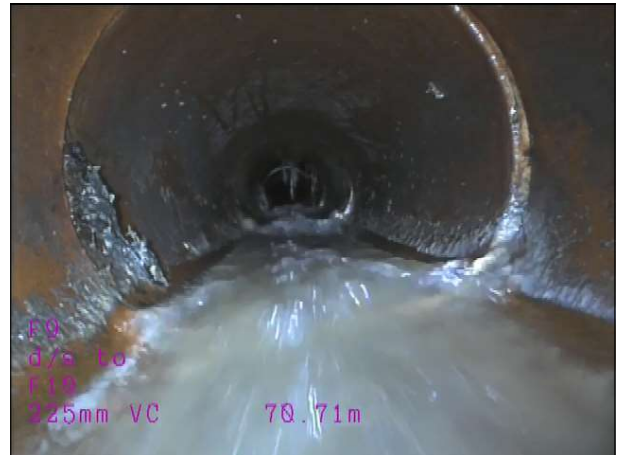
Photo: 14_15A
 70.71m, Roots, mass at joint, 5% cross-sectional area loss

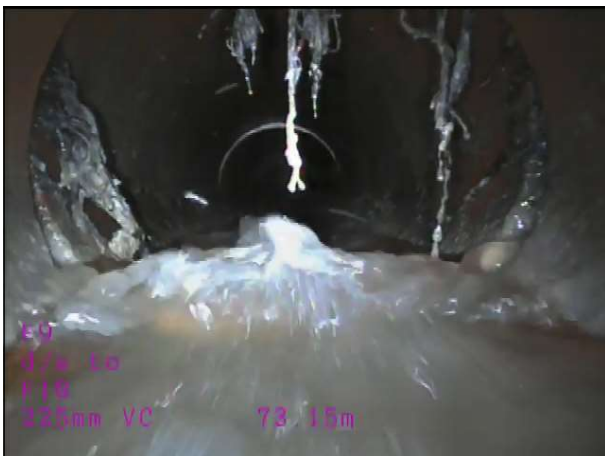
Photo: 14_16A
 73.15m, Roots, mass at joint, 10% cross-sectional area loss
