# ARBORICULTURAL REPORT

To BS 5837:2012 at:

*Land at*  
**28 Paddock Road**  
**Staincross**  
**Barnsley**  
**S75 6LG**

Reference: AWA3588

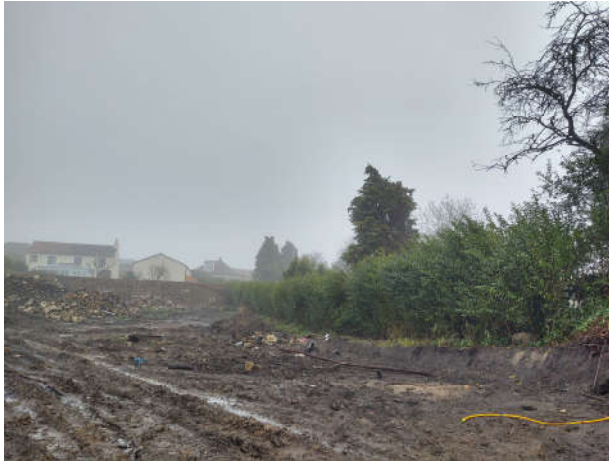
Photo 1: G1 and T2

| | Tree Species | | | Measurements | | | | Crown (m) | | | | Tree Condition | | | | | | | Value | | Management | |
|---|---|---|---|---|---|---|---|---|---|---|---|---|---|---|---|---|---|---|---|---|---|---|
| G1 | Privet | Ligustrum ovalifolium | Semi-mature | 2 | 10+ | 40 avg | No | 0 | See Plan | | | | No visual defects | Multiple stemmed at base, Vertical, Tight union | Old pruning wounds, Minor deadwood | Managed boundary hedge. | Good | Good | >40 yrs | Low | C | No works required in current site context |
| T2 | Lawson Cypress | Chamaecyparis lawsoniana | Semi-mature | 6 | 1 | 160 | Yes | 1 | 1.5 | 1.5 | 1.5 | 1.5 | No visual defects, Limited access around base | Single stemmed, Vertical | Minor deadwood | Limited visibility due to boundary hedge. | Good | Good | >40 yrs | Low | C | No works required in current site context |

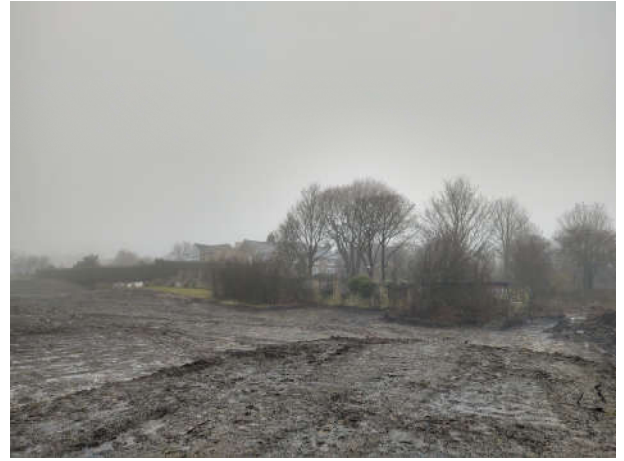
Photo 2: G8 and G11 with T9 and T10 in the background

| | Tree Species | | | Measurements | | | | Crown (m) | | | | Tree Condition | | | | | | | Value | | Management | |
|---|---|---|---|---|---|---|---|---|---|---|---|---|---|---|---|---|---|---|---|---|---|---|
| T9 | Oak | <i>Quercus robur</i> | Early-mature | 14 | 1 | 400 | Yes | 3.5 | 3 | 5 | 4 | 4 | No visual defects, Limited access around base | Single stemmed, Vertical, Old pruning wounds, Epicormic growths | Minor deadwood | Very limited visibility due to high boundary wall. Distance from site boundary estimated. | Good | Good | >40 yrs | Moderate | B | No works required in current site context |
| T10 | Sycamore | <i>Acer pseudoplatanus</i> | Early-mature | 12 | 2 | 340, 280 | Yes | 4 | 4 | 4 | 3 | 3 | No visual defects, Limited access around base | Twin stemmed, Vertical, Old pruning wounds | No visual defects | very limited visibility due to high boundary wall. Distance from site boundary estimated. | Good | Good | >40 yrs | Moderate | B | No works required in current site context |

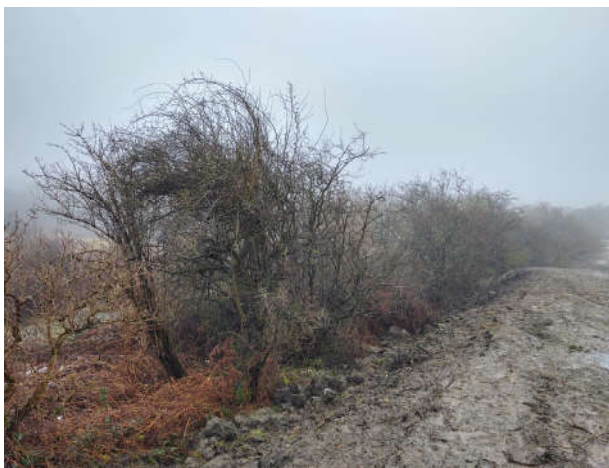
- 3.2.9 The eastern boundary of the southern half of the site is formed by the trees and groups G12, G13, T14 to T16, G17, T18 and T19. Collectively this is a landscape feature of reasonable value. It is likely that this was once a more managed hedgerow. The canopy could be pruned back and the sparse sections enhanced with additional planting to reform the hedgerow.

Photo 3: G13

| | Tree Species | | | Measurements | | | | Crown (m) | | | | Tree Condition | | | | | | | Value | | Management | |
|---|---|---|---|---|---|---|---|---|---|---|---|---|---|---|---|---|---|---|---|---|---|---|
| G13 | Hawthorn | Crataegus monogyna | Semi-mature | 5 | 10+ | 130 avg | No | 1 | See Plan | | | | Soil compaction, Adjacent ground works | Multiple stemmed at base, Significant lean, Bark damage, Tight union | Stubs, Moderate deadwood, Snapped / hanging branches | Linear group forming a single canopy. Several sparse sections & areas full of brambles. Occasional Elder. Earth has recently been piled up to west of stems. Possibly a managed hedge in the past. Could be pruned back, enhanced with additional planting & managed as a boundary hedgerow. | Fair | Fair | >40 yrs | Low | C | No works required in current site context |

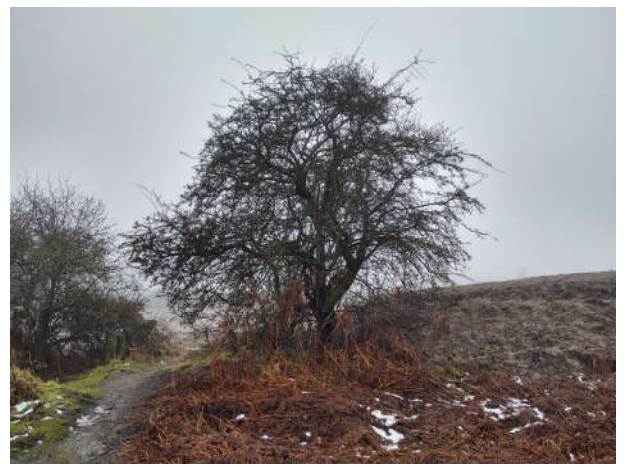
Photo 4: T14

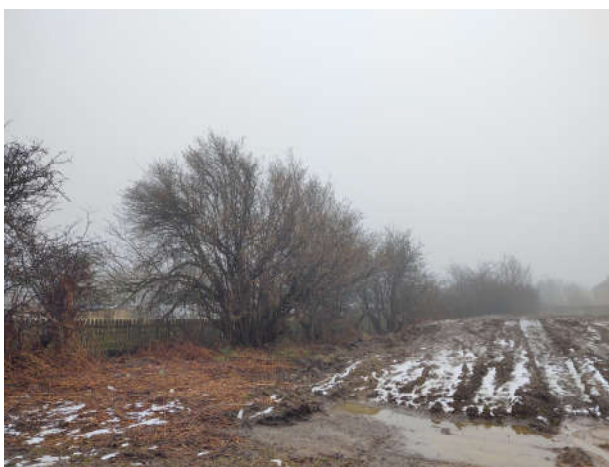
Photo 5: T16 and G17

| Tree ID | Tree Species | | Maturity | Measurements | | | | Crown (m) | | | | | Tree Condition | | | | | | | Value | | Management |
|---|---|---|---|---|---|---|---|---|---|---|---|---|---|---|---|---|---|---|---|---|---|---|
| G17 | Hawthorn | <i>Crataegus monogyna</i> | Semi-mature | 5 | 10+ | 130 avg | No | 1 | See Plan | | | | Soil compaction, Adjacent ground works | Multiple stemmed at base, Significant lean, Bark damage, Tight union | Stubs, Moderate deadwood, Snapped / hanging branches | Linear group forming a single canopy. Several sparse sections & areas full of brambles. Occasional Elder. Earth has recently been piled up to west of stems. Possibly a managed hedge in the past. Could be pruned back, enhanced with additional planting & managed as a boundary hedgerow. | Fair | Fair | >40 yrs | Low | C | No works required in current site context |

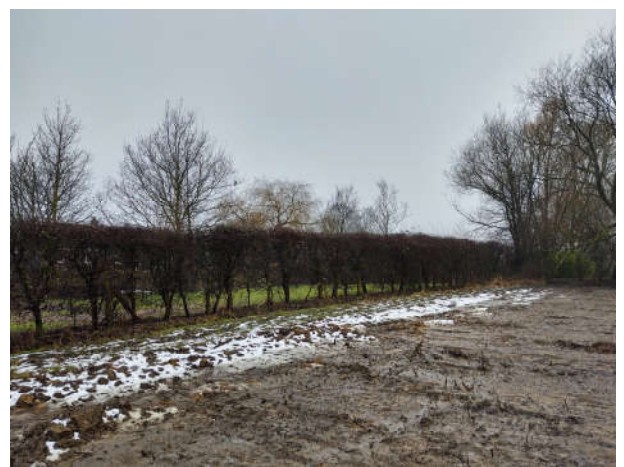
Photo 6: G20

| Tree ID | Tree Species | | Maturity | Measurements | | | | Crown (m) | | | | | Tree Condition | | | | | | | Value | | Management |
|---|---|---|---|---|---|---|---|---|---|---|---|---|---|---|---|---|---|---|---|---|---|---|
| G20 | Hawthorn | <i>Crataegus monogyna</i> | Semi-mature | 2 | 10+ | 60 avg | No | 0 | See Plan | | | | No visual defects | Single stemmed, Vertical, Old pruning wounds, Tight union | Old pruning wounds | Well managed hedge. | Good | Good | >40 yrs | Low | C | No works required in current site context |

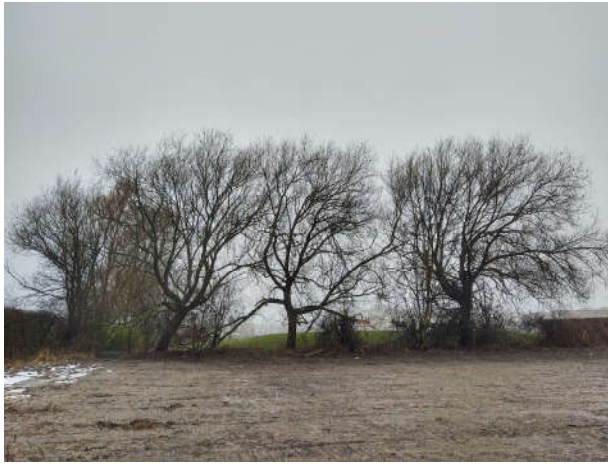
- 3.2.8 At the south west corner of the site are the three Willow trees, T21, T22 and T23. These trees all have various large snapped branches, primarily on the eastern side of their crowns. It is recommended to remove these snapped branches, as detailed at appendix 4, although T21 is in a particularly poor overall condition and its removal is advised. These trees appear to be beyond the boundary of the site. If this is the case the owner of the trees should be informed so that, as a minimum, a formal health and safety inspection of the trees can be carried out.

Photo 3: T21 to T24

| Tree ID | Tree Species | | Maturity | Measurements | | | | Crown (m) | | | | | Tree Condition | | | | | | | Value | | Management |
|---|---|---|---|---|---|---|---|---|---|---|---|---|---|---|---|---|---|---|---|---|---|---|
| T21 | Willow | <i>Salix fragilis</i> | Mature | 15 | 1 | 630 | No | 3 | 6 | 8 | 2.5 | 5.5 | Soil compaction | Single stemmed, Significant lean, Bark damage, Stubs | Minor dieback, Major deadwood, Snapped / hanging branches | Large superficial bark wound from base to 1.5m on west of stem. Further longer wound on western limb that overhangs an entrance to the recreation area. Large eastern branch at 2m has partially snapped & is resting in adjacent foliage. Several small Hawthorn saplings at base. | Fair | Poor | <10 yrs | Moderate | U | Removal advised regardless of any development, but tree may not be in site owners property |

| Tree ID | Tree Species | | Maturity | Measurements | | | | Crown (m) | | | | Tree Condition | | | | | | | | Value | | Management |
|---|---|---|---|---|---|---|---|---|---|---|---|---|---|---|---|---|---|---|---|---|---|---|
| T22 | Willow | <i>Salix fragilis</i> | Mature | 15 | 1 | 560 | No | 2 | 6 | 6.5 | 3 | 6 | Soil compaction | Single stemmed, Slight lean, Stubs, Bark damage | Moderate deadwood, Snapped / hanging branches | Large eastern & south eastern branches have partially snapped & are resting on the ground. Further recent branch failure higher in the crown. Surrounded by small Hawthorn saplings. Full health & safety inspection advised due to likelihood of further branch failures, but tree is likely to have very limited prospects. | Fair | Poor | 10 to 20 yrs | Moderate | C | Remove failed branches regardless of any development |
| T23 | Sycamore | <i>Acer pseudoplatanus</i> | Semi-mature | 14 | 2 | 220, 130 | No | 1 | 4 | 5 | 2.5 | 2 | No visual defects | Twin stemmed at 1m, Slight lean, Tight union, Partially included bark | Minor deadwood | Surrounded by small Hawthorn saplings. | Fair | Good | >40 yrs | Moderate | C | No works required in current site context |

| Tree ID | Tree Species | | Maturity | Measurements | | | | Crown (m) | | | | Tree Condition | | | | | | | | Value | | Management |
|---|---|---|---|---|---|---|---|---|---|---|---|---|---|---|---|---|---|---|---|---|---|---|
| T24 | Willow | <i>Salix fragilis</i> | Mature | 15 | 1 | 580 | No | 2 | 8.5 | 7.5 | 5 | 7.5 | No visual defects | Single stemmed, Vertical, Stubs, Bark damage | Moderate deadwood, Snapped / hanging branches | Several eastern branches have snapped & are resting on the ground or in surrounding foliage. Full health & safety inspection advised, but tree is likely to have relatively limited prospects. | Fair | Fair | 20 to 40 yrs | Moderate | C | Remove failed branches regardless of any development |

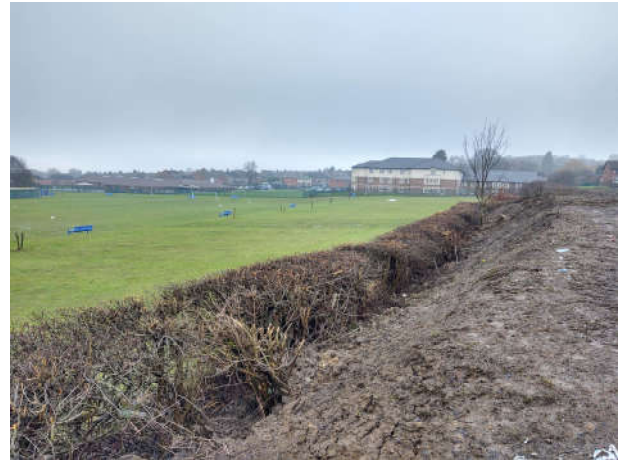
Photo 4: G26 and T27

| Tree ID | Tree Species | | Maturity | Measurements | | | | Crown (m) | | | | Tree Condition | | | | | | | | Value | | Management |
|---|---|---|---|---|---|---|---|---|---|---|---|---|---|---|---|---|---|---|---|---|---|---|
| T27 | Sycamore | <i>Acer pseudoplatanus</i> | Young | 6.5 | 1 | 110 | No | 2 | 1 | 1.5 | 1 | 1 | Soil compaction, Adjacent ground works | Single stemmed, Tight union | No visual defects | Earth piled up against northern side of stem. | Good | Fair | 10 to 20 yrs | Low | C | No works required in current site context |

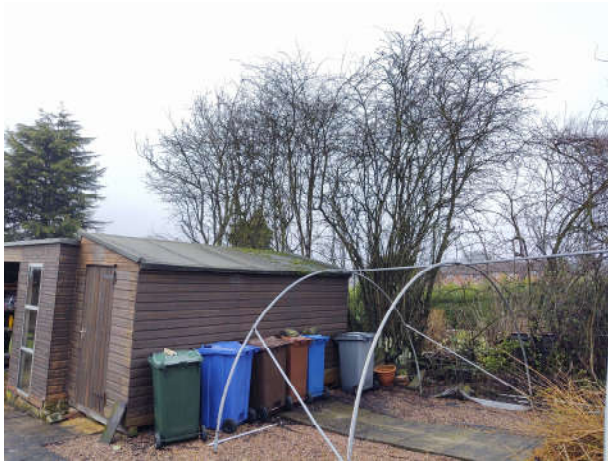
Photo 5: T6 and G30

| | Tree Species | | | Measurements | | | | Crown (m) | | | | Tree Condition | | | | | | | Value | | Management | |
|---|---|---|---|---|---|---|---|---|---|---|---|---|---|---|---|---|---|---|---|---|---|---|
| T6 | Ash | Fraxinus excelsior | Semi-mature | 6.5 | 1 | 210 | Yes | 3 | 2 | 2 | 1.5 | 2 | No visual defects | Single stemmed, Slight lean, Old pruning wounds | Stubs | | Good | Good | >40 yrs | Low | C | No works required in current site context |

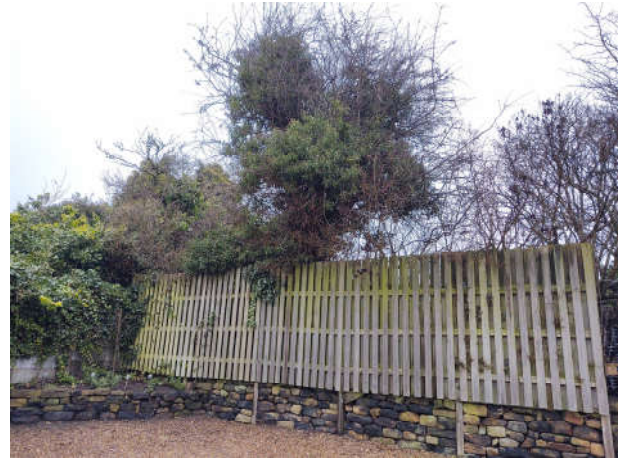
Photo 6: T32

| Tree ID | Tree Species | | Maturity | Measurements | | | | Crown (m) | | | | | Tree Condition | | | | | | | Value | | Management |
|---|---|---|---|---|---|---|---|---|---|---|---|---|---|---|---|---|---|---|---|---|---|---|
| T32 | Hawthorn | <i>Crataegus monogyna</i> | Early-mature | 6.5 | 2 | 240, 210 | Yes | 2 | 2.5 | 2.5 | 1.5 | 2.5 | No visual defects, Limited access around base | Twin stemmed at base, Significant lean, Ivy covered | Small / sparse, Old pruning wounds, Minor deadwood, Ivy in crown | Growing directly to north of 1m retaining wall. Very limited visibility due to boundary fence & dense ivy. | Poor | Fair | 10 to 20 yrs | Low | C | No works required in current site context |
