# TREE RISK REPORT

***Worsbrough Mill & Country Park,  
Worsbrough,  
Barnsley,  
S70 5LJ***

Prepared for:  
***Sharon Sutton***  
***Barnsley Metropolitan District Council***

Reference: AWA4309

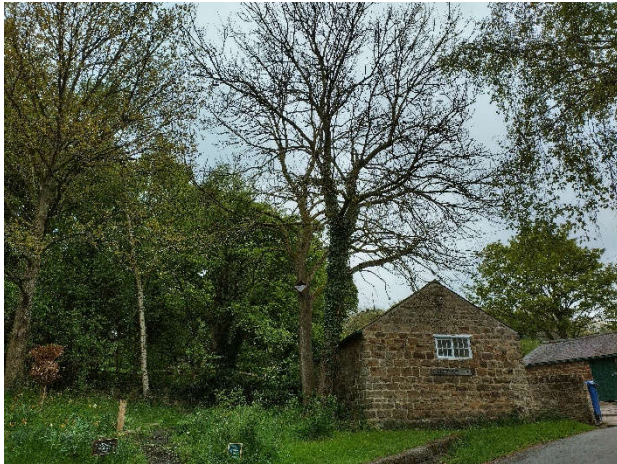
Photo 1: Ash T60, in decline and with signs of fungal infection. To be felled to ground level, or reduced to a monolith

| | Tree Species | | Measurements | | | | | | Tree Condition | | | | | Management | | | |
|---|---|---|---|---|---|---|---|---|---|---|---|---|---|---|---|---|---|
| T60 | Ash | <i>Fraxinus excelsior</i> | Early-mature | 17 | 2 | 400 avg | 6 | High | No visual defects | Twin stemmed at base, Bird box, Natural stubs, Ivy covered | Moderate dieback, Ash dieback, Minor deadwood | Poor | <i>Inonotus hispidus</i> bracket at base which appears to have falled off southern stem | U | Fell to ground level OR Monolith at 4m | High | N/A |

- 3.3.3 T60, T65, T100, T119, T123 and T129 are recommended for removal as a high priority.
- 3.3.4 T68, T70, T80, T90, T92, T93, T125 and T131 are dead or in decline and are situated in moderate target areas. These trees are recommended for removal as a moderate priority.

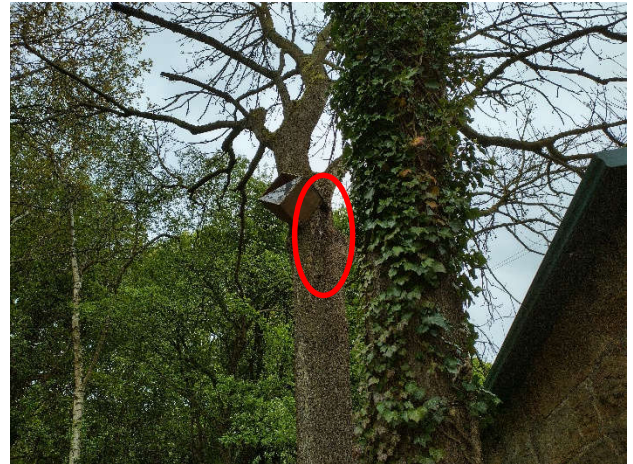
Photo 2: Signs of fungal infection on Ash T60 (circled). Desiccated fungal bracket was found at the base of the tree

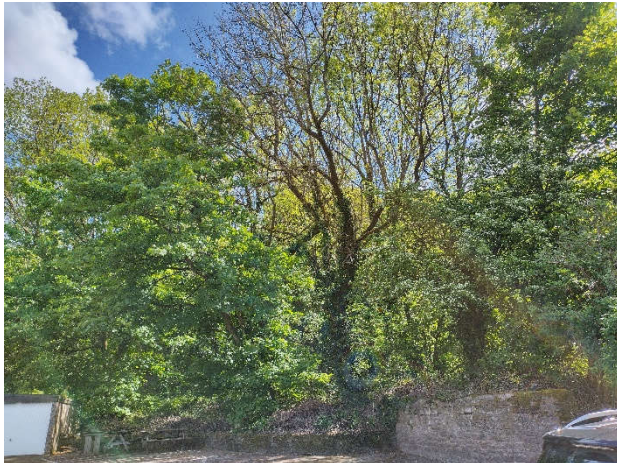
Photo 3: Ash T129, leaning over the pub car park, with signs of Ash Dieback. To be felled to ground level

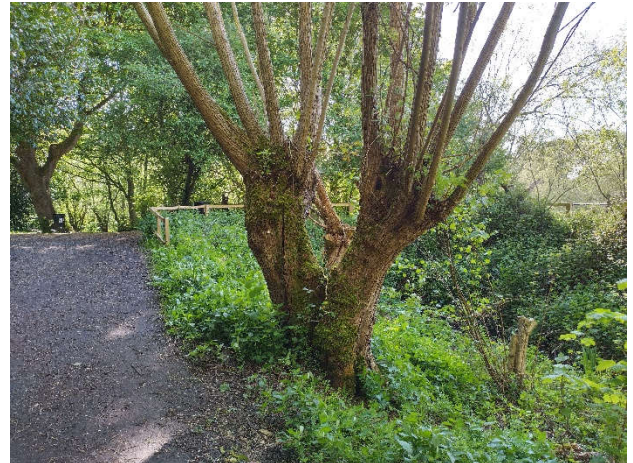
Photo 4: T1, a lapsed Willow pollard with a prominent split on the stem. To be pollarded at 2m from ground level

| | Tree Species | | Measurements | | | | | | Tree Condition | | | | | Management | | | |
|---|---|---|---|---|---|---|---|---|---|---|---|---|---|---|---|---|---|
| T1 | Willow | Salix fragilis | Mature | 17 | 2 | 500 avg | 6 | Moderate | Situated on stream banking | Split, Historically pollarded, Tight Union and partially included bark, Minor cavities, Decay | Minor deadwood | Poor | Longitudinal Split in stem visible from path | B | Pollard at 2m from ground level. Manage as pollard | Moderate | 24 months |

- 3.3.10 T1, T16, T31, T34, T35, T36, T40 and T84 are Willow trees situated close to path and roads. T1 has a prominent longitudinal split in the main stem. T16, T31, T34, T35 and T36 have prominent Willow Bracket fungus (*Phellinus igniarius*), which causes rot and appears to have contributed to the failure of a number of Willow trees throughout the site. T84 is a large, multiple-stemmed tree with tight unions close to a road. These trees should be pollarded at 2m from ground level and maintained as pollards in the longer term.

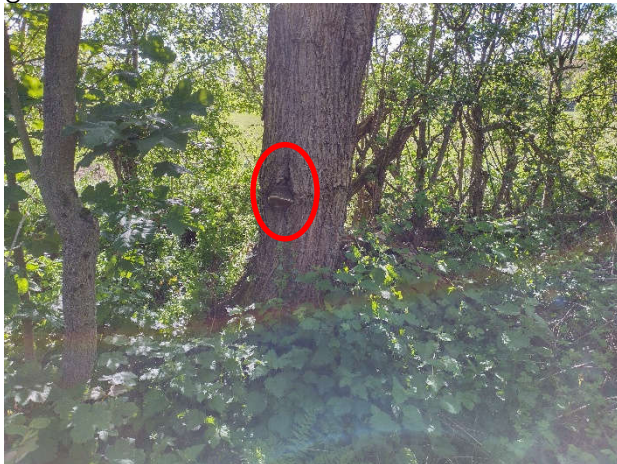
Photo 5: Willow Bracket fungus (circled, on tree in G14), has caused some high profile failures adjacent to paths in Area 1

| Tree ID | Tree Species | | Measurements | | | | | | Tree Condition | | | | | Management | | | |
|---|---|---|---|---|---|---|---|---|---|---|---|---|---|---|---|---|---|
| G14 | Alder, Ash, Hawthorn, Sycamore, Willow | <i>Alnus sp., Fraxinus sp., Crataegus sp., Acer sp., Salix sp.</i> | Early-mature | 18 | 10+ | 250 avg | See Plan | Low | Wet woodland-type group. Waterlogged areas. Occasional dead or failed stems in low target areas. Low target deadwood. Occasional low target dead stems with Willow Bracket Fungus | | | Good | | A | | | 24 months |

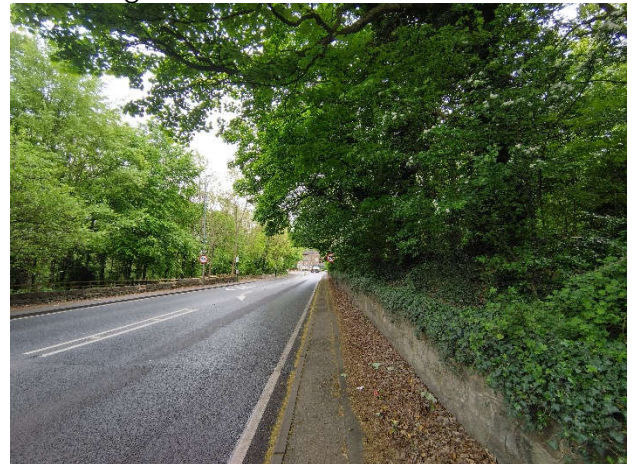
Photo 6: Trees in G77 overhang the highway. Trees are at suitable height for the majority of passing vehicles

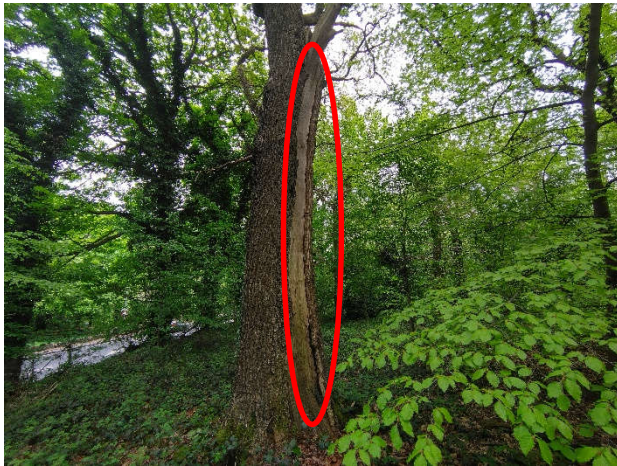
- 3.3.24 T99 is a large Oak, situated to the south of the A61. T99 has a large area of bark damage at the south-west aspect, with minor decay extending from the base to approximately 4m from ground level, with the potential for further long-term decay. While this is a notable defect, there was good reaction wood at the edges of the bark wound and the crown was in very good physiological condition, indicating the tree was actively compensating for the damaged area and, at time of survey, has the capacity to continue compensating for this damage. Additionally, the tree stem and crown balance is to the east, suggesting it is not likely to fail toward the highway. As such, the tree is suitable for retention and no works are recommended. However, due to the size of the defect and location of the tree, T99 will require regular formal monitoring.

Photo 7: Oak T99, with extensive bark damage and signs of decay. Reaction growth can clearly be seen at the edge of the bark damage (circled), and the tree leans away from the highway

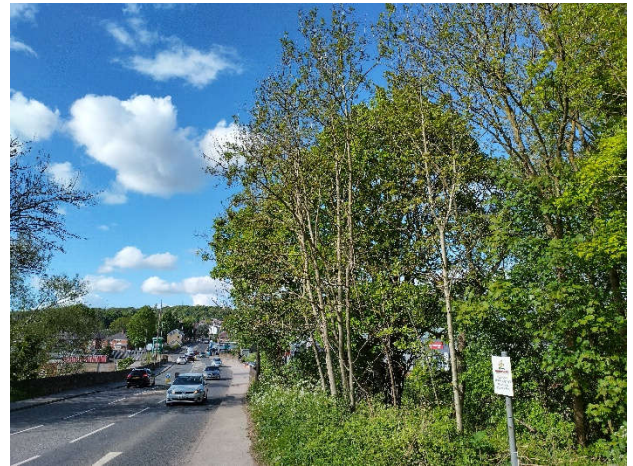
Photo 8: Self-set Ash G102, situated adjacent to the highway, with Ash dieback and limited prospects. Groups with Ash dieback to be removed

- 4.2.3 The removal of G10, G25, T37, G53, G102, T104, T108, T109, T115, G116, G121, T122, G126, T127, T128, G130, G132, G134, T135 and T148, and works to T3 to T6, T8, T11, T12, T15, T17, T19, T20, T24, T28, G32, T39 to T41, T51, T69, T71, T72, G74, T85, T95, T105 to T107, T117, G143, T145 to T147 and T149 to T152 are recommended as a low priority.

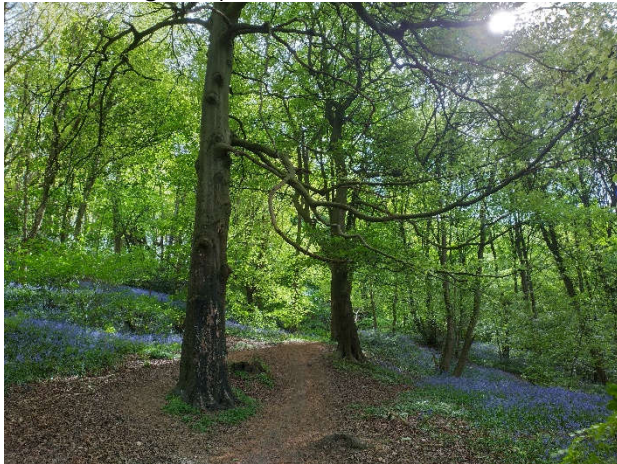
Photo 9: Beech T146, with fire damage at the base and deadwood in the low crown. Fire damage to be monitored, and deadwood to be removed

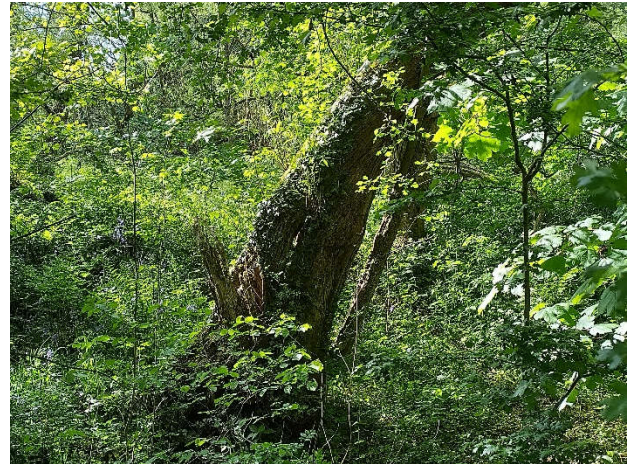
Photo 10: There are occasional failed trees in G14, in low target areas. Due to the low target and low potential risk, these trees require no action
