**elliottconsultancy**ltd.  
arboricultural consultants

Location:  
**The Seam  
Barnsley**

Report Type:  
**Arboricultural Survey  
Arboricultural Impact Assessment  
Arboricultural Method Statement  
Tree Protection Plan**

Ref:  
**ARB/AE/3428**

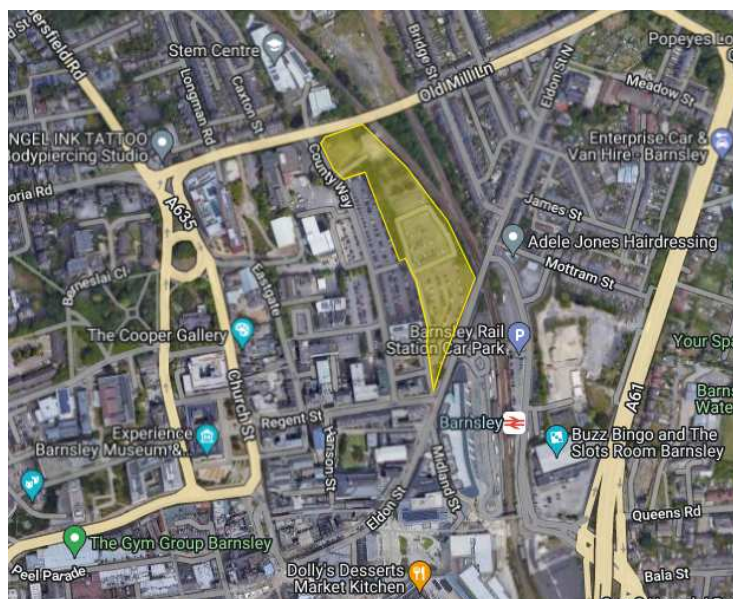
**Figure 1: Survey area highlighted – exceeding the proposals extent.**

- 2.1 The survey included an assessment of trees on and around the lower parking area at The Seam in Barnsley. The tree survey area was larger than that of the proposals to allow for adjacent tree cover on the site to be assessed and considered within any proposals. Figure 1 shows the approximate extent of the area surveyed.

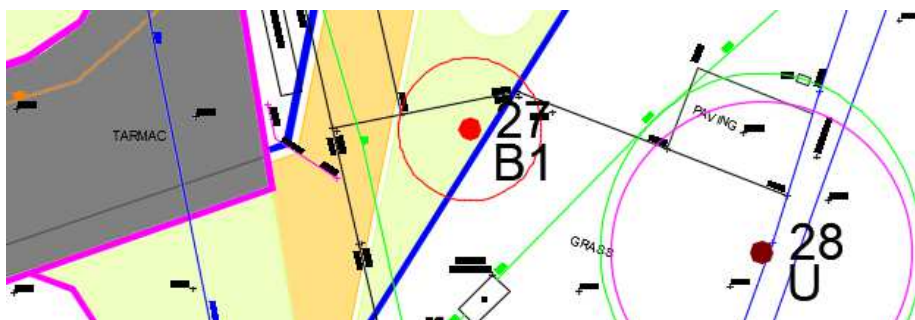
Tree 16, 20, 27, and immature bushes at the edge of Tree Group 3 will require removal to allow construction. N.b. Tree 28 requires removal regardless of the proposals (Category U tree damaging retaining wall structure), and the stump between Trees 21 & 22 should also be removed.

**Mitigation / Countermeasure:** No countermeasures or mitigation can be undertaken to retain this vegetation. Trees 16 & 20 are Italian Alder located within the main carpark that are to be removed to allow the access road to be excavated and reconstructed with adequate construction space, and Tree 27 is a small Rowan. Although all were classified as Category B trees of moderate quality, it is not expected that their removal will have a significant arboricultural or visual impact within the site surrounding landscape. At the northwestern entrance to the lower carpark, a realignment of the access footpath will require bushes and small trees to be removed or cut back from the edge of Tree Group 3.

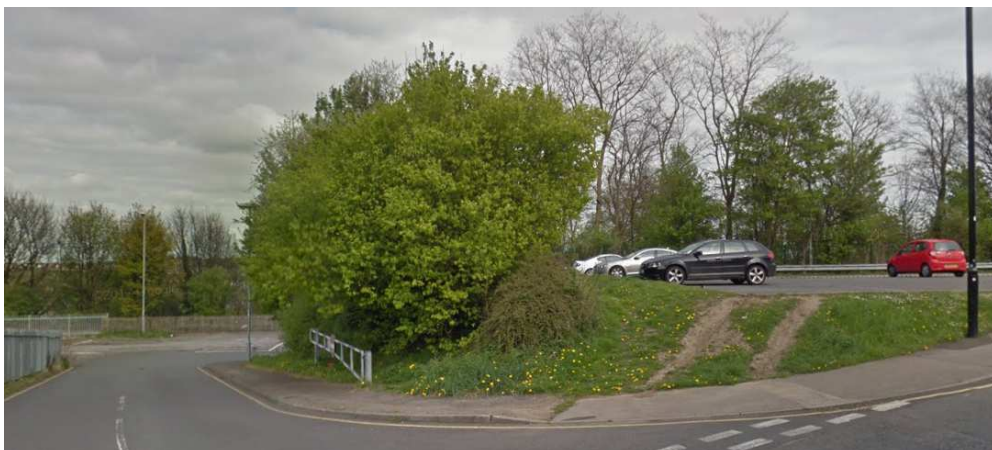
**Figure 2: In 2017 – limited growth on corner.**

As seen with the previous detail taken from April 2017, vegetation on this corner has only recently become established and the cutting back of such new growth will have no visible or physiological impact on the larger group. The arboricultural impact removals is therefore considered to be minor. All tree removal can be compensated for by tree planting within the comprehensive post-construction landscape proposals.
