**Nether Mill Barn  
Penistone  
South Yorkshire**

Level 3 Historic Building Recording  
Report No. Y582/22

**Report No. Y582/22**

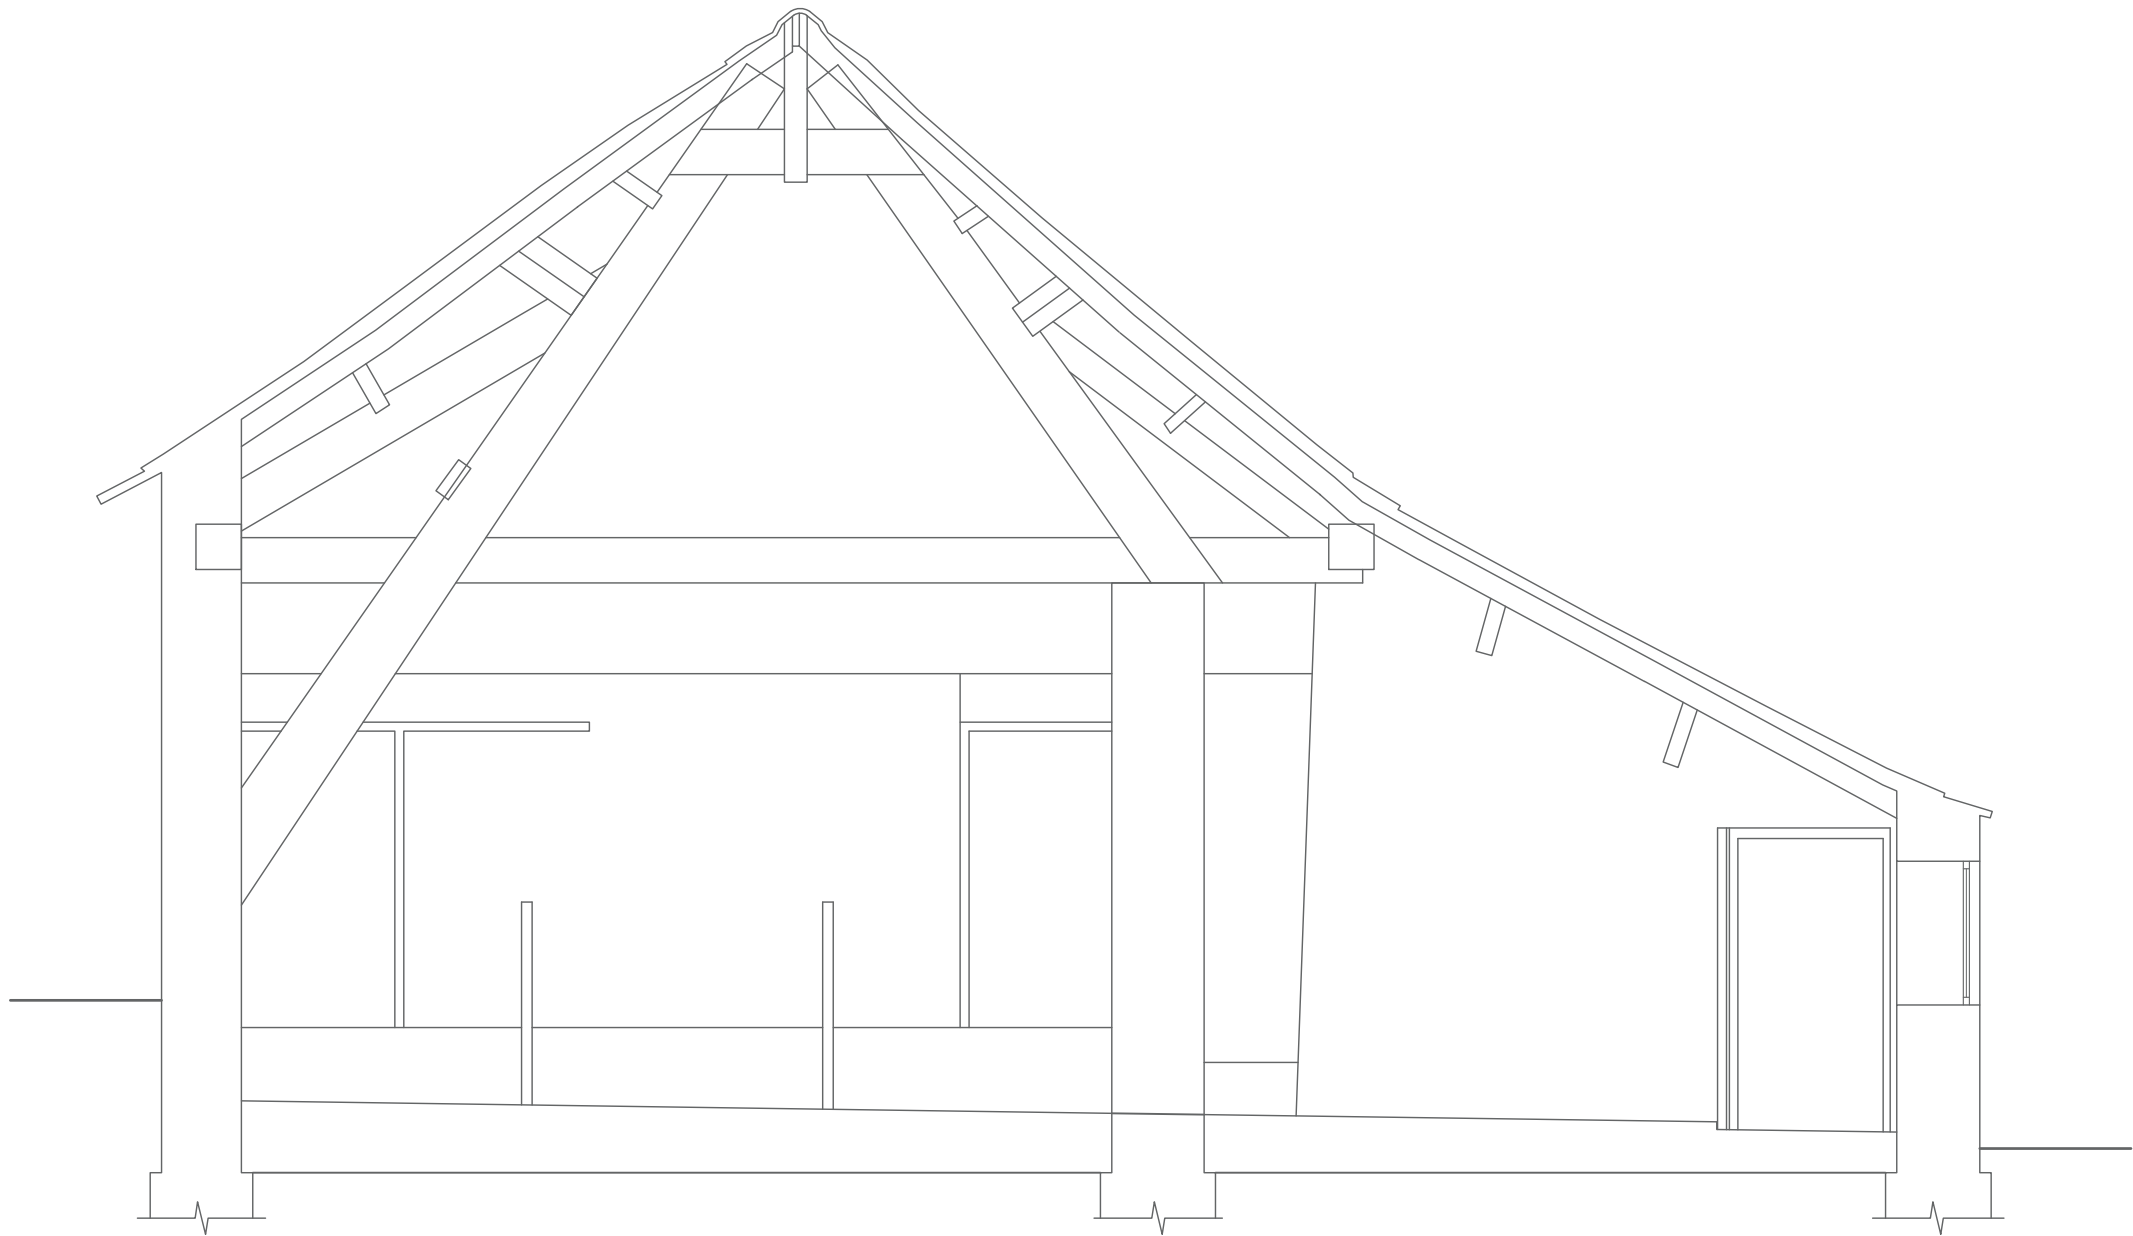
| Report.No:<br><b>Y582/22</b> | Fig. No:<br><b>3g</b> |

Each truss was comprised of pegged collared blades which extended from ridge to ground. The SE cruck blade of Truss 1 has been truncated below the tie beam and was supported by a chamfered brick pier (fig. 3g; Photograph 4). The SE cruck blade of Truss 2 extended the full length to the ground (figs. 3h and 4h; Photograph 26). However, both NW cruck blades were supported by the NW wall (Photographs 27 and 28). At the top, the blades met with a notable gap from which the former ridge beam had been replaced with machine-cut timbers (figs. 3g and 3h; Photograph 29). At approximately 1.5m high, both Truss 1 and 2 NW blades contained 0.3m high empty lap mortices on the NE faces (Photograph 30 and 28). The pegged double notched joint tie beams of each truss extended beyond the blades to the cruck base, joined to the blades at the NE faces. Between the tie beam and former ridge, each cruck supported pegged scarf joint historic purlins, however, additional machine-cut timbers were placed between to support machine cut rafters (Photograph 31). The historic purlins were secured to the blades through upward angled pegs (Photograph 32). The Bay 1

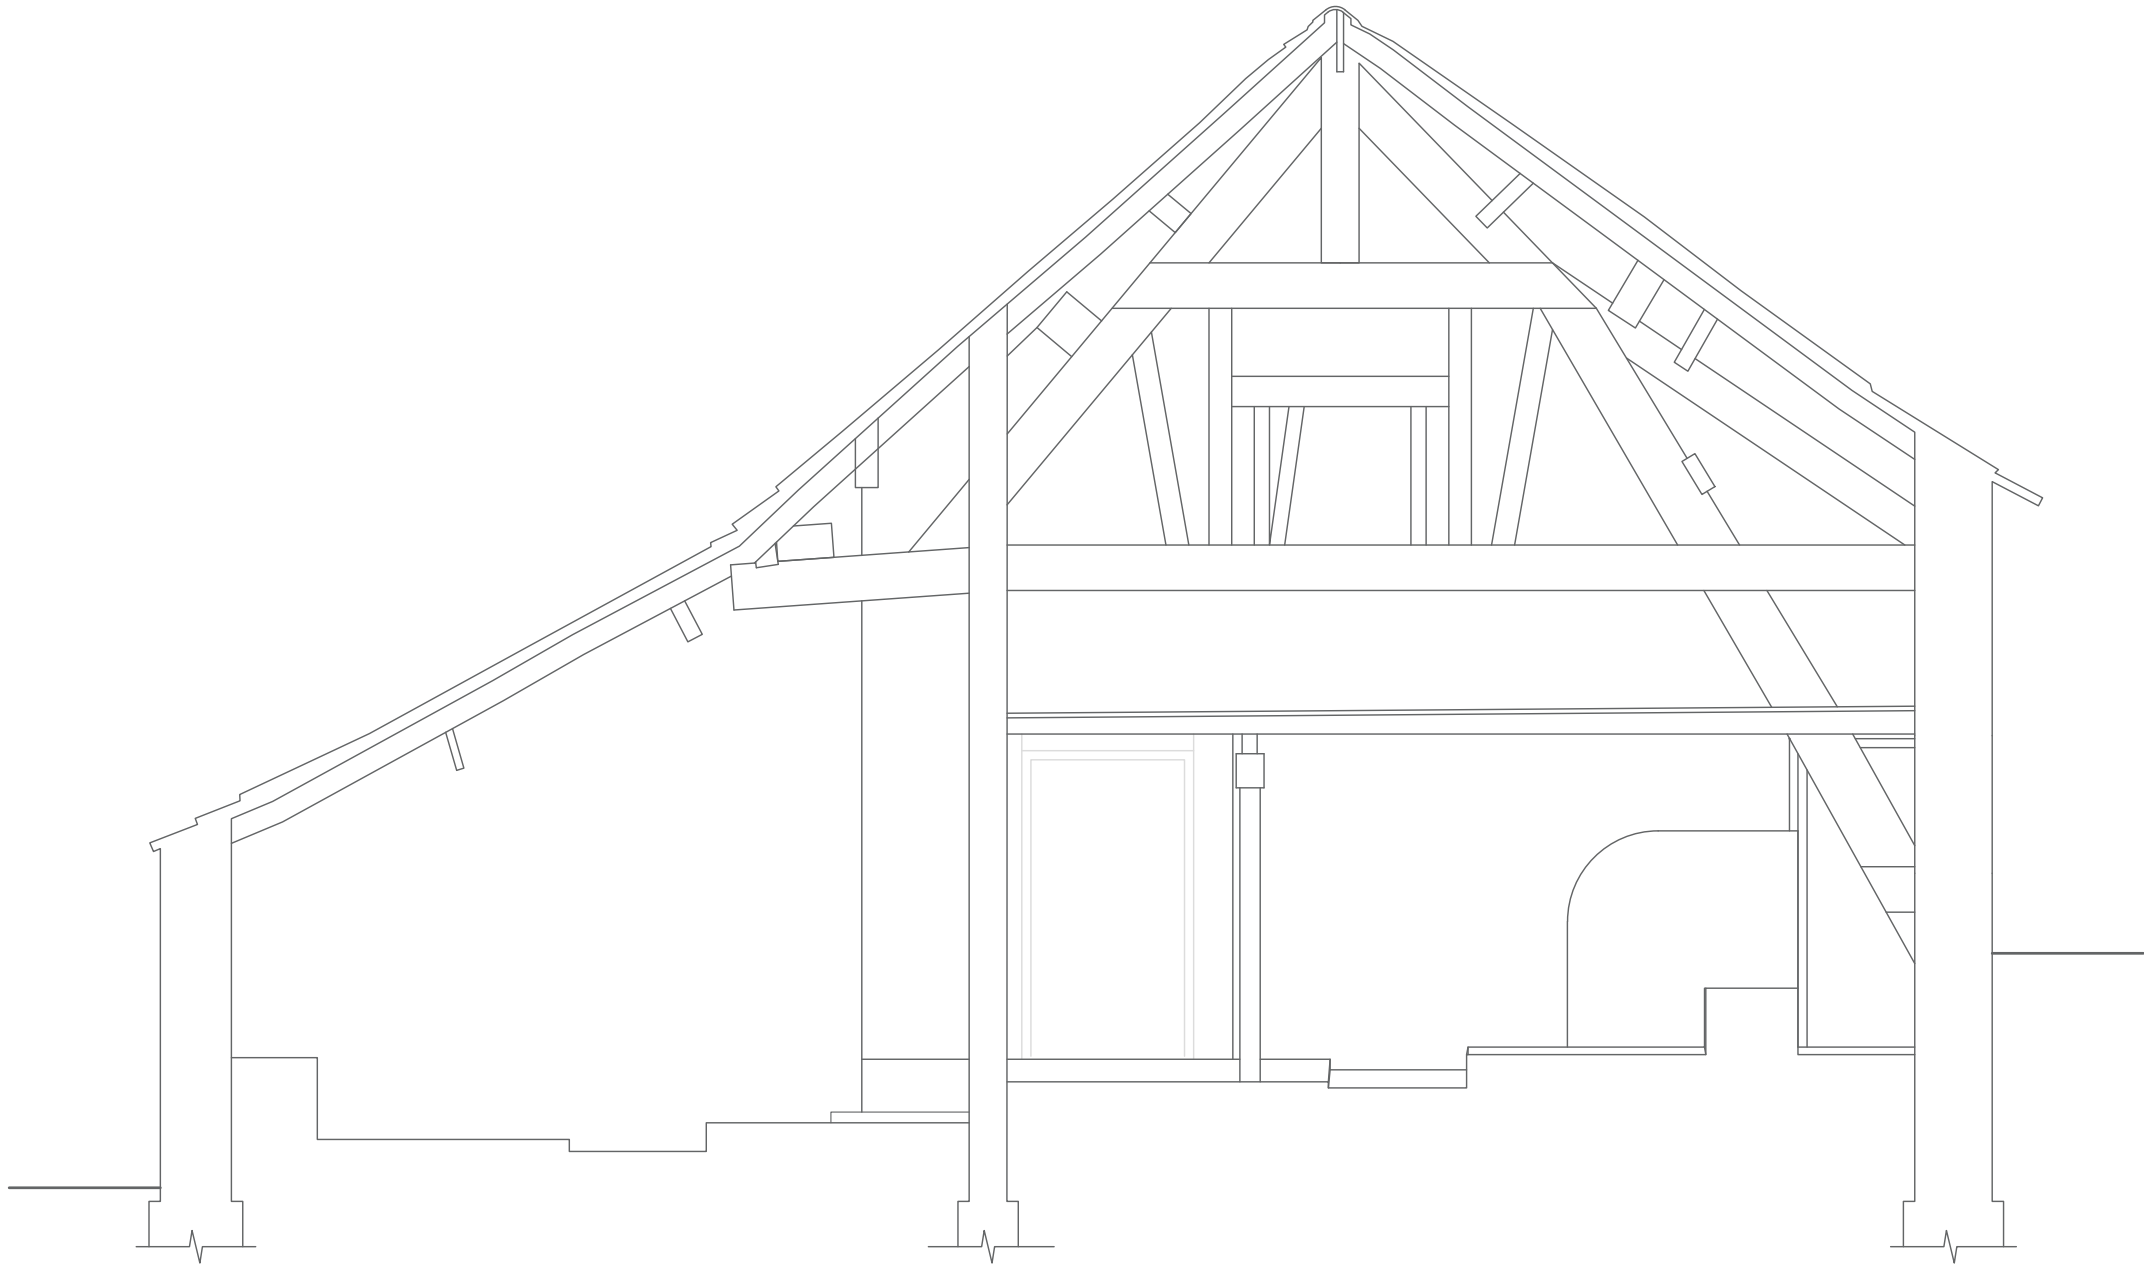
| Report.No:<br><b>Y582/22</b> | Fig. No:<br><b>3i</b> |

The bays were divided by Truss 3 and Truss 4 (Photographs 44 and 45). Truss 3 was an irregular combination cruck and queen construction (figs. 3i and 4i). The loft floor was constructed 0.75m below Truss 3. The truss appeared to be constructed of a combination of materials with partial remains of an earlier cruck below the collar, particularly the partial remains of the cruck blades and tie beam. The tie beam continued through the later brick wall into **Area D** (Photographs 46 and 47). As found in Truss 1 and Truss 2, below the tie beam were mortices in the soffit (Photograph 48). The NW cruck blade was similar to Truss 2 as it passed through the floor and into the NW wall in **Area C** where it contained a shallow mortice on the NE face. The SE cruck blade appeared to have similarly survived, however, was sawn just below the tie (Photograph 45 and 47). Both the cruck blades contained single upward curved braces at the SW faces (Photograph 49). At the NW there was a blocking piece wedged between the brace and purlin with a surviving peg (Photograph 50). The blocking piece at the SE, however, had been altered and was wedged between the brick wall and purlin (Photograph 45). The collar was wedged just below where the cruck blades were sawn where they support rafters to the apex. A central post rose from the collar to ridge. Between each cruck, the tie beam supported seven timbers between the soffits of the cruck blades, soffit of the collar, and supported a secondary collar and struts within. Mortices were in the soffit of the secondary collar (Photograph 51).

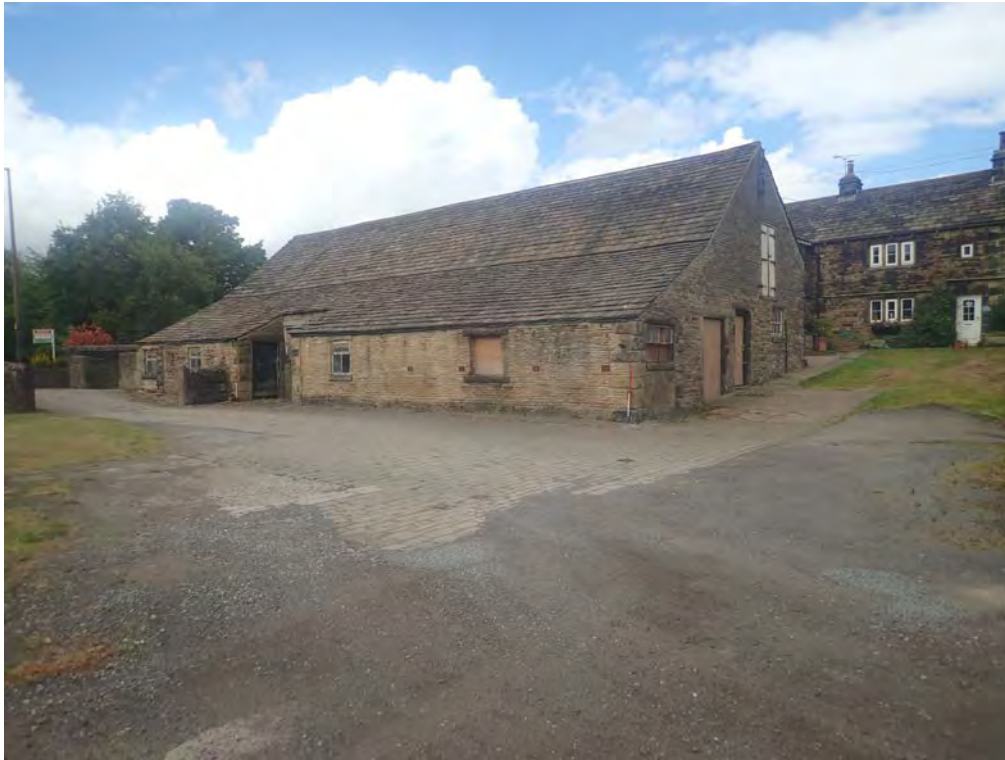
Photograph:1 Direction: W  
 Digital Ref: NEMB2\_0001  
 Description: General view of site of Nether Mill Barn as seen from approach

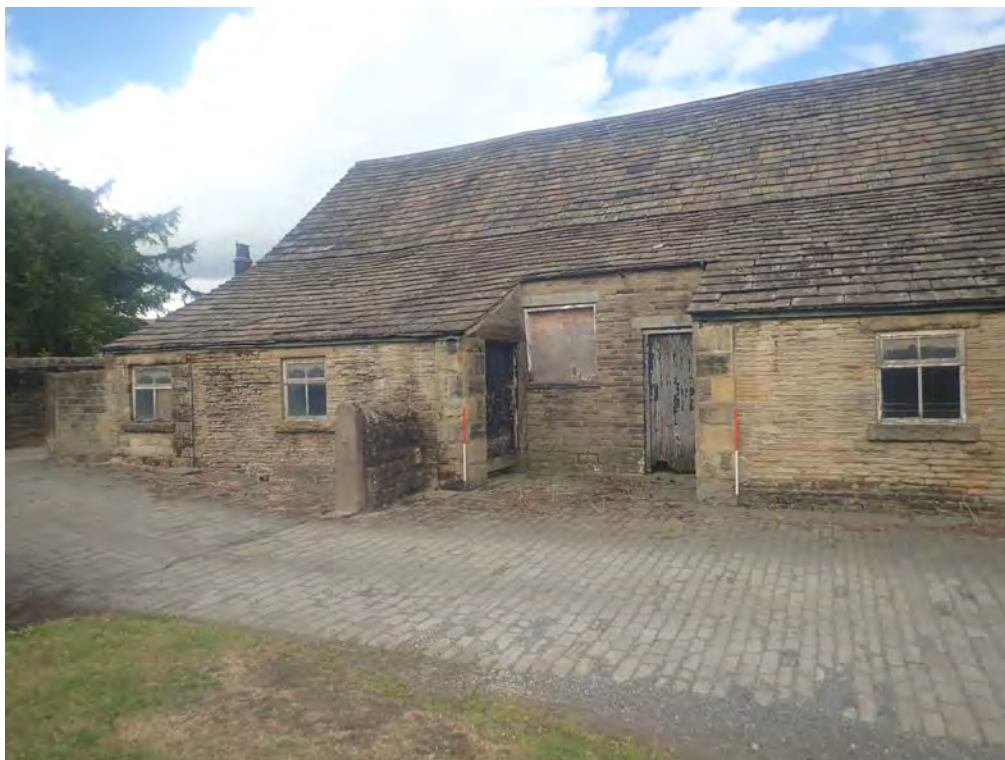
Photograph:2 Direction: W  
 Digital Ref: NEMB2\_0004  
 Description: SW extent of SE elevation detailing SW outshut (left), catslide roof, blocked door at SW extent (left), stone wall, and two doorways.

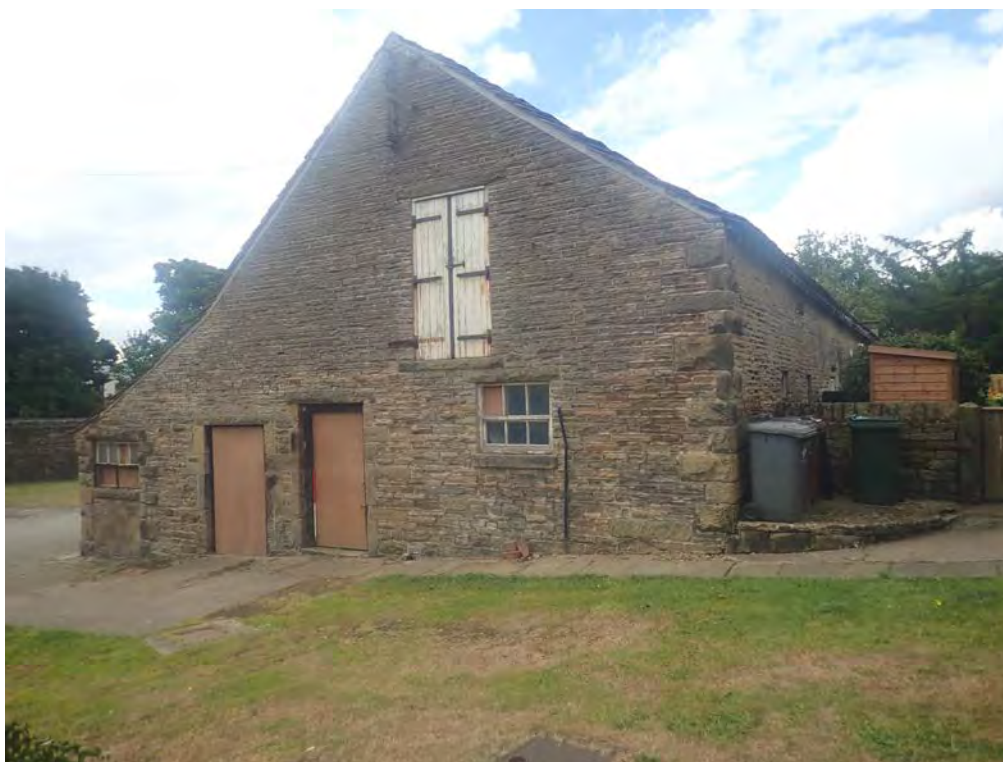
Description: SE slope of NE elevation with blocked door at the SE (left), taking-in door, two doors, a window, and alternating quoins. Subtle change in stone pattern below window.

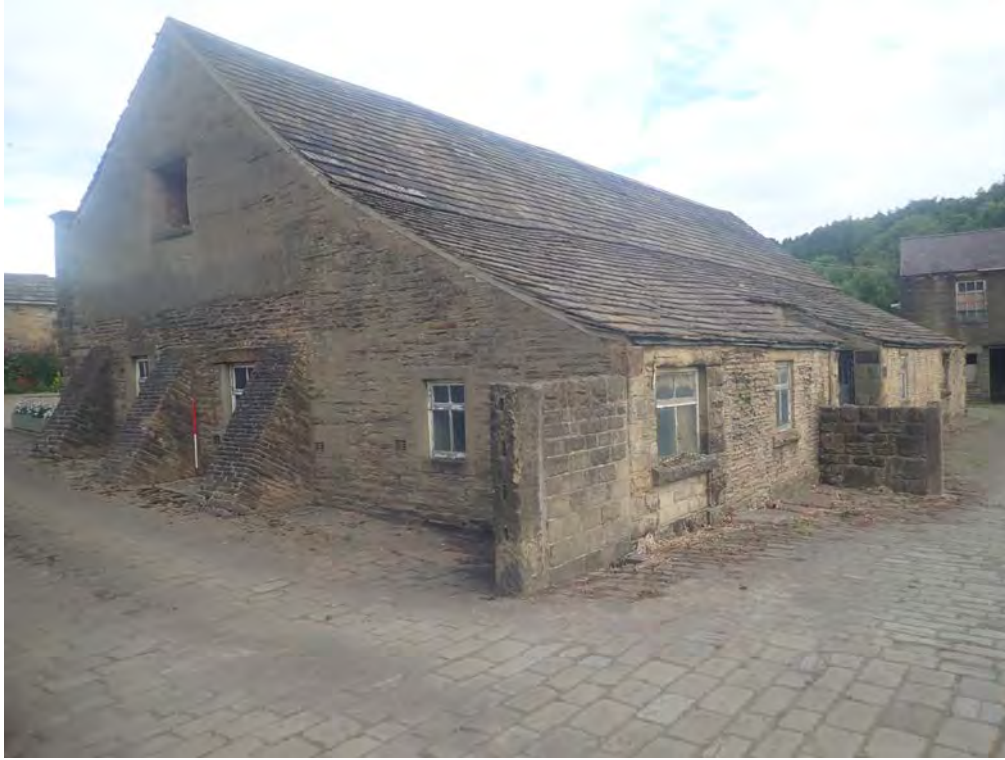
Description: South corner with SW elevation (left) and SE elevation (right). Buttresses against SW gable with windows between and winnow above. Stone wall projecting SW from SE extent.

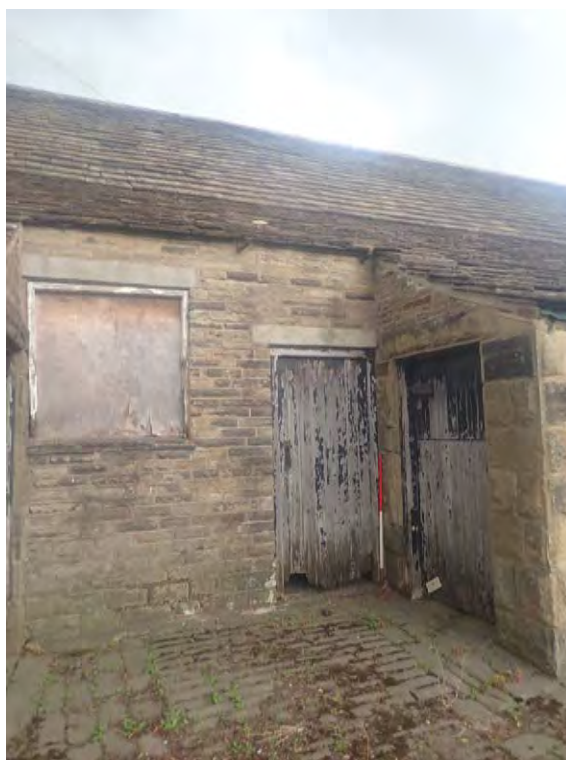
The 20th century or *seventh phase* of construction included the reconstruction of the SE wall between the two outshuts. This likely occurred between 1906 and 1949 as indicated on OS maps and by the presence of concrete lintels in the new doorway (Sections 4.2.3 and 5.2.1). The stone coursing was carefully matched to the rest of the building. This stonework is similar to that found within the blocked cart door and buttresses of the SW elevation (Sections 5.2.2 and 5.2.3). The SW wall was likely partially reconstructed in machine-cut brick around the same time.

Description: SE elevation and SW elevation of NE outshut. Outshut elevation identical to SW outshut opposite while SE elevation had concrete lintels above door and window and less degraded stone coursing.

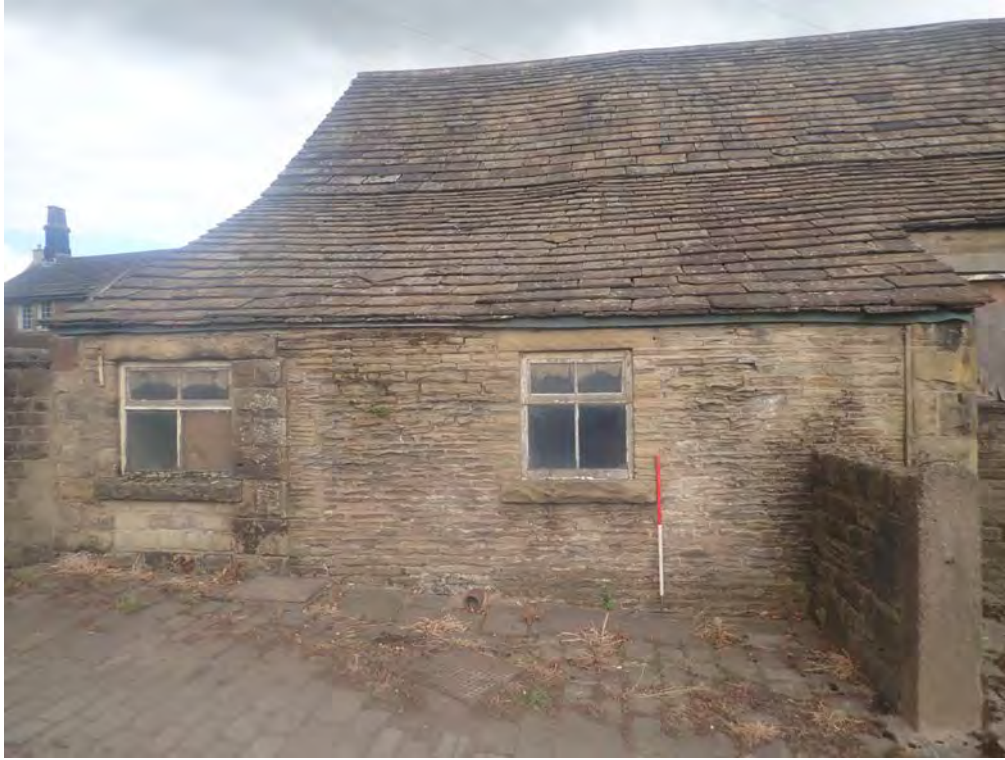
Description: SE elevation of SW outshut with central window, partially blocked door to SW (left) and projecting stone wall to NE (right).

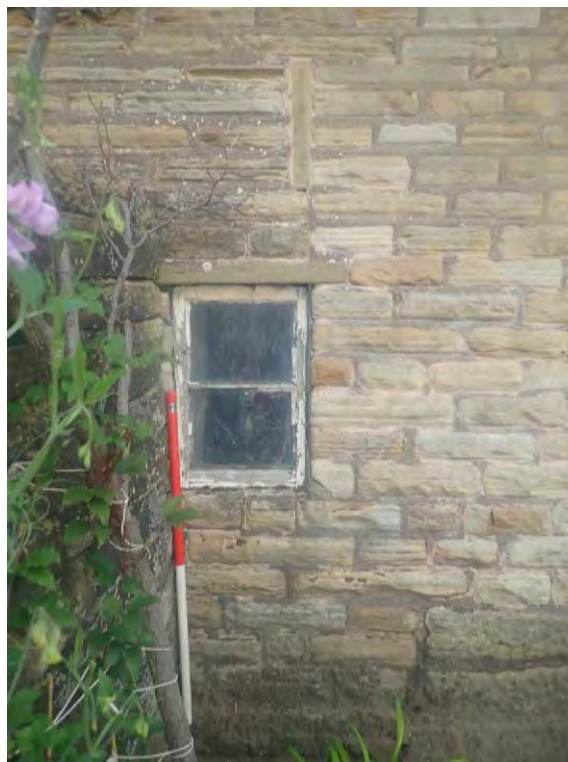
Description: Detail of two pane picture window to immediate SW of stone wall in NW elevation. Vertical set stone above window and possible cruck stone foundation to SW (right).

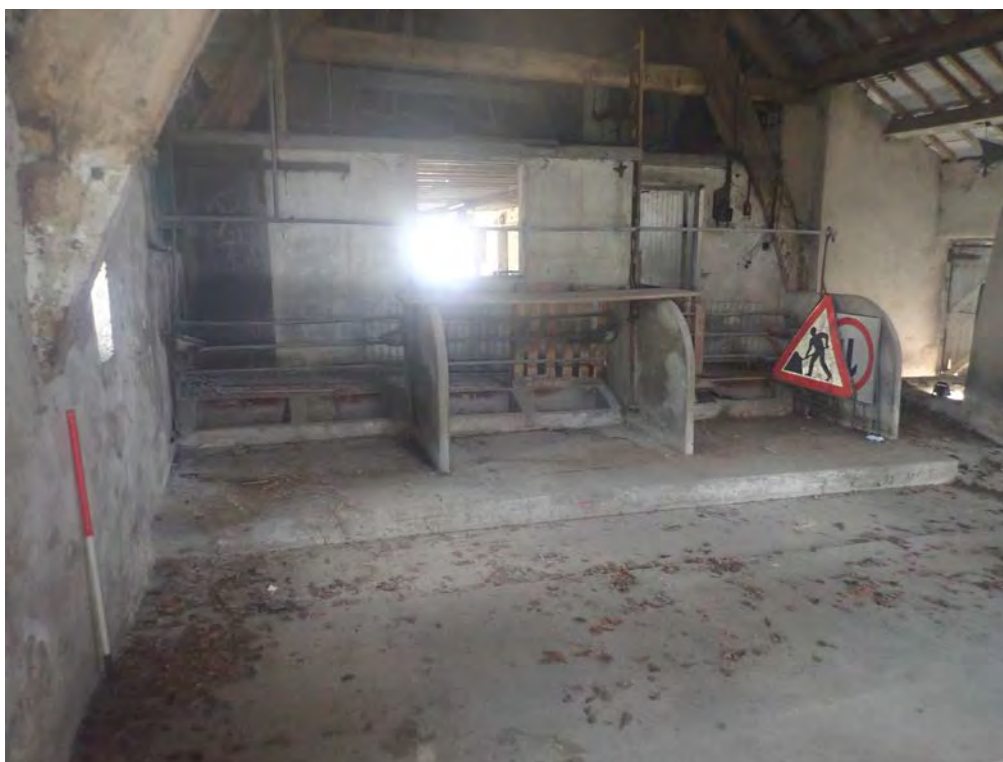
At the time of survey, the Barn had undergone adaptations to house cows, thus 20th century concrete stall dividers were found throughout and the internal floor had been concreted at a slight decline with changing levels for waste channels.

Description: General view of floor level change of waste chanel with stall dividers and troughs. Truss 2 in background with door at NE extent of internal dividing wall.

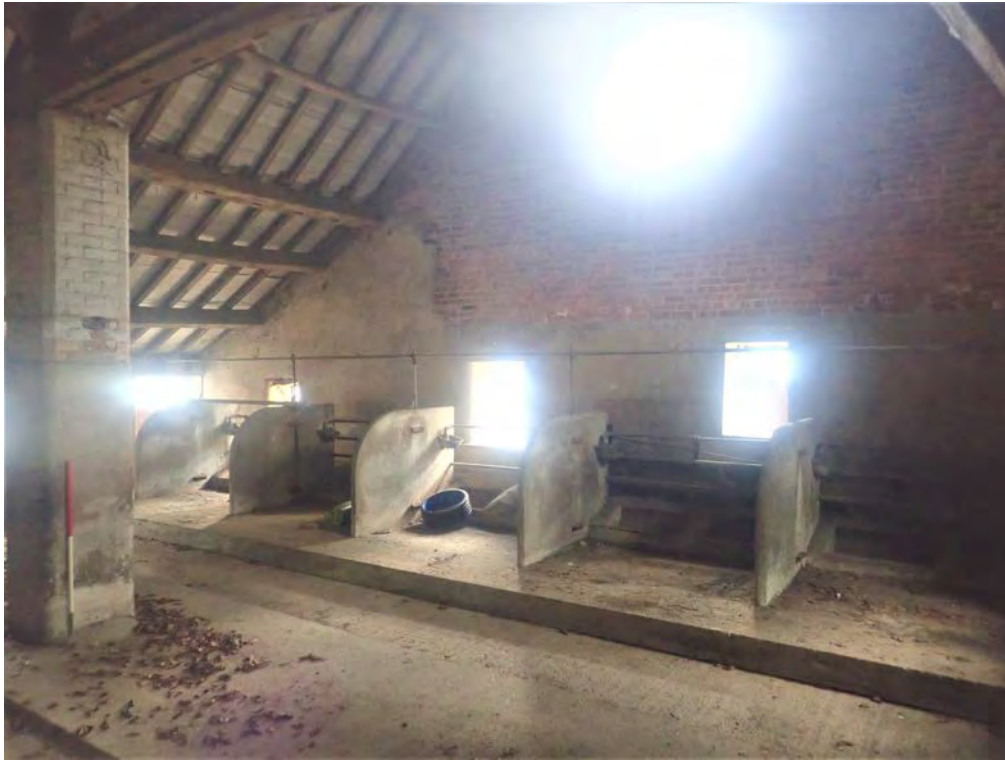
Description: General view of SW wall with cow stalls and troughs between. Above windows the wall is comprised of alternating header and stretcher courses of machine-cut bricks. Bay 1 SE wallplate with soffit mortices.

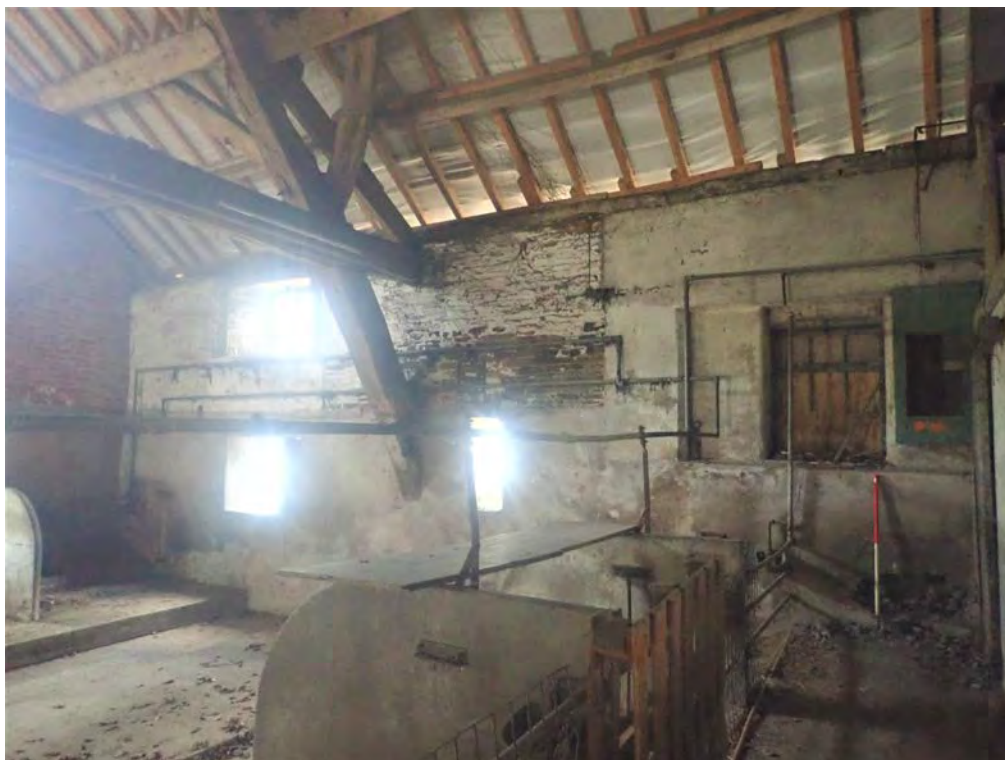
Description: General view of NW wall with straight joint and partially blocked cart door. Bay 1 and Bay 2 NW wall-plates.

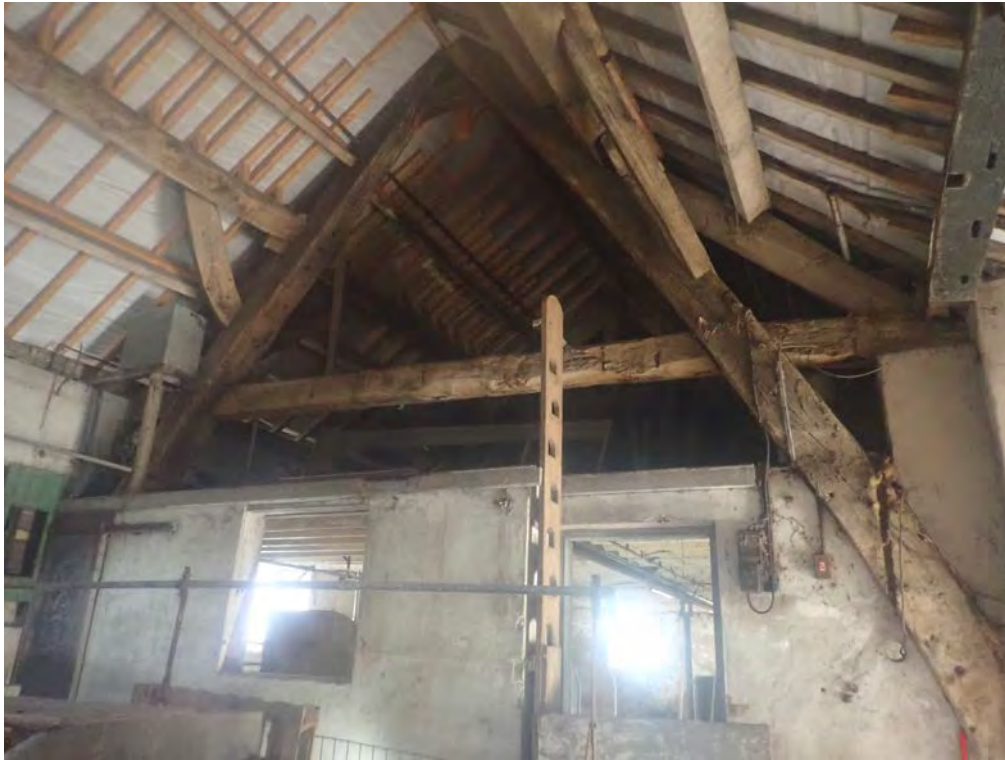
Description: SW face of Truss 2 with internal wall constructed within and to SW with doors at NW extent and towards the SE. Bay 2 SE wallplate (right). Ladder to loft.

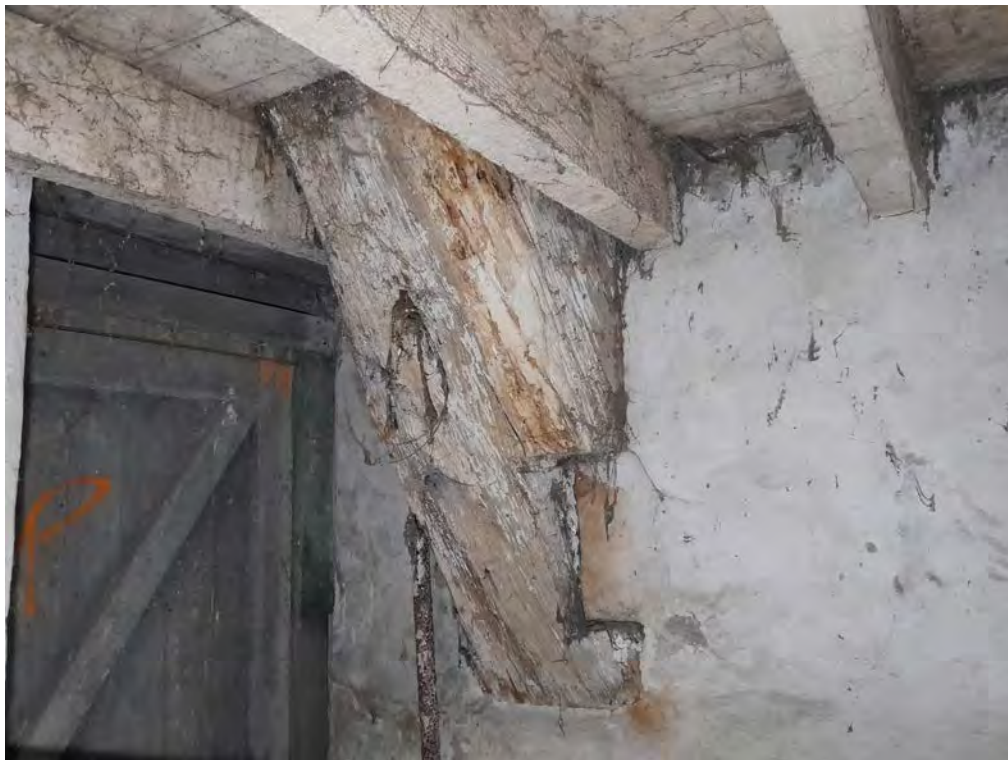
Photograph:28 Direction: W  
Digital Ref: NEMB2\_0090  
Description: Detail of Truss 2 NW cruck blade from wall and through loft floor with door in background (left).

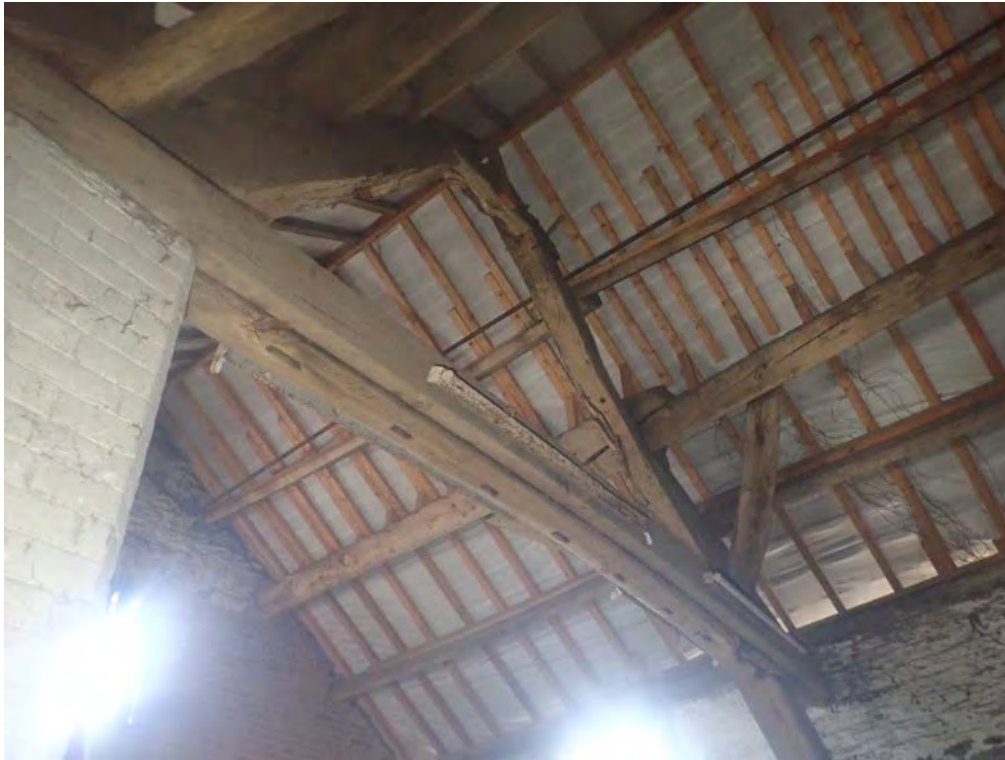
Description: Upward view of Truss 1 as seen from Bay 2 showing mortices in tie beam soffit and later support timber on NE face. Scarf joints of purlins and upward brace in background.

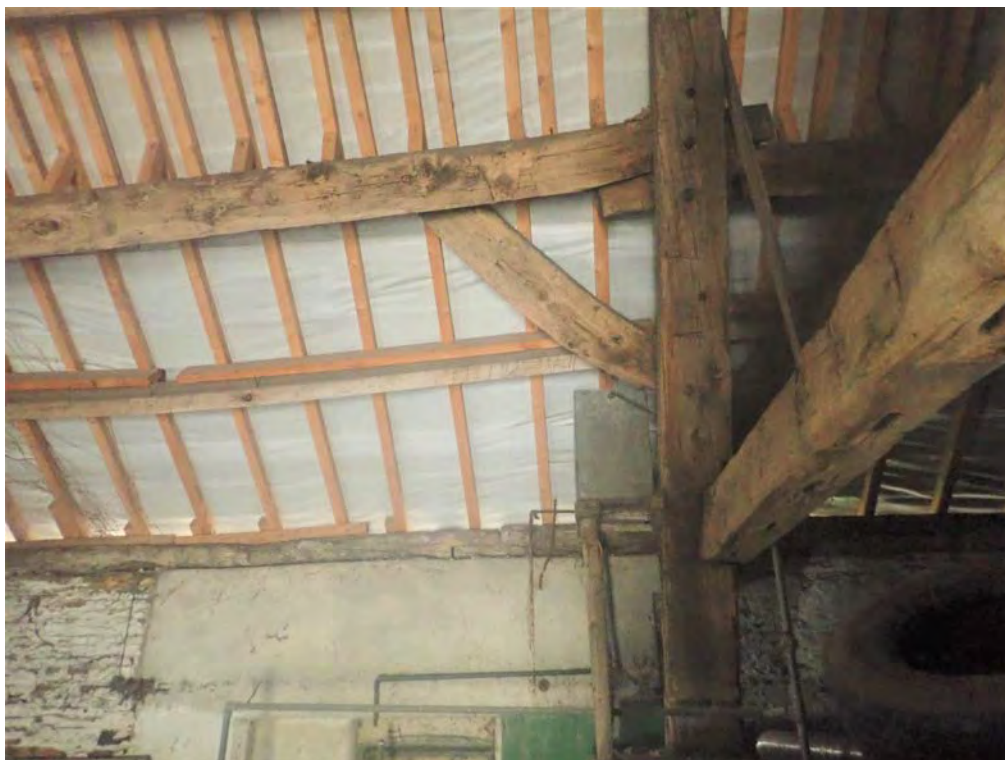
Description: Soffit of Truss 2 NW cruck blade with pegs to purlins and brace, Bay 2 and Bay 3 wall plates, mortices in tie beam soffit.

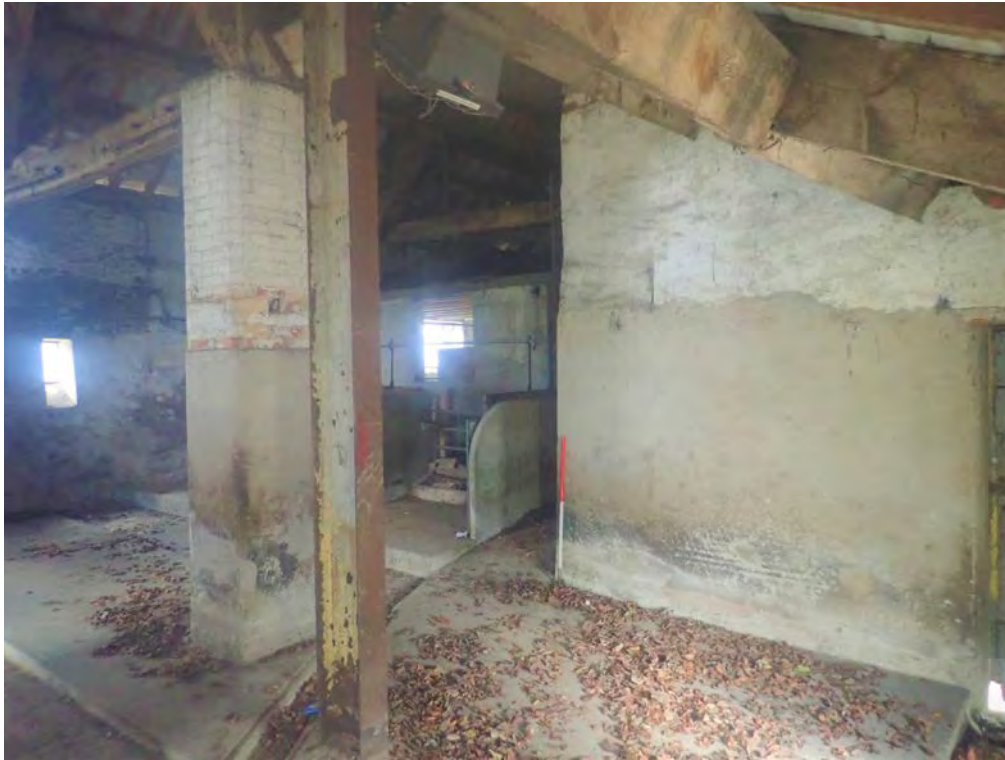
Photograph:39 Direction: N  
 Digital Ref: NEMB2\_0028  
 Description: NW extent of NE wall of SW outshut with steel I-beam post and brick pier to west (left).

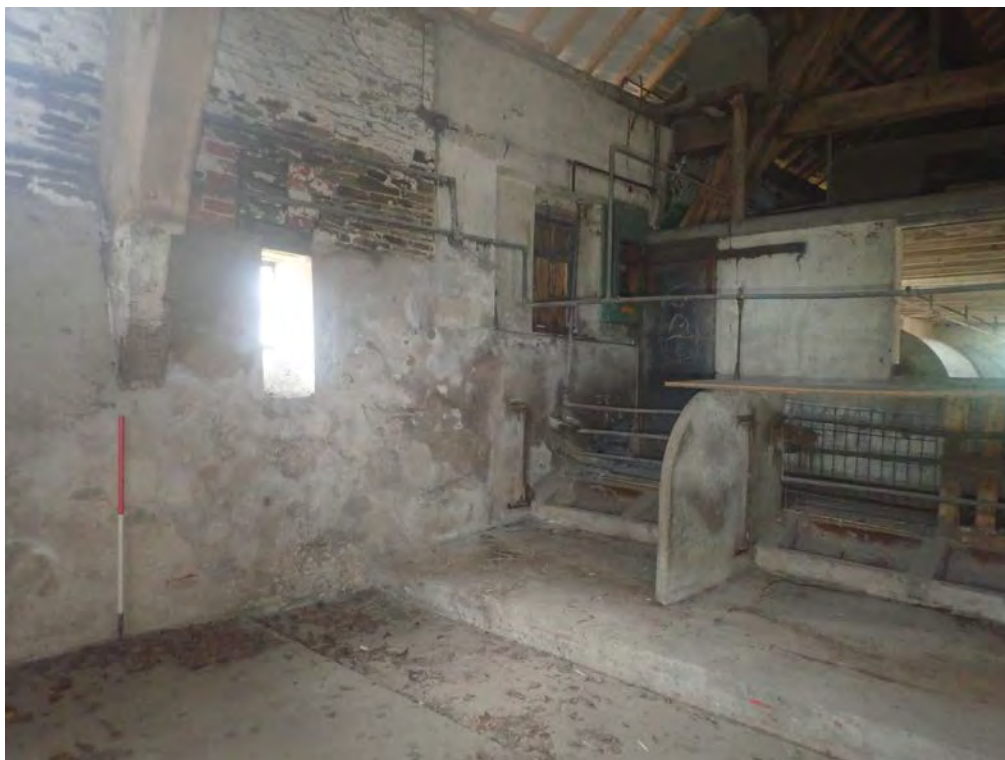
Photograph:40 Direction: N  
 Digital Ref: NEMB2\_0035  
 Description: Partially blocked cart door in Bay 2 NW wall.

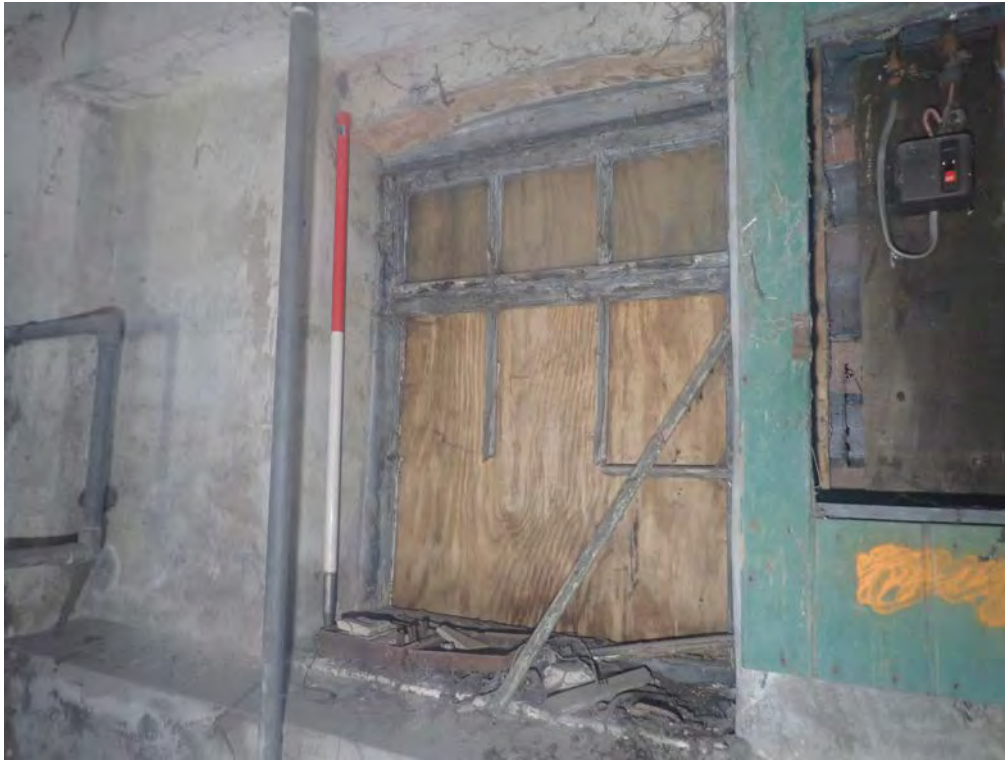
Photograph:41 Direction: W  
 Digital Ref: NEMB2\_0056  
 Description: Detail of partially blocked cart door to window in NW wall of Bay 2.

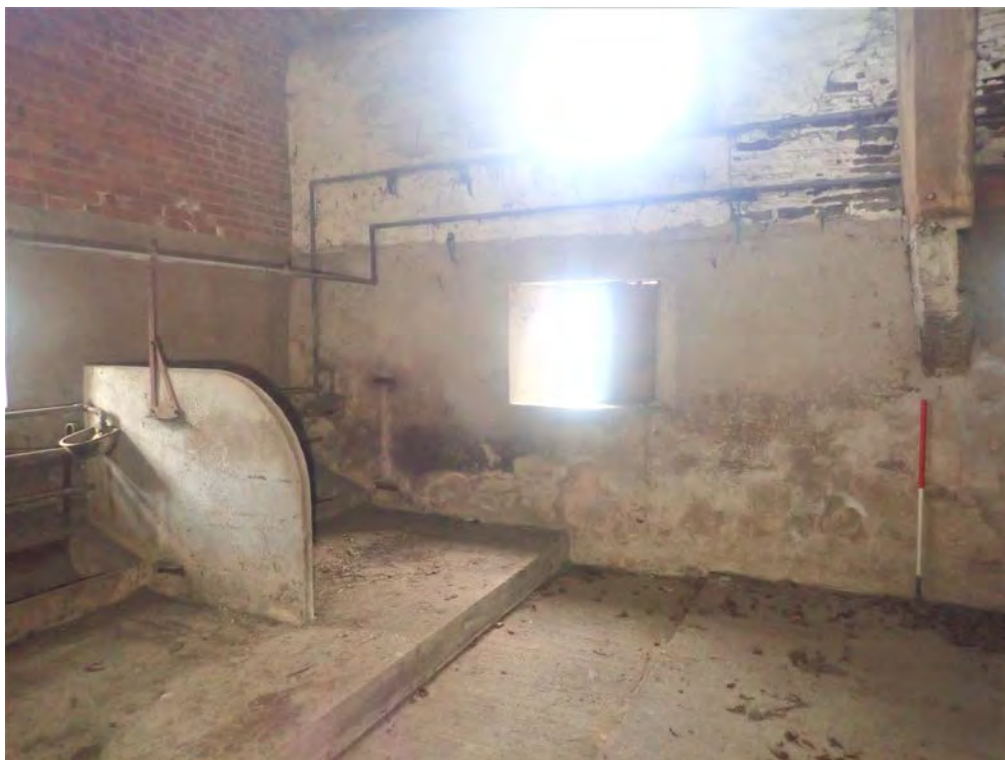
Photograph:42 Direction: W  
 Digital Ref: NEMB2\_0034  
 Description: West corner of Bay 1 with brick SW wall and stone NW wall with no evidence of fireplace.

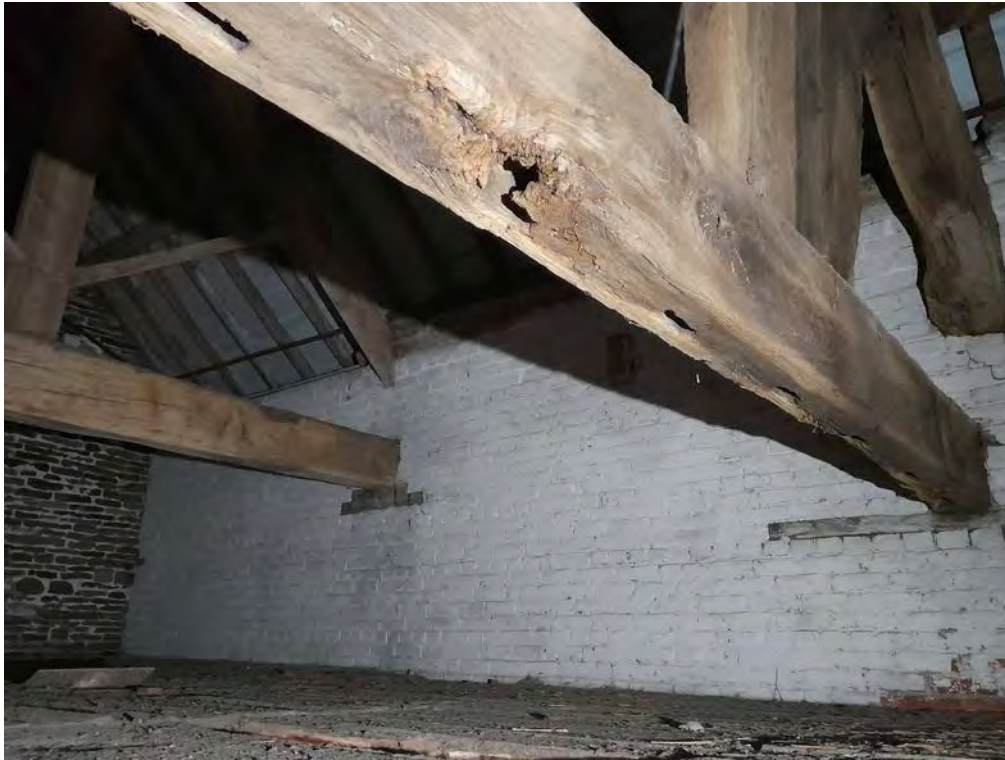
Description: General eastwards view showing how Truss 3 and Truss 4 have been fitted into SE brick wall.

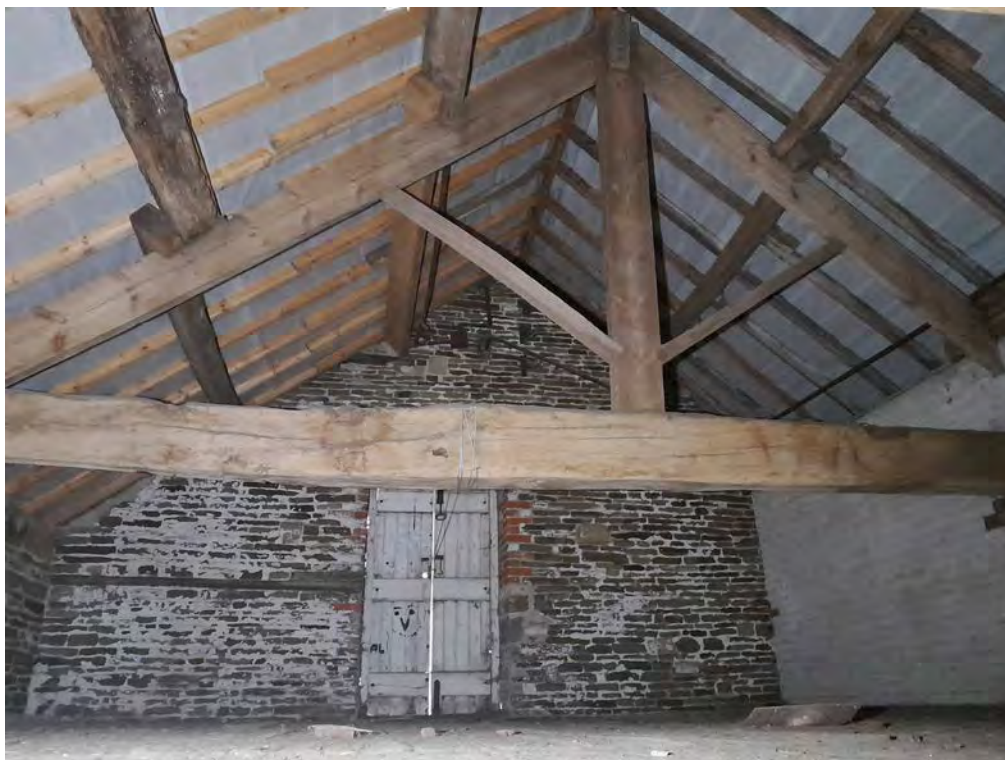
Description: Truss 4 king post truss with possible different phase in tie beam as king post, rafters, and braces. Several reused timbers in purlins. NE wall in background with taking-in door which appears to have been elevated with stone surrounds below and red brick above.

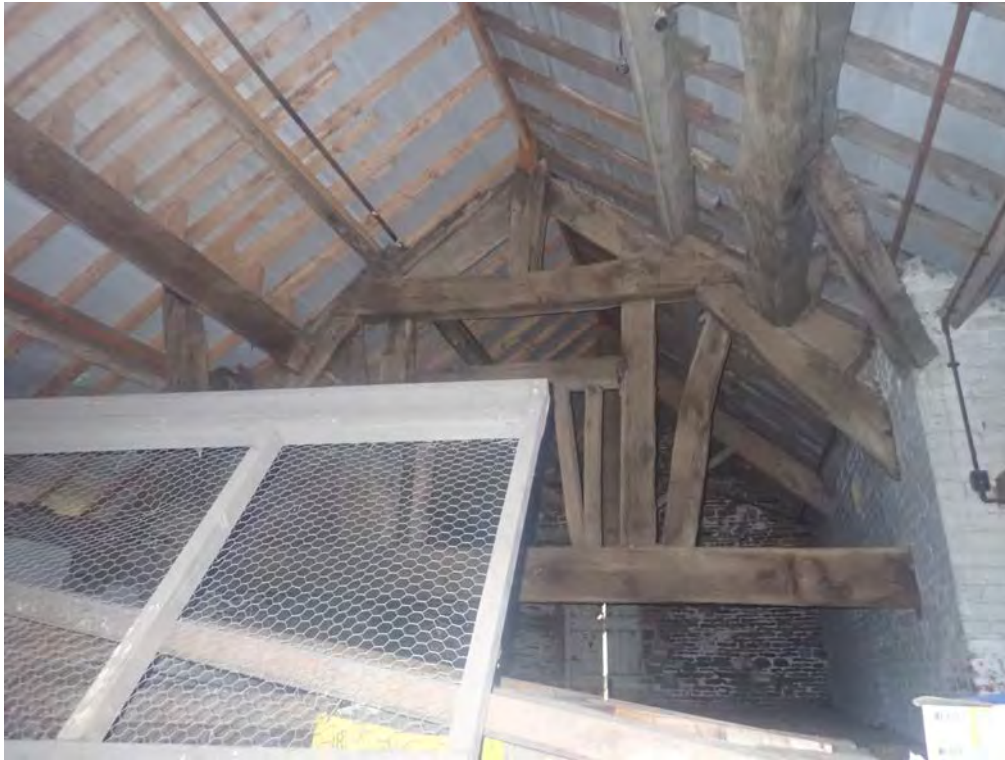
Description: View of SW face of Truss 3 showing combination cruck truss with queen truss alterations above collar. Minor collar and struts between queen struts and additional braces outside of struts. Original purlins and braces in Bay 3.
