**Nether Mill Barn  
Penistone  
South Yorkshire**

Level 3 Historic Building Recording  
Report No. Y582/22

**Report No. Y582/22**

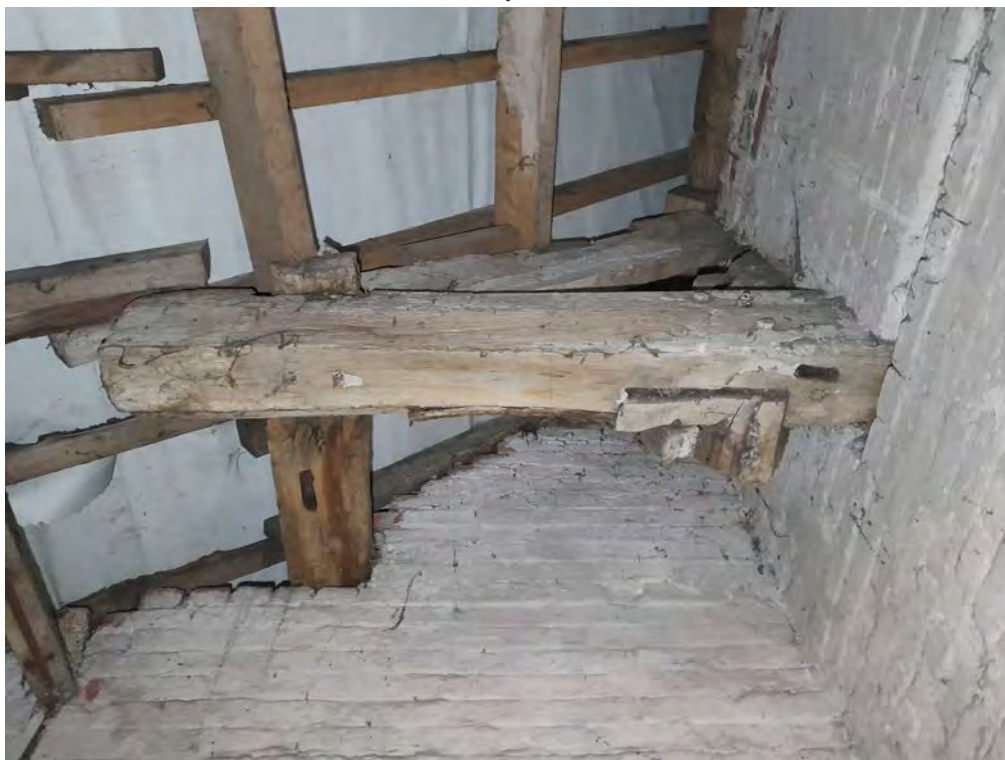
Description: SE extent of Truss 3 tie beam and sawn cruck blade with mortice through brick wall (right). Tie beam has mortice in soffit. Bay 3 wall-plate in background with morice in soffit.

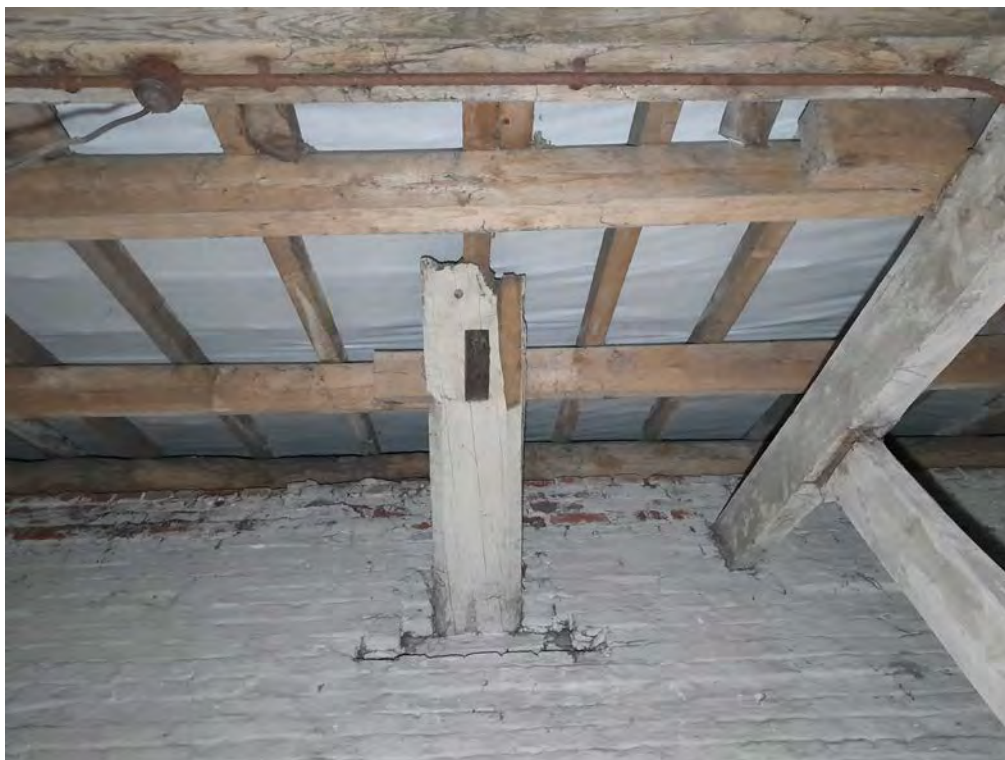
Photograph:52 Direction: NW  
Digital Ref: NEMB2\_0108  
Description: SE extent of Truss 4 tie beam with single mortice in soffit extent indicating former post.

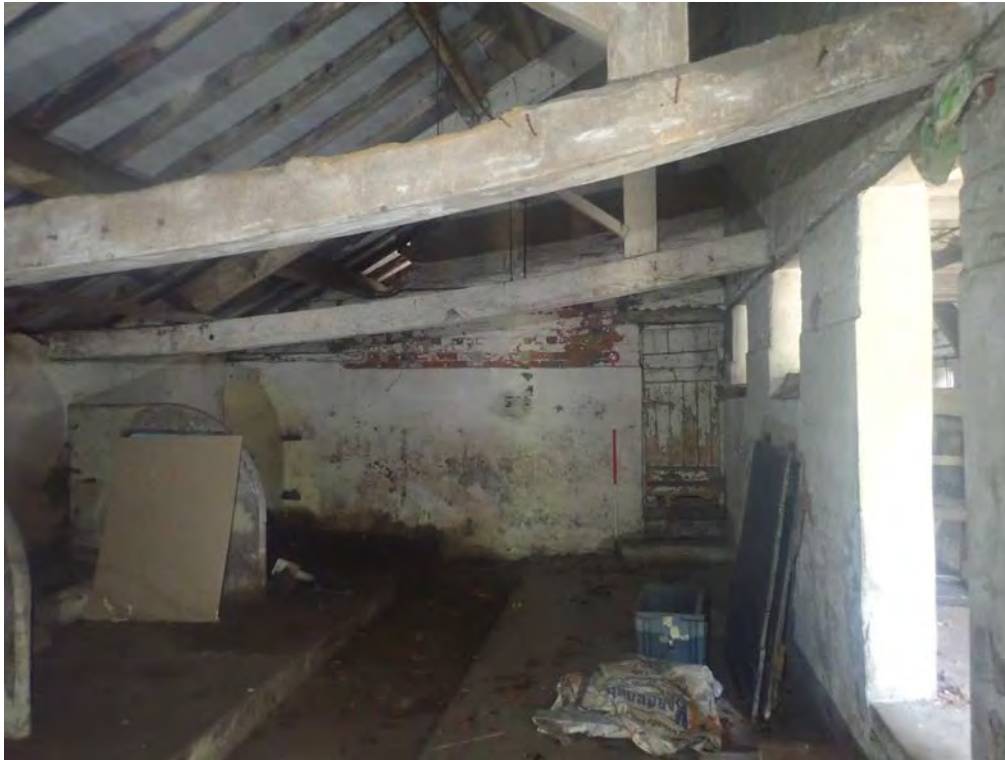
Description: General internal SW view of NW outshut (Area D) with doorway to walkway in SW brick wall and doorway Bay 5 (Area C) in foreground (right). Bend in softwood trusses.

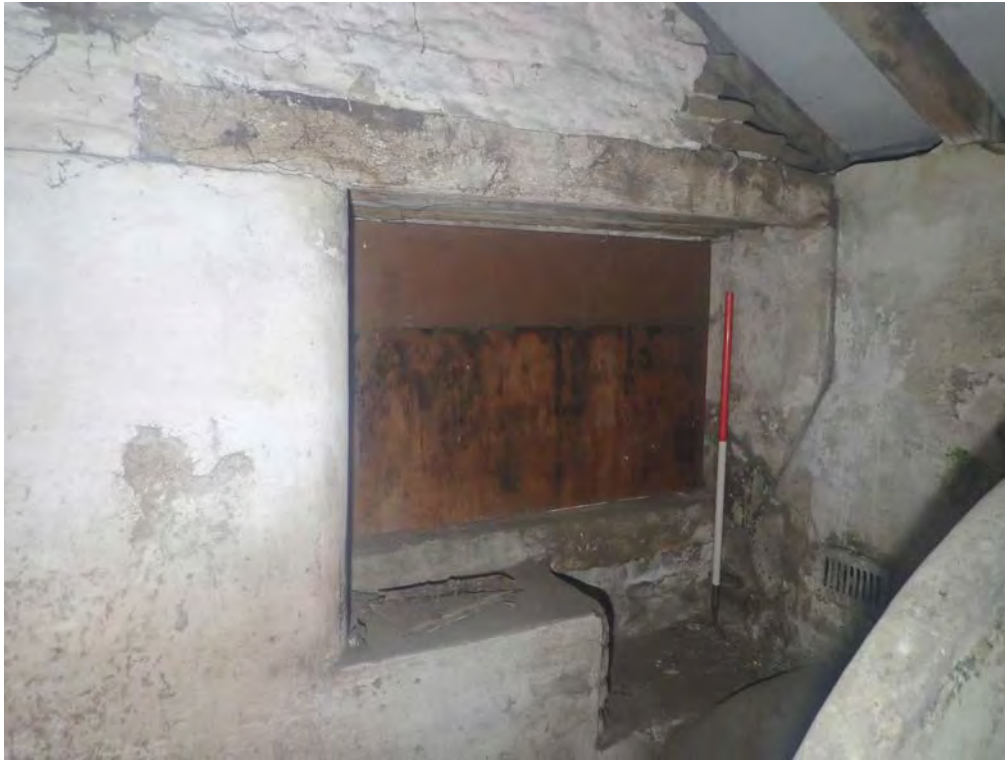
Description: Internal detail of partially blocked door in SE extent of NE wall of NW outshut. Timber lintel above and partial wall rebuild.

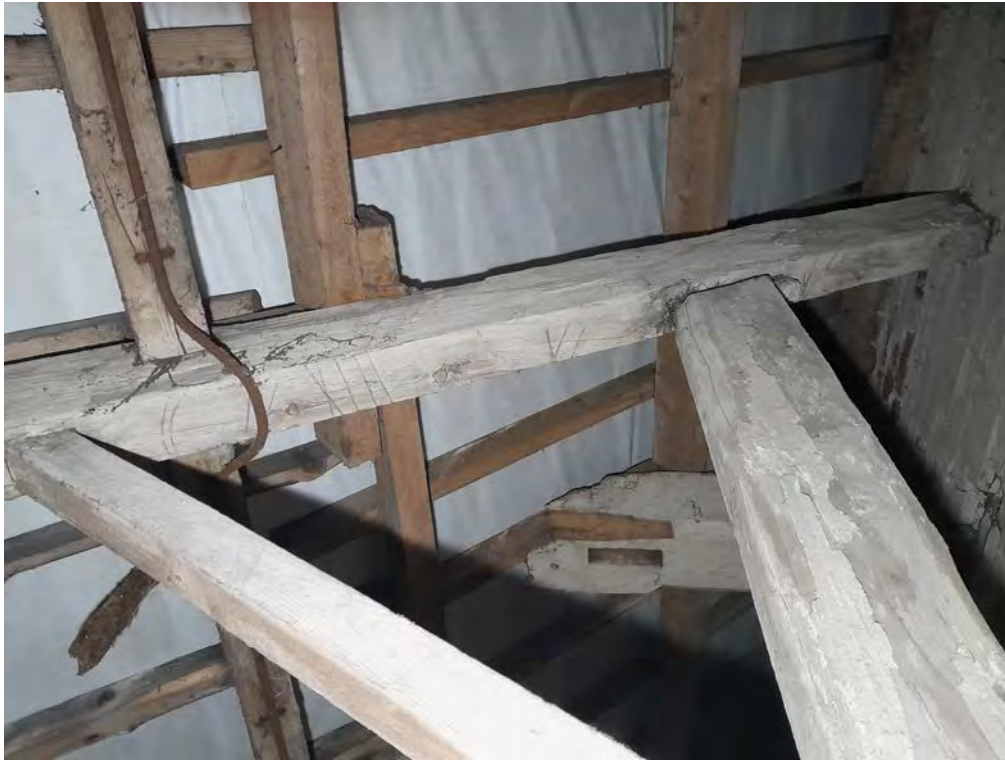
Photograph:67 Direction: SW  
 Digital Ref: NEMB2\_0107  
 Description: Baltic marks in rafter soffit of NE truss of NE outshut.

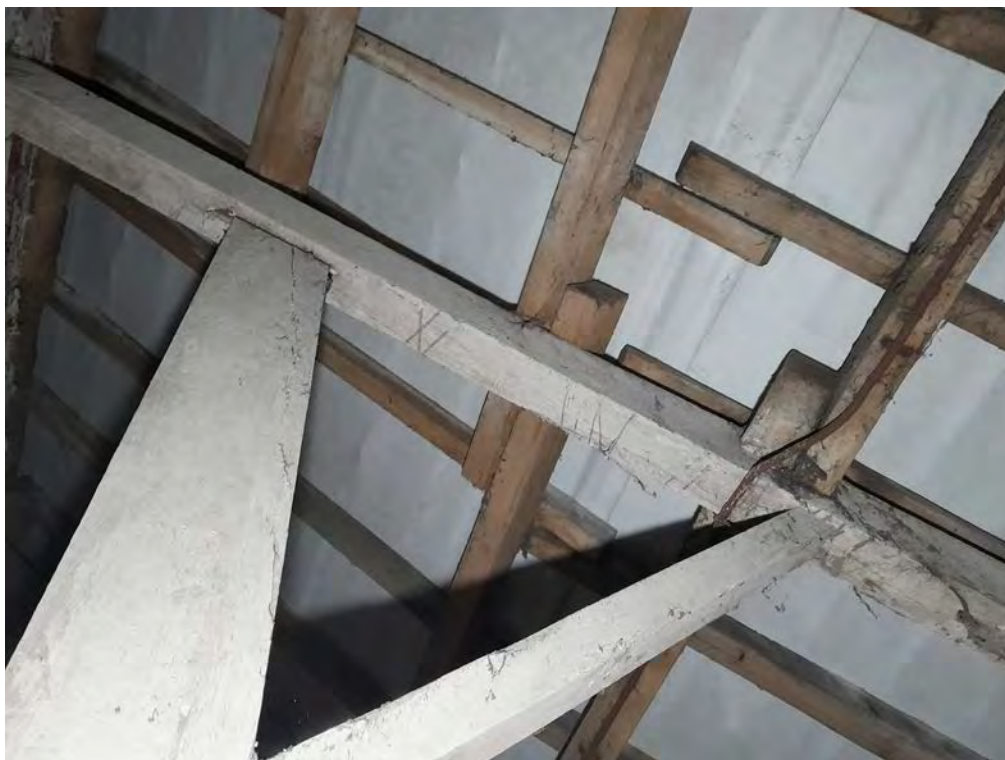
Photograph:68 Direction: N  
 Digital Ref: NEMB2\_0110  
 Description: Baltic marks in rafter soffit of SW truss of NE outshut.

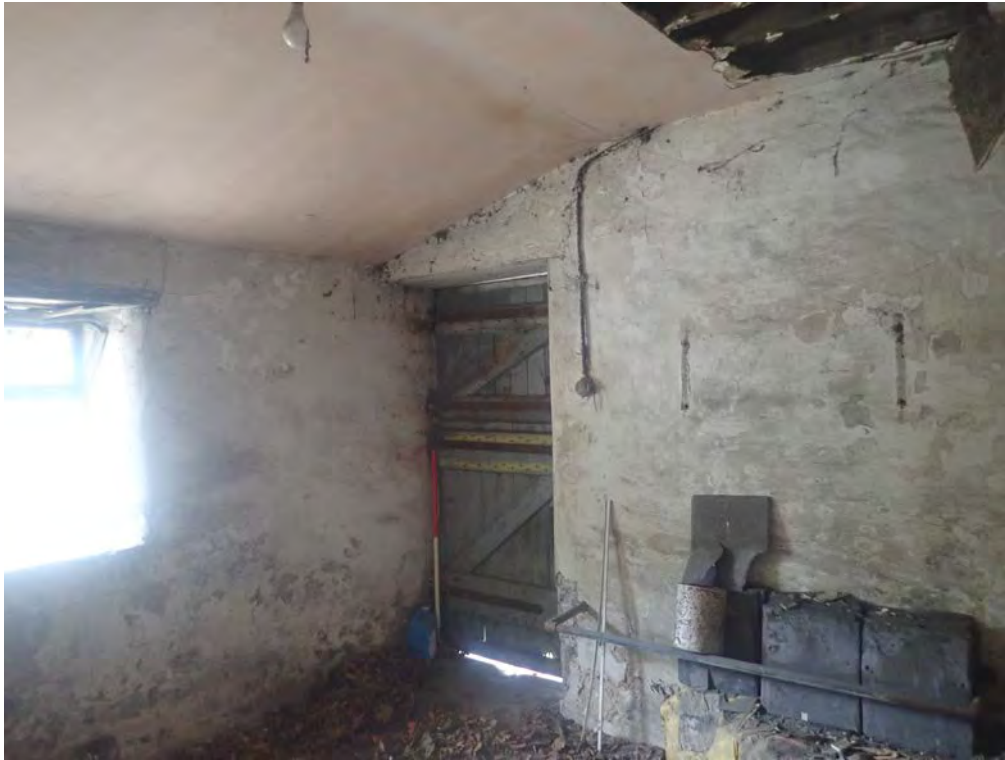
Photograph:69 Direction: S  
 Digital Ref: NEMB2\_0112  
 Description: Doorway in SE extent of SW wall of the NW outshut (Area E) with timber lintel.
