BS 5837: 2012 Arboricultural Constraints Report

Site Address:	Vernon House Yews Lane Kendray Barnsley S70 3LJ	Client:	Richard Senior
Report Ref:	YLKB01-23	Report Date:	19th September 2023
Author:	Laurence Smith BSc (Hons) Arb, M Arbor A	Signed:	<i>Laurence Smith</i>

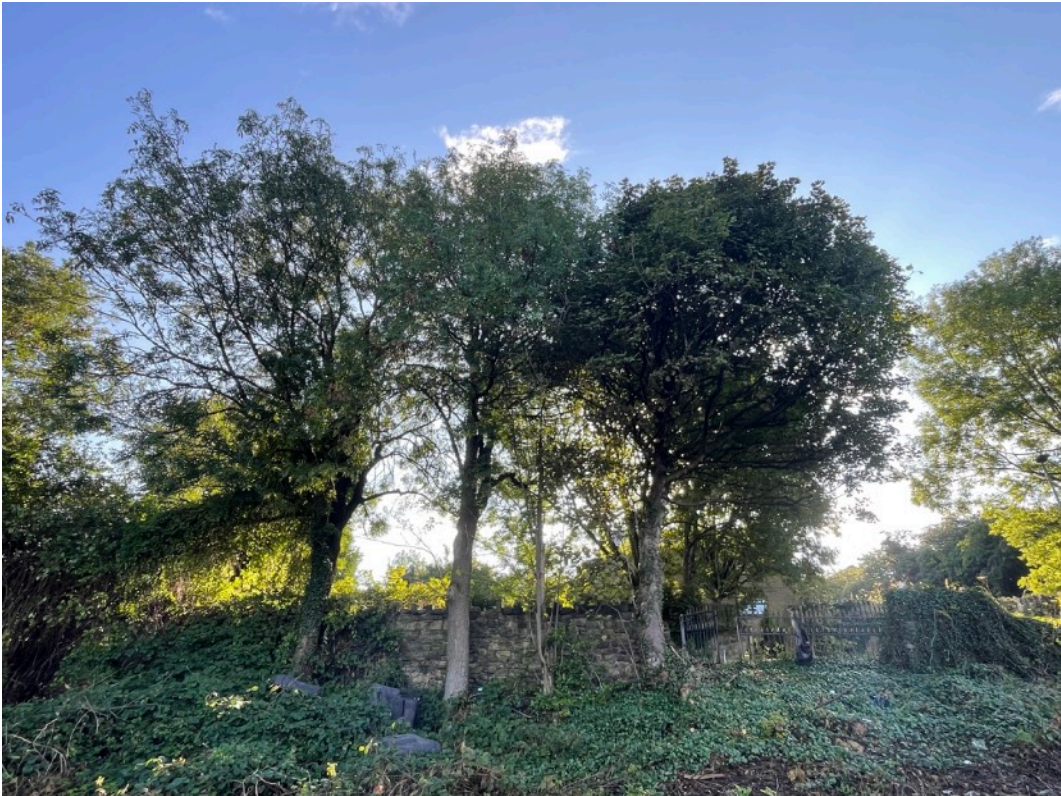
Figure 2. Trees from left to right: T1934, T1933, T3 & T1932.

T3	Young	Ash (<i>Fraxinus excelsior</i>)	6.5	180	3, 1, 1, 2	N/A	3	Poor	Standing deadwood with young shoots extending from close to the base. Leaves appear to be infected with Ash Dieback.	Fell	<10	U	2.2
T1933	Early Mature	Ash (<i>Fraxinus excelsior</i>)	14	450	4.5, 7.5, 6.5, 4	5 E	7	Normal	Two moderate pruning wounds partially occluded on the north side of the stem. One with minor decay. Some minor deadwood but no indication of Ash Dieback at present.	None	>20	B2	5.4
T1934	Early Mature	Ash (<i>Fraxinus excelsior</i>)	15	430*	6.5, 8, 2.5, 2.5	5 E	5	Fair	The lower canopy is becoming entangled with Russian vine and Ivy. Minor internal deadwood	Remove climbing vine	>20	B2	5.2
T1935	Semi Mature	Ash (<i>Fraxinus excelsior</i>)	12	300	3, 3, 3, 3	4 S	4.5	Fair	A large vertical column of decay from ground level to around 6m. Assumed historic fire damage. Possible habitat and not considered at risk of failure at present.	None	<10	U	3.6

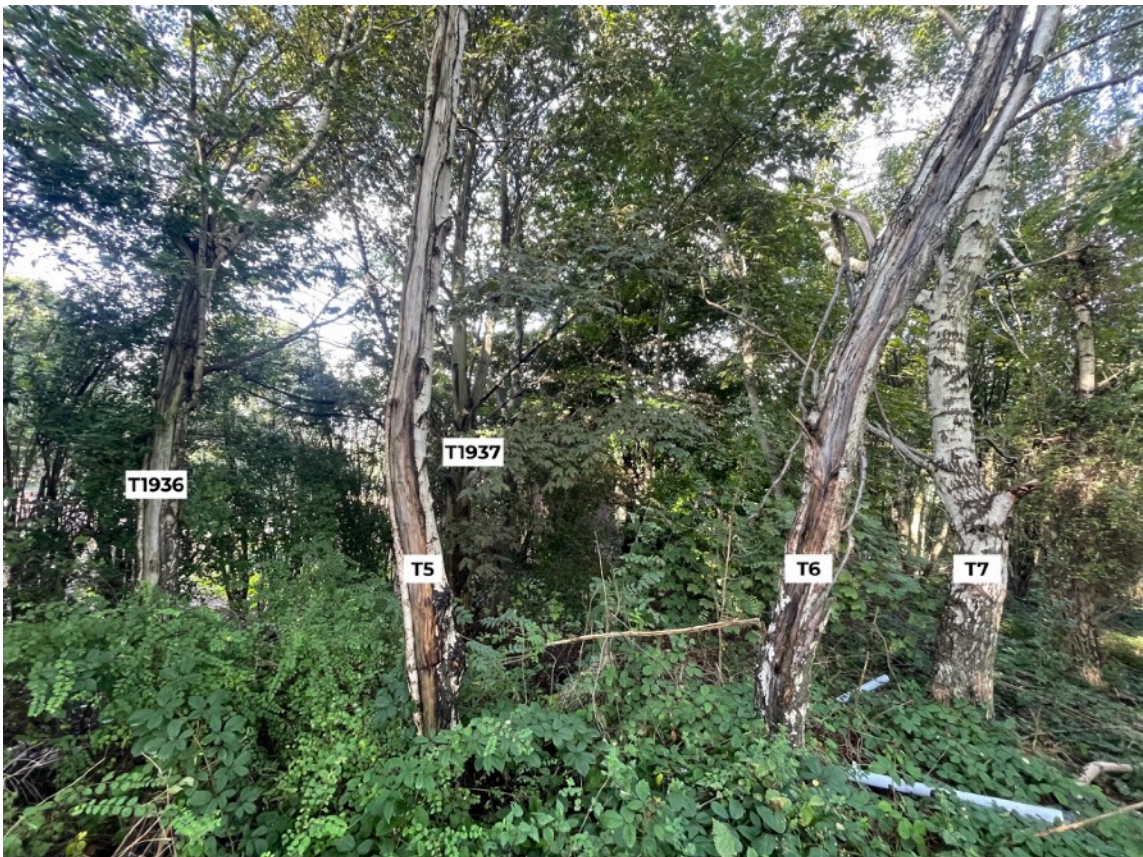
Figure 4. Trees to the north east of the site.

There are several trees in the northeastern corner of the site which have suffered significant fire damage and may not be viable for long-term retention.

problematic in the northeastern corner where there are several trees which are unsuitable for retention. Where possible an agreement should be sought on how any arboricultural features in this region will be managed.

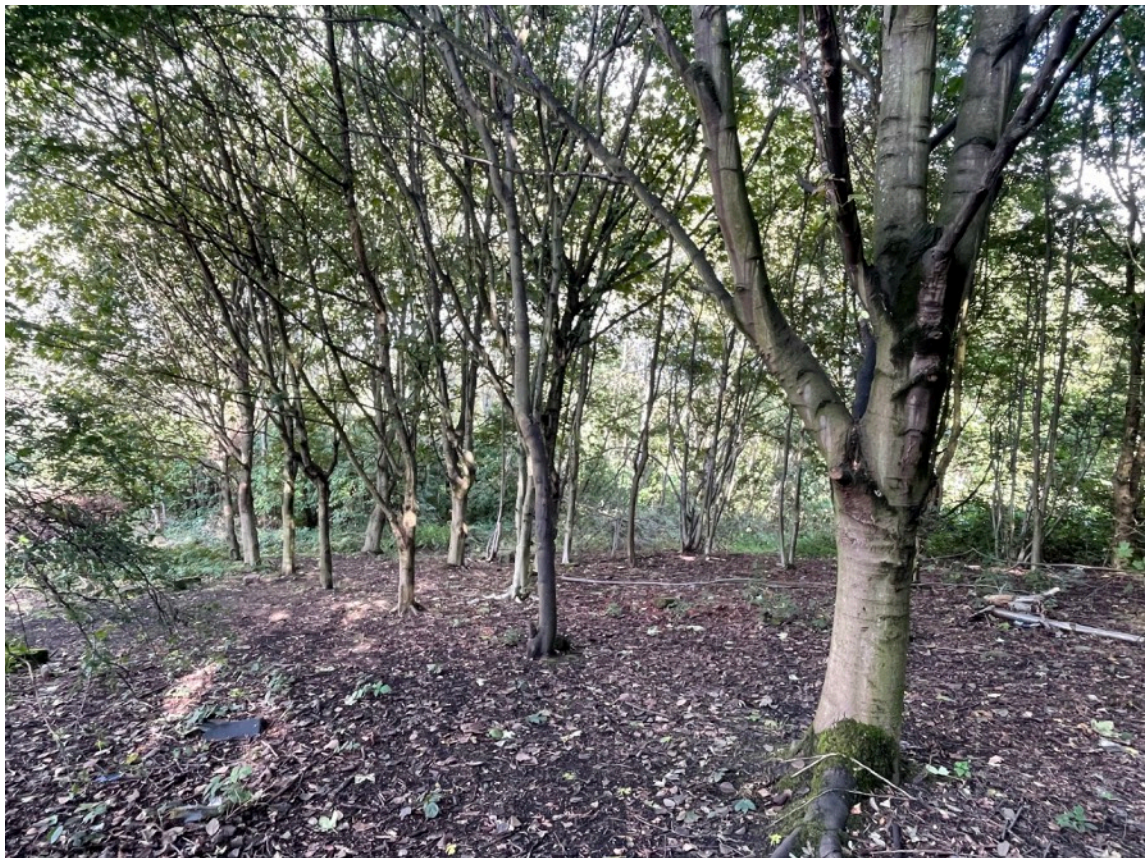
T10	Semi Mature	Sycamore (<i>Acer pseudoplatanus</i>)	12	330	3.5, 3, 4, 4	1.5 W	6	Normal	Larger tree with row. Generally good condition.	None	>20	B2	4.0
G11	Semi Mature	Sycamore (<i>Acer pseudoplatanus</i>)	9	140-270	2, 2, 4.5, 2	N/A	2	Normal	A row of Sycamore trees with one Field Maple. Assumed to have been part of a woodland planting given the uniform spacing and similar characteristics.	None	>20	B2	3.2
T1940	Early Mature	Beech (<i>Fagus sylvatica</i>)	14	320, 280	5.5, 5.5, 4, 5	N/A	3	Normal	Generally good health and vigour.	None	>20	B2	4.3

Figure 6. G11 with uniform planting.

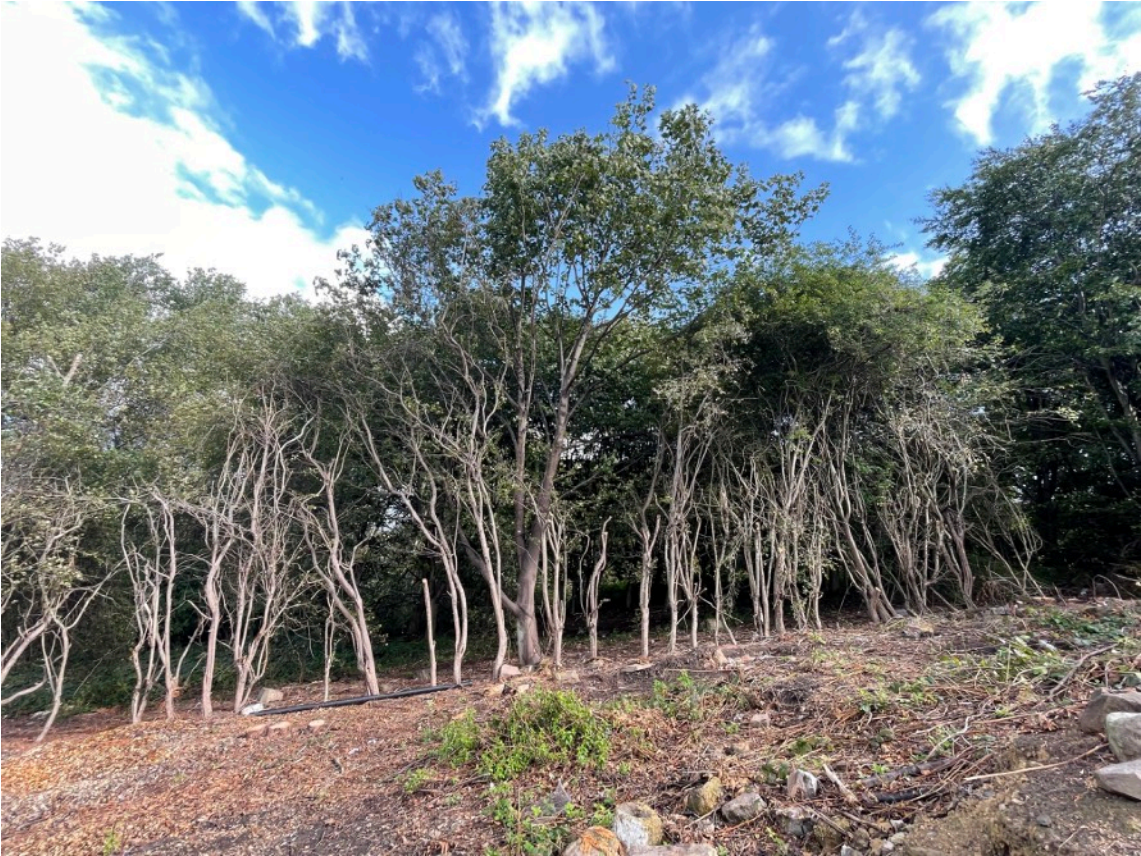
Figure 7. H13 with T1941 emerging in the center.

Around large parts of the perimeter of the survey area is a further unmanaged hedge feature which has become suppressed where it exists under the larger woody elements and overgrown in other locations. This feature is predominantly Hawthorn but also includes Privet in the northeast. While this has some ecological merit its retention viability is questionable.

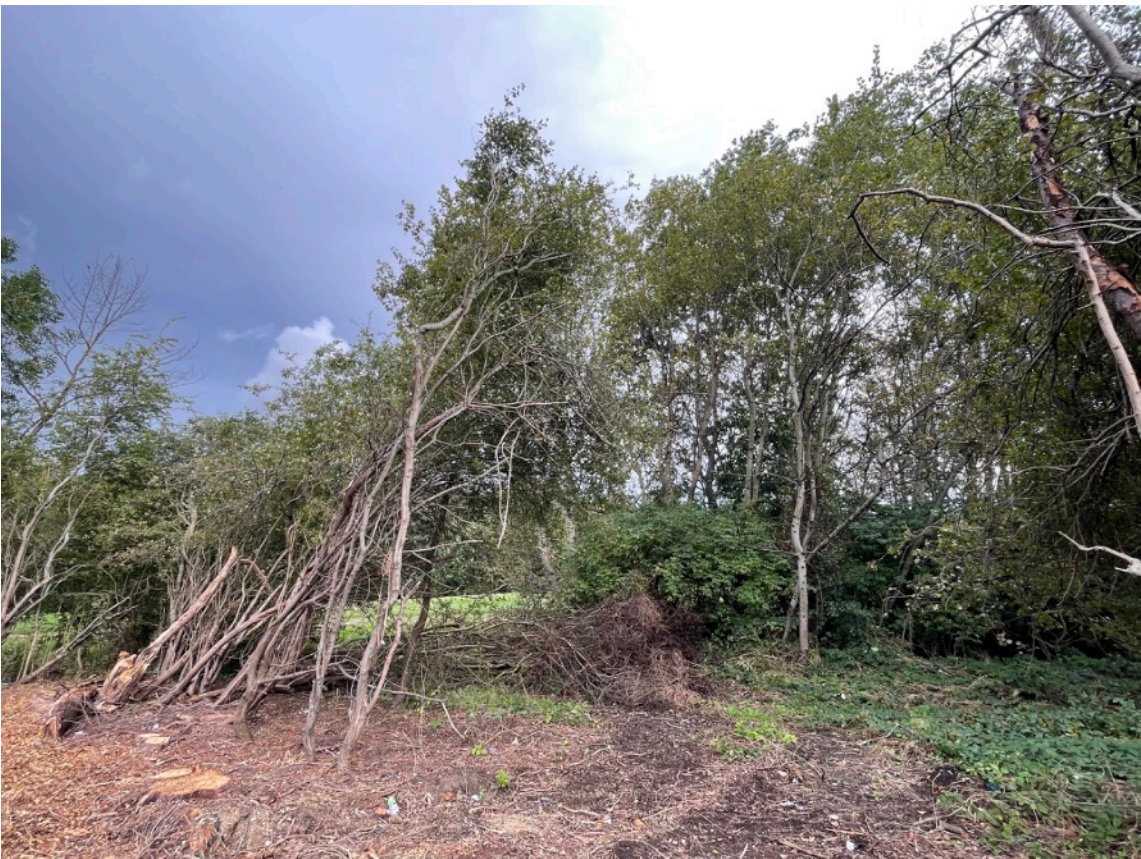
Figure 8. H13 to the left of the image with T14 and G15 in the background.

T14	Young	Aspen (<i>Populus tremula</i>)	8	120	3, 2.5, 1, 2	N/A	N/A	Normal	Tall slim stem with a minor lean to the north.	None	>10	C2	1.4
G15	Semi Mature	Aspen (<i>Populus tremula</i>)	13	250, 280*	6, 6, 6, 6	6 S	3	Normal	End trees of a shelter belt of Aspens which extends further east. Lower deadwood but generally in condition typical of the species.	None	>20	B2	3.8
G16	Semi Mature	Lawson's Cypress (<i>Chamaecyparis lawsoniana</i>)	8	150, 150, 150	2, 2, 2, 2	N/A	Ground level	Fair	The southeastern sides are dead with the only viable canopy at the crown and the opposing side only.	Potential to fell and replace.	>10	C2	2.6
T1942	Semi Mature	Layland Cypress (<i>Cupressus × leylandi</i>)	11	370	3, 3, 3, 3	2 W	2	Normal	Form and health typical of the species.	None	>20	B1	4.4
T1943	Semi Mature	Goat Willow (<i>Salix caprea</i>)	7.5	150, 170	4, 2.5, 0, 4	2 N	3	Poor	Hollowing stems with decay at the base.	Fell	<10	U	2.3

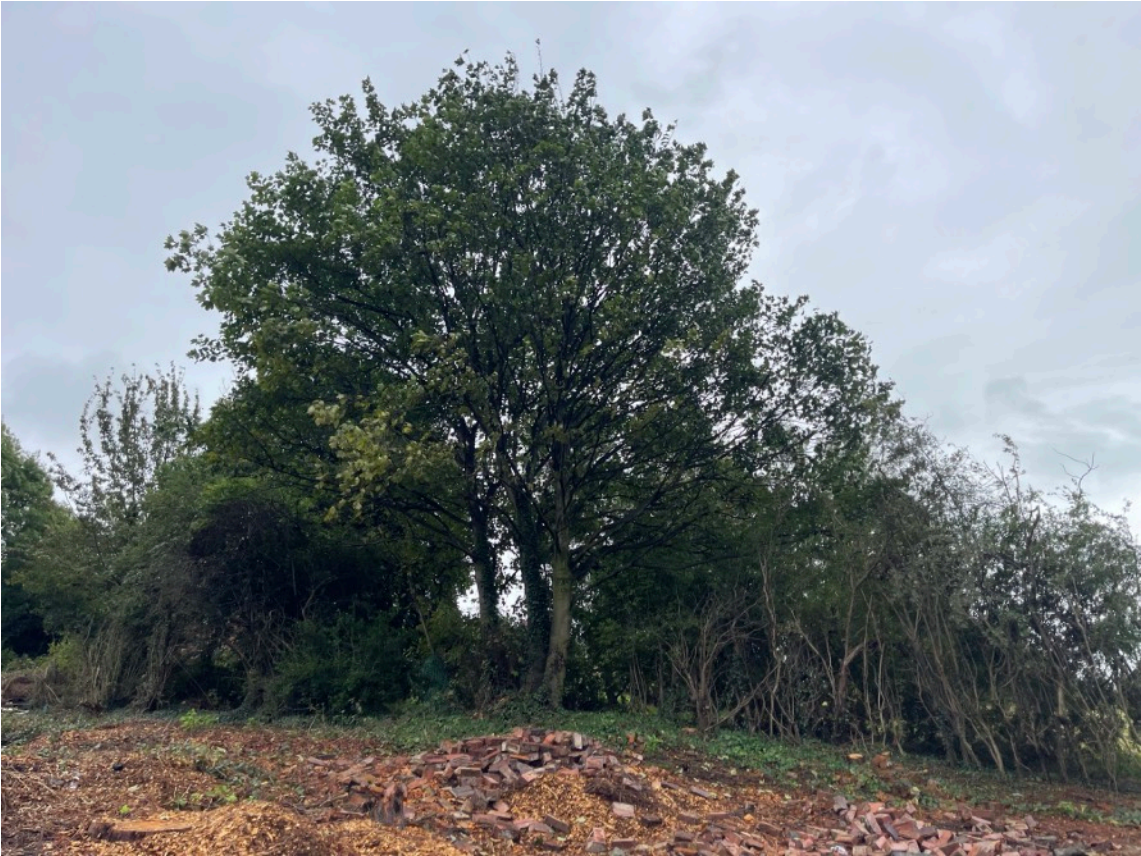
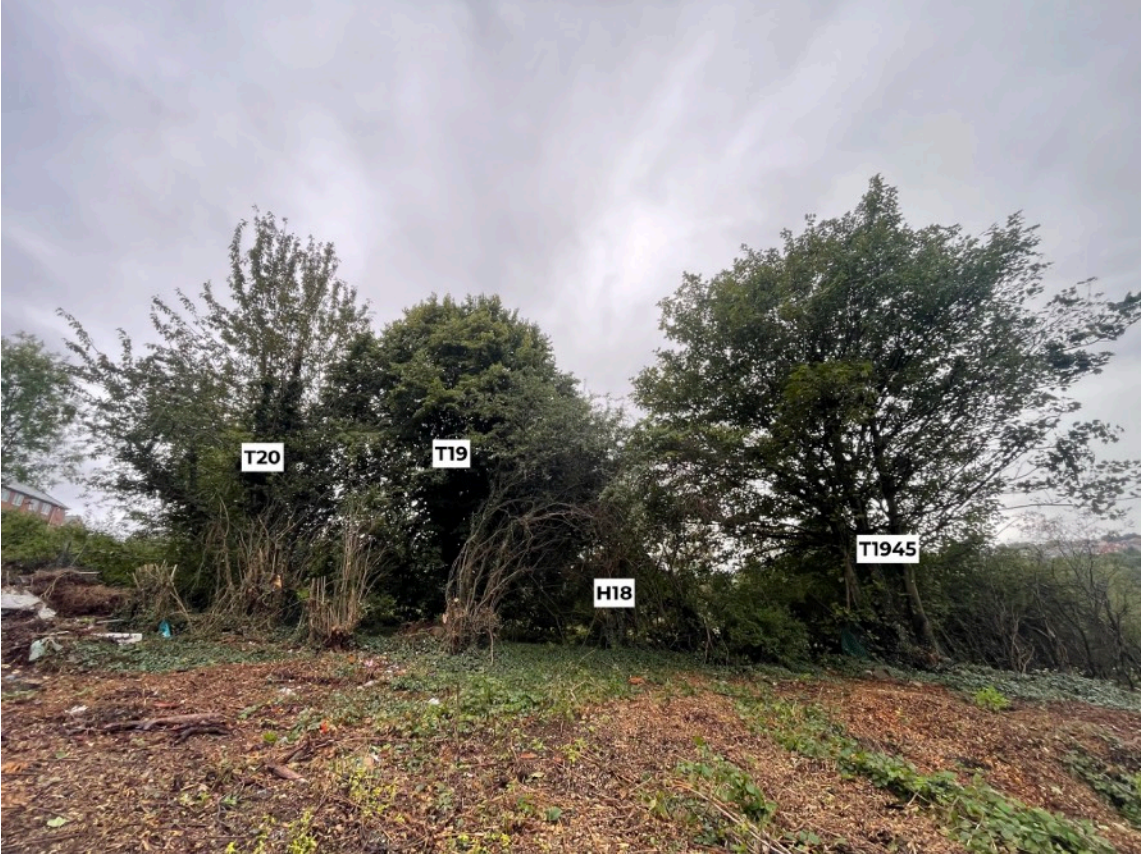
Figure 11. T1945 with H18 below.

The access, working area and overhanging canopies: Limited canopies are extending into the site which could cause constraints on development work. The one exception is the T1945 whose canopy is as low as 4m above the site at its lowest.

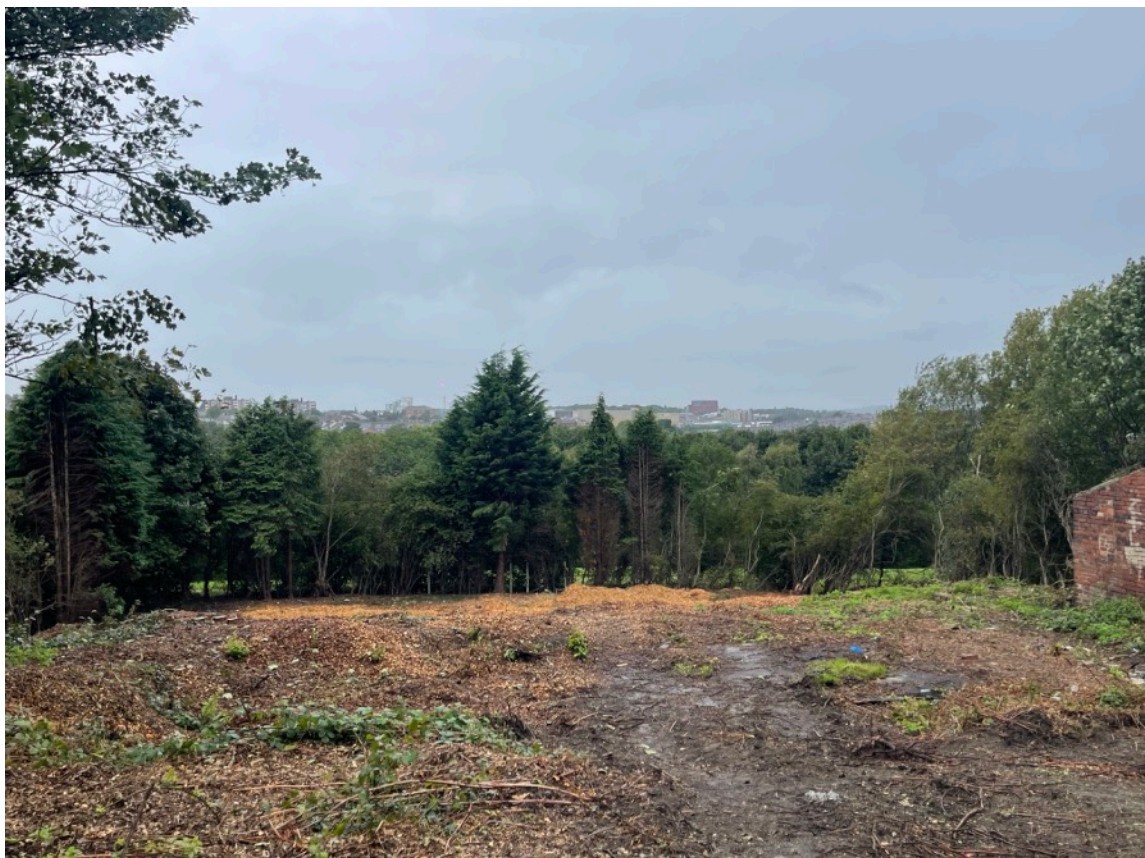
The western boundary has several coniferous trees and groups (G16, T1942 & G17) which are assumed to have once been part of a cohesive boundary feature. However, due to differences in growth speed and a lack of management, this feature has now become fragmented with some of the taller trees blocking the views of Barnsley. While some reduction pruning could be feasible for parts of this feature (G17 & T1942), it would not be feasible for all of it (G16) as this would bring the canopy below the height of any viable growth within the site. In addition, the Leyland Cypress (T1942) which makes up part of this boundary feature typically has a fast rate of growth and will need to be constantly managed to prevent its size from becoming out of scale within any development proposal.

Figure 14. The view west down the site with some of the taller Cypress trees blocking the view.
