# **Consented Residential Care Home Development**

**Perseverance Street, Barnsley**

**Pre-Construction Highway Condition Survey**

**August 2023  
3825-01-HTN01**

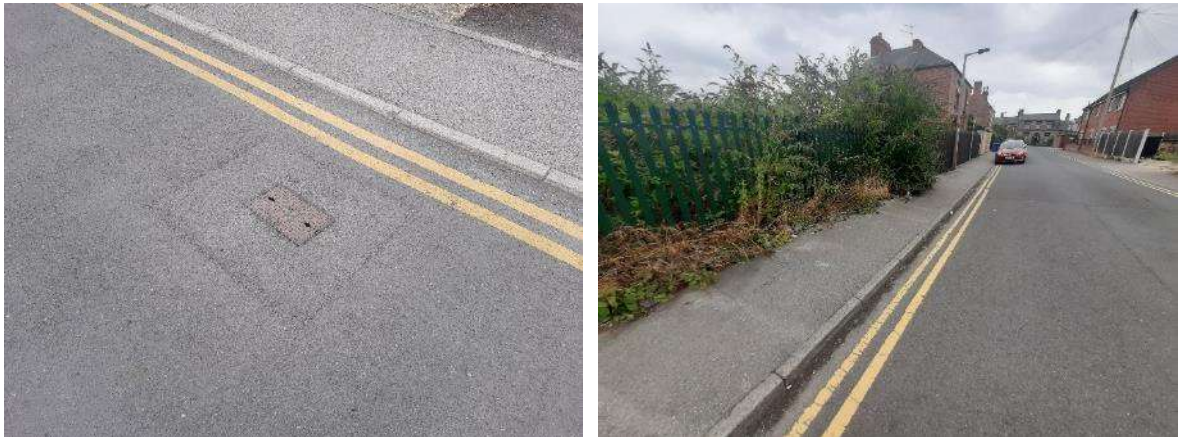
**Images 3.1 (left) and 3.2 (right) – Springfield Street (west)**

- 3.2.2 An existing service chamber hatch is present within the westbound side of the carriageway, which is surrounded by a patch of reinstated surface (**Image 3.1**, approx. grid ref. 433653, 406337). This was generally in good condition but was noted for further observation.

- 3.2.3 The footway along the section of site frontage is generally in good condition, with no observed defects in either the footway surface or kerb edging (**Image 3.2**, approx. grid ref. 433659, 406343). There is some encroachment of vegetation into the footway.

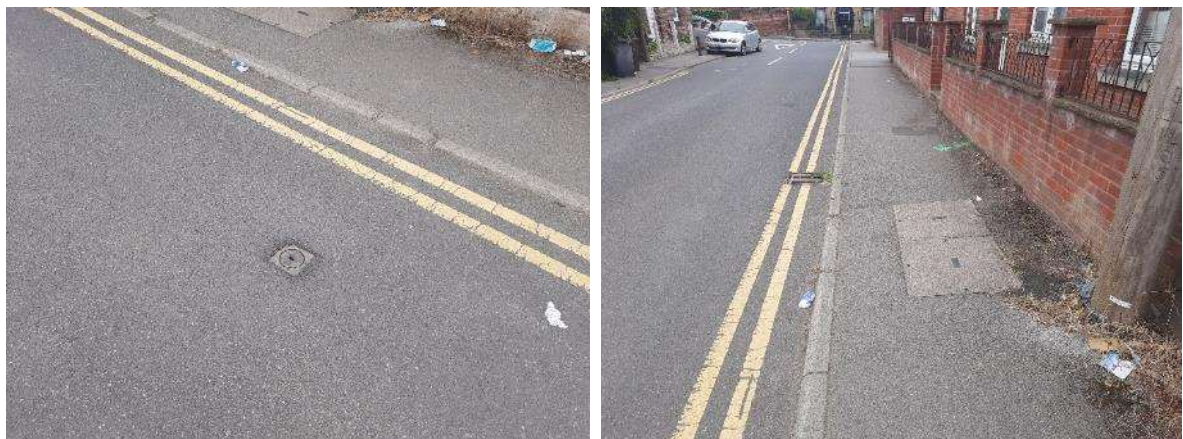
**Images 3.3 (left) and 3.4 (right) – Springfield Street (west)**

- 3.2.4 A drain access within the westbound side of the carriageway was noted for further observation (**Image 3.3**, approx. grid ref. 433683, 406338). Adjacent to this, patches of reinstated surface were observed around service chamber hatches within the footway along the southern side of the road (**Image 3.4**).

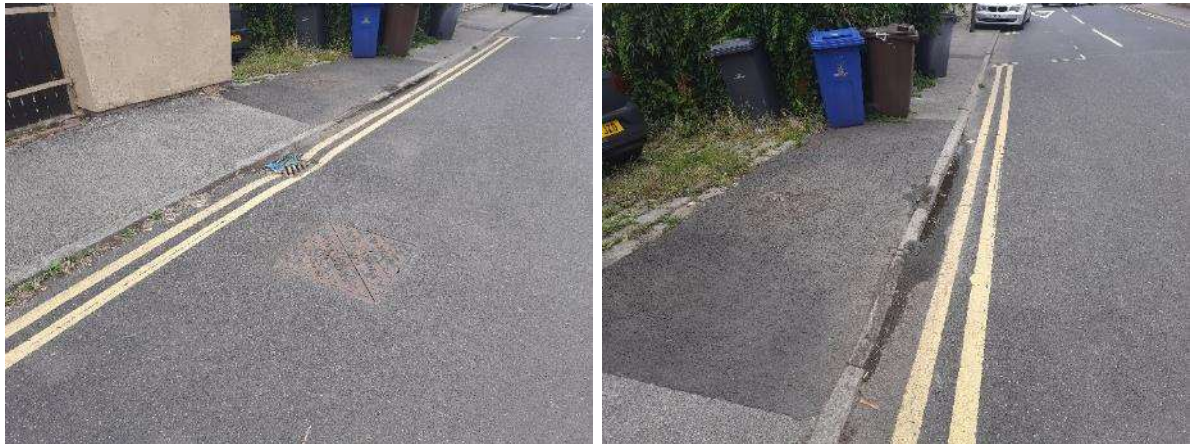
Images 3.5 (left) and 3.6 (right) – Springfield Street (west)

- 3.2.5 An existing service chamber access within the westbound side of the carriageway was noted for further observation (**Image 3.5**, approx. grid ref. 433686, 406341). Adjacent to this, a patch of reinstated surface within the footway across a private driveway access was observed, which displayed some discolouration along the edge of the carriageway (**Image 3.6**).

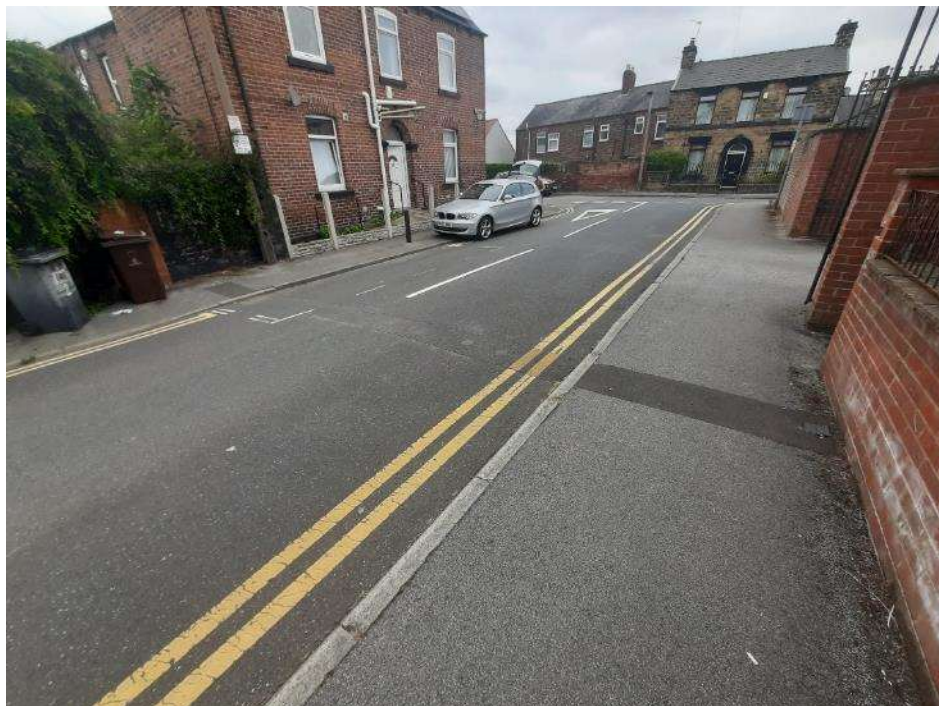
Image 3.7 – Springfield Street (west)

- 3.2.6 There is a strip of reinstated surface across the full width of the carriageway and both footways approximately 17m west of the junction with Perseverance Street (**Image 3.7**, approx. grid ref. 433696, 406339). This was generally in good condition but was noted for further observation.

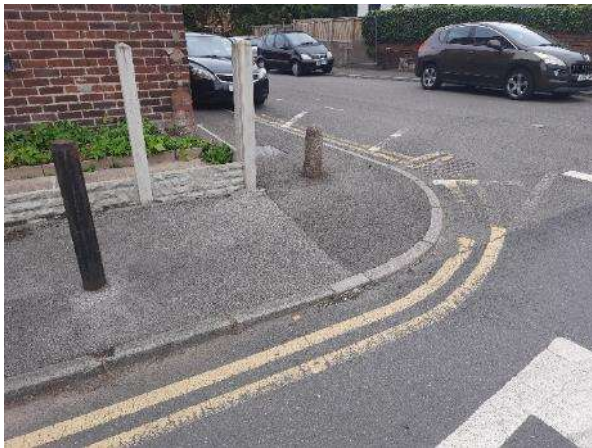
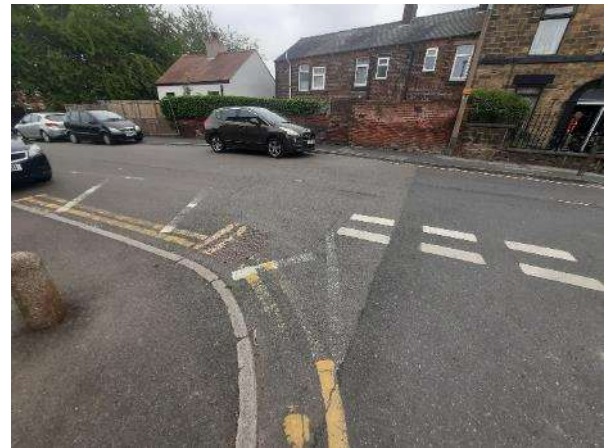
**Images 3.8 (left) and 3.9 (right) – Springfield Street (west) / Perseverance Street Junction – northern side**

- 3.2.7 A clear join was visible indicating different ages of surfacing between Springfield Street and Perseverance Street, within both the footway (**Image 3.8**) and carriageway (**Image 3.9**) on the northern side of Springfield Street. **Image 3.9** also illustrates an area of slight cracking within the footway surface on Perseverance Street, adjacent to a service chamber access (approx. grid ref. 433713, 406344).

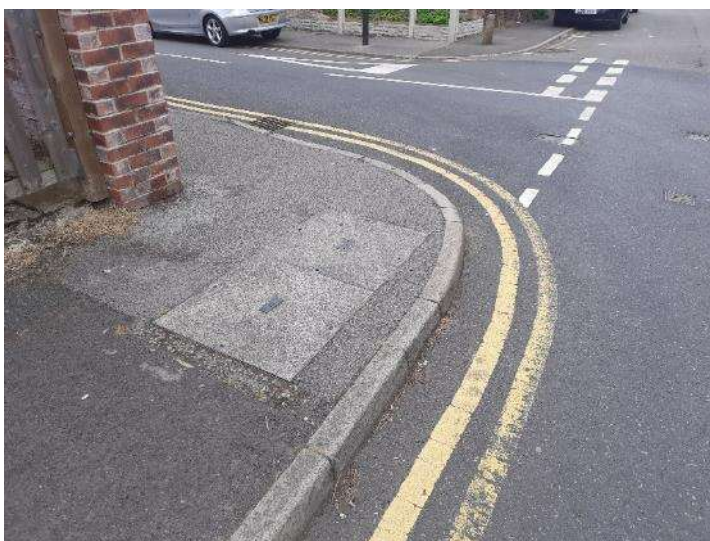
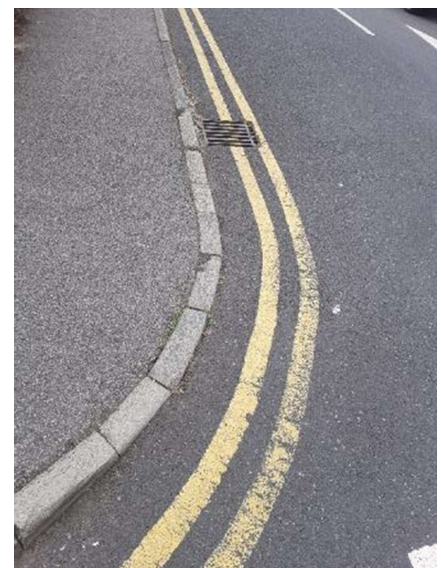
**Images 3.10 (left) and 3.11 (right) – Springfield Street (west) / Perseverance Street Junction – southern side**

- 3.2.8 To the southern side of the junction, a small patch of surface beak-up was observed adjacent to a service chamber access within the footway (**Image 3.10**, approx. grid ref. 433713, 406334). A single loose kerbstone was noted on the southern corner of the junction (**Image 3.11**).

- ii) A single loose kerbstone was observed on the southern side of the Perseverance Street / Springfield Street junction, adjacent to a small patch of surface break-up next to a service chamber access within the footway;

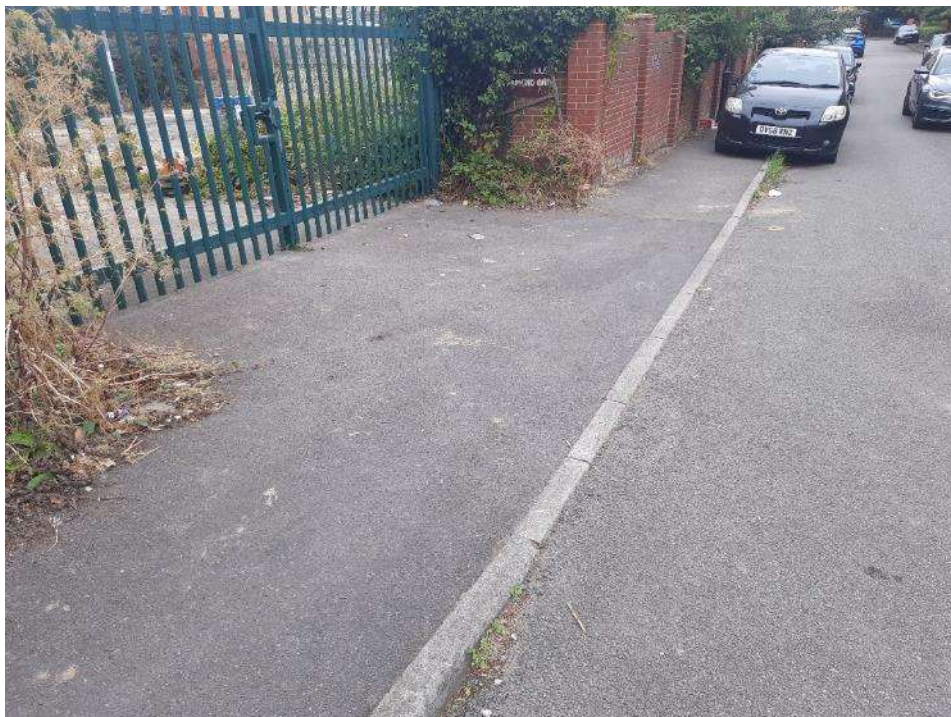
**Image 3.12 – Perseverance Street**

- 3.3.2 The existing crossover is generally in good condition (**Image 3.12**, approx. grid ref. 433707, 406364). There is some overgrowth of vegetation to both sides.

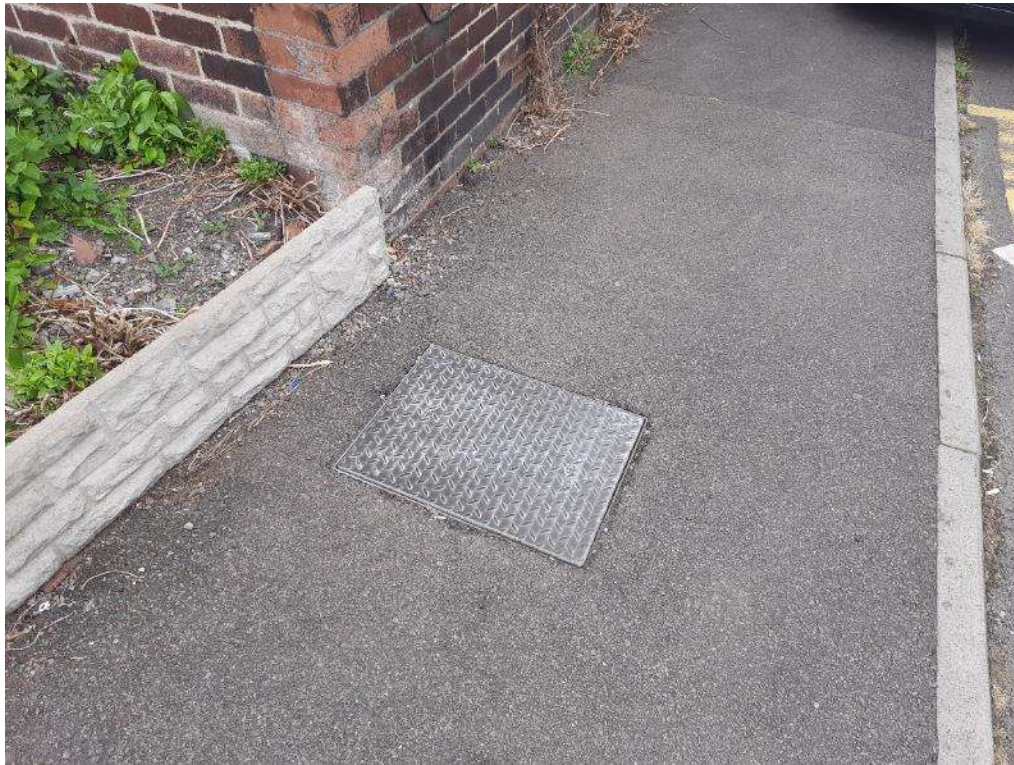
**Image 3.13 – Perseverance Street**

- 3.3.3 An existing service chamber hatch is present within the footway on the western side of Perseverance Street immediately to the north of the junction with Springfield Street (**Image 3.13**, approx. grid ref. 433709, 406345). This was generally in good condition but was noted for further observation.

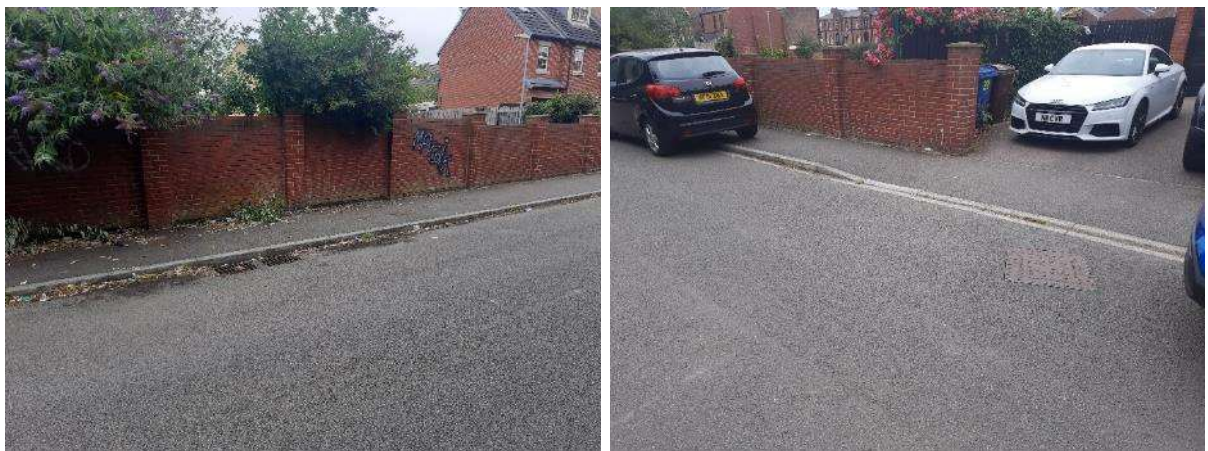
**Images 3.14 (left) and 3.15 (right) – Perseverance Street**

- 3.3.4 The carriageway and footway in the vicinity of the proposed access junction was generally in good condition, with only some slight discolouration observed along the edge of the carriageway (**Image 3.14**, approx. grid ref. 433713, 406344). Just to the north of this there is an existing service chamber access within the carriageway (**Image 3.15**). There were no observed defects relating to this, but it was noted for further observation.

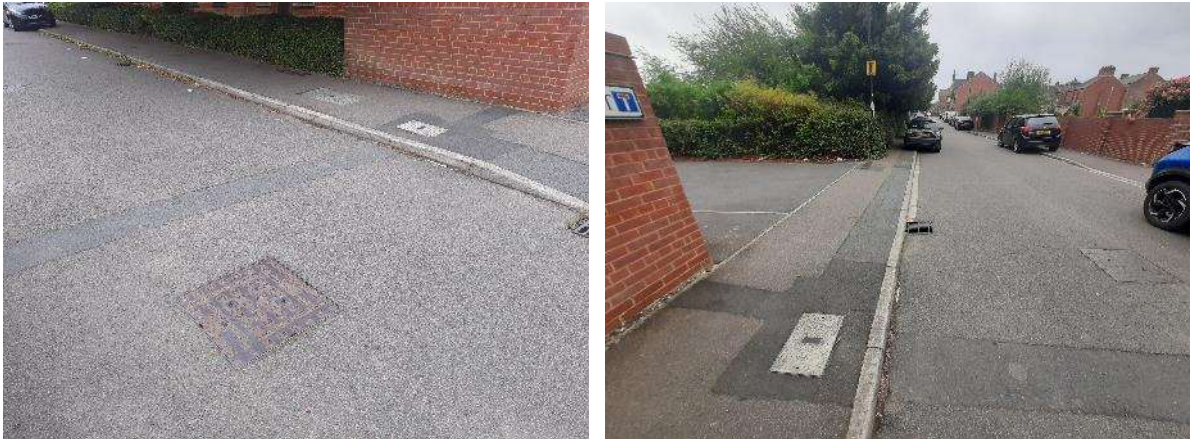
**Images 3.16 (left) and 3.17 (right) – Perseverance Street**

- 3.3.5 Immediately to the north of the private driveway known as Ashrams Court there is a service chamber access within the footway on the eastern side of Perseverance

Street (approx. grid ref. 433709, 406417). Originating from this are strips of reinstated surface across the width of the carriageway (**Image 3.16**) and along the length of the footway (**Image 3.17**). There was evidence of localised cracking within the reinstated surface course along the footway, but otherwise no obvious defects were noted.

- ii) There was evidence of localised cracking within the reinstated surface course along the footway on the eastern side of Perseverance Street near Ashrams Court.

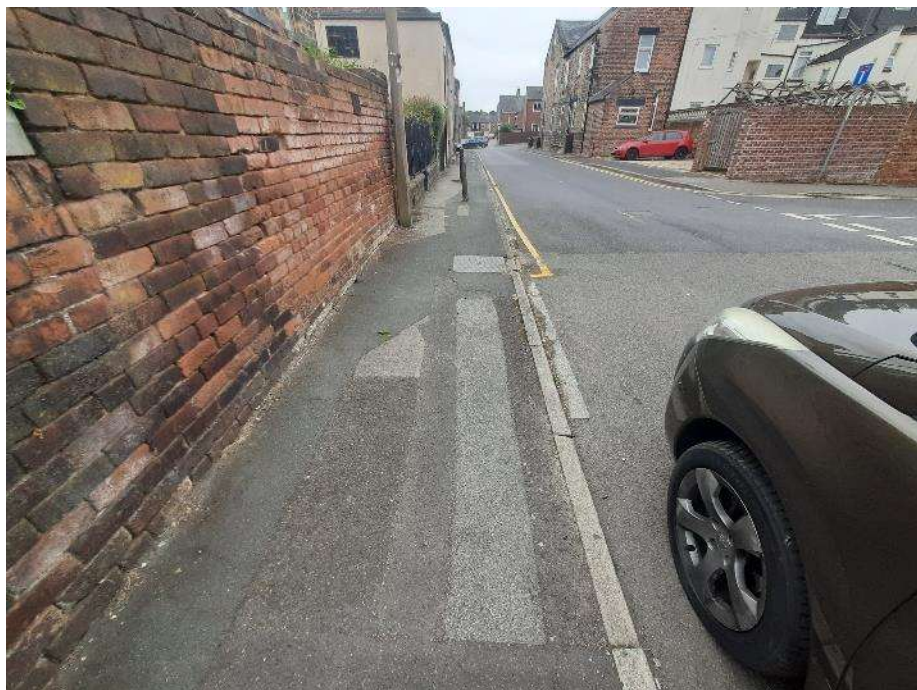
**Image 3.18 – Perseverance Street**

- 3.3.6 A strip of reinstated surface within the footway on the eastern side of Perseverance Street, opposite the junction with Springfield Street (west) was observed (**Image 3.18**, approx. grid ref. 433718, 406345). There is a localised depression within the reinstated surface, some localised surface cracking adjacent to a service chamber access, and some slight dislodgment of the kerb edging.

- iii) There is a localised depression within a strip of reinstated surface on the eastern side of Perseverance Street, opposite the junction with Springfield Street, as well as some localised surface cracking adjacent to a service chamber access, and some slight dislodgment of the kerb edging.

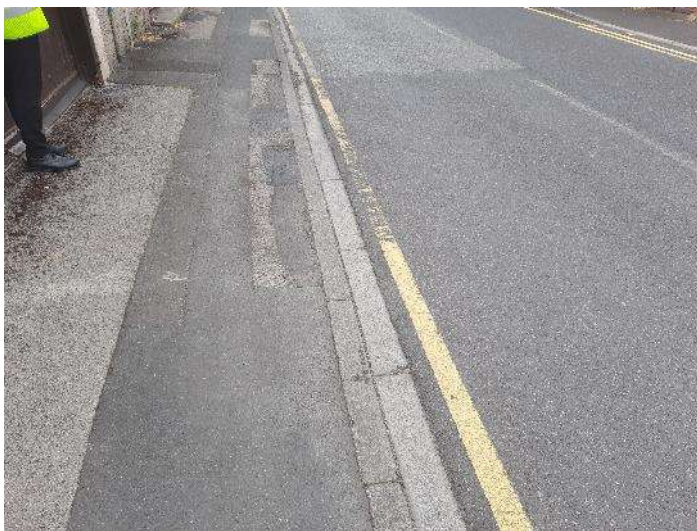
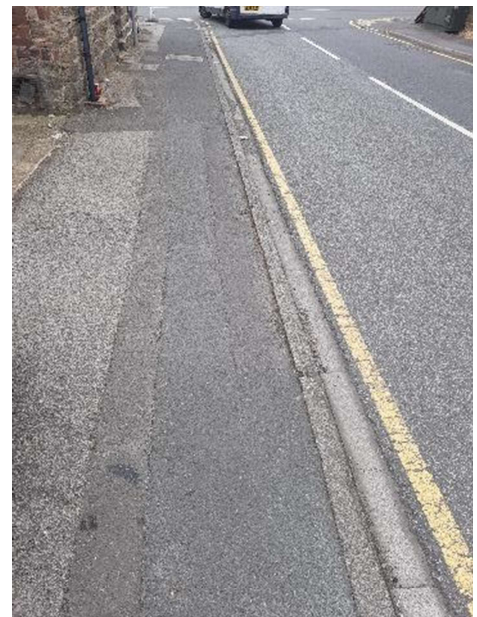
Images 3.19 (left) and 3.20 (right) – Springfield Street (south)

3.4.2 A strip of reinstated surface within the footway on the eastern side of the road, extending along the full length of Springfield Street (south) was observed to feature some localised pitting and cracking within the reinstated surface course (**Image 3.19**, approx. grid ref. 433720, 406327). Slightly to the south of this, an area of localised depression within the footway adjacent to the kerb edging was observed, along with some slight cracking within the original surface course (**Image 3.20**, approx. grid ref. 433722, 406307).

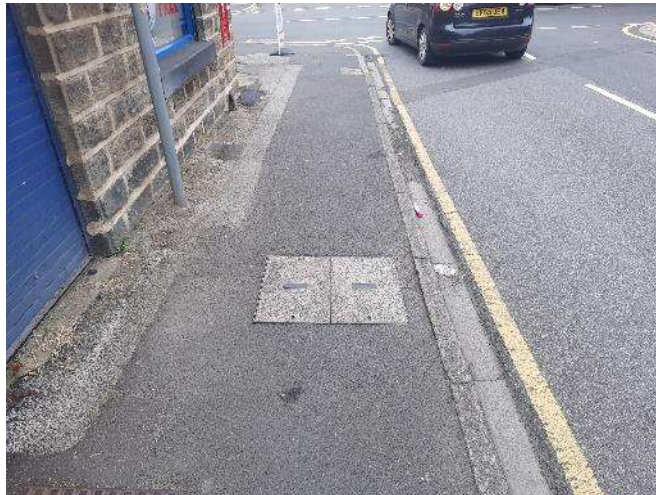
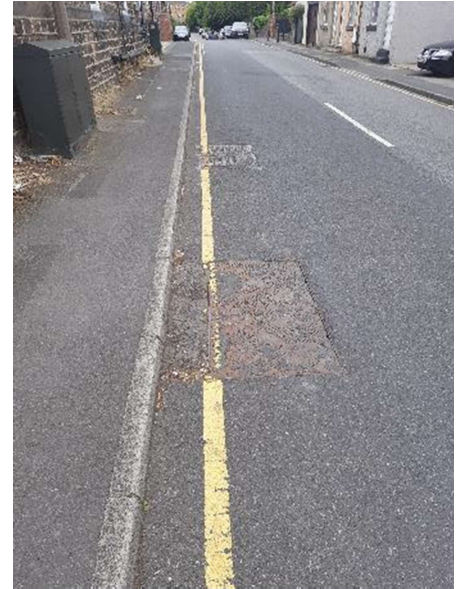
Images 3.21 (left) and 3.22 (right) – Springfield Street (south)

3.4.3 An existing service chamber hatch is present within the footway on the eastern side of Springfield Street just to the south of the junction with Dodworth Road (**Image 3.21**, approx. grid ref. 433722, 406300). Some localised pitting adjacent to the kerb edging was noted, but otherwise this was generally in good condition.

3.4.4 Opposite this, two service chamber access hatches are present within the carriageway on the northbound side of the road (**Image 3.21**, approx. grid ref. 433717, 406298). Next to the southernmost hatch there was a short strip of missing surface course between the hatch and the kerb. Otherwise, the carriageway and

footway in this vicinity was generally in good condition and was noted for further observation.

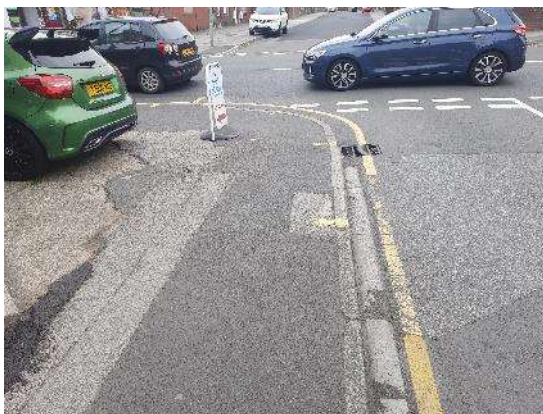
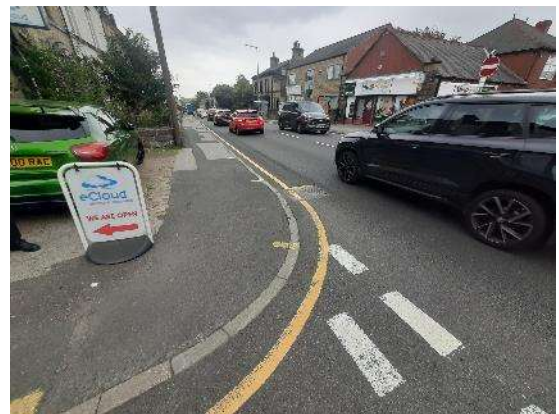
Images 3.23 (left) and 3.24 (right) – Springfield Street (south)

- 3.4.5 At the junction with Dodworth Road, the footway to the eastern side of the junction features extensive areas of reinstated surfacing (approx. grid ref. 433723, 406290). Some localised pitting was observed within the original surface course (**Image 3.23**), and there was some slight cracking of the kerbstones on the corner of the junction (**Image 3.24**). Otherwise, the footway on the eastern side of the Dodworth Road / Springfield Street junction was in generally good condition.

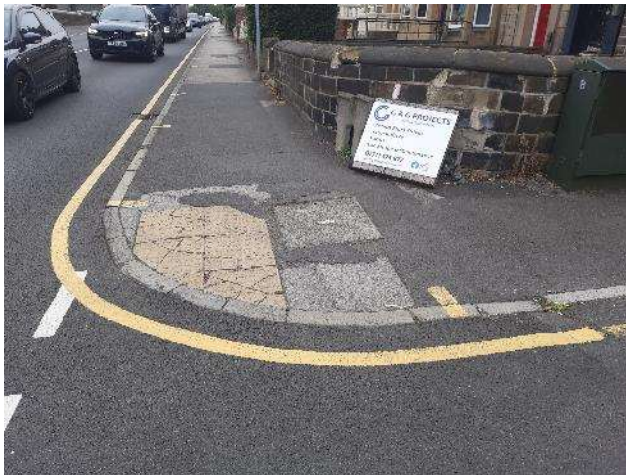
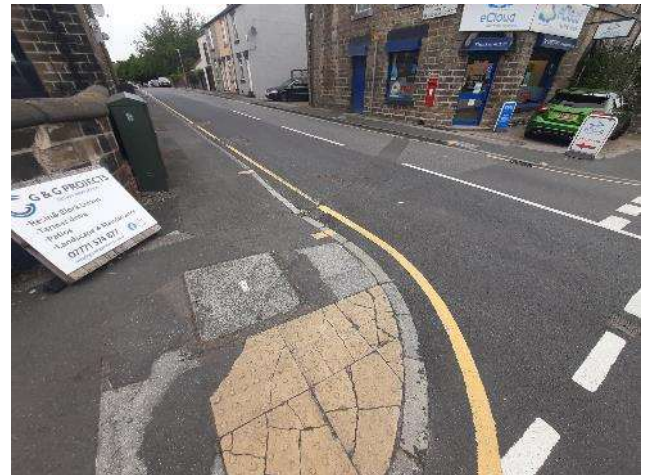
**Images 3.25 (left) and 3.26 (right) – Springfield Street (south)**

- 3.4.6 The tactile paving present on the western side of the junction was observed to be extensively cracked. There was also some slight cracking within the footway surface surrounding the tactile paving, and in the kerb edging adjacent to Dodworth Road (**Image 3.25**, approx. grid ref. 433716, 406290).

- 3.4.7 The carriageway along Dodworth Road in the vicinity of the junction with Springfield Street, including a short length of Springfield Street within the junction bell mouth, appeared to have been resurfaced relatively recently and so was in good condition. There is also a strip of reinstated surface stretching across the width of Springfield Street immediately adjacent to the junction with Dodworth Road (**Image 3.26**, approx. grid ref. 433719, 406394). No obvious defects were observed in relation to this, and the carriageway surface along Springfield Street between Dodworth Road and Perseverance Street was generally in good condition.

- 4.2.1 Some localised minor surface course repairs may be required at these locations in due course should any substantive deterioration over and above the identified pre-construction condition take place over the period of the construction project.
- 4.2.2 Should any substantive deterioration of these locations and / or any immediate sections of the local adopted highway be demonstrated to have been caused by site construction work / regular construction related deliveries to site, the developer / contractor will be required to undertake to repair any damage caused and make good any parts of the highway that are affected. The full extent of any such works would need to be agreed with the Local Highway Authority and delivered upon substantive completion of the construction work & prior to formal opening of the development.
