# OUGHTIBRIDGE MILL

**Tree Survey**  
March 2016

**ARBORICULTURAL REPORT  
to BS 5837:2012  
at  
Oughtibridge Mill  
Main Road  
Sheffield  
South Yorkshire  
S35 0DN**

**JCA Ref:**  
12563/AJB

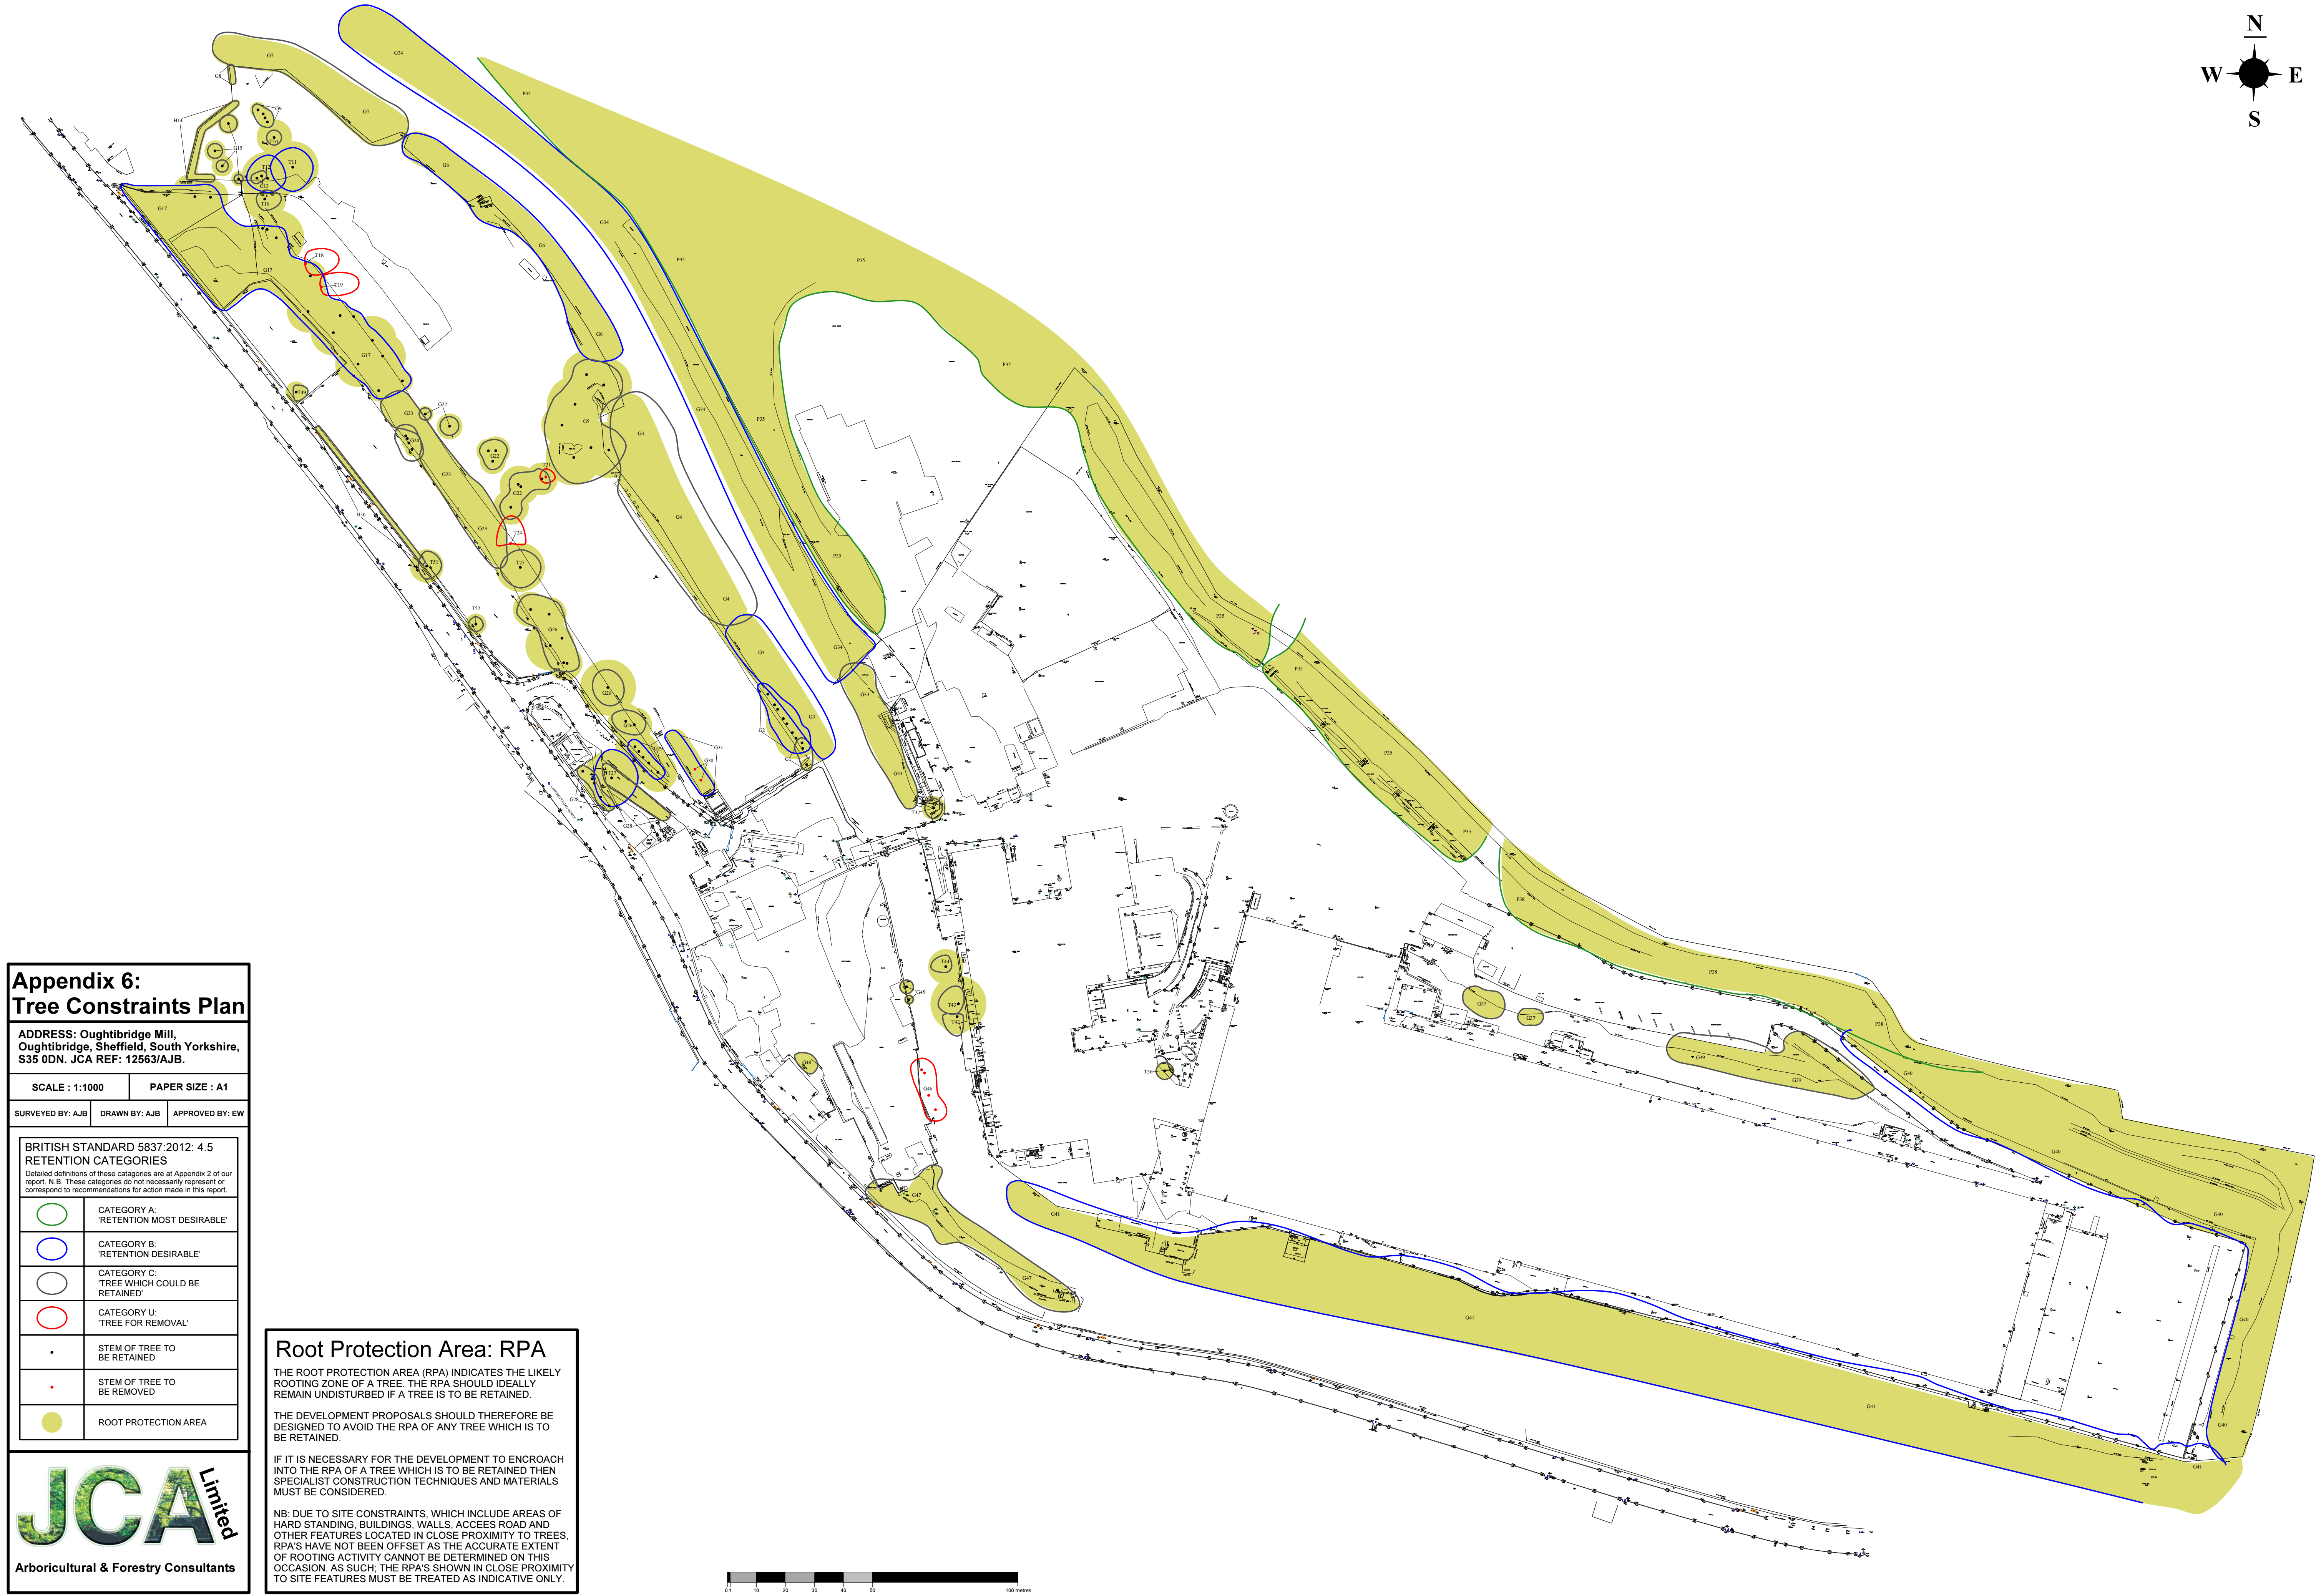
# Appendix 6: Tree Constraints Plan

- 5.2.1 **T18, T19, T21, T24, G30** and **G46** were identified as retention category 'U' due to the presence of defects detailed in **Appendix 1**. Due to the low public land use at present, the removal of these trees is of a **low priority**.

- 5.3.1 **Low** or **moderate priority** remedial tree works, as detailed in **Appendix 1**, have been recommended for **G5, T11, T12, G17, T25, T27** and **G47** in order to manage foreseeable risks, to prevent the development of defects or for general maintenance purposes.
- 5.3.2 Those trees which overhang public footpaths or public highways shall require future maintenance in order to maintain clearance heights for vehicular or pedestrian traffic. These heights should be 5.6m above a road and 2.5m above a footpath.
- 5.3.3 In addition to the remedial works highlighted, all trees to be retained within the site should be re-inspected on a regular basis in the interests of risk management.

- 5.4.1 **G4, G5, T11, T12, T16, G17, G22, T25, T27 and T49** were noted to have structural or physiological defects, as detailed at **Appendix 1**. Although these trees were considered to be in an acceptable condition at the time of the inspection, the defects observed may lead to their early demise or render them unsafe in the future. As such, if these trees are to be retained post-development, it is recommended that these trees be monitored (re-inspected and assessed) on an annual basis to assess if their condition is still acceptable (as advised at **Appendix 1**).
- 5.4.2 Where a full detailed inspection of trees was inhibited by restricted access or by the presence of Ivy or dense understorey vegetation, it is advised that these trees be re-inspected for any possible defects when the Ivy or dense understorey vegetation has been removed or when access has been made available.

- 6.3 **T18, T19, T21, T24, G30** and **G46** have been recommended for removal for arboricultural reasons, as discussed in **Section 5.2** and detailed at **Appendix 1**.

- 6.4 **G5, T11, T12, G17, T25, T27** and **G47** have been recommended for remedial works, as discussed in **Section 5.3** and detailed at **Appendix 1**.

- 6.5 **G4, G5, T11, T12, T16, G17, G22, T25, T27** and **T49** have been recommended for annual monitoring if they are to be retained post-development, as discussed in **Section 5.4** and detailed at **Appendix 1**.
