Belle Green Court Care Home, Cudworth

Bat Survey Report

24th January 2024

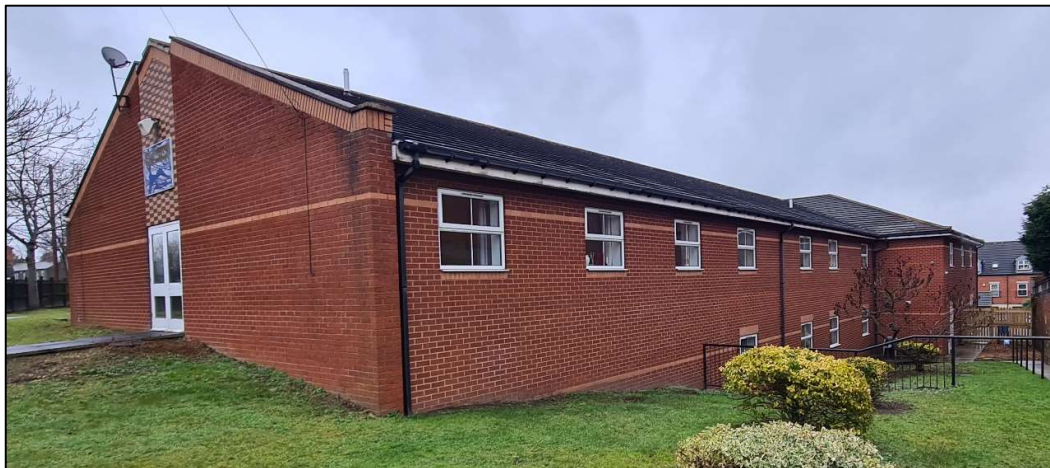
Plate 2. The southern elevation and southernmost gable of the care home

- 5.2.2 The care home was in good condition, the only potential bat roost features were gaps behind roofing felt on the parapet walls at the western gable ends. However, the felt was located over lead flashing and therefore overall, these features were considered to be of negligible suitability. The building was warm and dry.

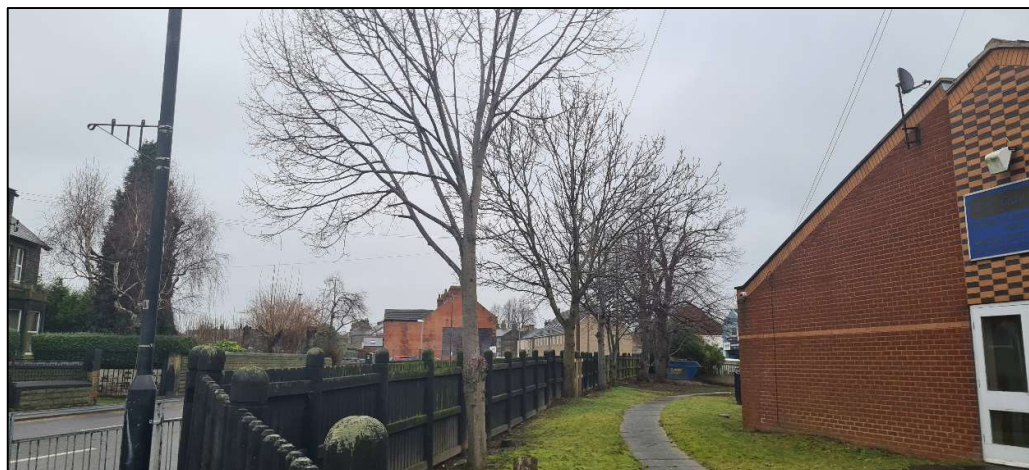
- 5.2.4 No bats or signs of bats were recorded in either building and the suitability of both was considered to be negligible.
- 5.2.5 The trees present within the site were considered unsuitable for use by roosting bats but were likely to be used by nesting birds.

5.2.8 The garden of the care home included semi-mature trees along Barnsley Road to the west and semi-mature shrubs in the centre of a patio area for residents which was sheltered to the north, east and south by the building (Plate 3). A line of Leyland cypress *Cupressus × leylandii* was also present along the eastern end of the former cinema.

Plate 3. Semi-mature trees along the western site boundary

6.2.2 It is recommended that vegetation clearance / demolition takes place outside the nesting bird season (March to August inclusive). If this is not possible a nesting bird check should be completed by an experienced ecologist within 48 hours of the work commencing.

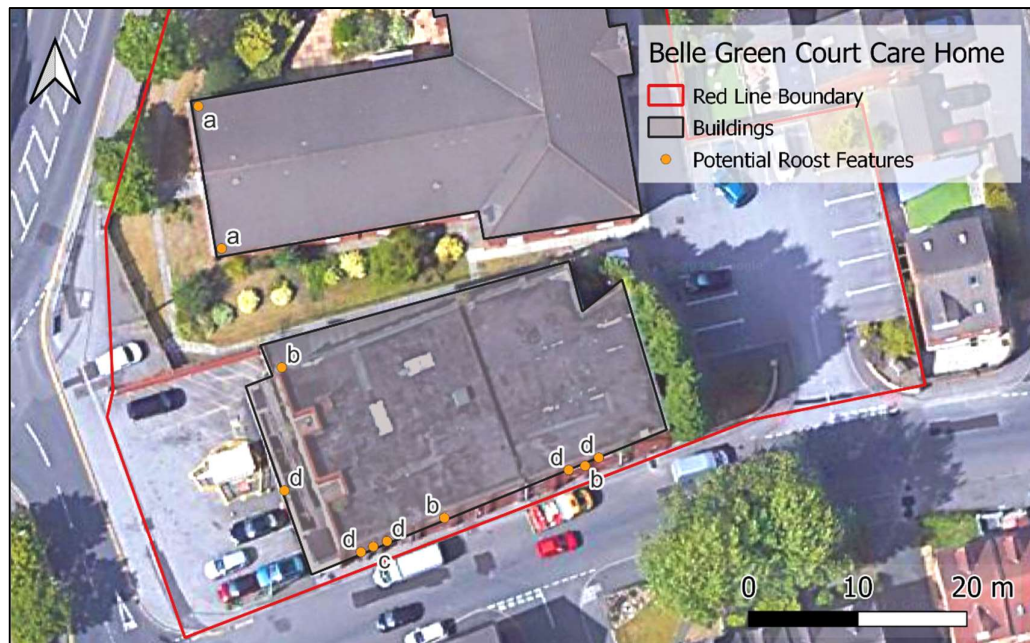
Figure 3. PRF Locations

5.2.9 The only potential bat roost feature identified on the care home were loose flashing on the back of the parapet walls on the gables. The potential roost features (PRFs) are shown in Table 3 and Figure 3 below.

PRF	Photo	Description
A		<p>Gap beneath flashing on the back of the gable parapets.</p>

5.2.10 While it is acknowledged that loose flashing in this sort of location can occasionally be used by roosting bats, it was considered that the lead soakers behind and below the flashing significantly reduced its suitability. Overall, these features were considered to be of negligible suitability.

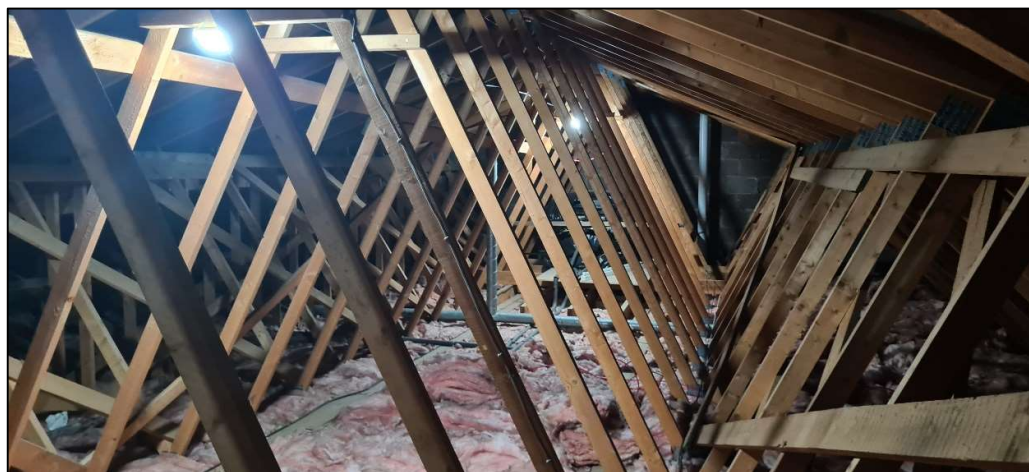
Plate 4. A typical roof void

- 5.2.11 The roof voids were approximately 3 m high and supported by modern prefabricated 'W' trusses (Plate 4). The tiles were backed by Type 1F bitumen felt. A small amount of damage to the felt was present below the valley at the southern end of the building but the lead within the valley appeared to be sufficiently tight to the tiles to prevent any access for bats.
- 5.2.12 Approximately 300 mm of insulation was present above the ceilings. No bats or signs of bat activity were recorded.

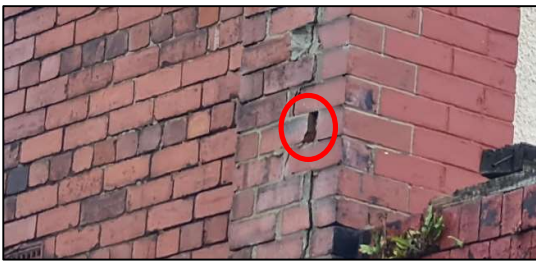
Cracks in the brickwork. The crack on the northern side of the building (pictured) was at a height of approximately 3 m, the cracks on the southern elevation were all at low level – approximately 1m.
C

5.2.16 The crack in the brickwork pictured as PRF B in Table 4 was checked with binoculars and a high powered cluelight torch and considered to have been thoroughly checked, the other low-level cracks in the brick work were inspected thoroughly at close range with a torch and endoscope.

6.1.1 The PRFs on the care home were located on the western gables. These features are unlikely to be impacted by the proposed works. The PRFs on the former cinema were considered to be of negligible suitability to be used by roosting bats. The cracks in the brickwork narrowed quickly and were mostly located at a low level. The barred open window and the gaps above the roller doors potentially allowed bats into the interior of the building but no signs of bat presence were visible and it is considered likely that bat droppings on walls would have been present if bats were using the interior of the building.

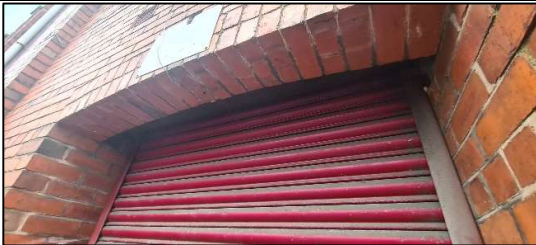
Gaps above roller doors.

5.2.17 PRFs C and D allowed bats access into the building but did not provide a suitable roost in themselves.

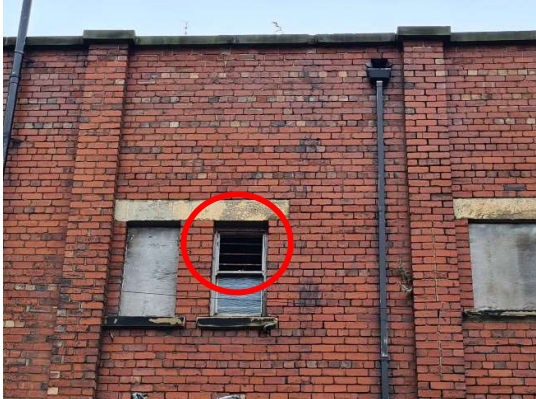
<p>Open, barred window leading into the former cinema building.</p>

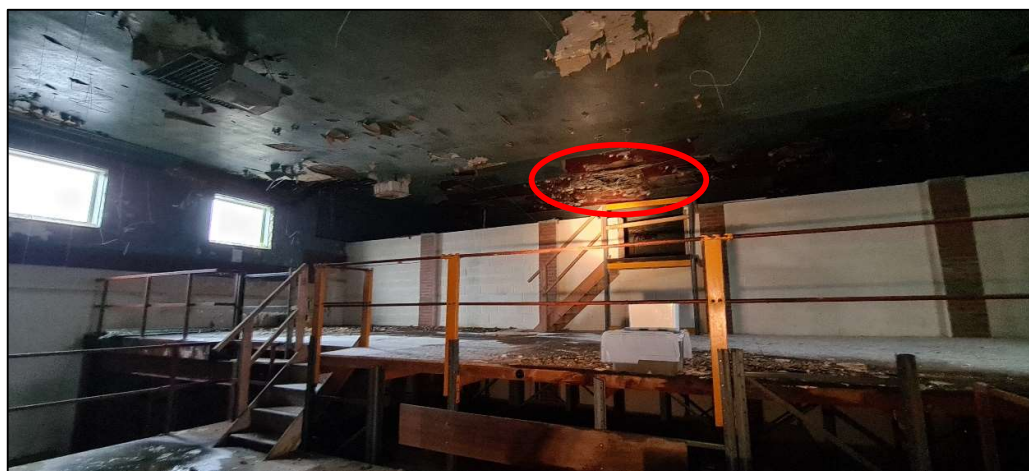
5.2.18 The interior of the building was very wet. The ceiling had been damaged and in places the plaster had fallen off exposing the laths above (Plate 6). The roof was constructed from concrete and the internal floors included steel and wooden beams. The foyer at the front of the building had a suspended ceiling which had almost entirely fallen down (Plate 7). Hanging cobwebs were present in that area.

Plate 6. damaged ceiling with laths (circled red) visible

5.2.19 Although rotten flooring and ceiling meant that health and safety concerns prevented access onto the platform (shown in Plate 6), the space could be viewed relatively clearly from the safely accessible areas and the white painted walls meant that it was considered relatively likely that any droppings on the walls in these inaccessible locations would have been recorded.

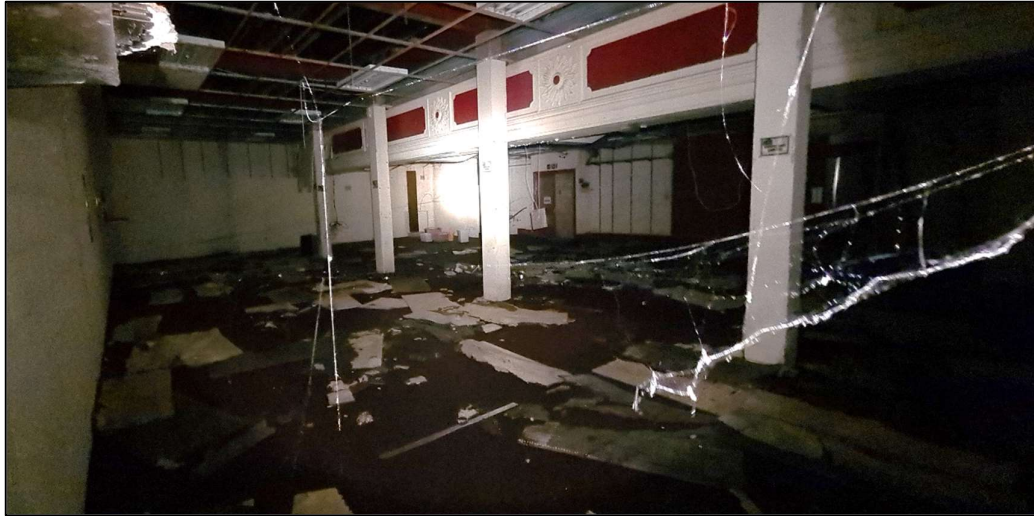
Plate 7. The foyer with very few suspended ceiling tiles remaining and hanging cobwebs shown
