Wakefield Road, Mapplewell Highway Condition Survey 1

June 2026 (Initial Issue)

Prepared on behalf of
Vistry West Yorkshire

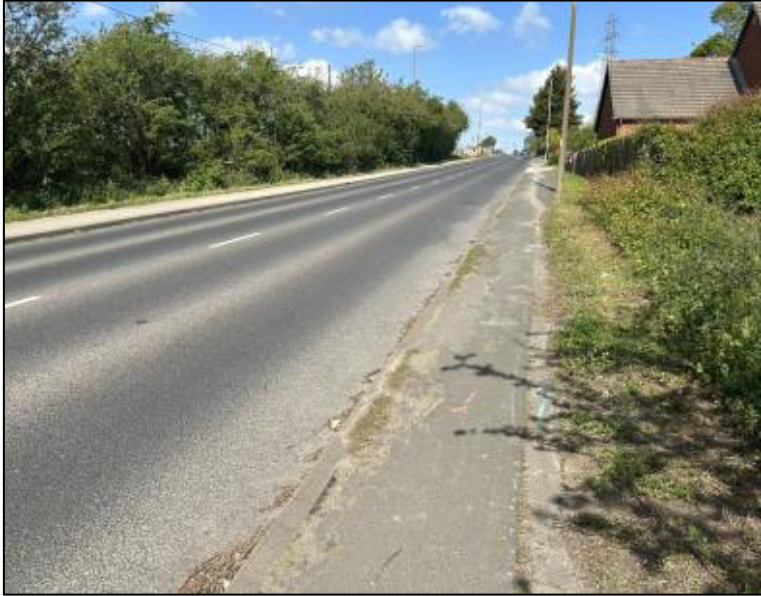
Table 2.8 Defect 8 (Image 64-72)

DEFECT	
Location	A61 Wakefield Road
Summary	<ul style="list-style-type: none">• Footway fretting• Footway cracking

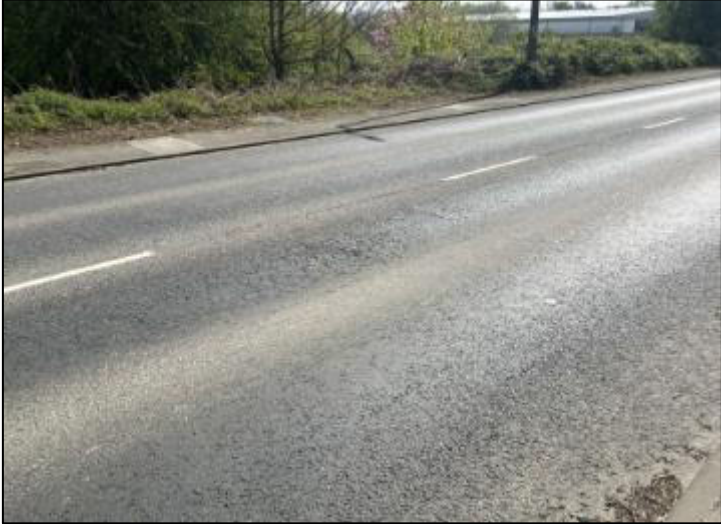
Table 2.10 Defect 1 (Images 7-9)

DEFECT	
Location	A61 Wakefield Road
Summary	<ul style="list-style-type: none">• Fretting• Fatting

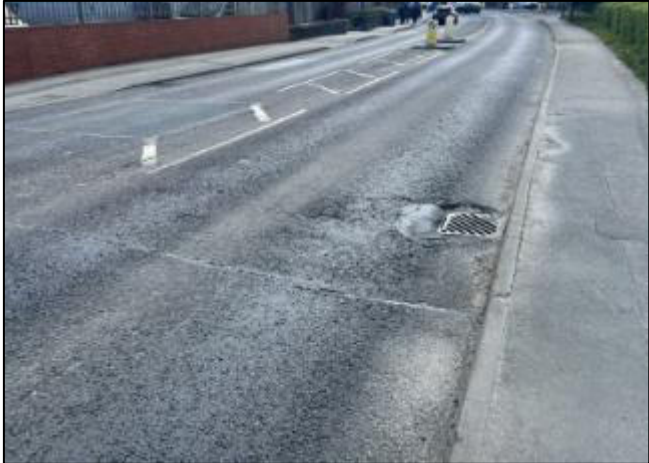
Table 2.11 Defect 2 (Images 39-41)

DEFECT	
Location	A61 Wakefield Road
Summary	<ul style="list-style-type: none">• Fretting• Cracking• Damaged ironworks

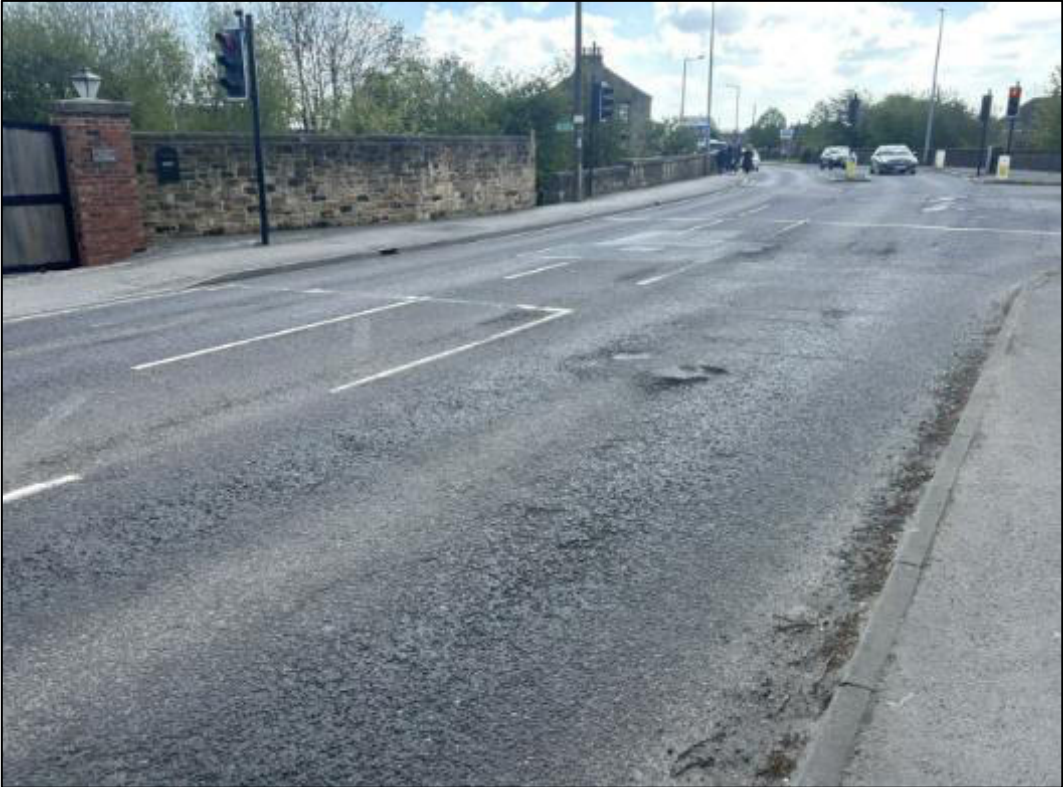
Table 2.12 Defect 3 (Images 47-54)

DEFECT	
Location	A61 Wakefield Road
Summary	<ul style="list-style-type: none">• Fretting• Cracking• Potholes

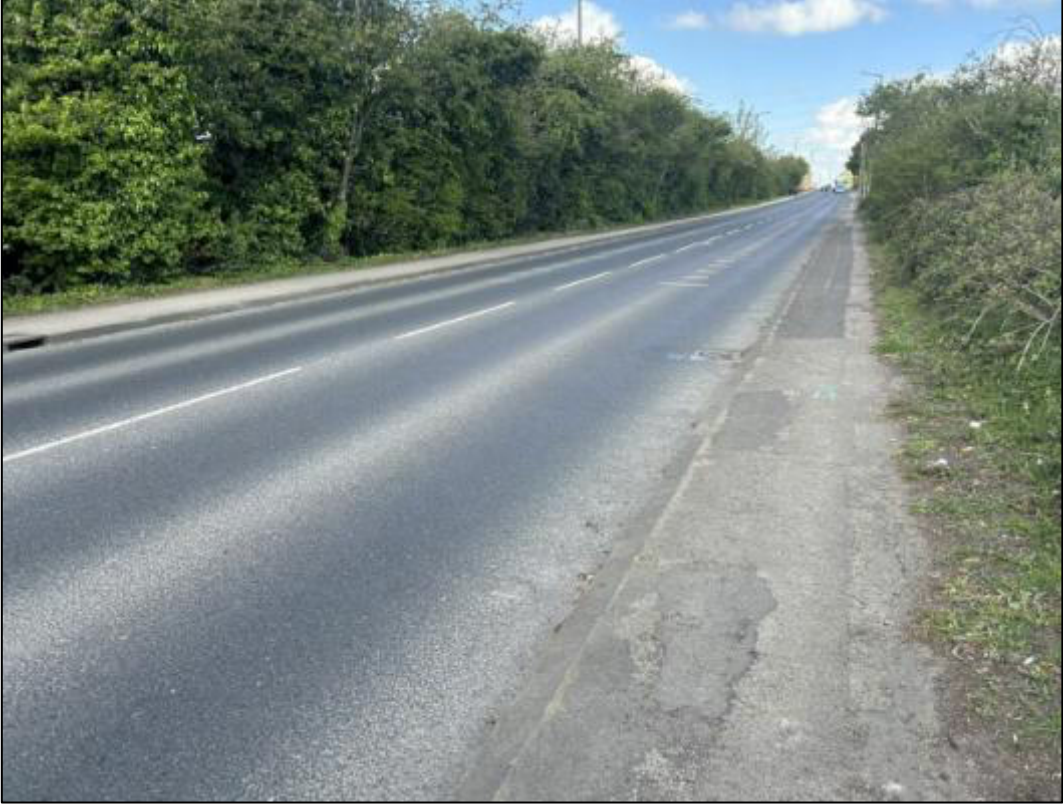
Table 2.13 Defect 4 (Images 91)

DEFECT	
Location	A61 Wakefield Road
Summary	<ul style="list-style-type: none">• Footway fretting

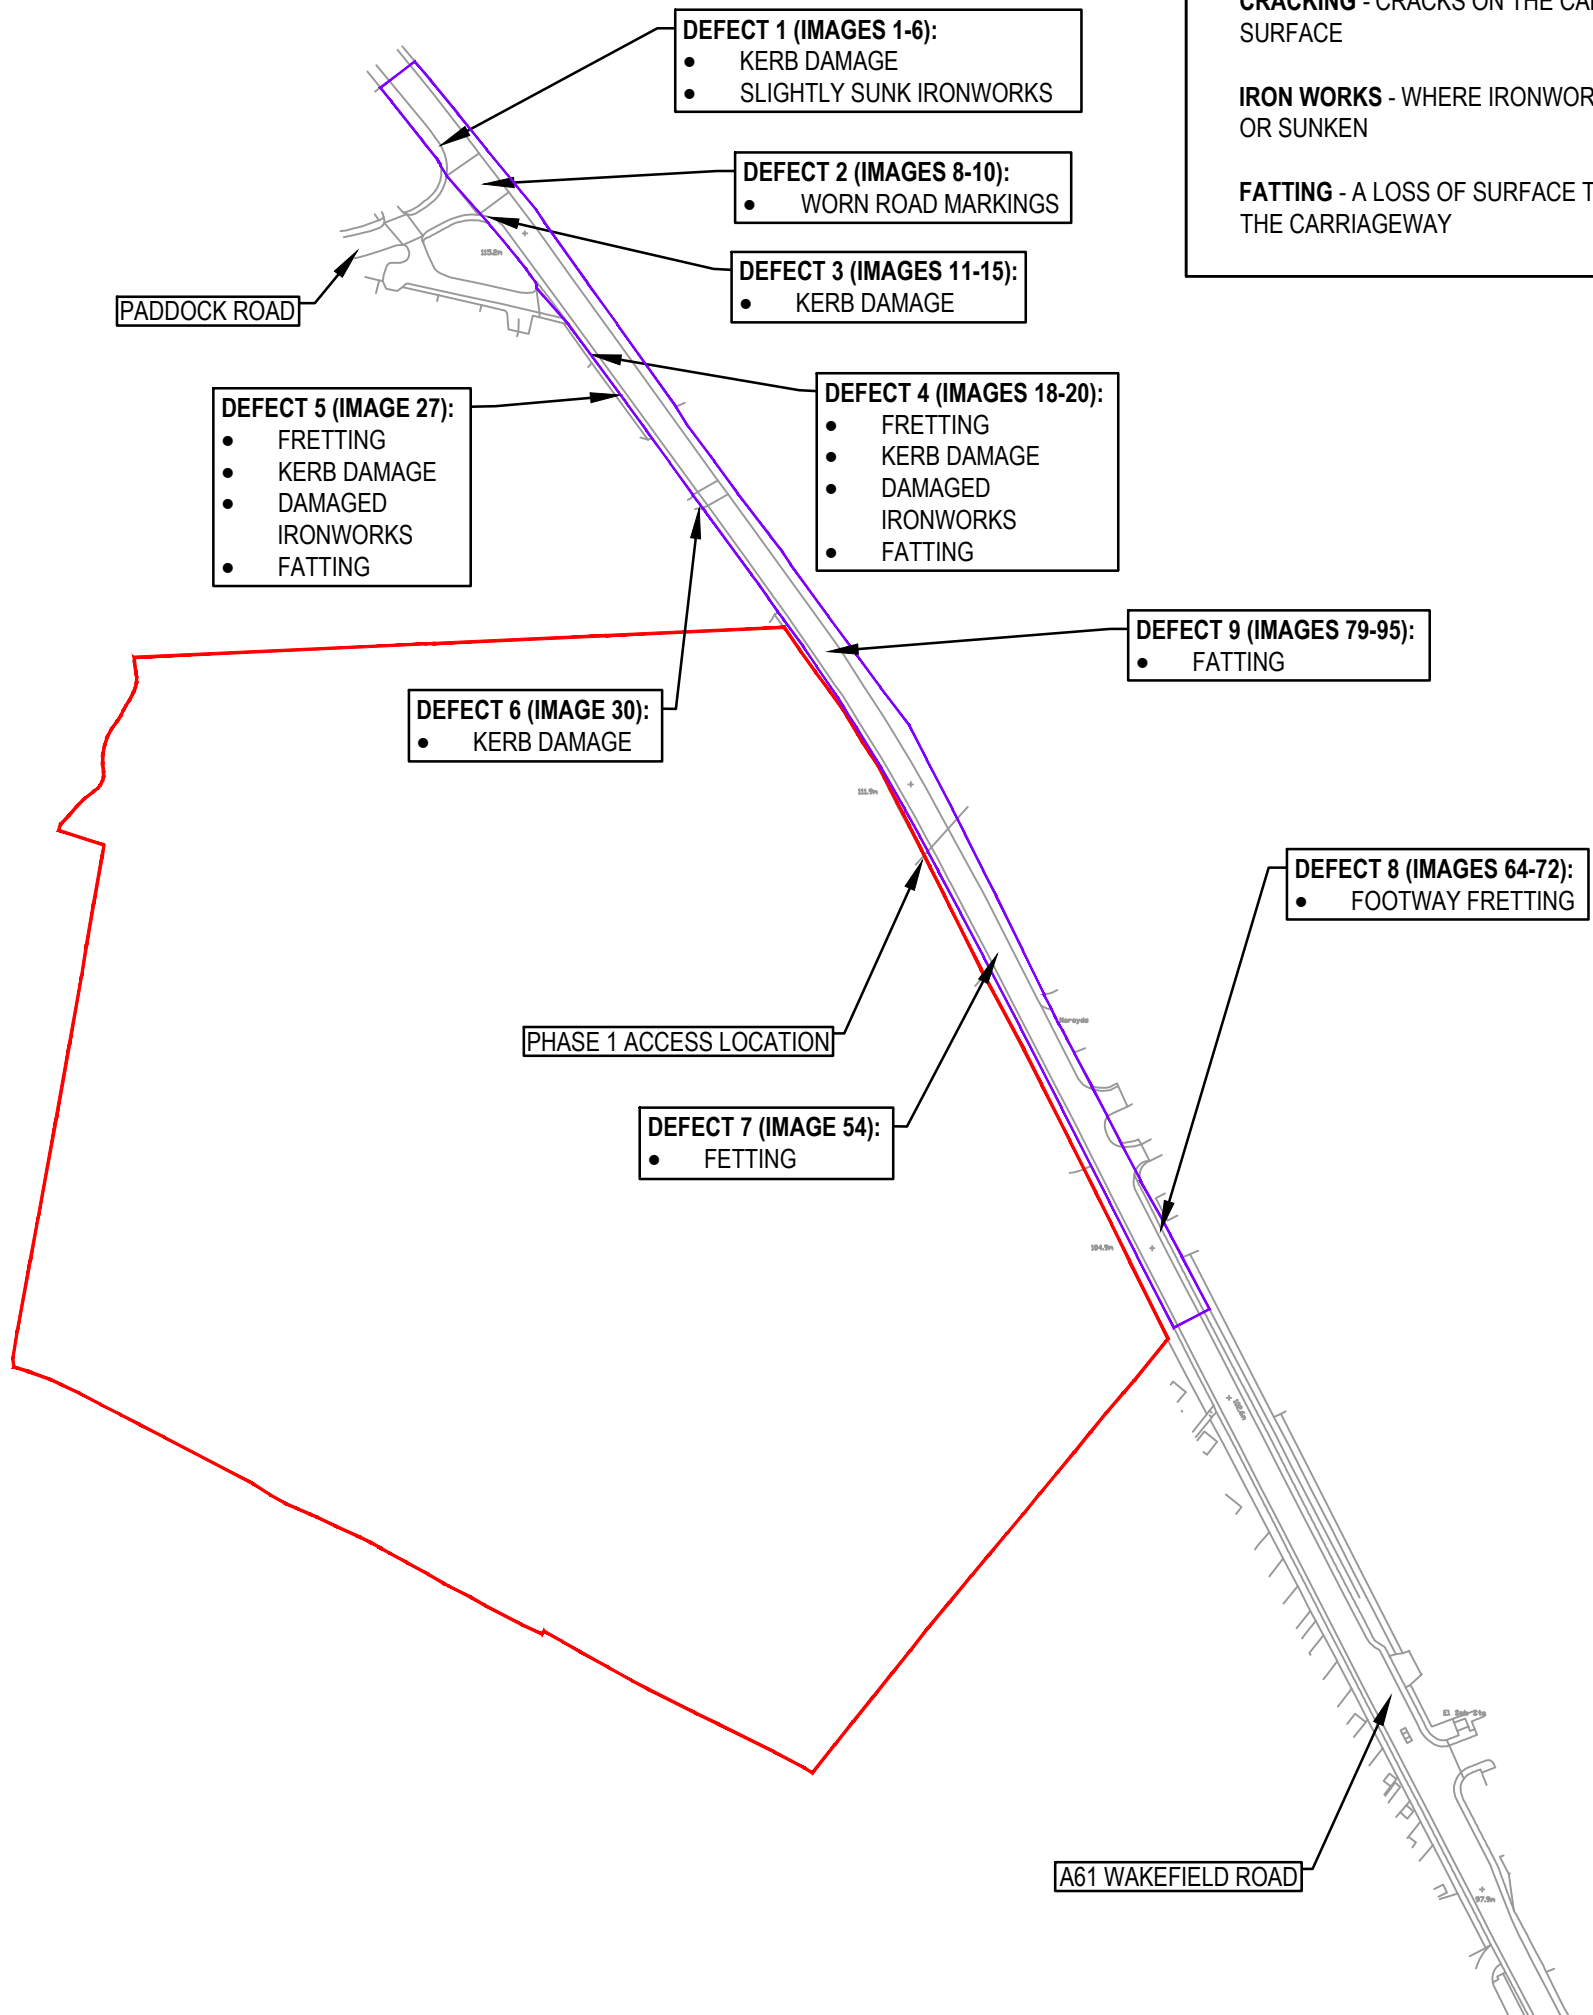
TITLE	WAKEFIELD ROAD, MAPPLEWELL HIGHWAY CONDITION SURVEY - SECTION 1 - DEFECT LOCATIONS
REF	26039/IN/03
SCALE	1:2,500@A3

2.1.4 Major areas of deterioration and isolated defects along Section 1 are identified below and illustrated on drawing 26039/IN/03 contained at Appendix D.
