CANNON HALL PARK

WALLED GARDEN SURVEY

BAART HARRIES NEWALL
architects

2577-REP7-15.07.15
15 July 2015

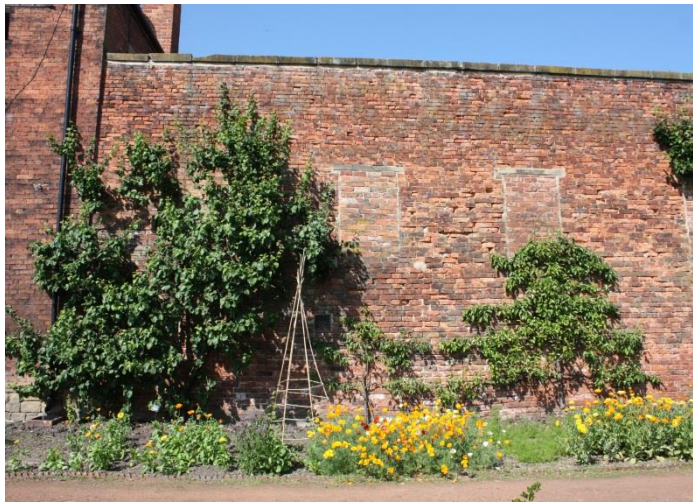
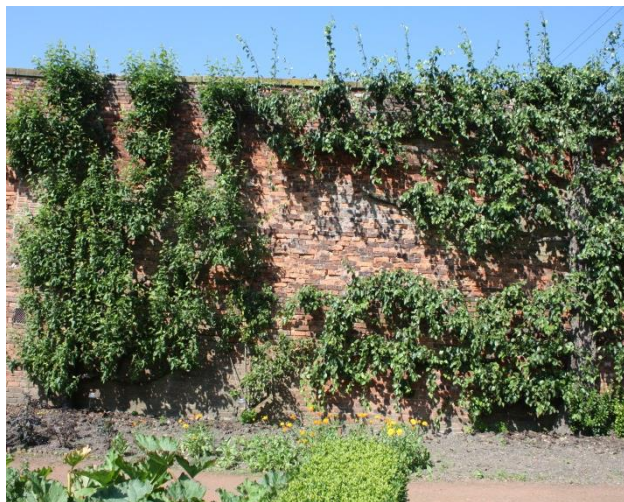
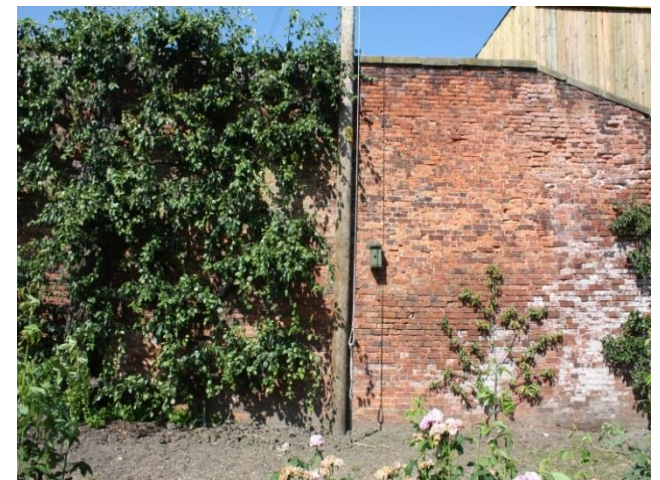
WALLED GARDEN – 0 to 30m

Section	Construction	Repairs	Height of wall
0 – 10m	Soft clay stock brickwork in varied bond, partly in English garden wall bond – suggesting a 225mm deep brick face. Two bricked up former window openings, and clay air vents.	Cut in approx. 55 matching bricks.	5130 to u/s pf coping
	Lime mortar pointing.	Repoint using NHL 3.5 lime mortar.	
	150mm deep stone copings.	Rebed and point using NHL 5 lime mortar.	
10 – 20m	Soft clay stock brickwork in varied bond, partly in English garden wall bond – suggesting a 225mm deep brick face. Bricked up former window openings, and clay air vents.	Cut in approx. 25 matching bricks.	5130 to u/s pf coping
	Lime mortar pointing.	Repoint using NHL 3.5 lime mortar.	
	150mm deep stone copings.	Rebed and point using NHL 5 lime mortar.	
20 – 30m	Soft clay stock brickwork in varied bond, partly in English garden wall bond – suggesting a 225mm deep brick face. Telegraph post at 25m. Wall slopes down to lower level from 28 to 32m.	Cut in approx. 35 matching bricks.	5130 to u/s pf coping

Lime mortar pointing.	Repoint using NHL 3.5 lime mortar.	
	150mm deep stone copings.	Rebed and point using NHL 5 lime mortar.

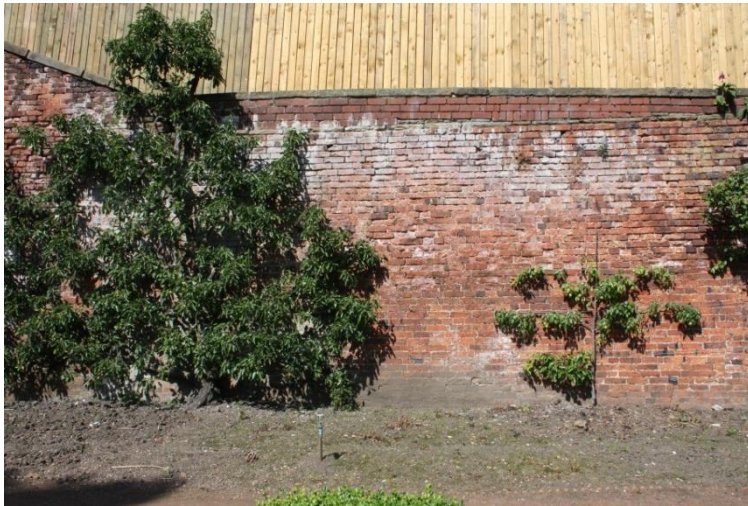
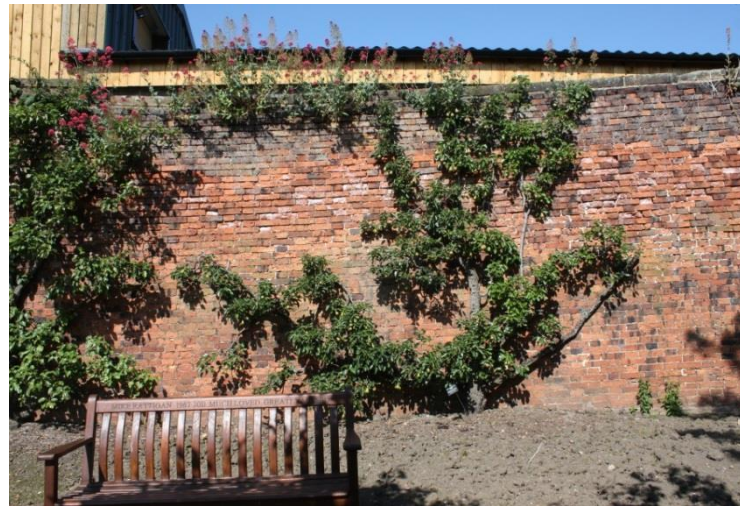
WALLED GARDEN – 30 to 50m

Section	Construction	Repairs	Height of wall
30 – 40m	Soft clay stock brickwork in varied bond, partly in English garden wall bond – suggesting a 225mm deep brick face. 4 – 2 tapering courses of engineering brick on top of an old 65mm stone coping. Section of dislodge brickwork at foot of sloping section at 32m.	Cut in approx. 30 matching bricks. Rebuild approx. 6 courses x 0.5m length.	3500 to u/s pf coping
	Lime mortar pointing.	Repoint using NHL 3.5 lime mortar.	
	150mm deep stone copings.	Rebed and point using NHL 5 lime mortar.	
40 – 50m	Soft clay stock brickwork in varied bond, partly in English garden wall bond – suggesting a 225mm deep brick face. 200mm step down at 42m. top of wall slopes down, then back up again.	Cut in approx. 20 matching bricks. Weedkill and remove buddleias.	3450 to u/s pf coping
	Lime mortar pointing.	Repoint using NHL 3.5 lime mortar.	
	150mm deep stone copings.	Rebed and point using NHL 5 lime mortar.

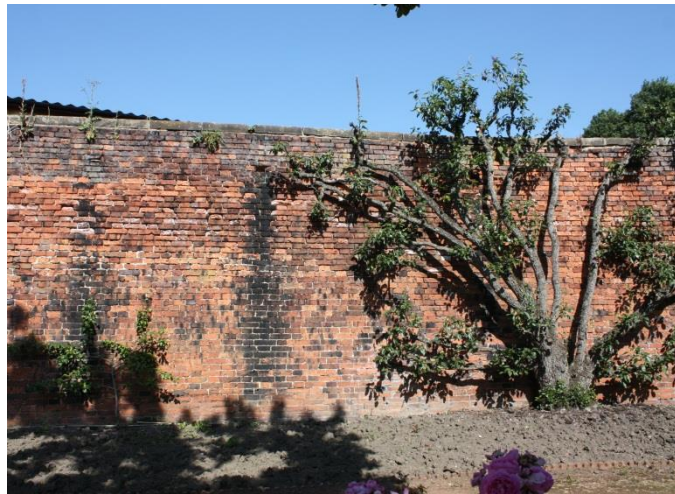
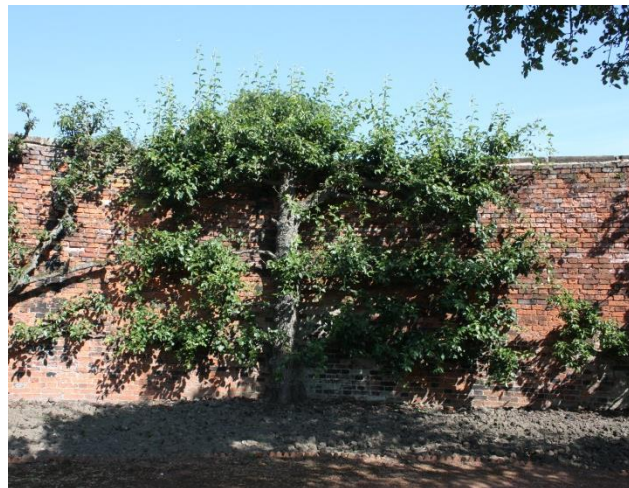
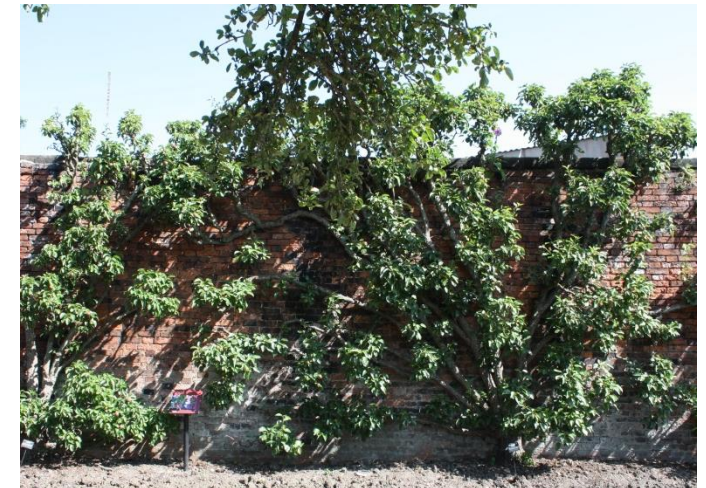
WALLED GARDEN – 50 to 70m

Section	Construction	Repairs	Height of wall
50 – 60m	Soft clay stock brickwork in varied bond, partly in English garden wall bond – suggesting a 225mm deep brick face. Brick courses following downward slope of the ground. Bees nest beneath coping.	Cut in approx. 6 matching bricks.	3250 to u/s pf coping
	Lime mortar pointing.	Repoint using NHL 3.5 lime mortar.	
	150mm deep stone copings.	Rebed and point using NHL 5 lime mortar.	
60 – 70m	Soft clay stock brickwork in varied bond, partly in English garden wall bond – suggesting a 225mm deep brick face. Vertical joint where old gateway infilled,	Cut in approx. 6 matching bricks. Stick vertical joint through 8 courses, with matching bricks.	3260 to u/s pf coping
	Lime mortar pointing.	Repoint using NHL 3.5 lime mortar.	
	150mm deep stone copings. 3m in poor conditions.	Rebed and point using NHL 5 lime mortar. Replace 3m of matching stone copings.

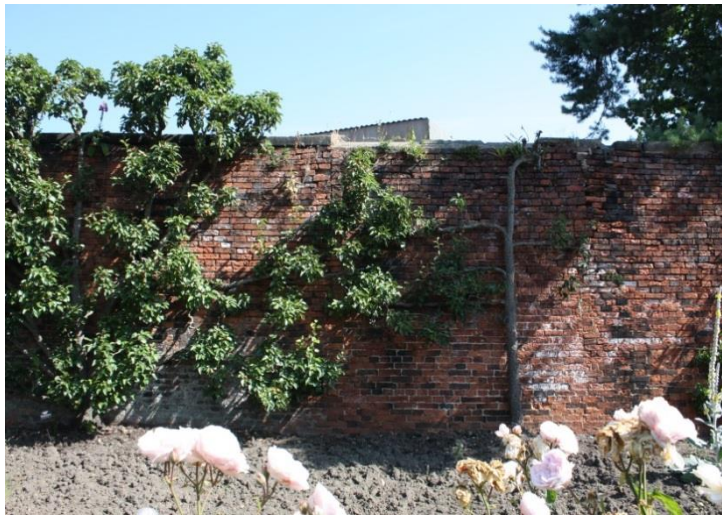
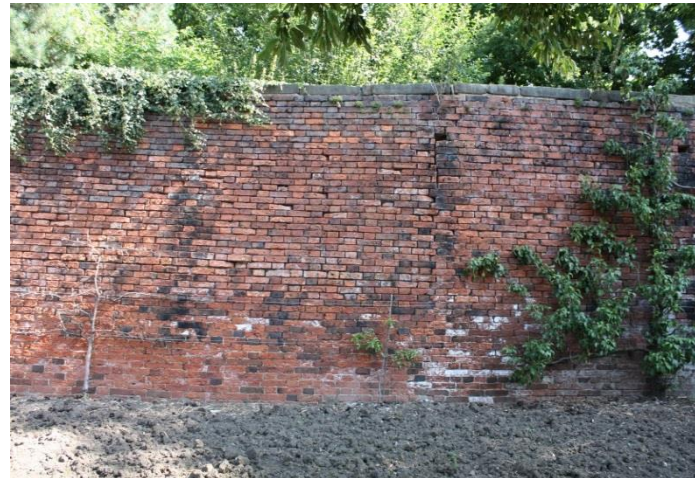
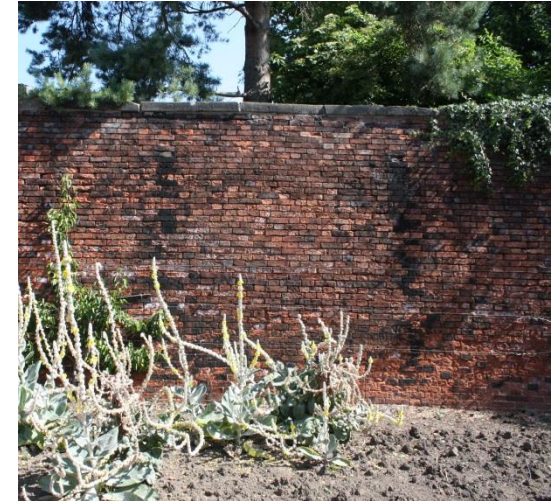
WALLED GARDEN 70 to 85m

Section	Construction	Repairs	Height of wall
70 – 80m	Soft clay stock brickwork in varied bond, partly in English garden wall bond – suggesting a 225mm deep brick face. Slight backward lean to wall face.	Cut in approx. 12 matching bricks.	3360 to u/s pf coping
	Lime mortar pointing.	Repoint using NHL 3.5 lime mortar.	
	150mm deep stone copings.	Rebed and point using NHL 5 lime mortar.	
80 – 90m	Soft clay stock brickwork in varied bond, partly in English garden wall bond – suggesting a 225mm deep brick face. Vertical joint through 5 courses at 83m, Outward bulge to brick facing, starting at 89m.	Cut in approx. 25 matching bricks. Stick vertical joint through 5 courses, with matching bricks.	3260 to u/s pf coping
	Lime mortar pointing.	Repoint using NHL 3.5 lime mortar.	
	150mm deep stone copings.	Rebed and point using NHL 5 lime mortar.

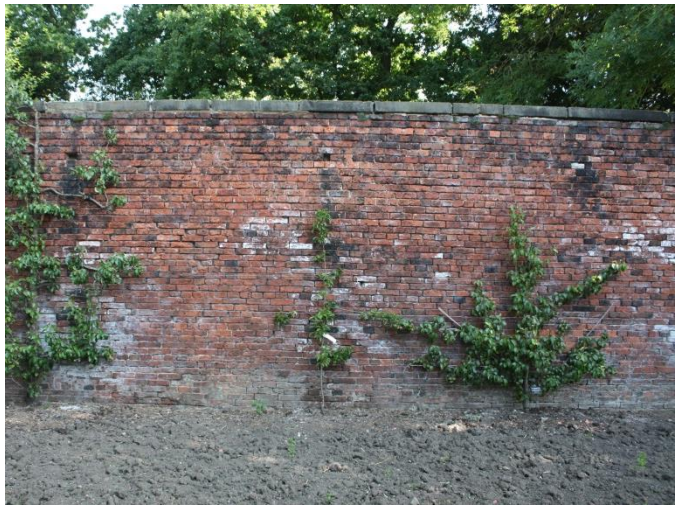
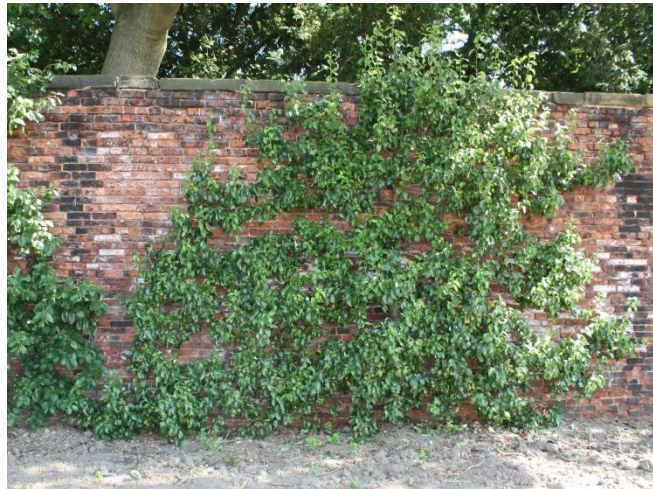
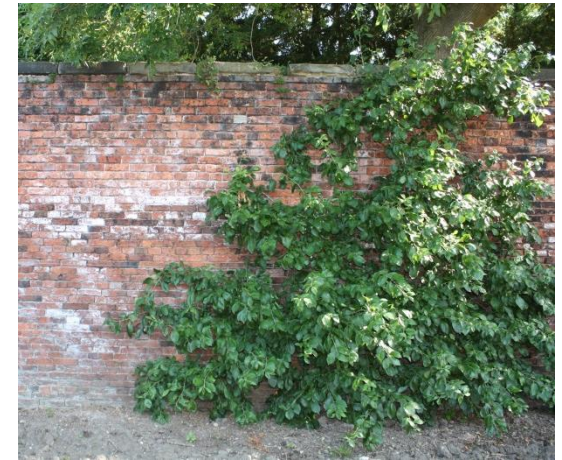
WALLED GARDEN - 85 to 100m

Section	Construction	Repairs	Height of wall
90 – 100m	Soft clay stock brickwork in varied bond, partly in English garden wall bond – suggesting a 225mm deep brick face. Outward bulge from 89 to 100m.	Cut in approx.5 matching bricks. Engineers report required.	3280 to u/s pf coping
	Lime mortar pointing.	Repoint using NHL 3.5 lime mortar.	
	150mm deep stone copings.	Rebed and point using NHL 5 lime mortar.

A structural engineers report should be obtained for the bulging section at 90 to 100m.

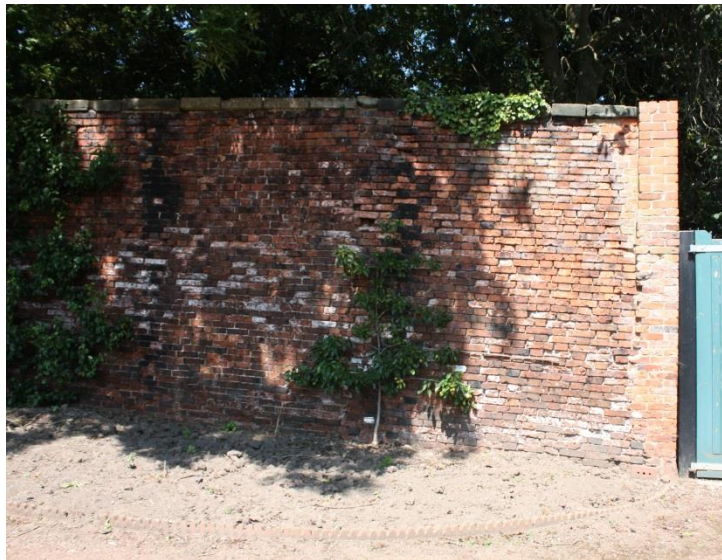
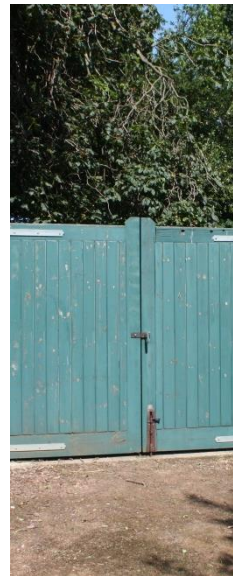
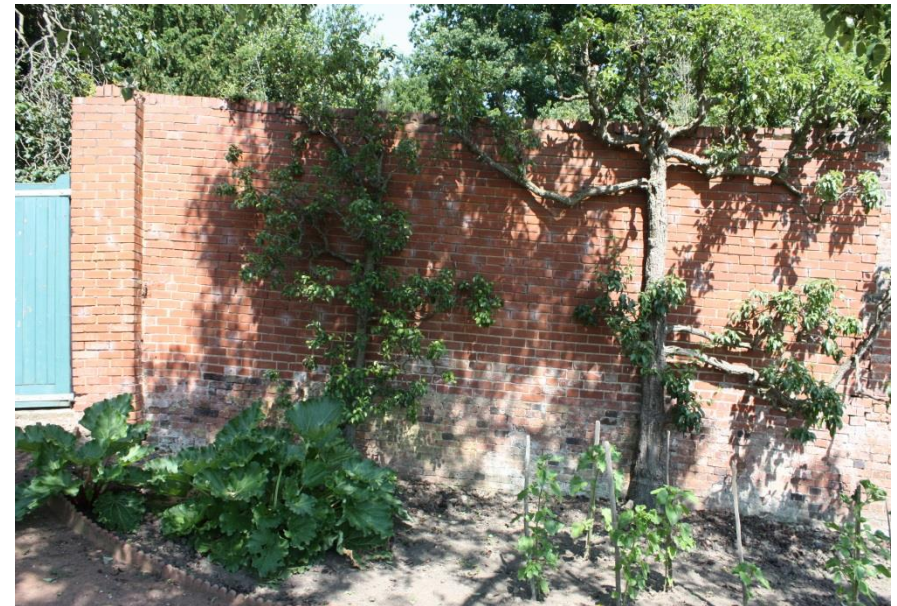
WALLED GARDEN – 100 to 120m

Section	Construction	Repairs	Height of wall
100 – 110m	Soft clay stock brickwork in varied bond, partly in English garden wall bond – suggesting a 225mm deep brick face. LH gate post in modern red engineering brick. Vertical joint through 15 courses at 108m.	Cut in approx. 15 matching bricks. Stitch vertical joint through 15 courses with matching brick.	3360 to u/s pf coping
	Lime mortar pointing. Cement pointing to newer brick gate post	Repoint using NHL 3.5 lime mortar. Rake out cement mortar and repoint with lime.	
	150mm deep stone copings.	Rebed and point using NHL 5 lime mortar.	
110 – 120m	Modern red engineering brick built on top of 12 courses of original brick. Wall head steps up 200mm at 120m,		2400 to u/s pf coping at RH gate pier
	Lime mortar pointing to lower 12 courses. Cement mortar pointing to new brick.	Rake out cement mortar and repoint using NHL 3.5 lime mortar.	
	Brick on edge coping – breaking up from frost action.	Replace with matching stone copings, bed and point using NHL 5 lime mortar.

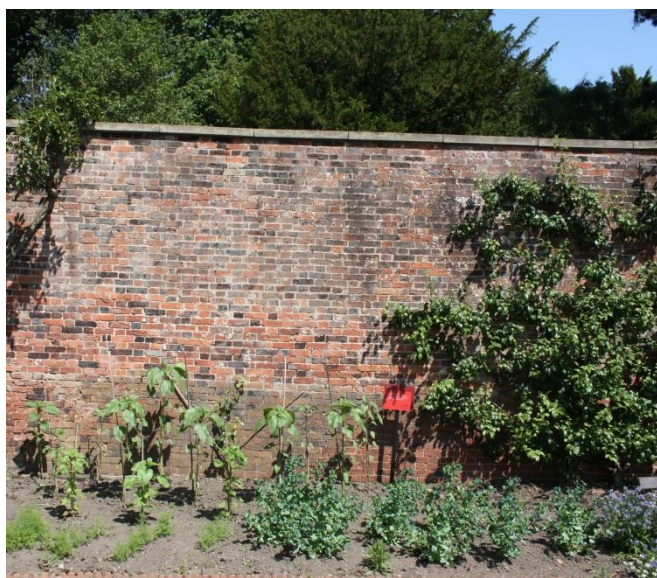
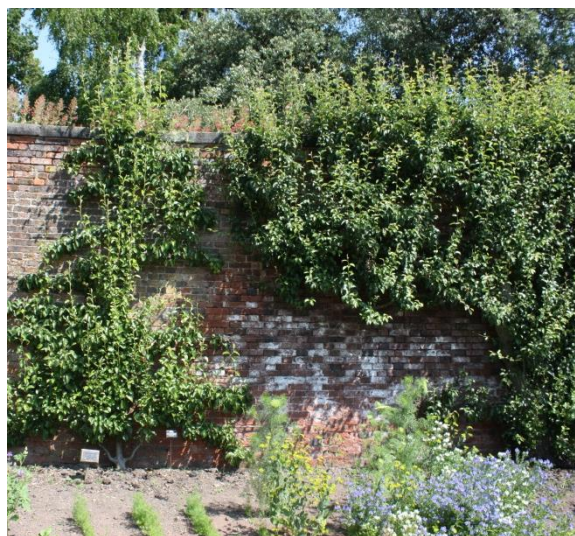
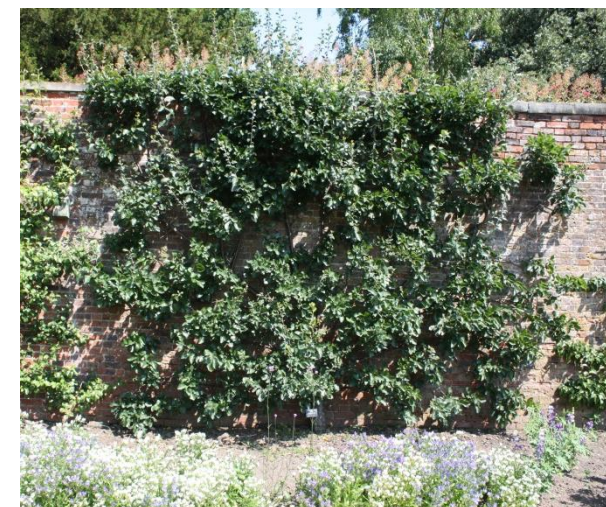
WALLED GARDEN – 120 to 135m

Section	Construction	Repairs	Height of wall
120 – 130m	Soft clay stock brickwork in varied bond, partly in English garden wall bond – suggesting a 225mm deep brick face.		3650 to u/s pf coping
	Lime mortar pointing.		
	150mm concrete copings.	Replace with matching stone copings, bed and point using NHL 5 lime mortar.	
130 – 140m	Soft clay stock brickwork in varied bond, partly in English garden wall bond – suggesting a 225mm deep brick face.		3400 to u/s pf coping
	Lime mortar pointing.	Repoint top 8 courses with NHL 3.5 lime mortar.	
	150mm deep stone copings.	Rebed and point using NHL 5 lime mortar.

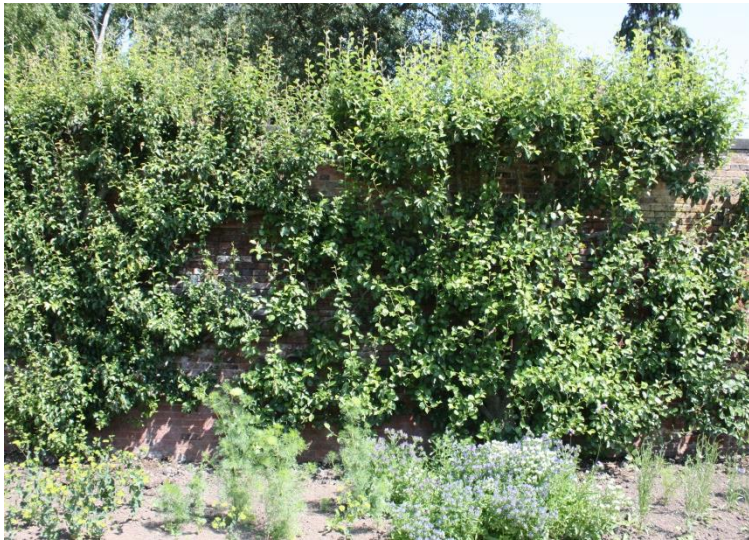
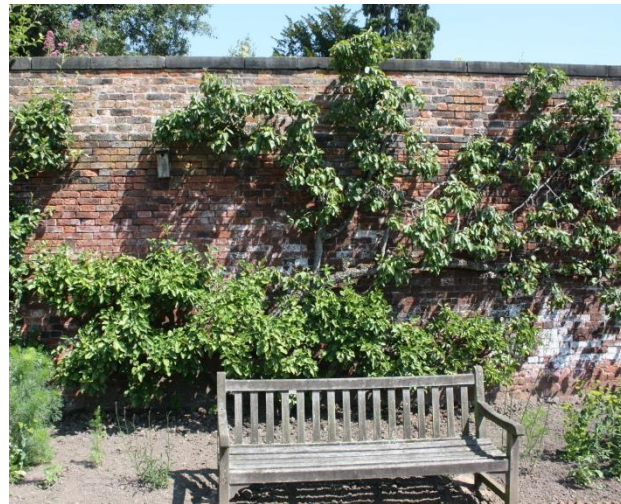
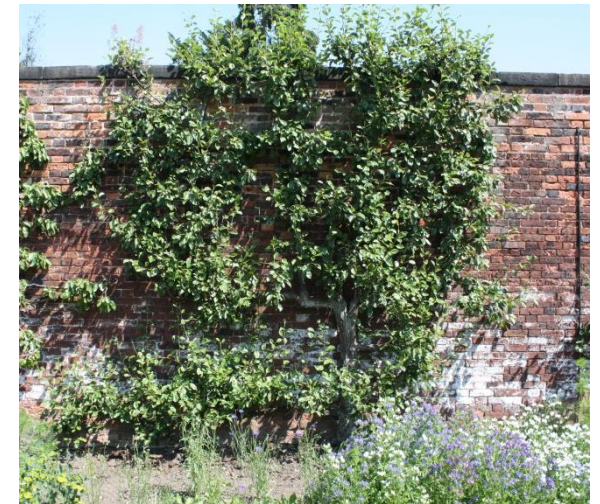
WALLED GARDEN – 135 to 150m

Section	Construction	Repairs	Height of wall
140 – 150m	Soft clay stock brickwork in varied bond, partly in English garden wall bond – suggesting a 225mm deep brick face.		3300 to u/s pf coping
	Lime mortar pointing.	Repoint 3 m2 using NHL 3.5 lime mortar.	
	150mm deep stone copings.	Rebed and point using NHL 5 lime mortar.

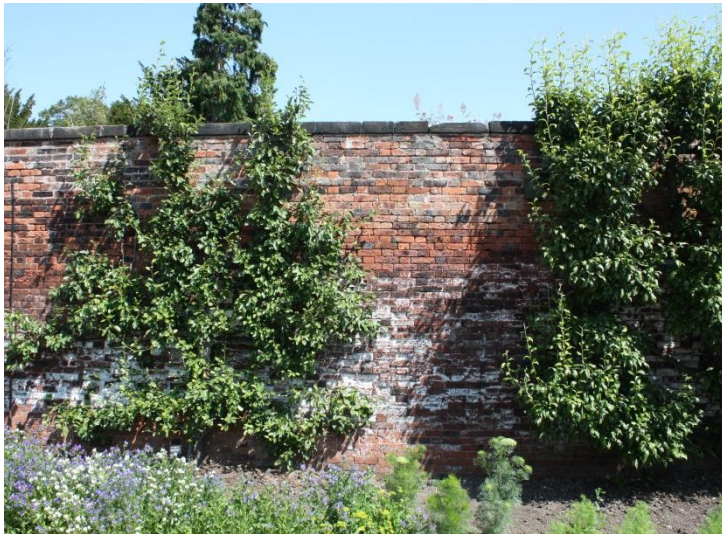
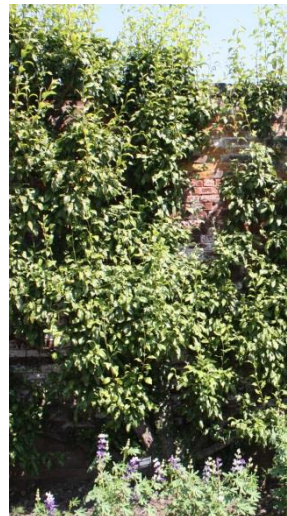
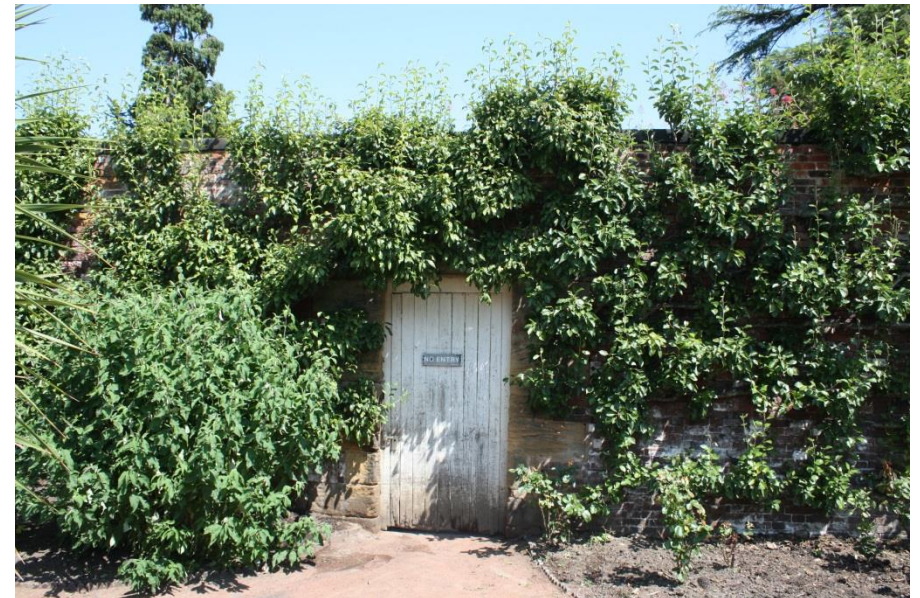
WALLED GARDEN – 150 to 170m

Section	Construction	Repairs	Height of wall
150 – 160m	Soft clay stock brickwork in varied bond, partly in English garden wall bond – suggesting a 225mm deep brick face. Electric cable at 151m.		3400 to u/s pf coping
	Lime mortar pointing.	Repoint 3m2 using NHL 3.5 lime mortar.	
	150mm stone copings.	Rebed and point using NHL 5 lime mortar.	
160 – 170m	Soft clay stock brickwork in varied bond, partly in English garden wall bond – suggesting a 225mm deep brick face. Pedestrian gate at 162 -163m.		3450 to u/s pf coping
	Lime mortar pointing.	Repoint 2m2 using NHL 3.5 lime mortar.	
	150mm deep stone copings.	Rebed and point using NHL 5 lime mortar.

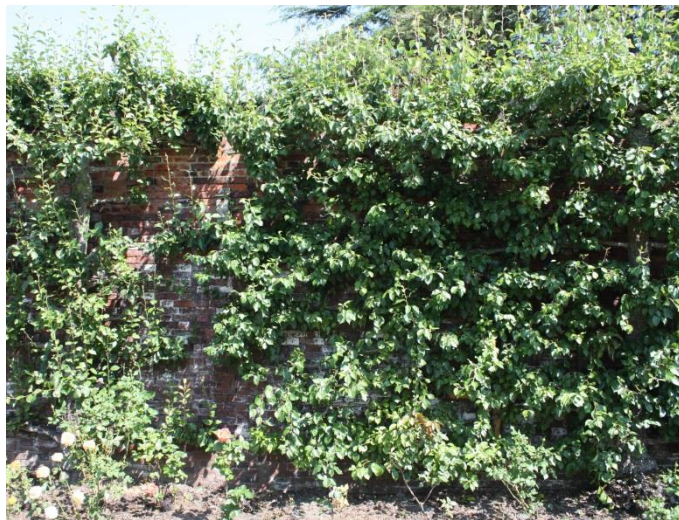
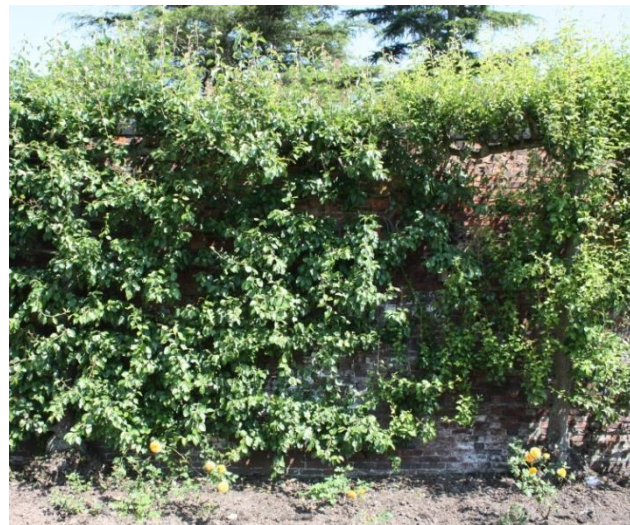
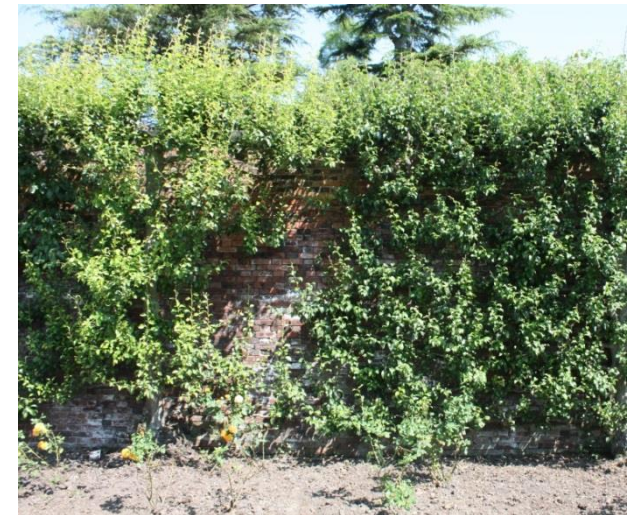
WALLED GARDEN – 170 to 185m

Section	Construction	Repairs	Height of wall
170 – 180m	Soft clay stock brickwork in varied bond, partly in English garden wall bond – suggesting a 225mm deep brick face. Electric cable at 151m.		3450 to u/s pf coping
	Lime mortar pointing.		
	150mm stone copings.	Rebed and point using NHL 5 lime mortar.	
180 – 190m	Soft clay stock brickwork in varied bond, partly in English garden wall bond – suggesting a 225mm deep brick face. Bricked up doorway at 187 – 189m, with stone lintol and quoins left in place.		3400 to u/s pf coping
	Lime mortar pointing.		
	150mm deep stone copings.	Rebed and point using NHL 5 lime mortar.

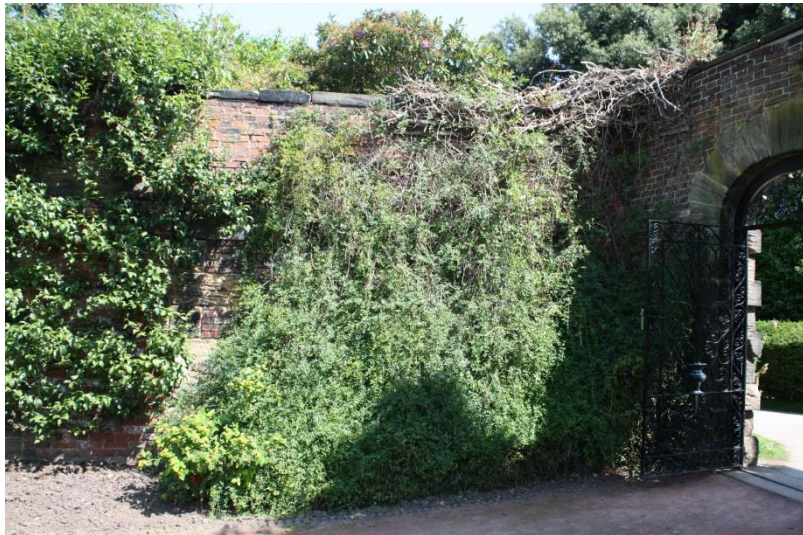
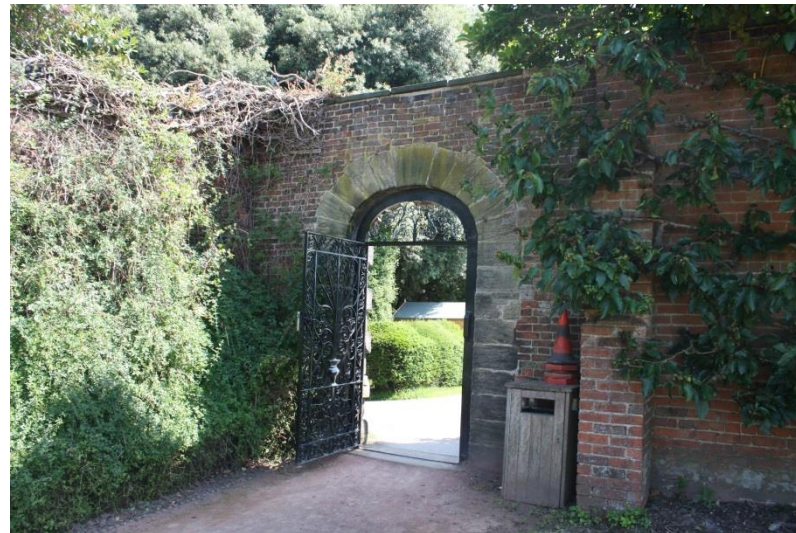
WALLED GARDEN - 185 to 194m (SOUTH EAST END OF WALL) AND RETURN WALL TO PINERY

Section	Construction	Repairs	Height of wall
190 – 195m	Soft clay stock brickwork in varied bond, partly in English garden wall bond – suggesting a 225mm deep brick face. Swept up to 3700 at SE corner.		3400 to u/s pf coping
	Lime mortar pointing.		
	150mm stone copings.	Rebed and point using NHL 5 lime mortar.	
3m return wall	Soft clay stock brickwork in varied bond, partly in English garden wall bond. Arched gate to Pinery, with stone voussoirs. Ironwork gate (replica?)		3450 to u/s pf coping
	Lime mortar pointing.	Repoint around voussoirs using NHL 3.5 lime mortar.	
	150mm deep stone copings.	Rebed and point using NHL 5 lime mortar.

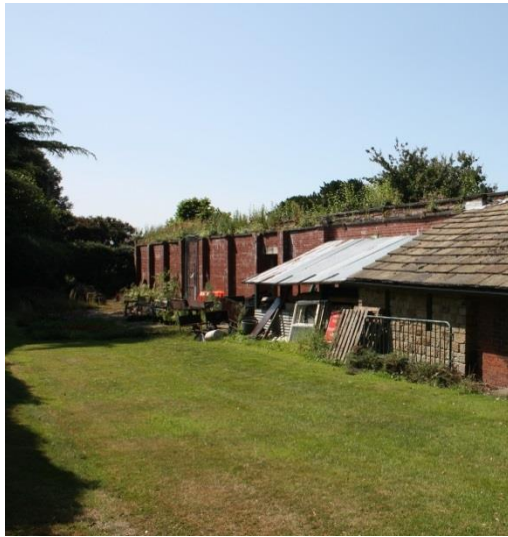
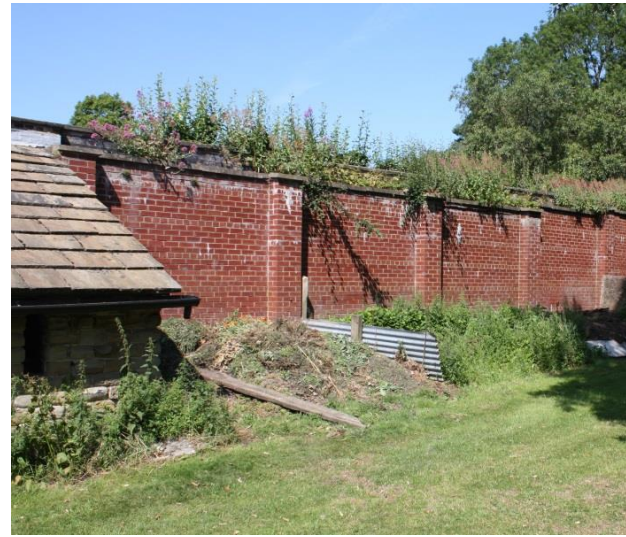
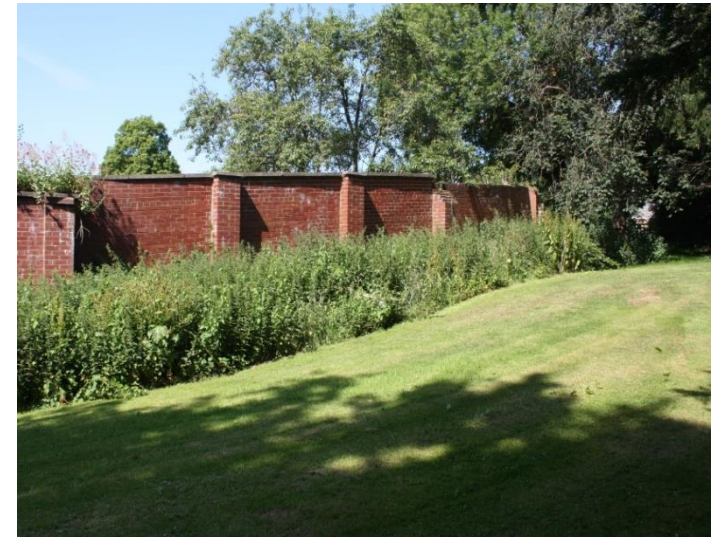
REAR OF GARDEN WALL – SOUTH EAST CORNER TO VEHICLE GATE

Section	Construction	Repairs	Height of wall
SE rear of wall	Original brick wall backed with modern wall and piers in red engineering brick. Original wall projects approx. 300mm higher than new backing wall.	Rebuild top course x 5m at 4 th bay south from vehicle gate. Re-flaunch pier head 1st bay south from vehicle gate.	3000 varies.
	Cement mortar pointing.	Repoint projecting 300mm rear of original wall using NHL 3.5 lime mortar.	
	100mm concrete copings.	Weed kill and remove numerous buddleias, Take off and rebed loose copings.

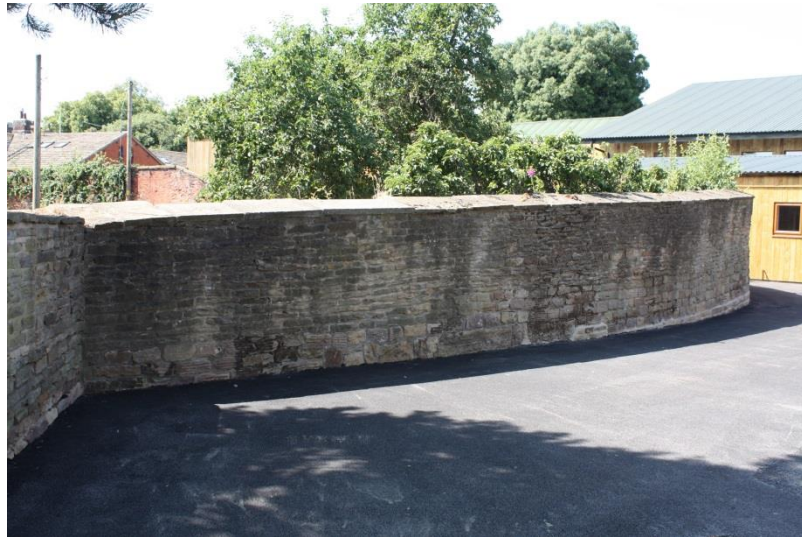
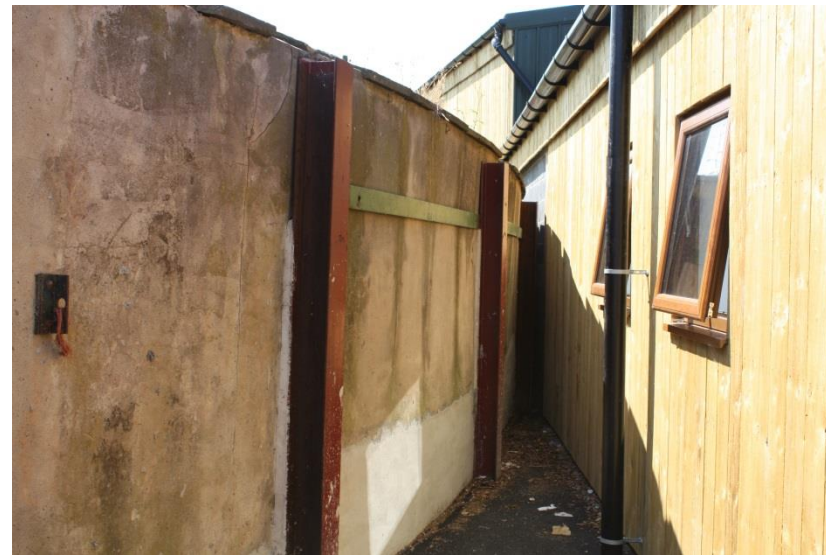
REAR OF GARDEN WALL – TO FARM YARD IN NORTH EAST CORNER

Section	Construction	Repairs	Height of wall
North rear of wall	Battered stone backing wall – assumed to be original construction. Ground rises to 1.5m below top of wall in location of bulge at 90 – 100m.		1500 varies
	Lime mortar pointing.	Repoint using NHL 3.5 mortar.	
	600 wide x 150mm deep chamfered stone copings in one piece over brickwork and stone backing.	Rebed and point using NHL 5 mortar.	
Farmyard	Same construction – but all in good condition.		1800
	Lime mortar pointing.		
	600 wide x 150mm deep chamfered stone copings in one piece over brickwork and stone backing.		
NW corner	Wall is rendered, with steel RSJ support posts.	No apparent defects.	2000

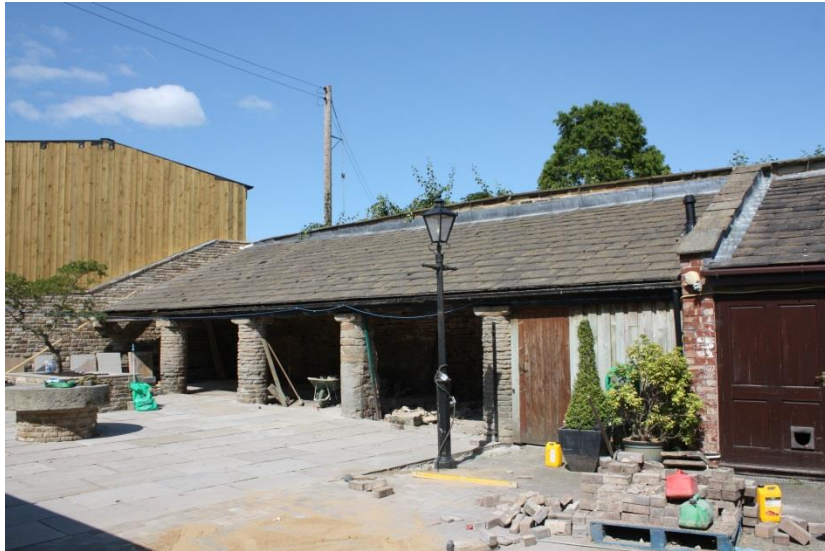
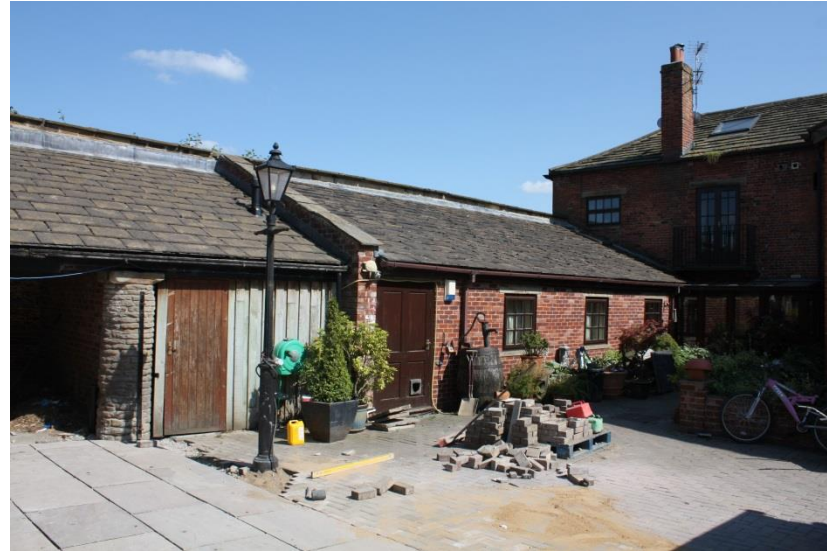
REAR OF GARDEN WALL TO REAR OF STABLE YARD ON WEST SIDE

Section	Construction	Repairs	Height of wall
West rear of wall	Wall is completely backed by lean-to outbuildings and an open-sided stock shed. Newish lead flashings between coping and roof surfaces.	No apparent defects.	5000 approx.
