Part Structural Report on Two Storey Stable Block

108 High Street, Shafton, Barnsley,
S72 8NJ

Project Number: MGC/ANW/LS/52332-Rp001

Doc. Reference: 52332-AWP-ZZ-XX-RP-B-0001-PO1

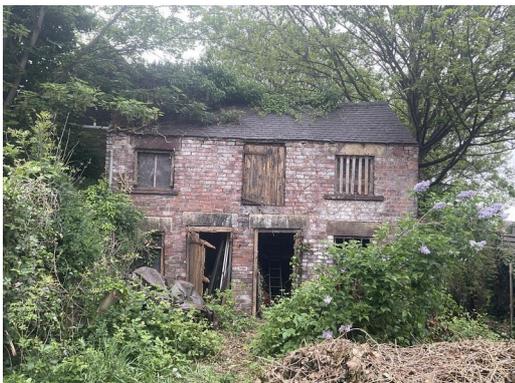
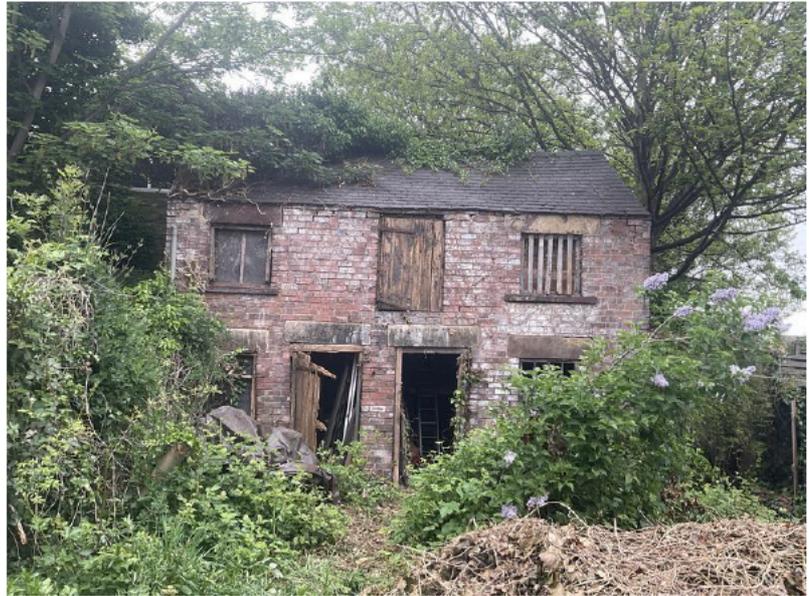
Photo - 1

There are no rainwater goods provisional to the slate covered roof. The left hand end of the roof is covered with vegetation.

Stone lintels are present over the openings, except for the central door at first floor level, where a timber lintel is used, this is deteriorated.

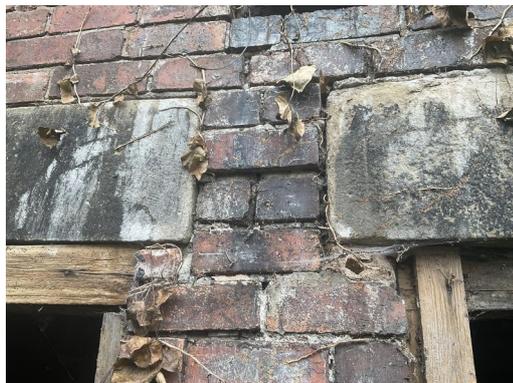
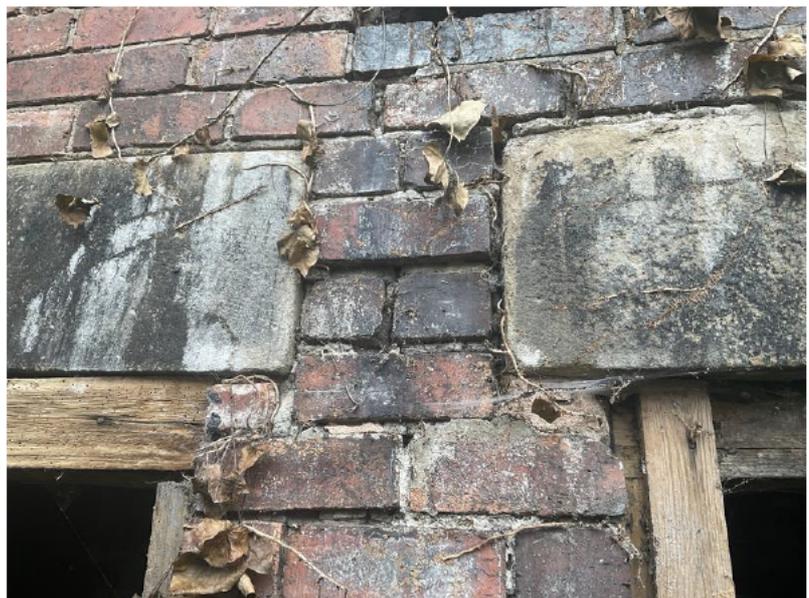
Photo - 2

Timber elements to the window frames, doors and units are heavily decayed.

Pointing is widely missing, especially at high level.

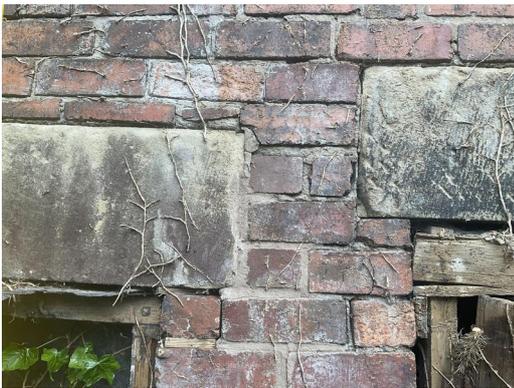
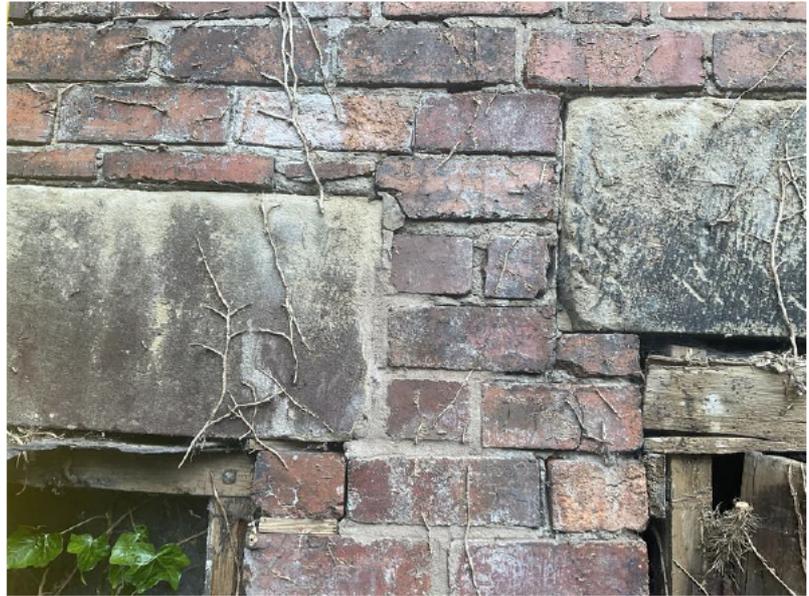
Photo - 3

Cracking around 20mm wide is present at high level to the right hand corner of the structure.

- Brickwork at the eaves corners should be stitched with external L-bars to tie the masonry at the corner together.
- Drainage to the roof should also be included, to ensure that it is disposed of correctly. Consideration needs to be given that guttering to the rear pitch would appear to overhang the neighbouring land.

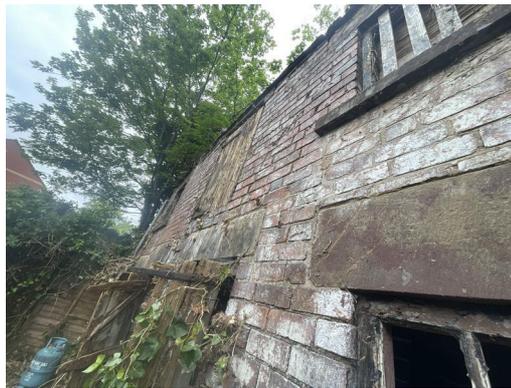
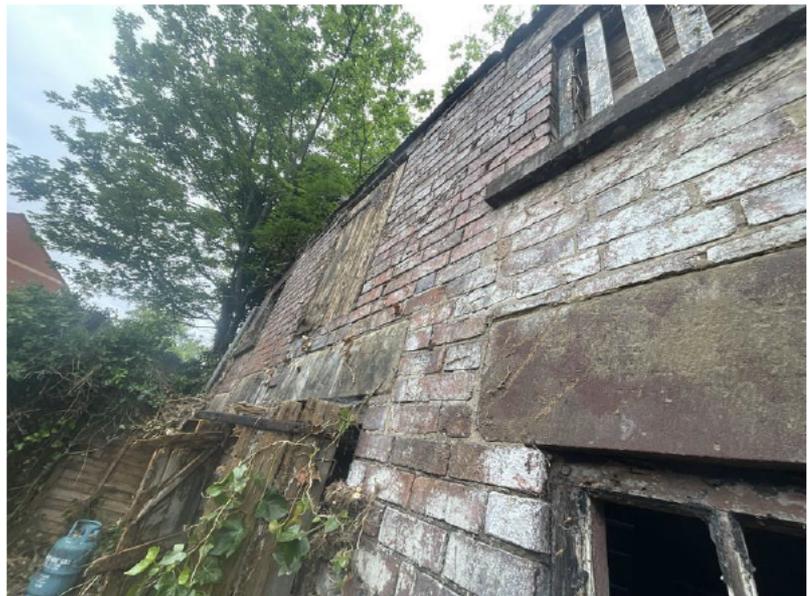
Photo - 4

Erosion is evident on the surface of the stone lintels, particularly at first floor level.

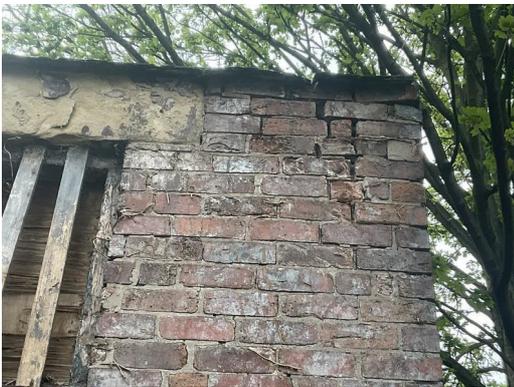
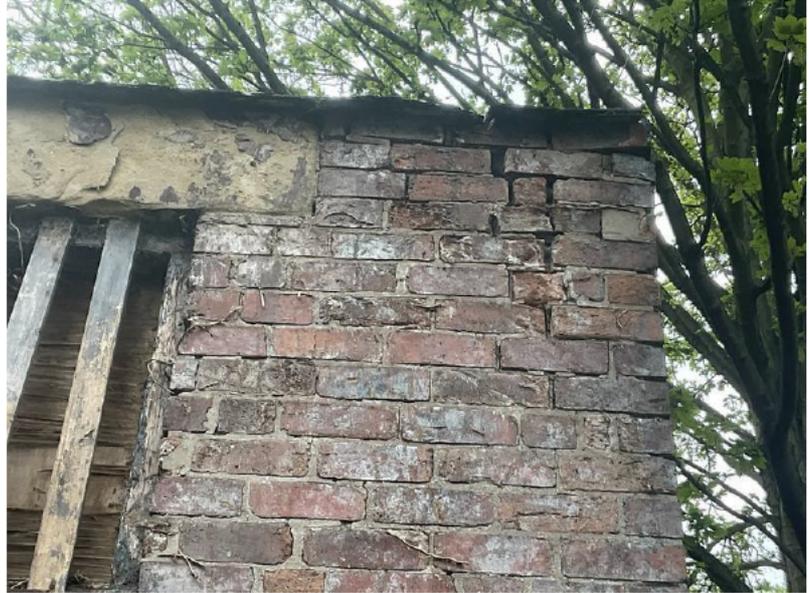
Photo - 5

There are two doors at ground floor level. The heads of both openings slope down towards the centre of the structure. The right hand door slopes down by approximately 30mm over 800mm and is supported at the left hand end on a heavily eroded brick. The left hand door opening slopes down towards the right hand side by approximately 10mm over 800mm. Support at the right hand end is poor, where it is sitting on sections of broken brick.

- The support of the stone lintels to the front elevation should be improved to include padstones, rather than the current arrangement of uneven and deteriorating brickwork. Consideration could be given to the releveling of these if you wanted to.

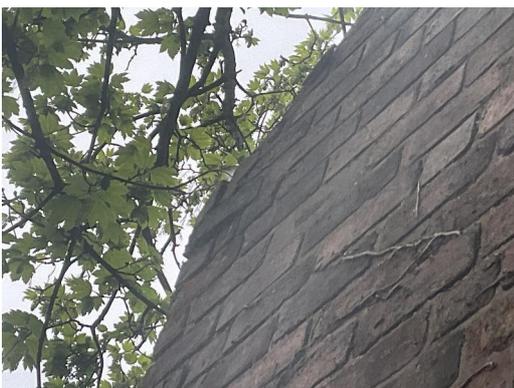
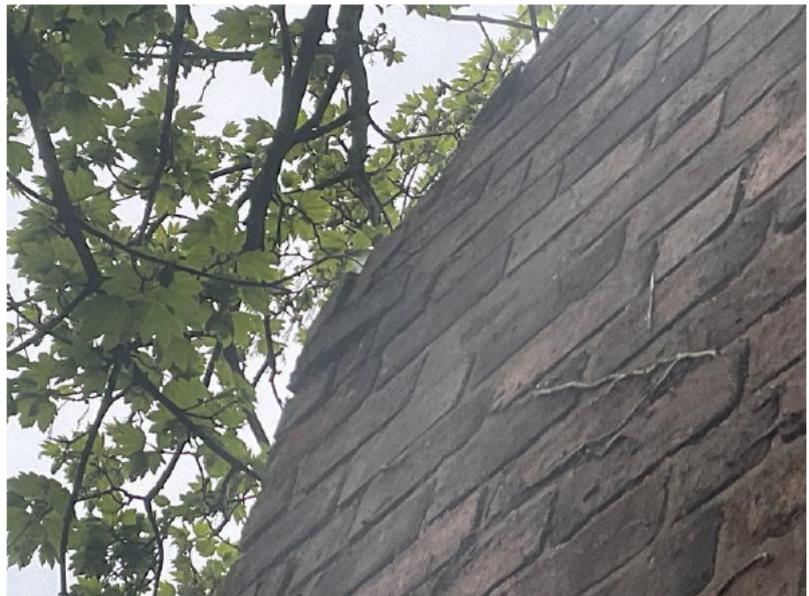
Photo - 6

Pointing is eroded on this elevation.

The brickwork slopes back towards the building at higher levels of approximately 10-15mm over 800mm.

There is displaced masonry at high level to the front left hand corner, at eaves level, which corresponds with the cracking observed at the front corner.

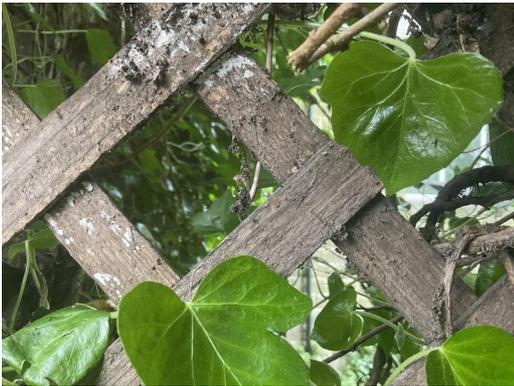
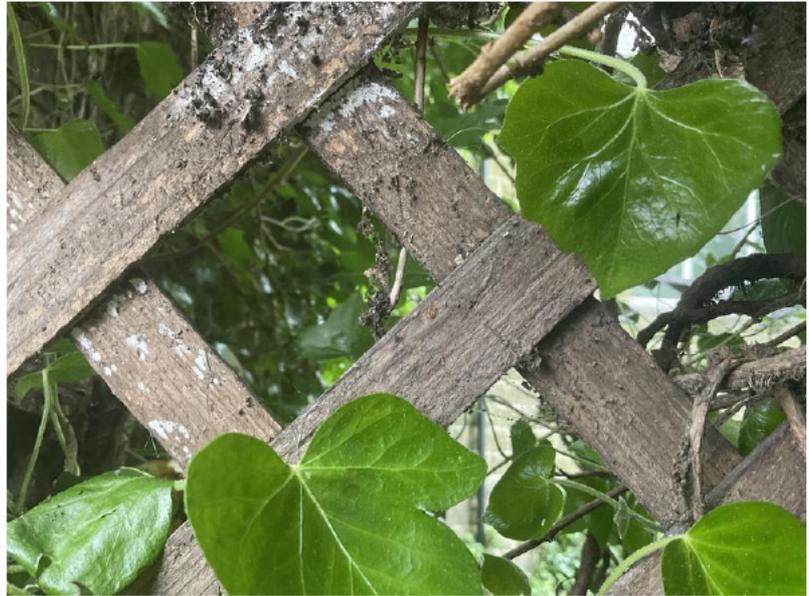
Photo - 7

The rear elevation backs onto a neighbouring property owned by the church and is covered in creeper growth.

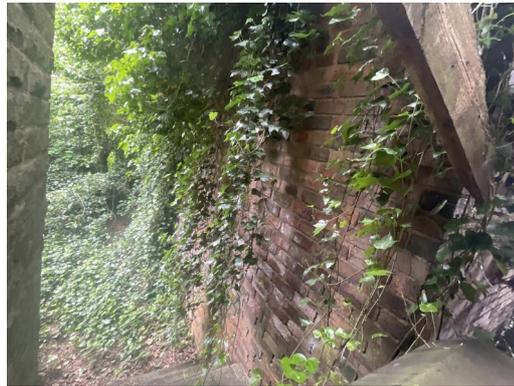
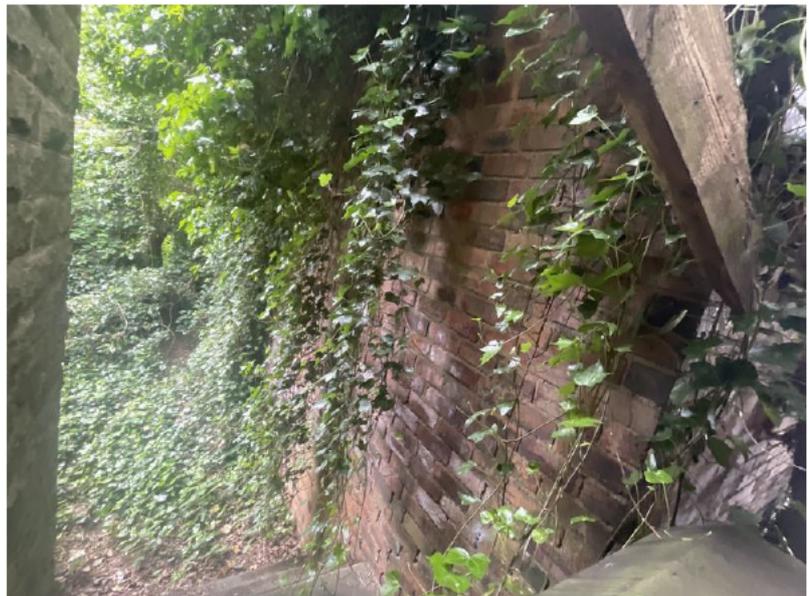
Photo - 8

A limited view of the left hand end of the rear elevation is possible.

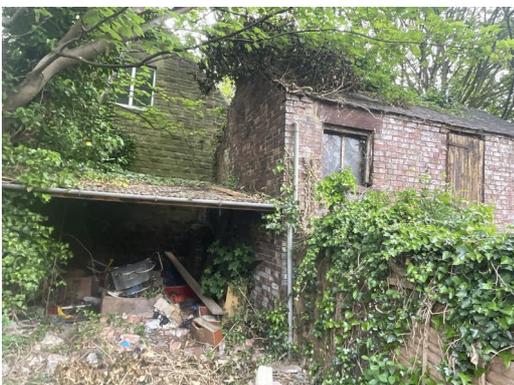
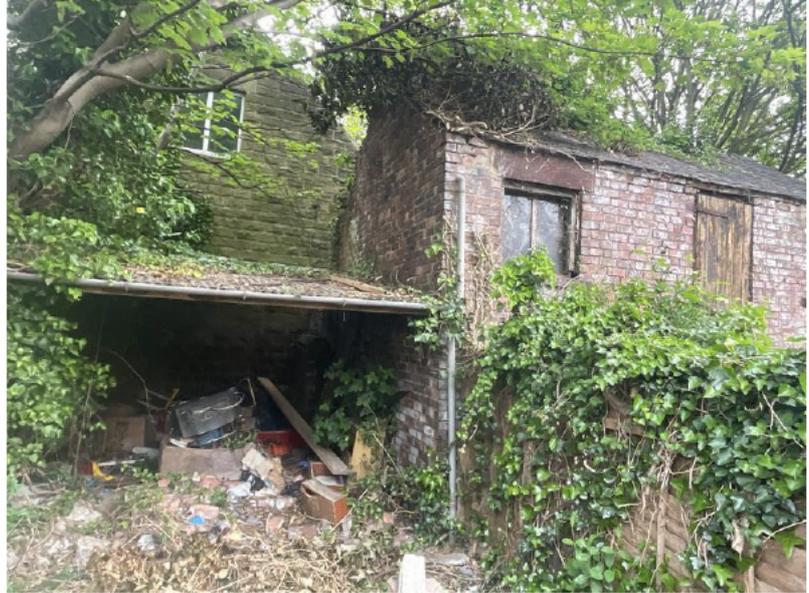
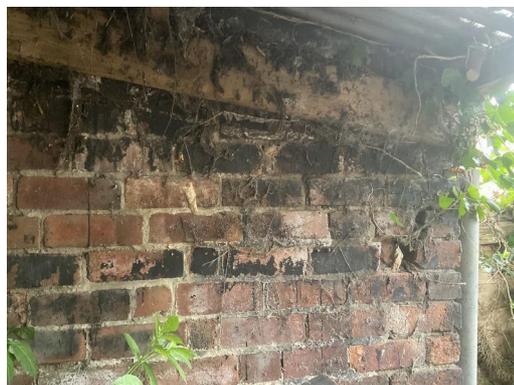
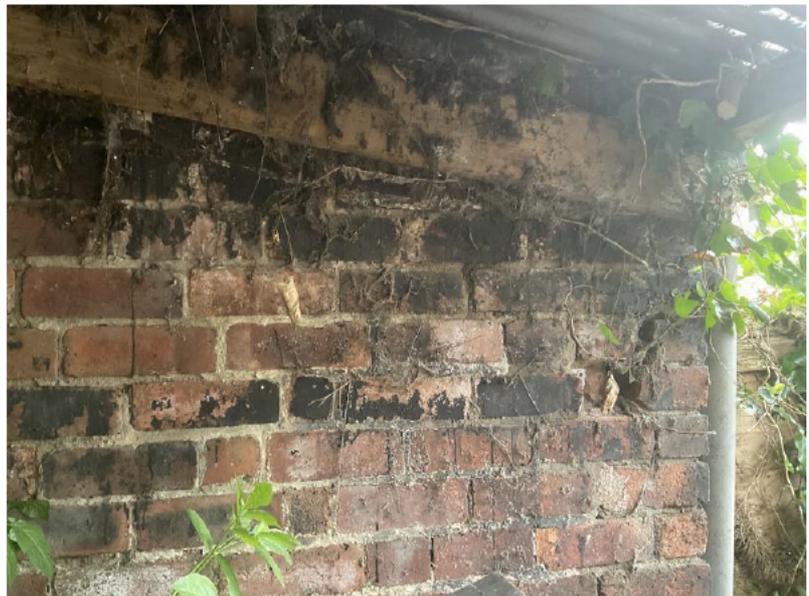
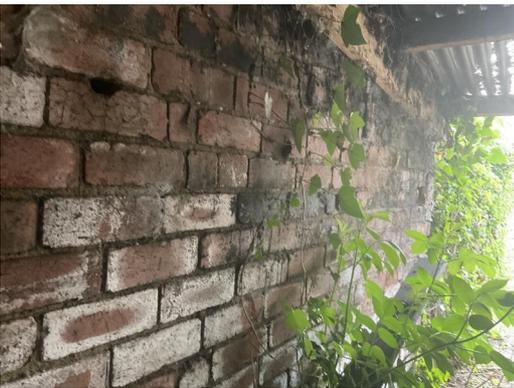
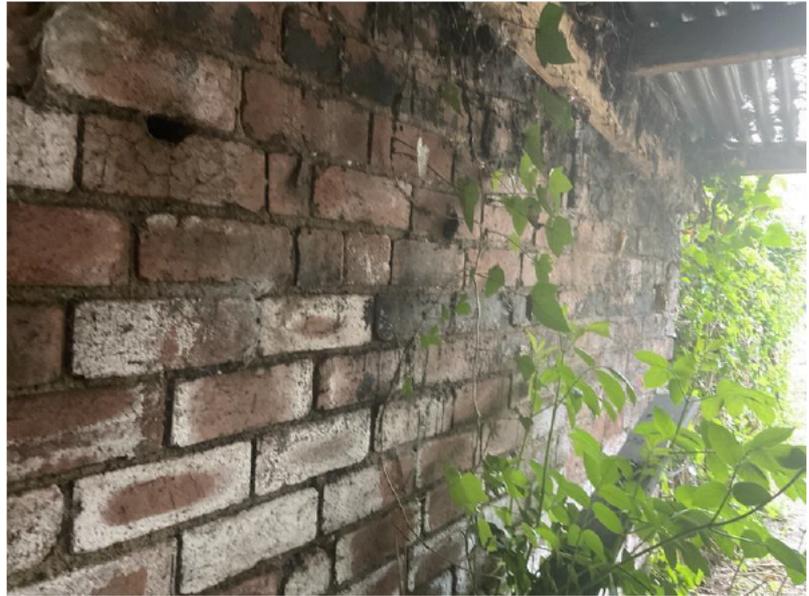
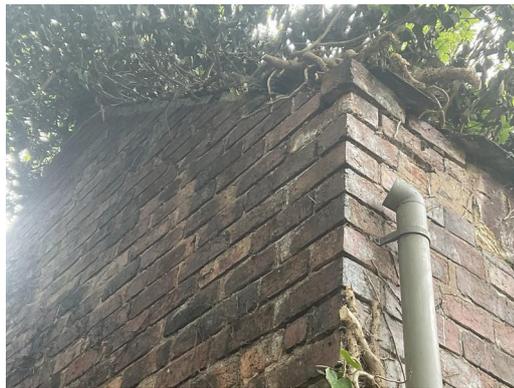
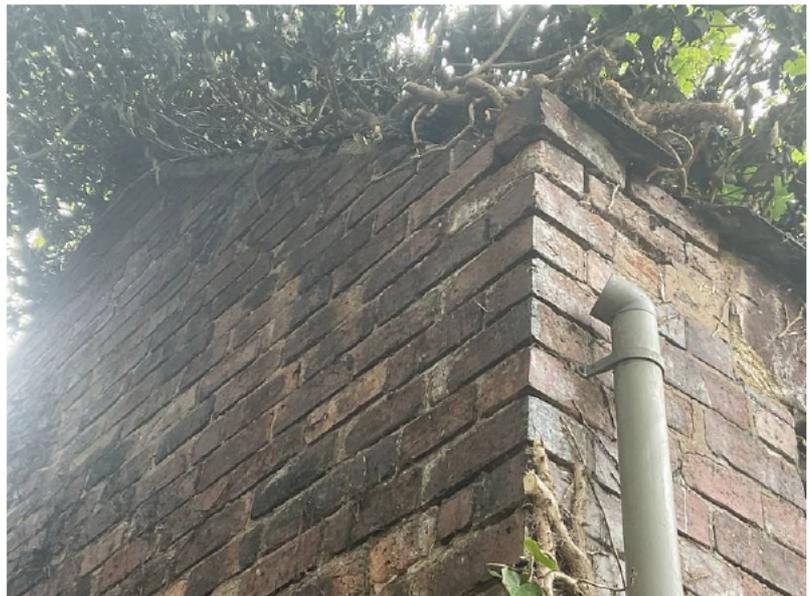
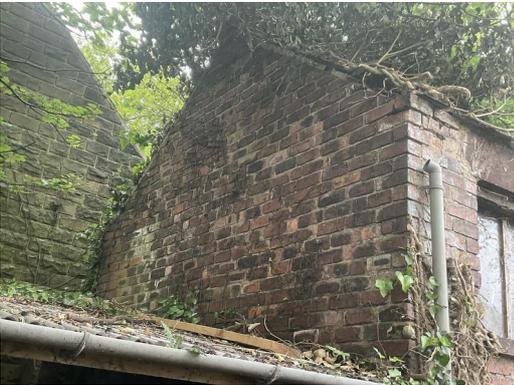
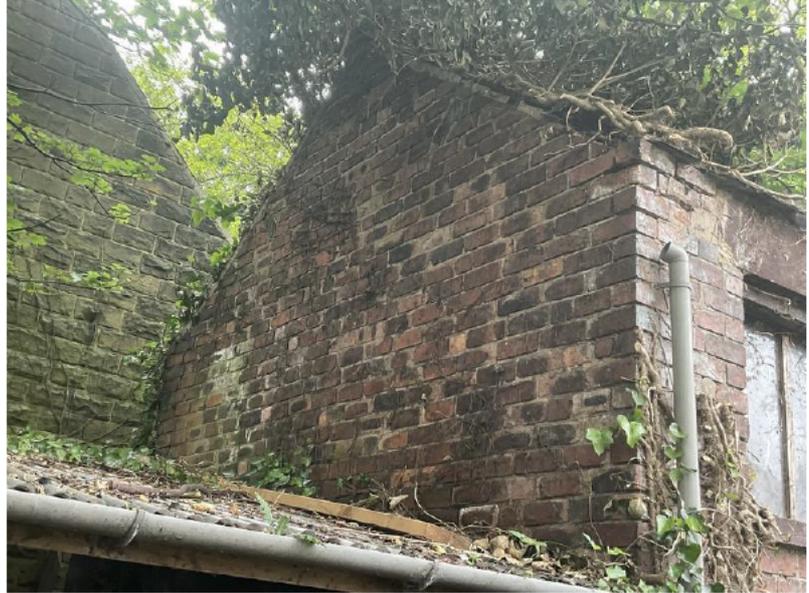
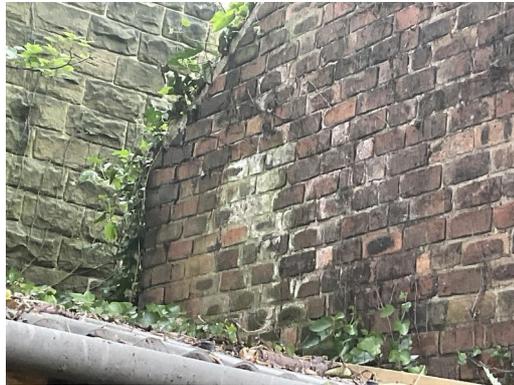
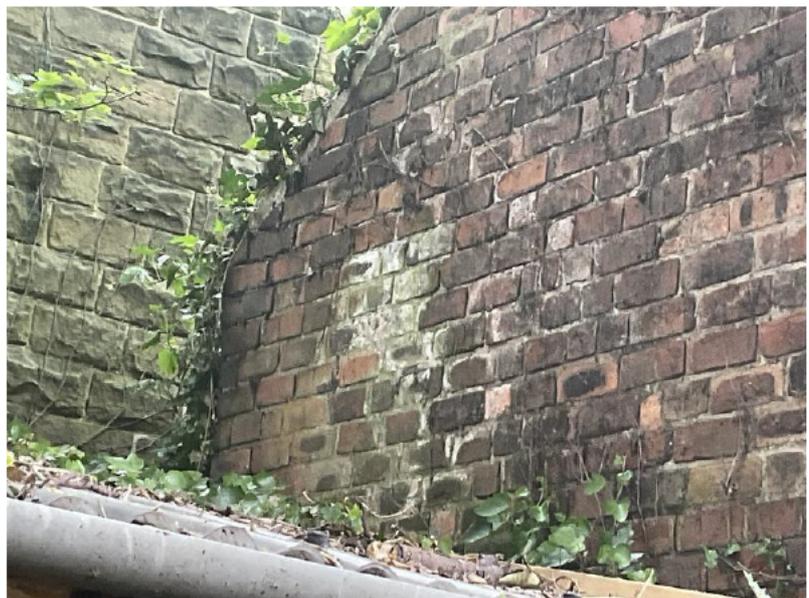
A carport structure is present at ground floor level, supported by a baton fixed to the left hand elevation of the building.

At ground level, the brickwork at the front corner leans to the left by around 40mm in 800mm.

There is some erosion of the brickwork at the front corner, and the pointing is widely deteriorated on the elevation.

Towards the rear, the wall leans to the left by around 40mm in 800mm.

Loose and displaced brickwork is present at high level in the front left hand corner.

Brickwork at high level to the rear corner appears to be displaced.

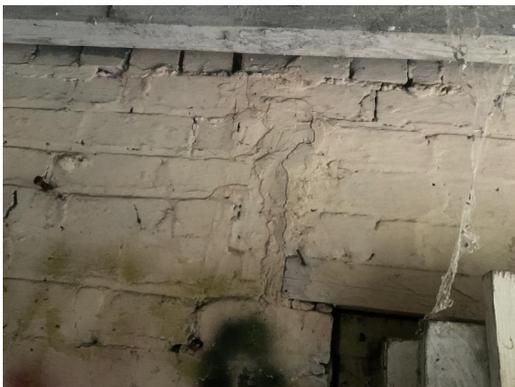
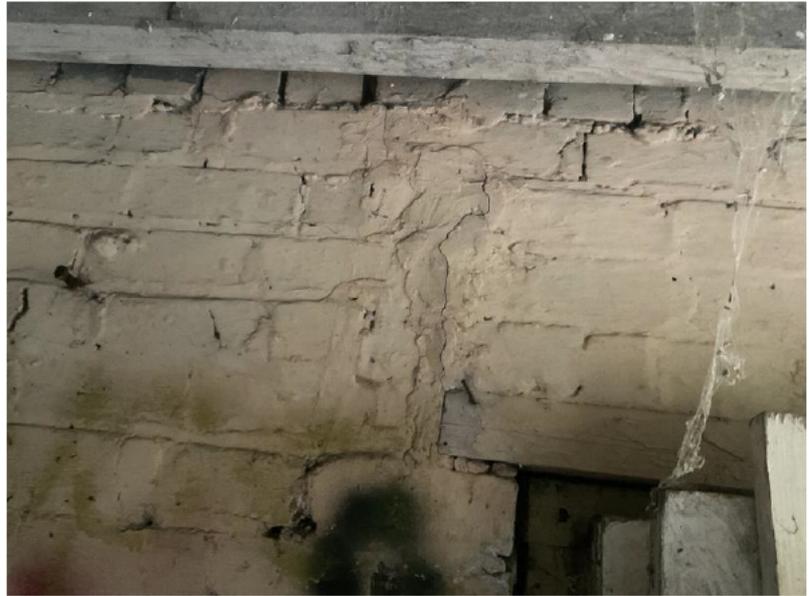
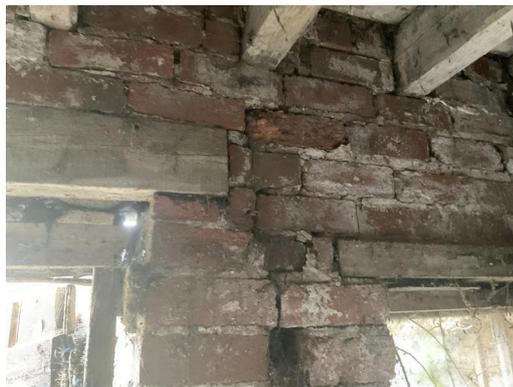
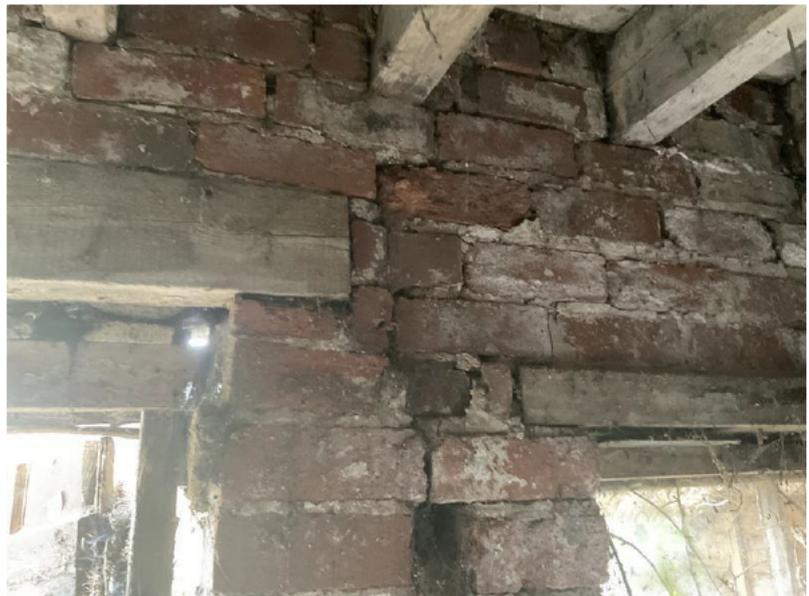
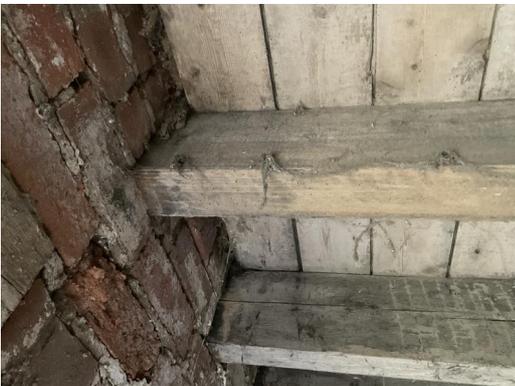
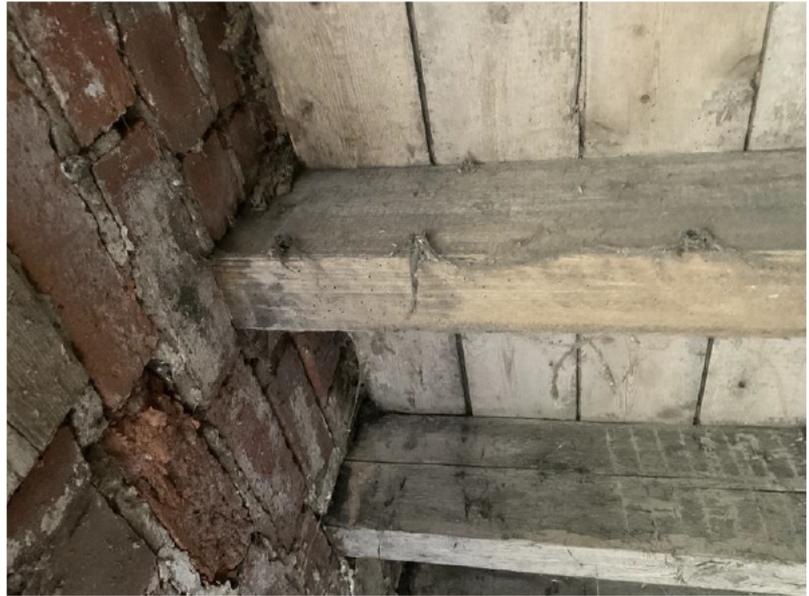
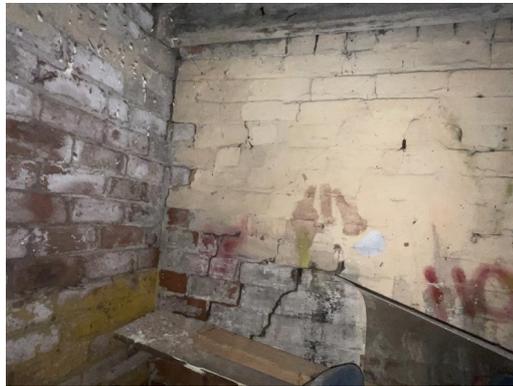
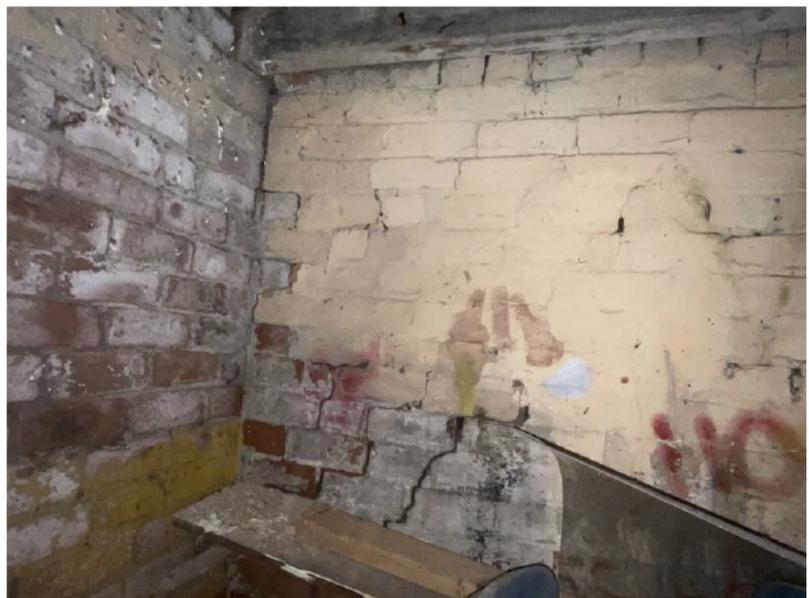
There is a door opening within the right hand wall. Previously filled cracking is present above the rear corner, this has been reformed and is approximately 1mm wide.

The first floor construction is supported by joists running from front to back, socketed into the external wall. Readings taken with a handheld damp meter showed approximately 16%, and there appear to be flight holes within the joists. There is no damp proof protection at the ends of the floor joists, where they are socketed into the walls.

Displacement of brickwork, poor pointing, and vertical joints are present on the front wall between the left hand window and the door opening.

Cracking up to 5mm wide is present towards the rear of the right hand wall, stepping up towards the front. Additionally, there is a 10mm wide gap at the junction between the rear wall and the right hand wall. This wall does not support the first floor, it appears to be an infill.

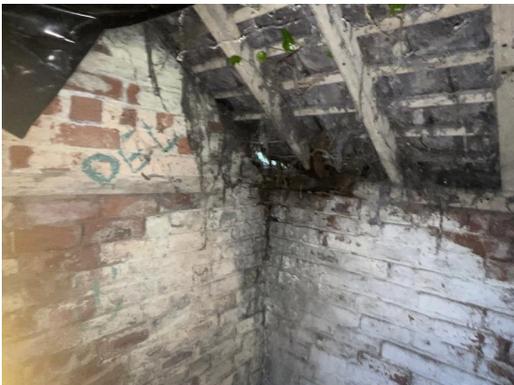
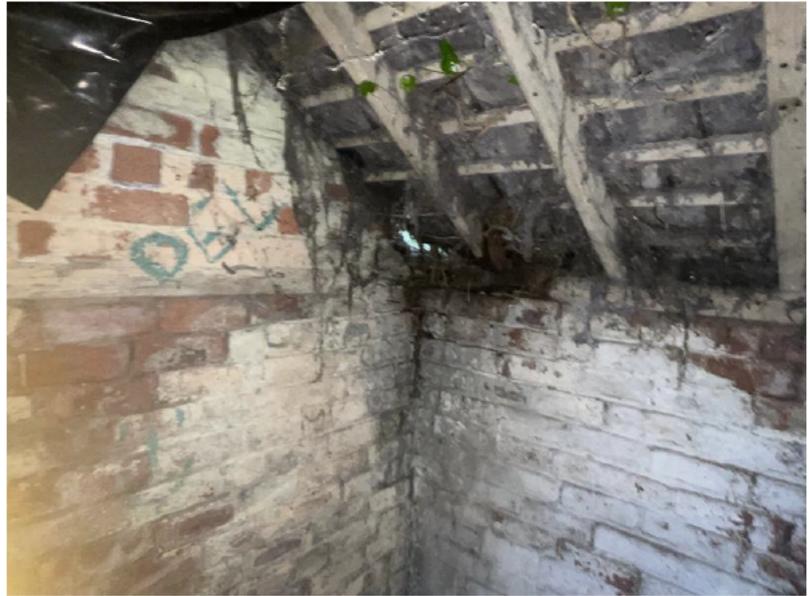
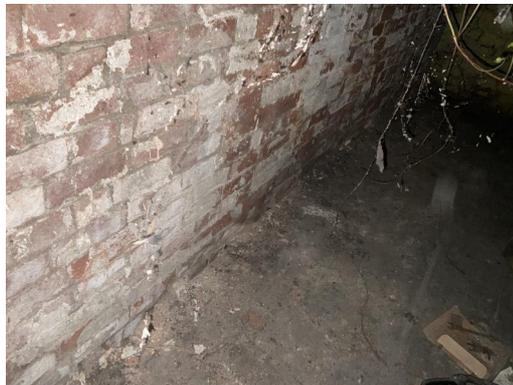
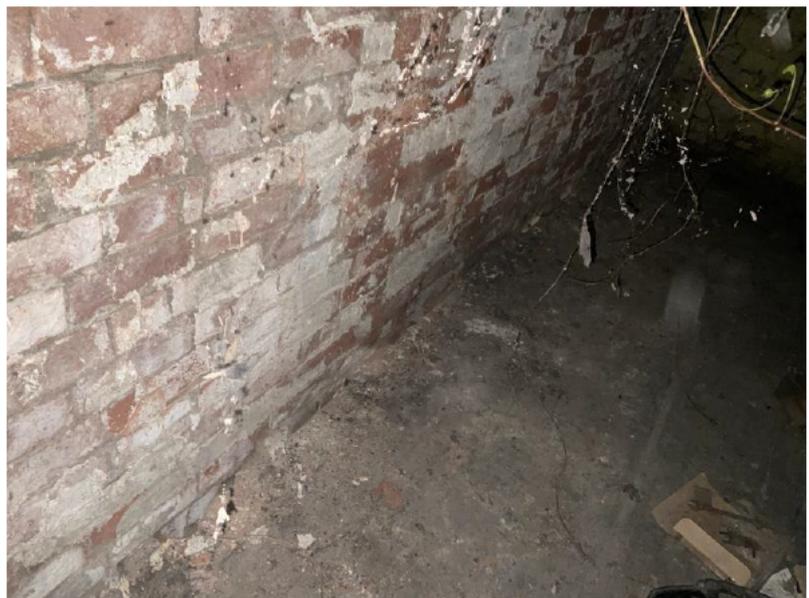
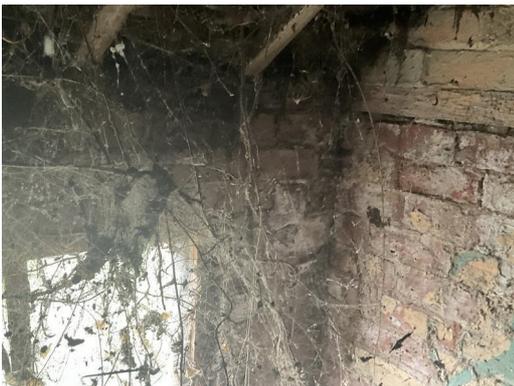
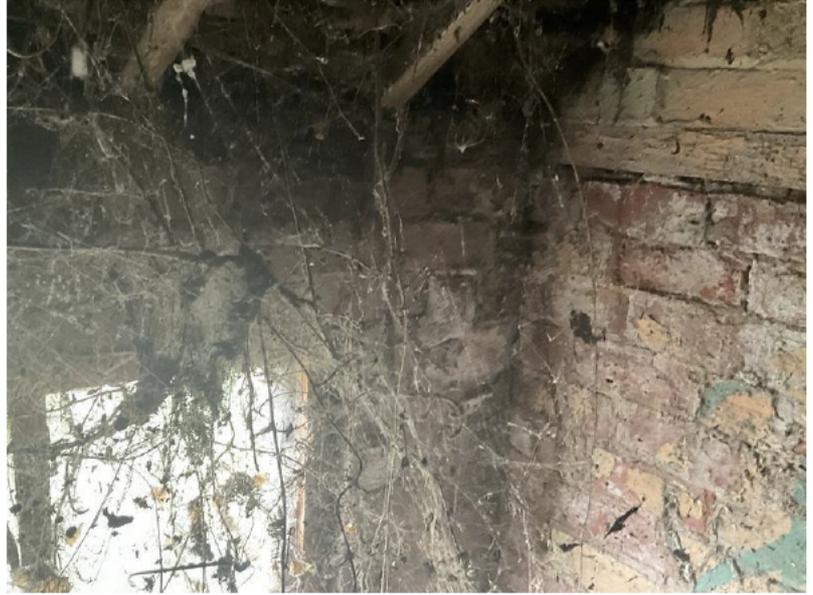
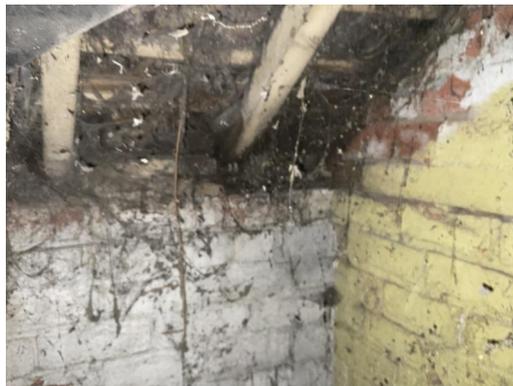
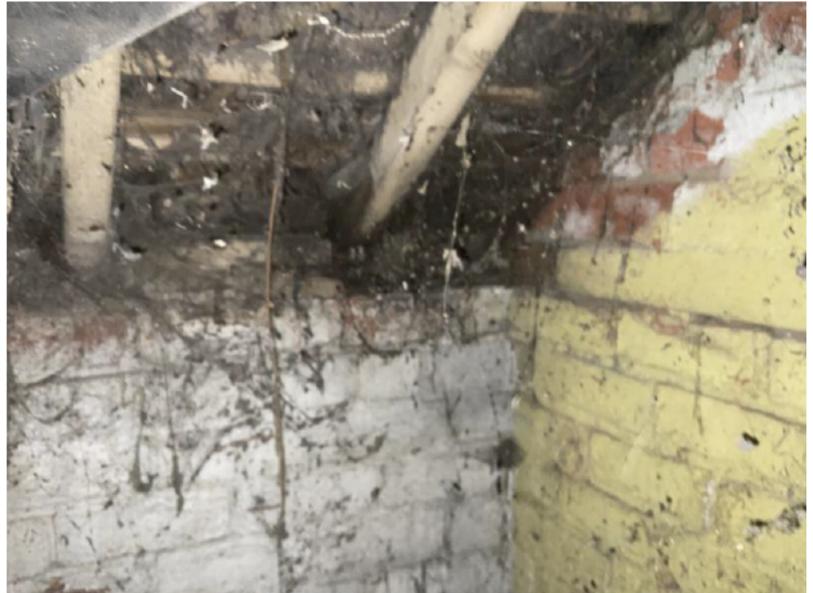
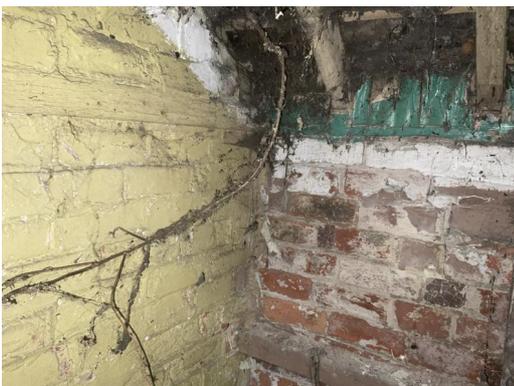
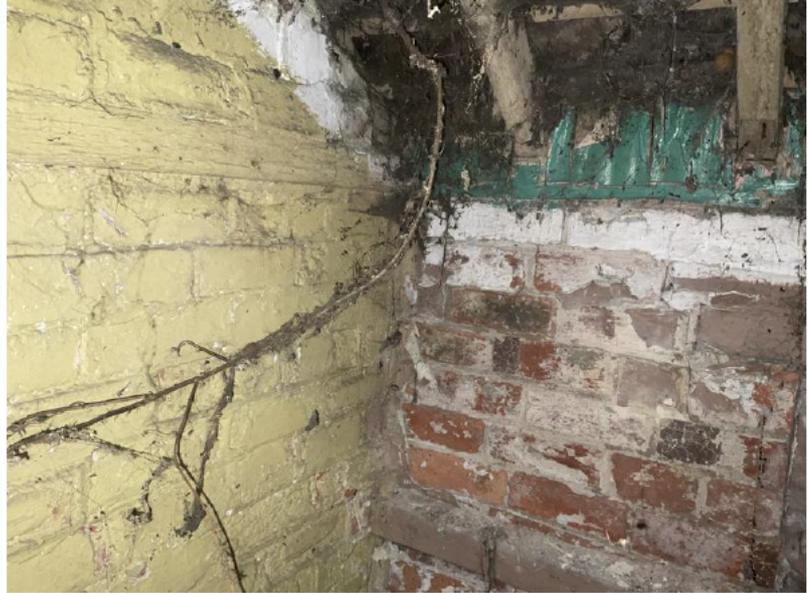
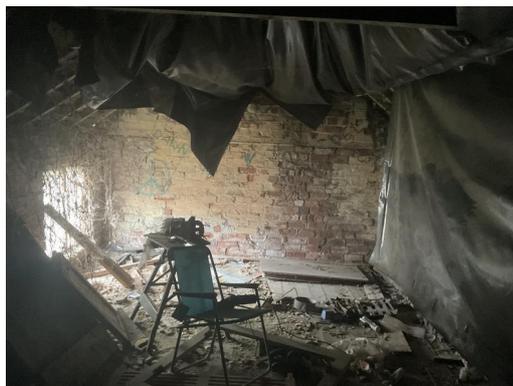
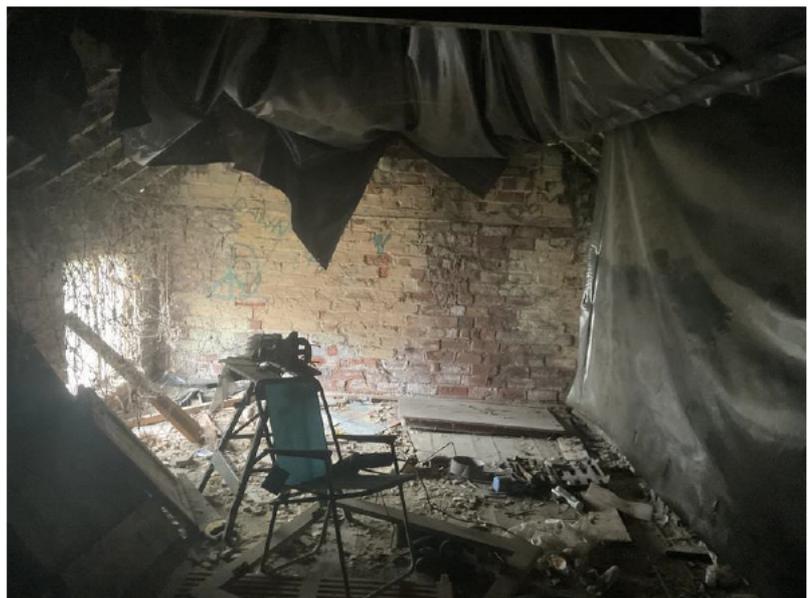
The roof is supported by rafters and purlins. There is extensive vegetation growth through the roof, and the underside of the roof is partially covered with plastic sheeting.

There is severe deterioration of the wall plate at the base of the rafters in the rear right hand corner, with light visible through the wall in this area.

The rear wall leans towards the rear by approximately 15mm over 800mm.

There is a gap at the end of the floor joists where they meet the rear wall, exposing the floor joists beneath.

Erosion of the stone and the formation of salts are evident at the front left hand corner, at eaves level.

The wall plate at the right hand end of the rear pitch of the roof has disintegrated.

Brickwork at high level to the front right hand corner is not properly tied in.

- The roof structure and covering need to be fully replaced. To enable this work to be done, it will be necessary to cut back the creeper growth of the neighbouring property. You should liaise with the owner before doing this work. The replacement roof structure must be designed by a fully qualified Structural Engineer, we could undertake this work on your behalf, and strapped to the external walls to provide restraint to the walls.

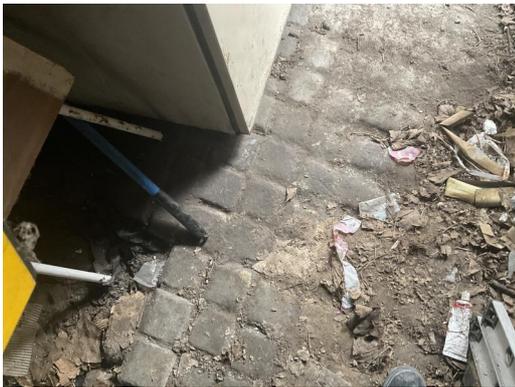
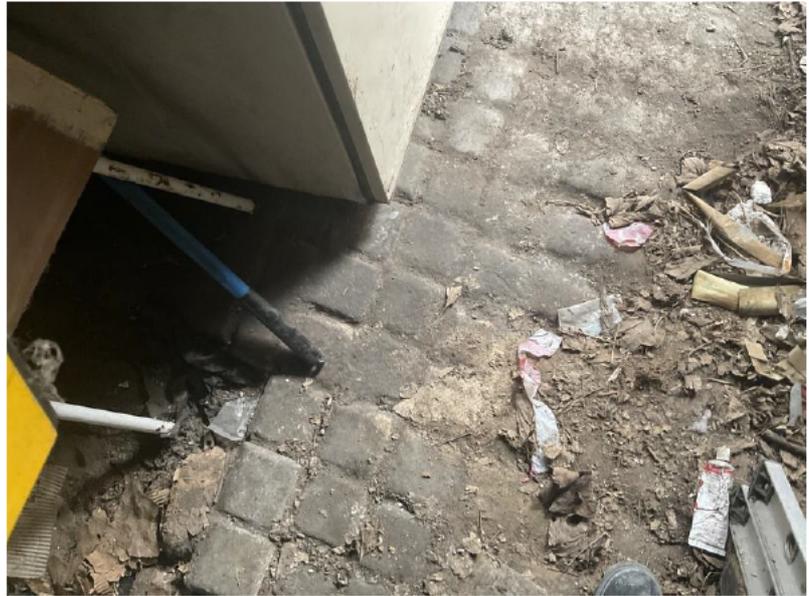
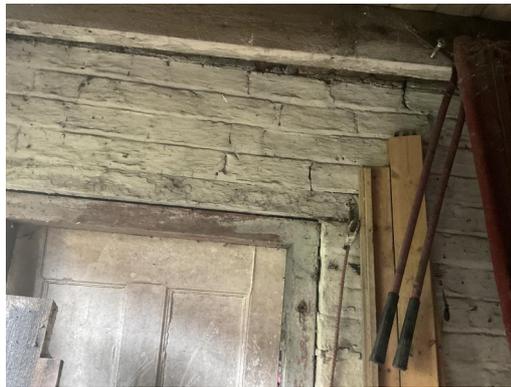
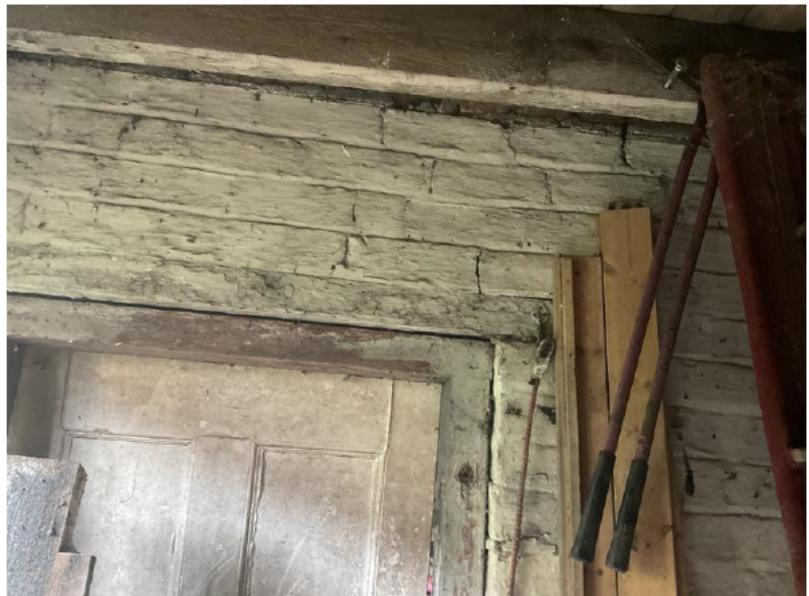
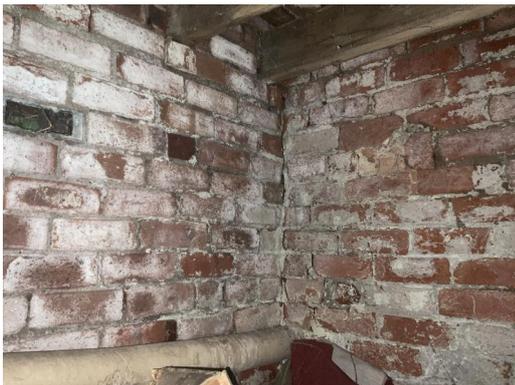
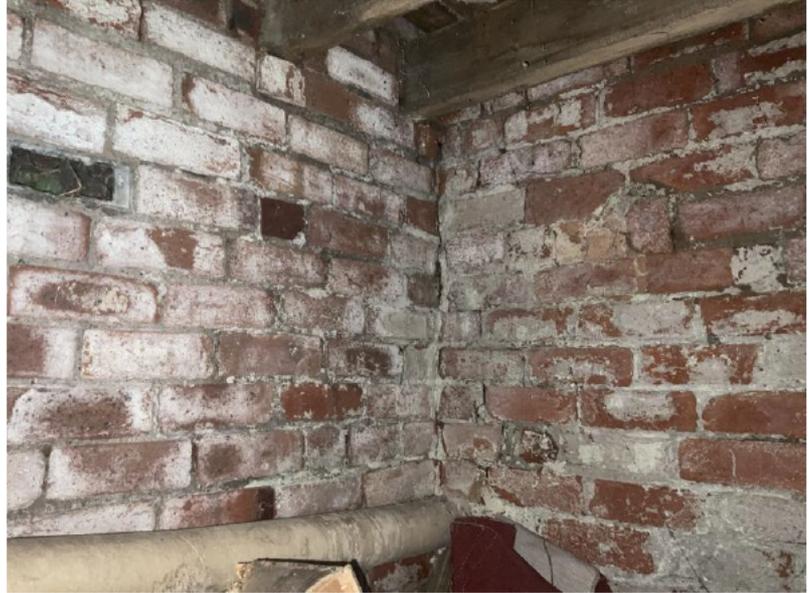
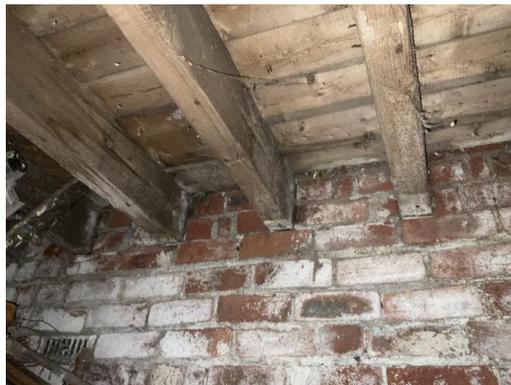
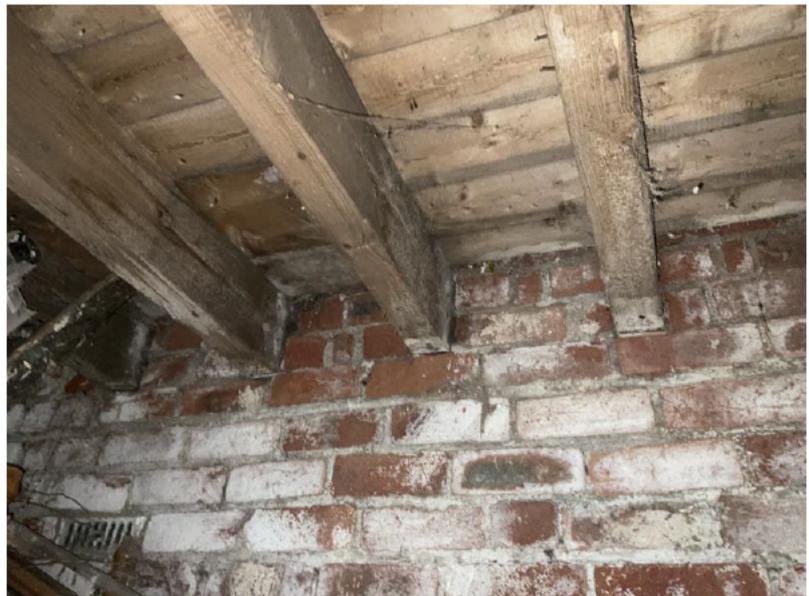
The floor is formed of bricks and is uneven, it is covered with possessions.

The timber lintels to the inner leaf above the front door and window slope down towards the left hand side by around 15mm over 800mm.

The central wall separating the left and right hand rooms is deformed over the door opening, where it bows and 1mm wide cracking to brickwork is present.

The first floor construction is supported by joists running from front to back, socketed into the external wall. These joists and floorboards have been replaced in the past. There is no damp proof protection at the ends of the floor joists, where they are socketed into the walls.

There is 2mm wide vertical cracking in the rear right hand corner.
