Photographic Survey of The Fitzwilliam Arms, Elsecar,
South Yorkshire

Tim Cockrell, freelance archaeologist

The author has undertaken a photographic survey (Historic England Level 1) of The Fitzwilliam Arms, Elsecar, South Yorkshire. The building has been subjected to two structural surveys, both of which concluded that it was structurally unsafe and must be demolished. The building will, however, be rebuilt to the same design and reusing many original features. The present survey records the building and its details in its existing state in order to preserve those by record. It is hoped that the resulting report and archive will inform the replication of the building. A particular challenge has been to prepare a photographic record while the building is partially obscured by scaffolding. This cannot be removed to facilitate recording due to the dangerous condition of the building. To account for this, in addition to the photographic record, a drawn elevation of the front of the building was prepared, based on images generated from a virtual 3d model, with as much of the scaffolding removed as possible (digitally).

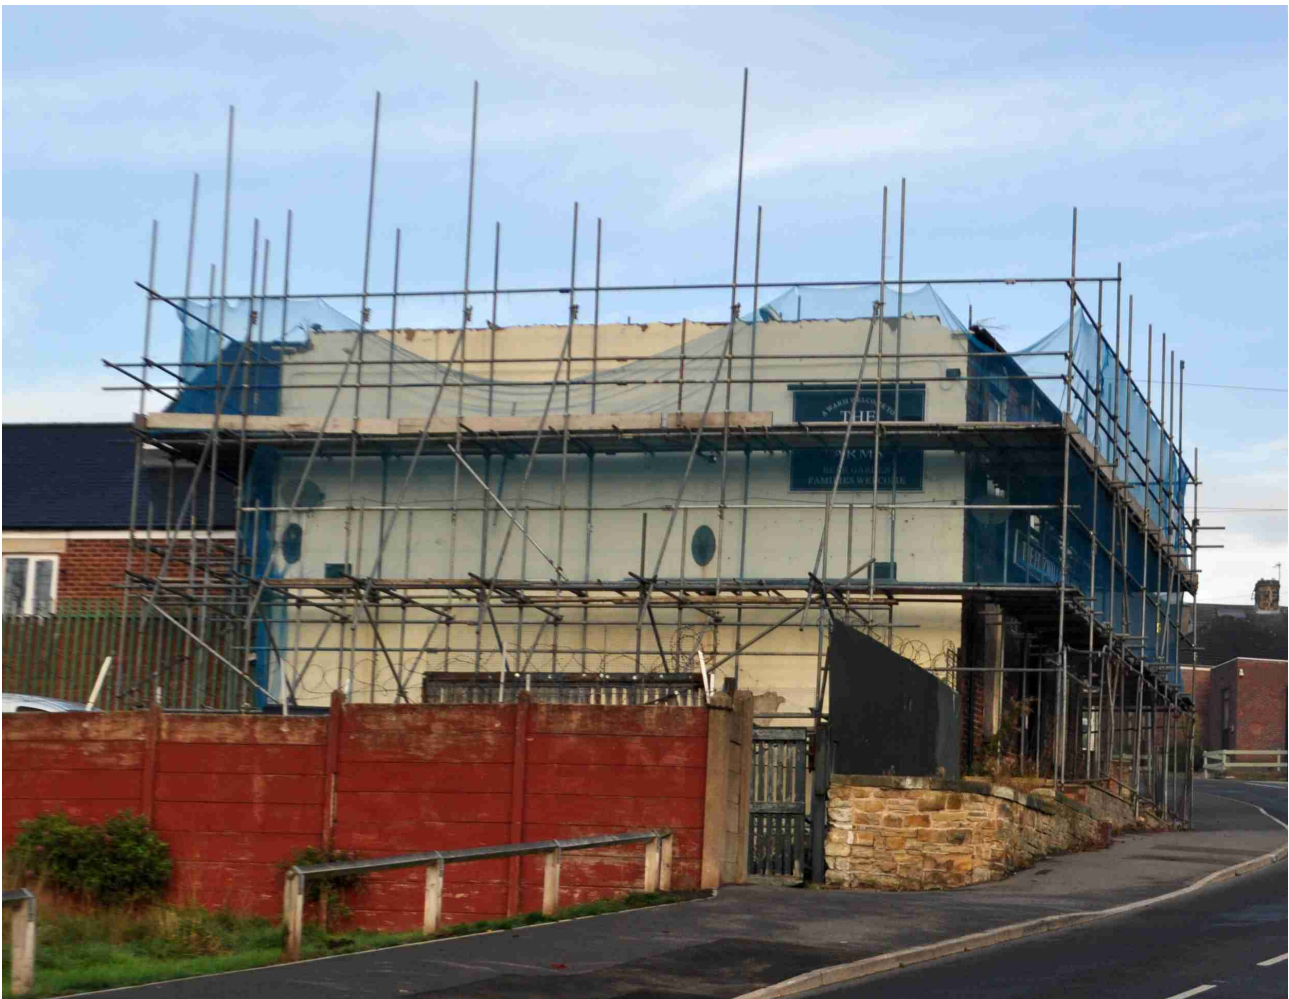
Figure 4: Southeast facing elevation of The Fitzwilliam Arms. Source: author.

Structural scaffolding is in place in order to prevent the collapse of what is a structurally very weak building and cannot be removed prior to demolition. In addition to the more traditional

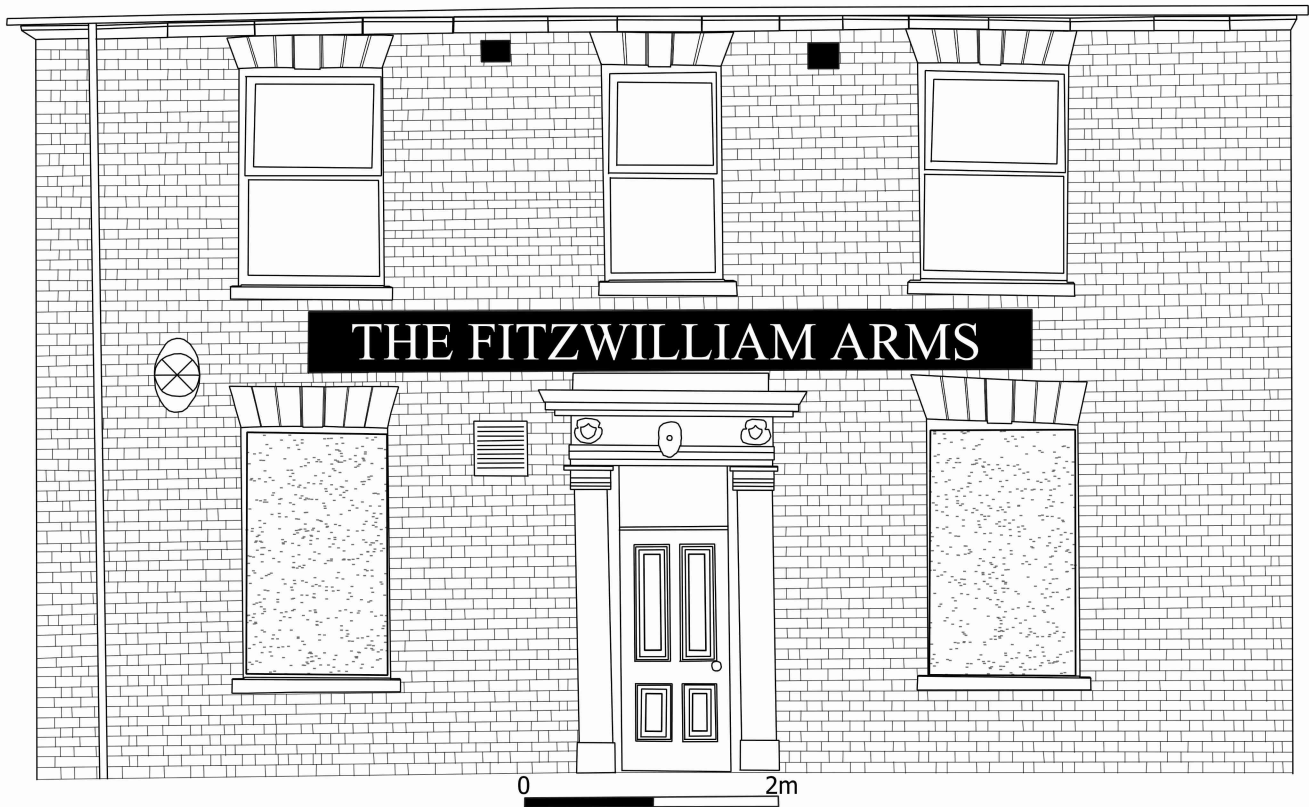
The ground floor windows were boarded up with sheets of chipboard. It was noted that all window frames were of uPVC and all downpipes were of plastic. Two contemporary light fittings were in place above the first floor windows on the northeast facing elevation (shown as black squares on Figure 5). Along with two decorative mouldings (photos 33-35, appendix 2), a crude ovoid hollow at the centre of the frieze above the door indicates the former presence of another decorative feature or possibly a light fitting (Figure 5; photo 36, appendix 2). The gutter to the front (northeast facing elevation) was of traditional square sectioned wood. That to the rear (southwest facing elevation) was of plastic. Neither the southeast facing elevation or the southwest facing elevation were fully accessible. However, the southeast facing elevation was featureless apart from the presence of two wall ties (Figure 4; photo 43, appendix 2). The southwest elevation was abutted by built extensions (photo 8, appendix 2).

Figure 5: The northeast facing elevation of The Fitzwilliam Arms.

The challenge presented by the presence of scaffolding was successfully mitigated for by the expedient of preparing a drawn elevation of the facade, the most sensitive part of the building (Figure 5). Details were adequately recorded by photograph.

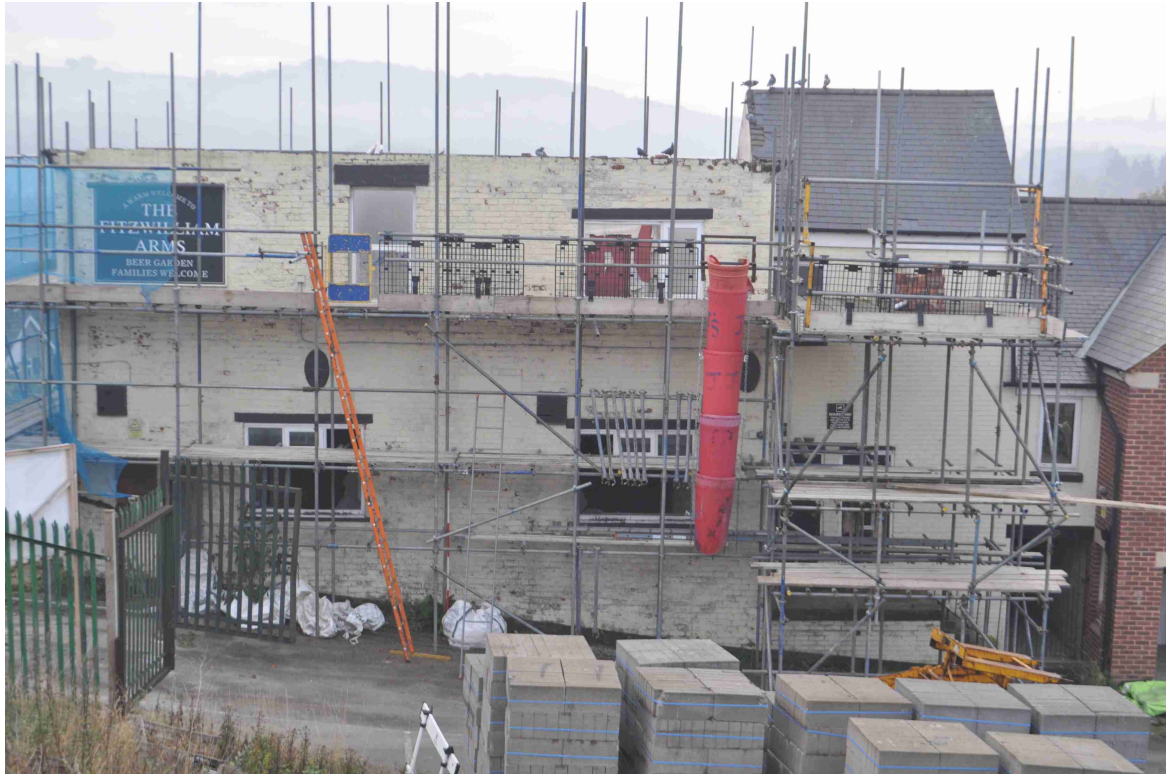
Figure 15: Photo 8. Northwest facing elevation.

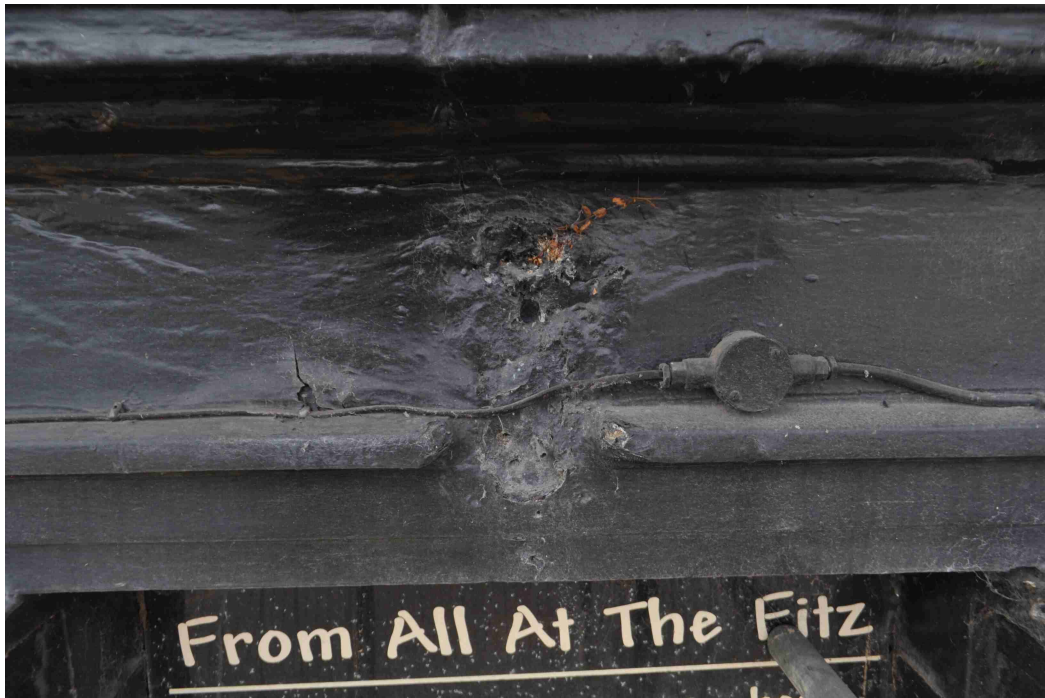
Figure 42: Photo 36. Gap for missing feature at the centre of the frieze.

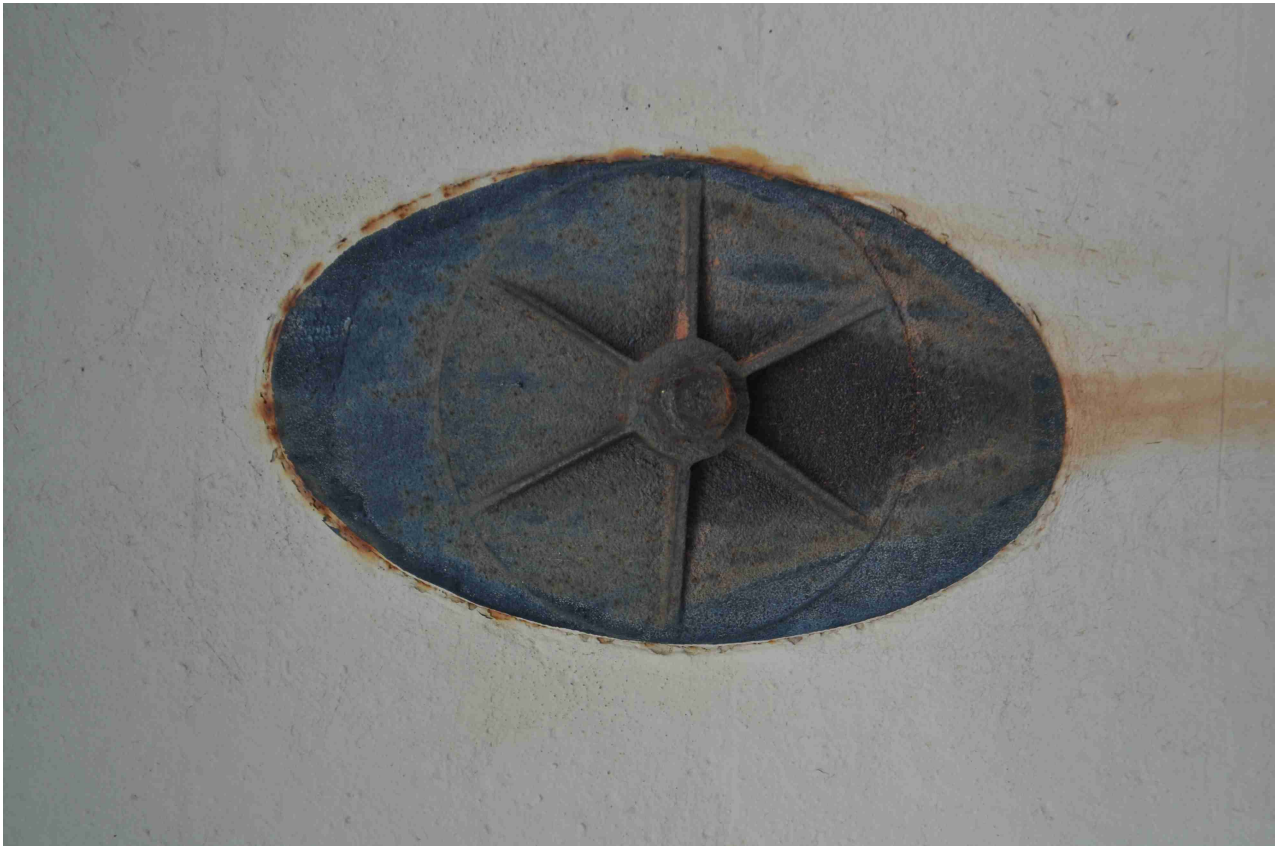
Figure 49: Photo 43. Wall tie.
