TREE SAFETY SURVEY - ROADS AND PUBLIC RIGHTS OF WAY - CANNON HALL ESTATE

Re: Report on a Tree Safety Survey conducted on all trees with potential to impact public on land under stewardship of Cannon Hall Estate - Doc CHE.01.24

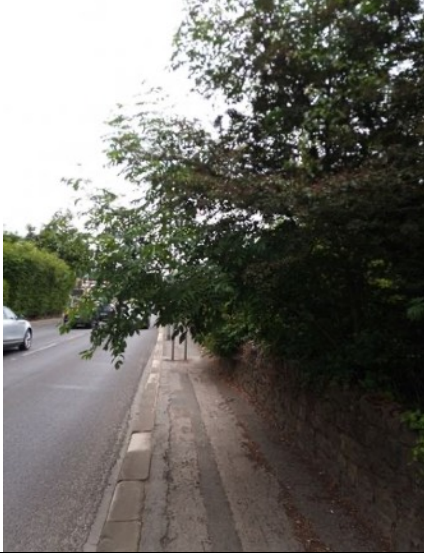
<p>G006</p> <p>Mixed species</p> <p>Showing path interference and proximity to road</p>

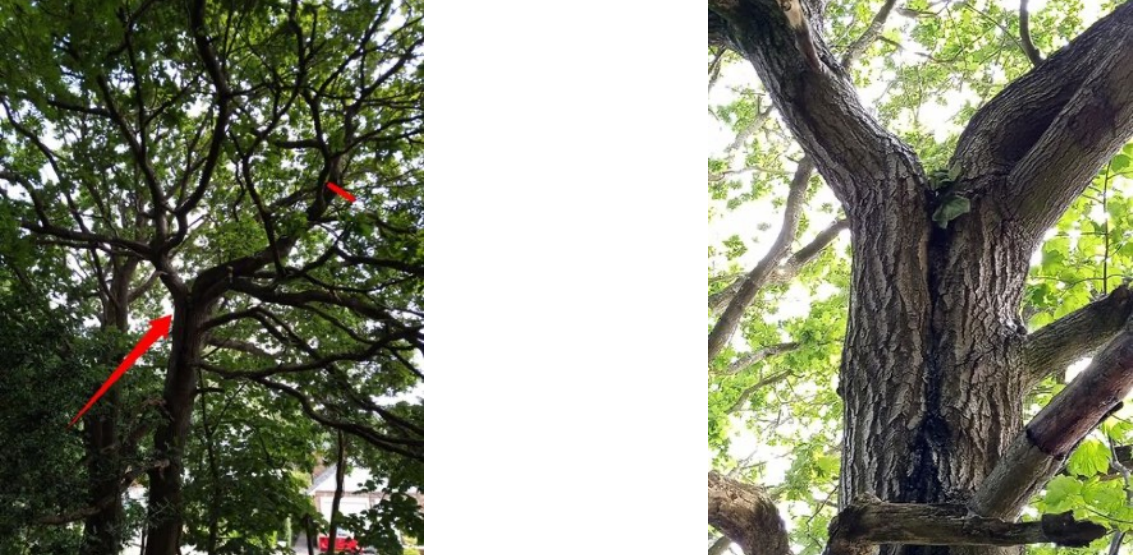
<p>T003</p> <p>Oak (<i>Quercus robur</i>)</p> <p>Showing splits and hazard beam locations</p>

T003	/// create. crops.r oyal	Pedunculate oak (Quercus robur)	Next to wall, roadside tree	Height (m): 13 Crown Radius (m): 5 DBH (cm): 45 Life Stage: Mature Life Exp.: 30+ Years	High	Fair	Physical Defect	Fair	Good	Good	Growing next to other Oak, sycamore saplings growing at base. Dual stemmed at 4m. Secondary unions with major split, crack appearing down main stem. Hazard beam on main upright stem over road.	Reduce S stem down to 2m above failed section (see image). Reduce S canopy to create new natural line. Reduce central stem with hazard beam to 1st branch after hazard beam to retain some central canopy. Reduce branches around to create new natural canopy line. Timescale: 25-Jun-2024 (Urgent)

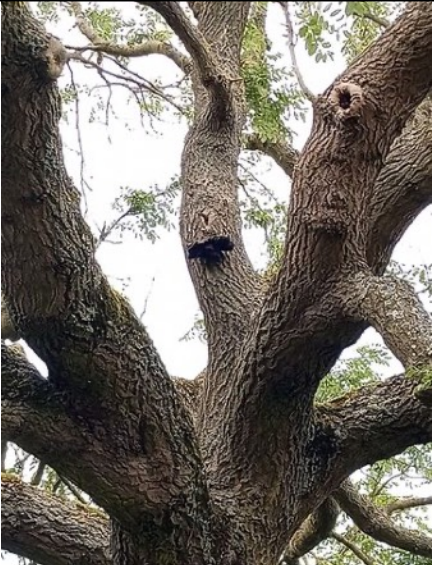
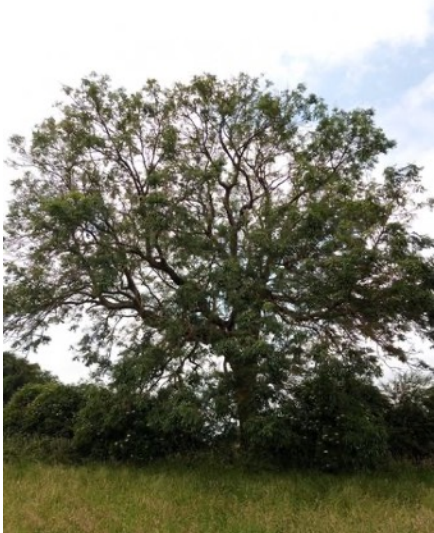
<p>T006</p> <p>Common ash (<i>Fraxinus excelsior</i>)</p> <p>Showing fungal bracket, and current canopy health</p>

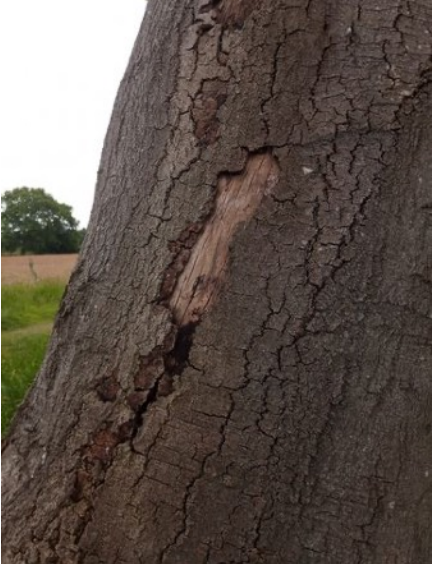
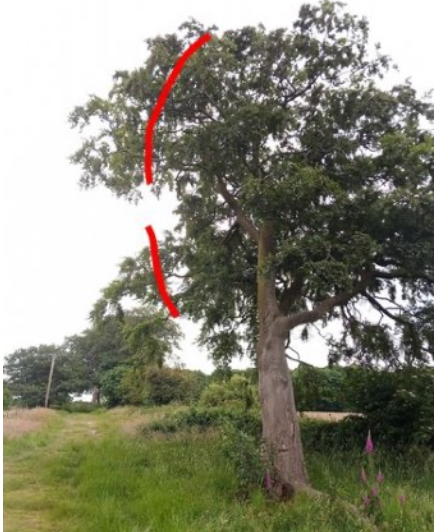
<p>T007</p> <p>Common beech (<i>Fagus sylvatica</i>)</p> <p>Showing condition of main stem, and canopy shape with intended reduction points</p>

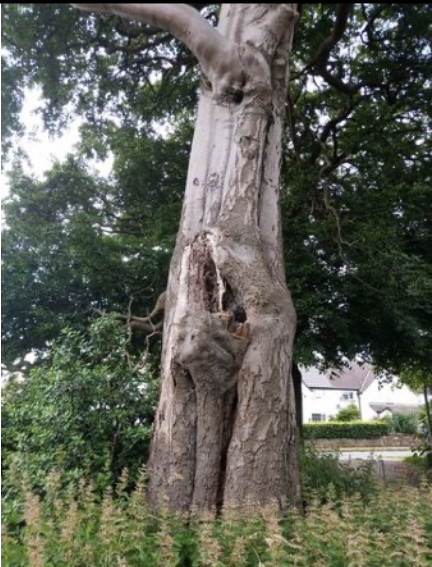
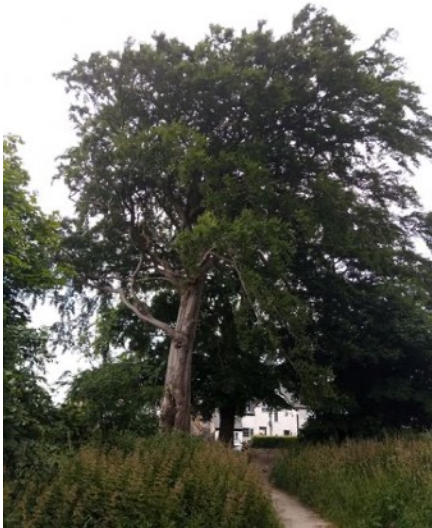
T010	/// supply. lonely	Common beech (Fagus sylvatica)	Next to footpath at start of copse.	Height (m): 20 Crown Radius (m): 5 DBH (cm): 100 Life Stage: Mature Life Exp.: <10 years	Medium	Poor	Fair	Poor			Canopy weakening, roots drying back and foliage sparse in upper canopy, weakening in mid canopy. Butt and main stem with multiple splits and cracks with areas of necrotic bark. Multiple fungal fruiting bodies and scales . Slight lean E towards path. In region of other tree recently removed leaving slightly exposed. Fungus: Kretzschmaria deusta (Brittle Cinder) Ganoderma australe (Southern Bracket)	Fell tree. Timescale: 25-Jun-2025 (1 Year)
T011	/// brave. prom. groups	Common beech (Fagus sylvatica)	Directly next to path, buttress roots in path.	Height (m): 19 Crown Radius (m): 8 DBH (cm): 110 Life Stage: Mature Life Exp.: 50+ Years	Medium	Good	Fair	Good	Good	Good	Strong buttress roots. Broad form favours W, field side. Recent main lower limb failed, lying on ground, leaving tear wound. Directly above failed point is limb with severe canker at union, now exposed.	Clear up snapped out branch out of path. Remove limb with canker at union. Timescale: 25-Jun-2025 (1 Year)

<p>T010</p> <p>Common beech (<i>Fagus sylvatica</i>)</p> <p>Showing location of fungal brackets, and current canopy health and shape</p>

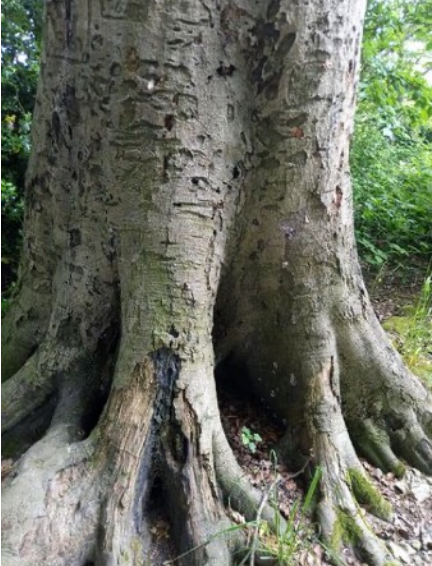
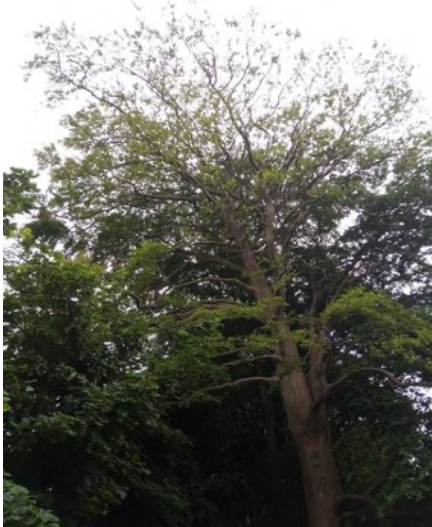
<p>T010</p> <p>Common beech (<i>Fagus sylvatica</i>)</p> <p>Showing condition of main stem and declining canopy health</p>

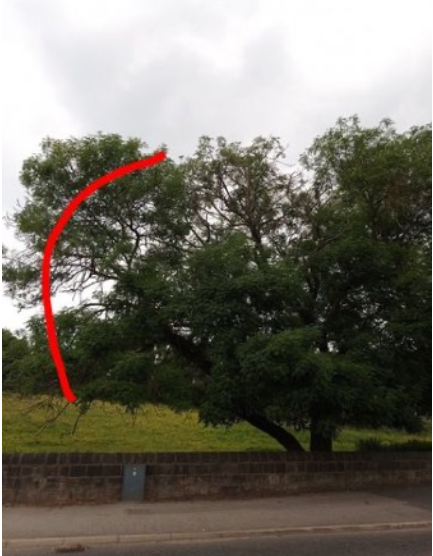
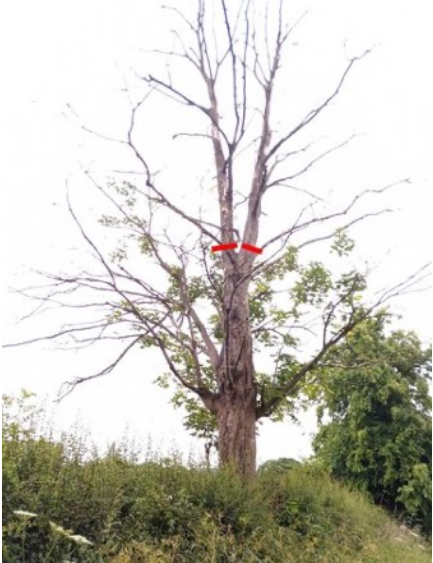
<p>T027</p> <p>Sycamore (<i>Acer pseudoplatanus</i>)</p> <p>Showing declining top, and cut points to begin retrenchment</p>

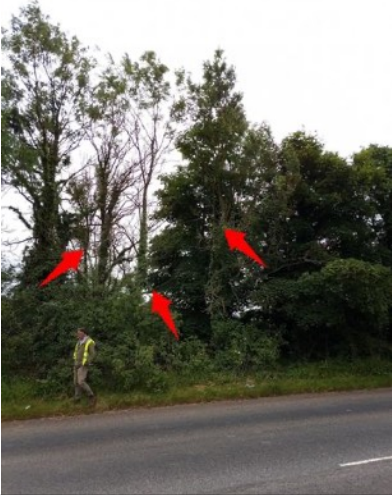
Ref.	What 3 Words	Species	Description	Measurements	Risk Category	Physio' Condition	Structural Condition	Overall Condition	Public Amenity Value	Wildlife Value	Survey Notes	Recommendations
G007	/// interview.shots.globe	Common ash x3 (Fraxinus excelsior)	Roadside trees. Tree next to sycamore group with rose growing at base	Height (m): 10 Crown Radius (m): 3 DBH (cm): 30 Trees: 3 Life Stage: Early Mature Life Exp.: <10 years	High	Poor	Fair	Poor	Low	Low	One tree multi stemmed. All trees ivy clad. Severely dying back. All three have upright form. One tree almost completely dead. Pests and Diseases: Ash Dieback Infection Level 3: 50% to 75%	Fell trees Timescale: 01-Jul-2025 (1 Year)
G008	/// crumples.demanding.tomb	Common ash x3 (Fraxinus excelsior)	Row of three road side tree, close together.	Height (m): 14 Crown Radius (m): 4 DBH (cm): 40 Trees: 3 Life Stage: Mature Life Exp.: <10 years	High	Poor	Fair	Poor	Low	Low	Severely ivy clad. Dying tips, mainly at top, little potential for regrowth. Pests and Diseases: Ash Dieback Infection Level 2: 25% to 50%	Fell trees Timescale: 01-Jul-2025 (1 Year)

<p>G007</p> <p>Common ash (<i>Fraxinus excelsior</i>)</p> <p>Showing trees to be removed</p>

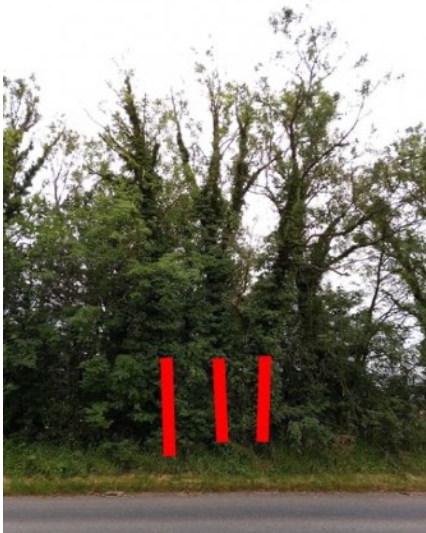
<p>T003</p> <p>Common ash (<i>Fraxinus excelsior</i>)</p> <p>Showing stems cached in undergrowth to be removed</p>

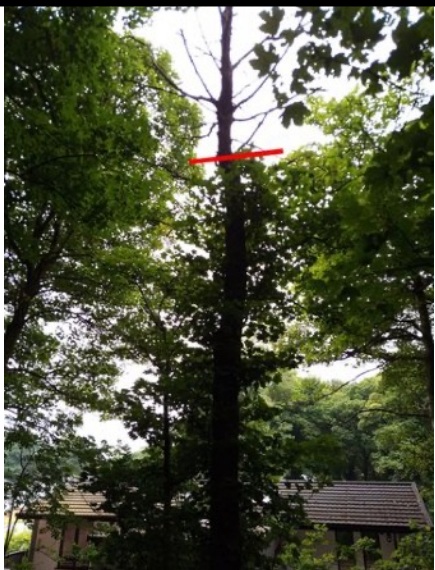
<p>T002</p> <p>Sycamore (<i>Acer pseudoplatanus</i>)</p> <p>Showing top to be removed, and proximity to buildings</p>

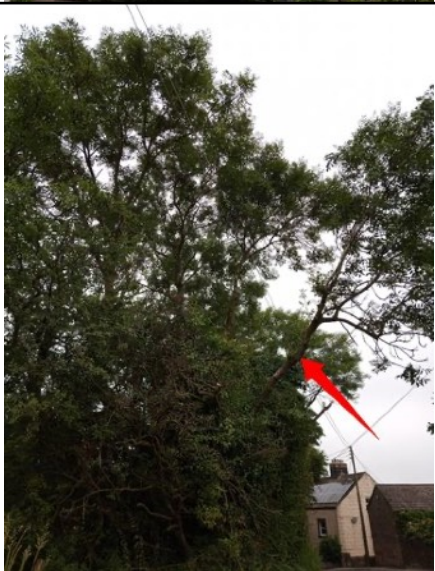
Ref.	What 3 Words	Species	Description	Measurements	Risk Category	Physio' Condition	Structural Condition	Overall Condition	Public Amenity Value	Wildlife Value	Survey Notes	Recommendations
T004	/// overdrive.drag.attention	Common ash (Fraxinus excelsior)	Next to road, power cables through canopy	Height (m): 9 Crown Radius (m): 3.5 DBH (cm): 30 Stems: 2 Life Stage: Early Mature Life Exp.: 20+ Years	High	Good	Fair	Good	Moderate	Moderate	Hedgerow tree growing with hawthorn and hazel. Single stems growing out over road with severe lean, epicormic growth on stem.	Remove leaning stem back to hedge Timescale: 26-Jun-2025 (1 Year)
T005	/// oath.mothering.single.s	Common ash (Fraxinus excelsior)	Dual stemmed roadside tree. Next to wall.	Height (m): 14 Crown Radius (m): 5 DBH (cm): 35 Stems: 2 Life Stage: Mature Life Exp.: 10+ Years	High	Fair	Fair	Fair	Moderate	Low	Dual stemmed. Slightly weakened canopy, sparse foliage with no internal growth. Smaller stem with wound from previous limb removal, creating split to rear. Also has strong lean over road with poor form, future potential hazard.	Reduce smaller leaning stem back to first major upright branch. Timescale: 26-Jun-2026 (2 Years)

<p>T004</p> <p>Common ash (<i>Fraxinus excelsior</i>)</p> <p>Showing severely leaning stem to be removed</p>

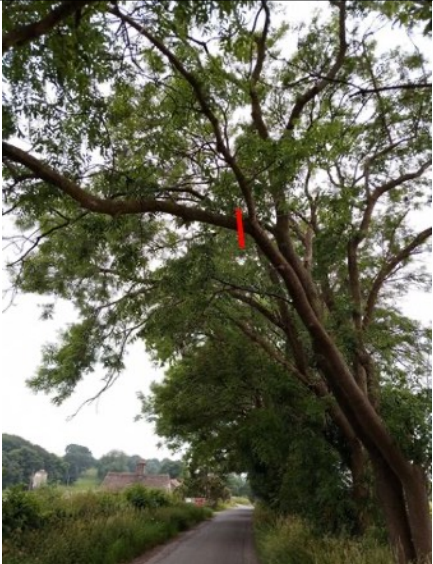
<p>T005</p> <p>Common ash (<i>Fraxinus excelsior</i>)</p> <p>Showing branch to reduce, smaller leaning stem to be cut back to first major upright branch.</p>

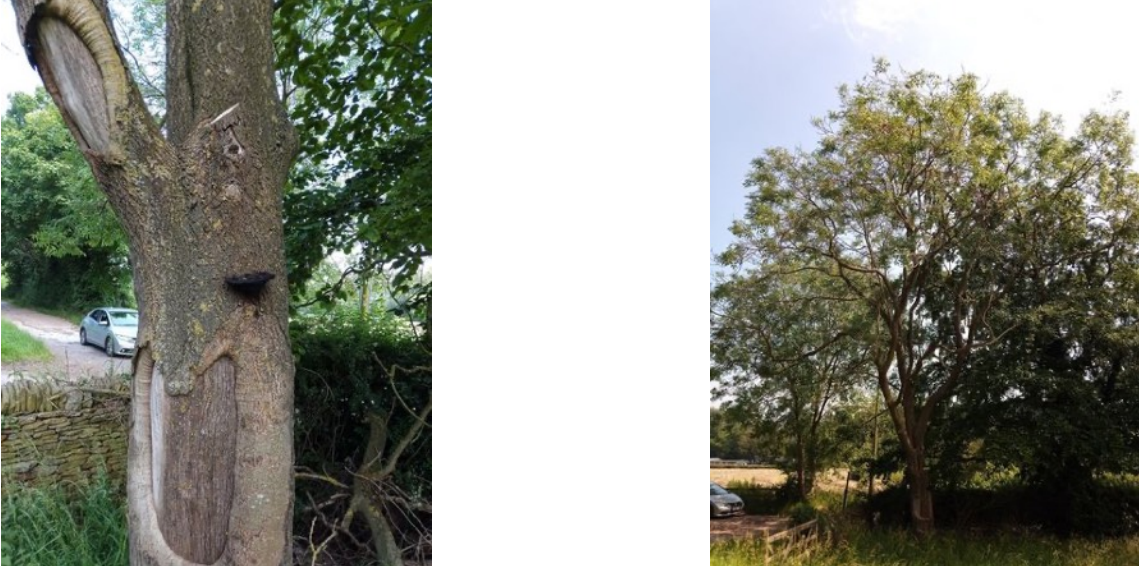
<p>T014</p> <p>Common ash (<i>Fraxinus excelsior</i>)</p> <p>Showing fungal bracket and foliage condition</p>

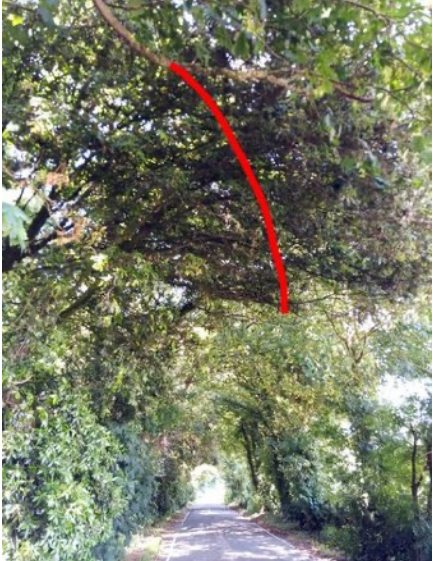
A photograph showing a paved road lined with trees. A red curved arrow points to a branch of a tree on the left side of the road.	<p>T016</p> <p>Holm oak (<i>Quercus ilex</i>)</p> <p>Showing potential line of reduction</p>

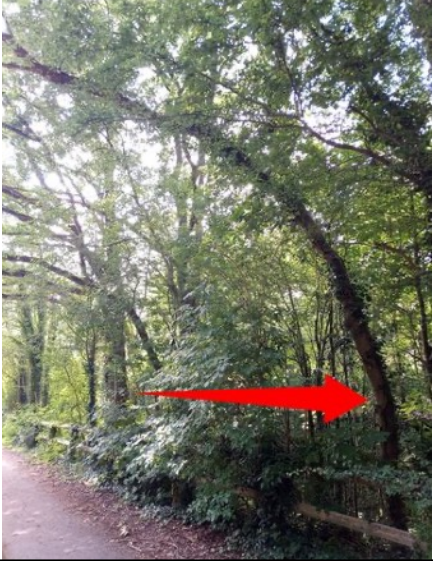
A photograph showing a dirt path lined with trees. A red arrow points to a tree stem on the right side of the path.	<p>T025</p> <p>Common ash (<i>Fraxinus excelsior</i>)</p> <p>Showing stem on proximity to road and path</p>

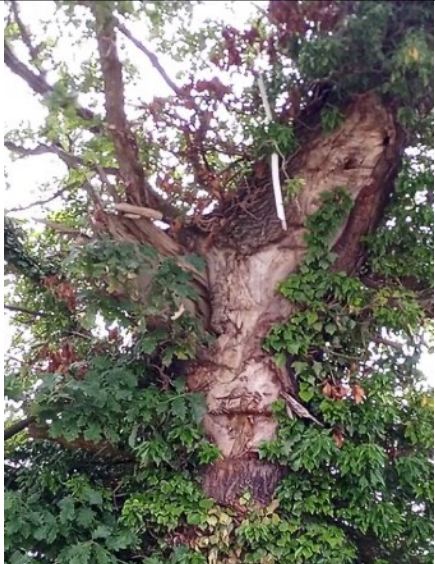
<p>T036</p> <p>Pedunculate oak (<i>Quercus robur</i>)</p> <p>Showing damage to main stem from vehicles</p>

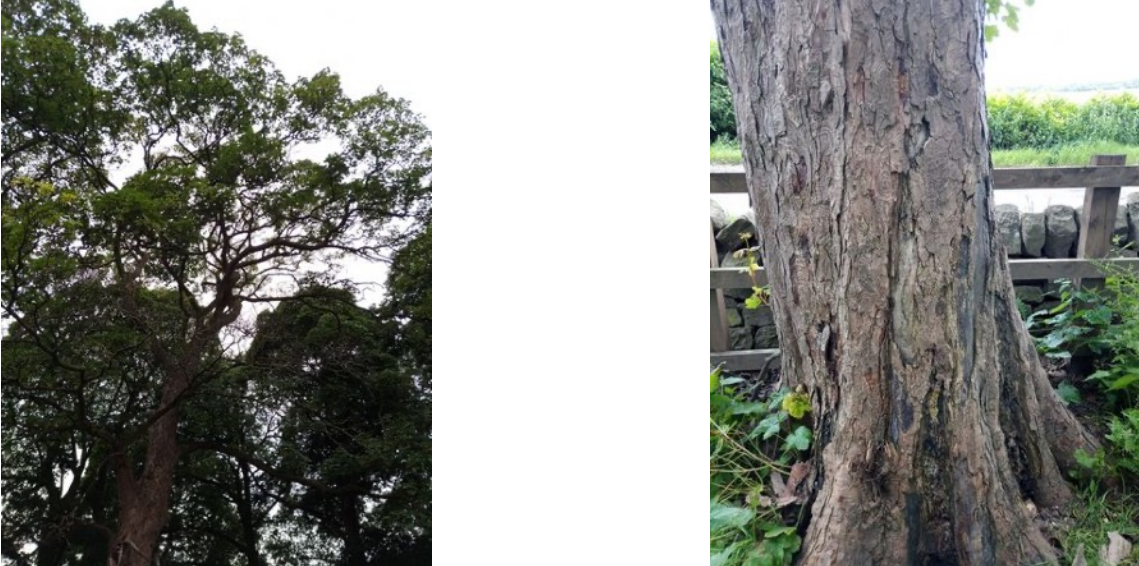
T037	/// steady.r.unheated.snores	Sycamore (Acer pseudoplatanus)	Roadside tree, in lower norcroft farm garden.	Height (m): 17 Crown Radius (m): 5 DBH (cm): 85 Life Stage: Mature Life Exp.: <10 years	High	Fair	Physical Defect	Fair	Moderate	Good	Growing in copse of established nature trees. Butteress roots, one damaged in fence installation, some decay in butteresses w side of tree with soft root. Leading to area of necrotic bark with exposed heartwood, large area leaving around 60 percent circumference of live tissue. Multiple dead branches in lower canopy, and heavily crown lifted, some major limbs removed leaving wound areas, good habitat. Sparse open upper canopy some deadwood. Slight lean NW away from road.	Recommendations 1: Remove all substantial dead. Timescale: 01-Jan-2025 (6 Months) Recommendations 2: Monitor tree vitality, spread of decay. Timescale: 01-Jul-2026 (2 Years)
T038	/// blush.animate.s.pins	Oak (Quercus sp.)	Roadside, slight stress back in waterlogged area	Height (m): 16 Crown Radius (m): 8 Life Stage: Dead	High	Dead	Poor	Dead	Low	Good	Large standing dead tree, ivy clad stem. Large branches roadside.	Fell tree Timescale: 01-Jul-2024 (Urgent)

<p>T037</p> <p>Sycamore (<i>Acer pseudoplatanus</i>)</p> <p>Showing stem condition, and canopy condition</p>

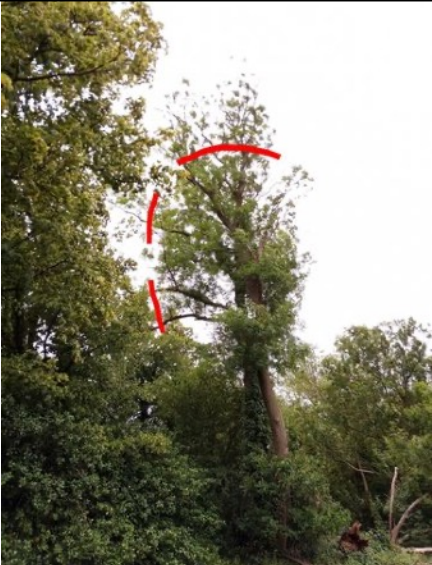
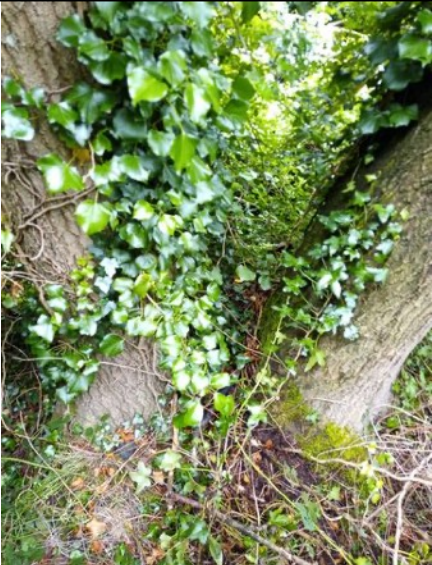
<p>T062</p> <p>Common ash (<i>Fraxinus excelsior</i>)</p> <p>Showing main union, and potential reduction points</p>

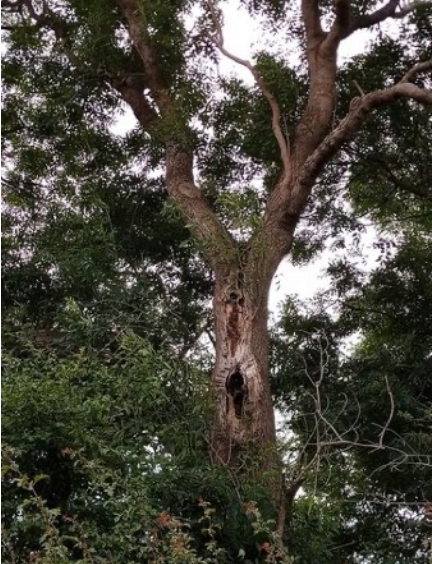
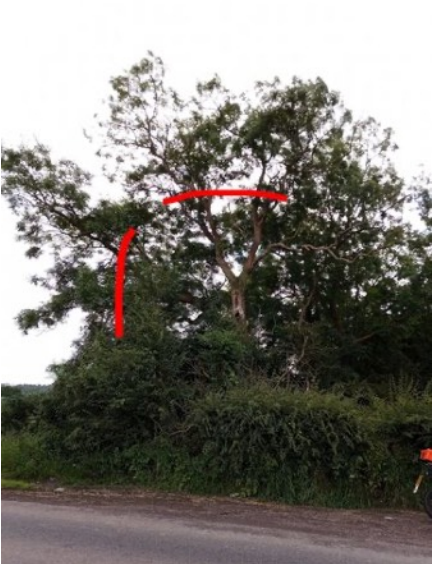
<p>T069</p> <p>Common ash (<i>Fraxinus excelsior</i>)</p> <p>Showing exposed damage, and potential reduction points</p>

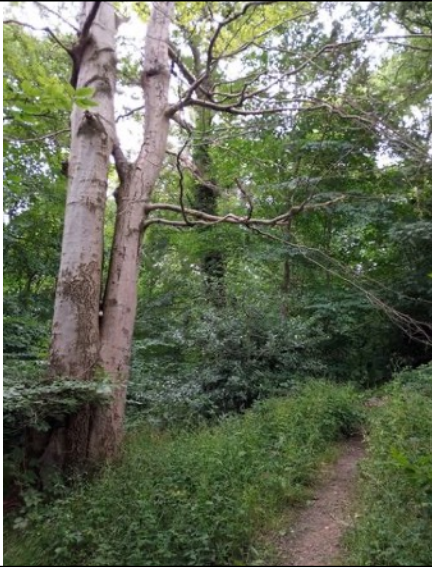
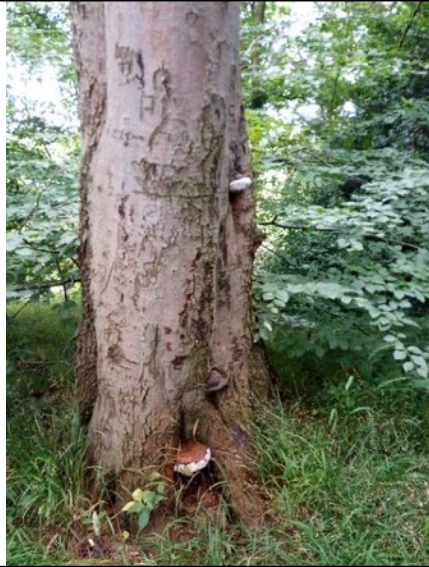
Ref.	What 3 Words	Species	Description	Measurements	Risk Category	Physio' Condition	Structural Condition	Overall Condition	Public Amenity Value	Wildlife Value	Survey Notes	Recommendations
T093	/// submitted.chopper.business	Common beech (Fagus sylvatica)	Next to small path near gateway on track, Haddon Green	Height (m): 16 Crown Radius (m): 6 DBH (cm): 105 Life Stage: Mature Life Exp.: <10 years	Low	Poor	Fair	Poor	Low	Good	Double Stemmed from 2m. In decline. Upper canopy dying back. Secondary stem has failed leaving totem. Fungal brackets in union. Dead patches of bark up main stem. Fungus: Ganoderma australe (Southern Bracket)	Fell tree. Timescale: 15-Jul-2026 (2 Years)
T094	/// sending.townhouse.apprehend	Sycamore (Acer pseudoplatanus)	N of track.	Height (m): 11 Crown Radius (m): 2.5 DBH (cm): 25 Life Stage: Dead	Low	Dead		Dead	Low	Moderate	Standing dead tree, holly undergrowth	Fell tree. Timescale: 15-Jul-2026 (2 Years)
