**1605 Oughtibridge Mill**

**Boiler House**

**Visual Structural Survey**

**Boiler House Visual Structural Survey**  
**At**  
**Oughtibridge Mill, Oughtibridge**  
**For**  
**CEG**

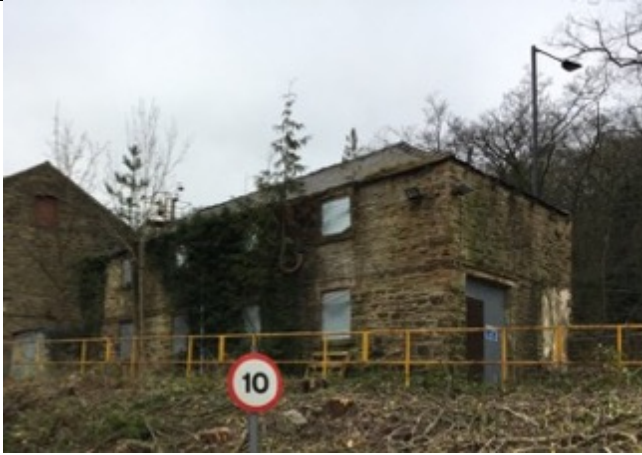
The Boiler House is a two-storey stone structure with a slate roof, timber rafters and a part first floor.

Access to the building is via the steel door on the North Elevation.

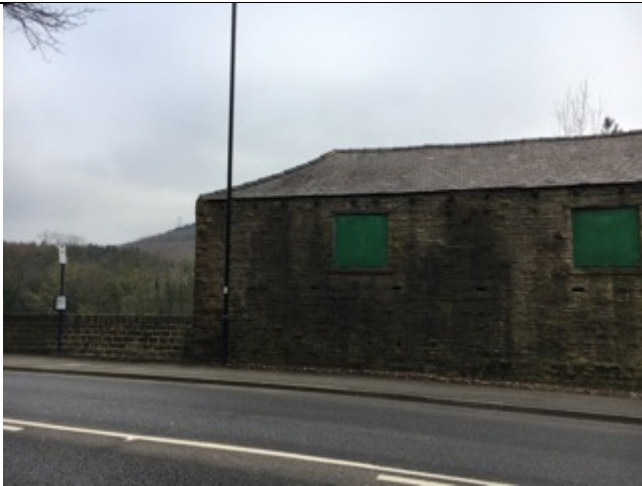
View of the roof showing excessive deflection to the hip rafter and the sagging between trusses along the ridge.

| Item | Proposal |
|---|---|
| Movement within the roof members | Appoint a timber specialist to survey the existing roof timbers and determine the extent of any rot or decay.<br><br>Design check on the rafters, purlins and trusses to ensure they comply with current regulations, including an allowance for new roof membranes, insulation and ceiling. If they don't comply, provide a new roof structure. |

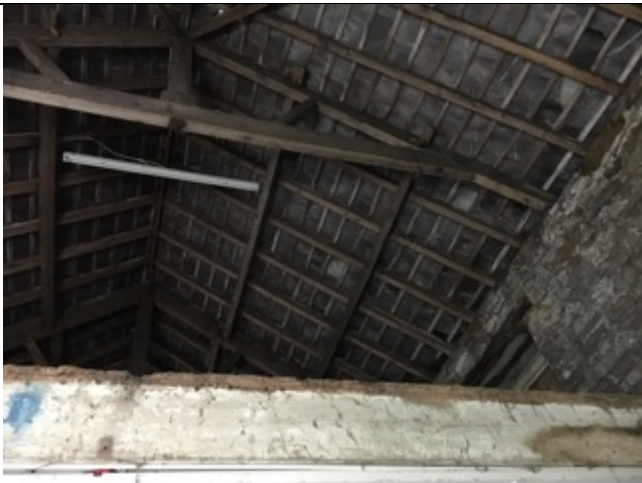
The roof is supported on several timber trusses with purlins and rafters. The hipped end has rafters spanning from the truss to the eaves.

The trusses are quite slender and due to the water penetration and movement may not be suitable to be re-used.

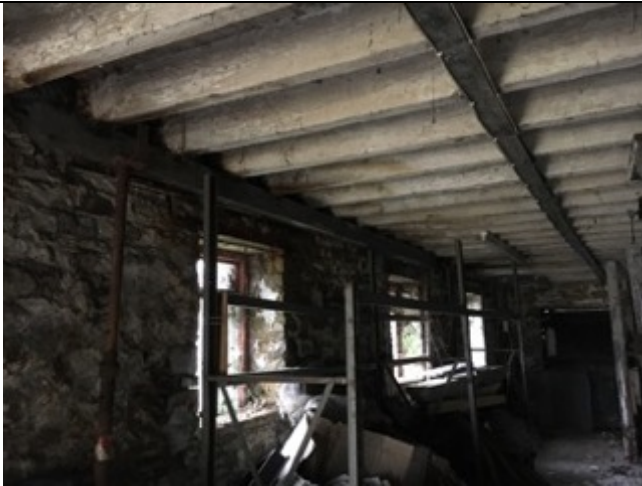
There is a part first floor within the building. The floor joists are showing signs of significant damp penetration and decay. The floor is propped in several areas but this shouldn't be relied upon.

| Item | Proposal |
|---|---|
| First Floor | Replace the first floor in its entirety. |

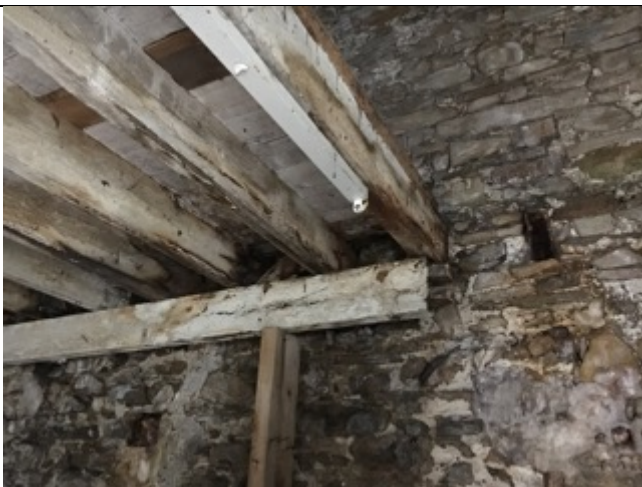
View of the failed joist ends

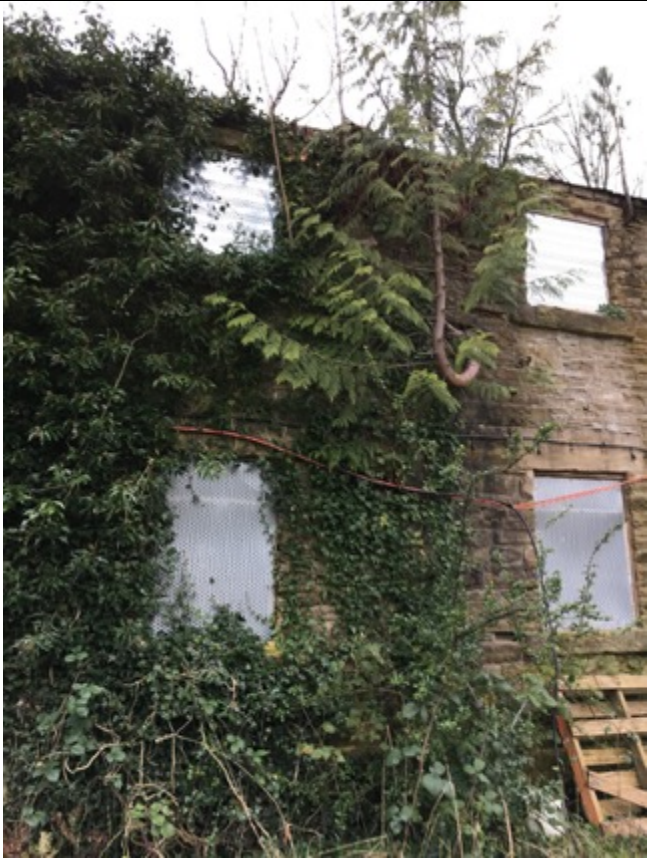
The site elevation is in a very poor condition with significant vegetation growth and movement in the brickwork.

In two locations, large trunks have grown in to the brickwork and displaced the wall.

| Item | Proposal |
|---|---|
| Site elevation - Brickwork is in very poor condition with movement at high level on the site elevation. | Take down the masonry to ground level and rebuild. |

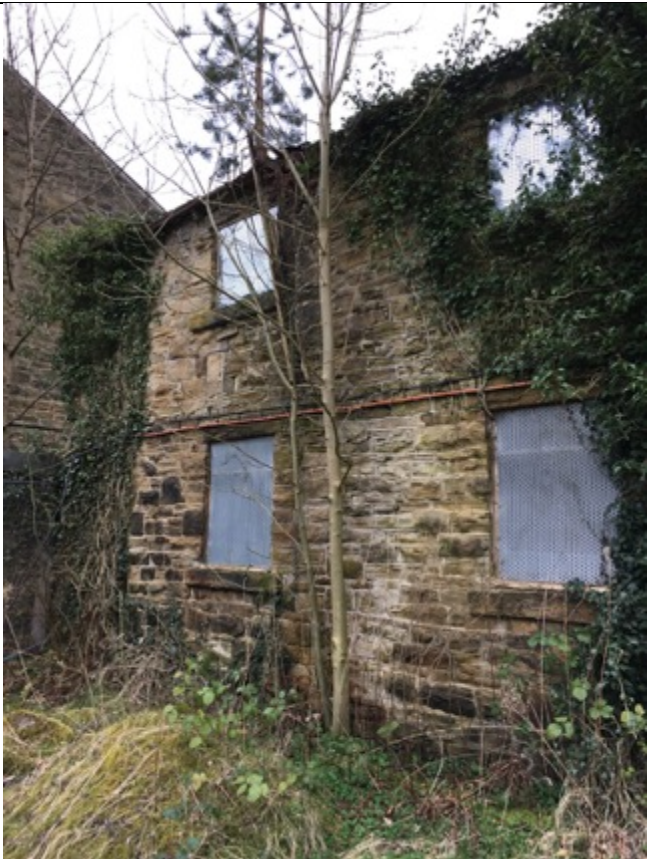
The roof and eaves have been displaced where the branch is growing between the brickwork.

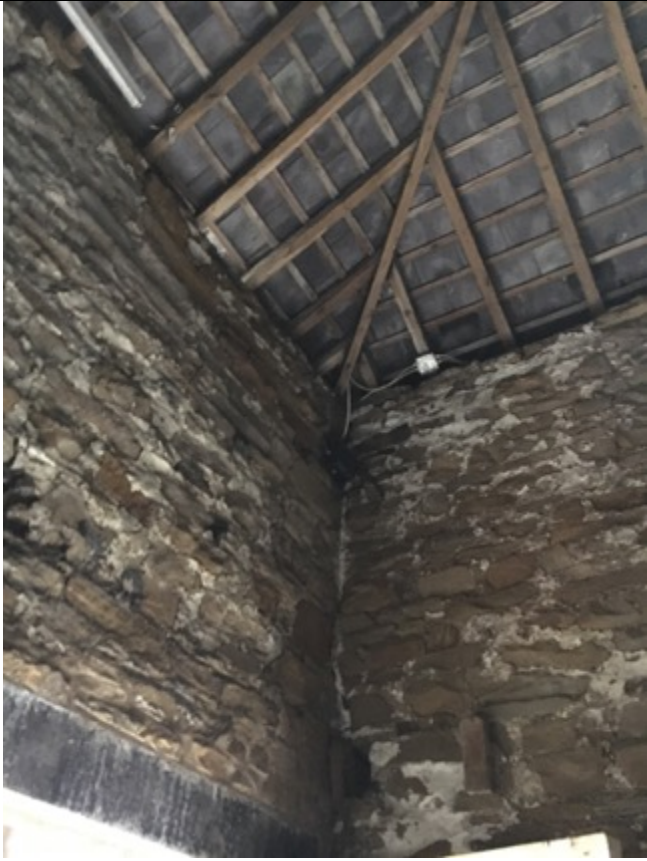
The junction between the front and side elevations shows signs of movement and the walls are not coursed in.

| Item | Proposal |
|---|---|
| Brickwork generally | Clean and repoint all brickwork, including "helibar" or "helifix" ties to restrain corners and areas of cracking. |

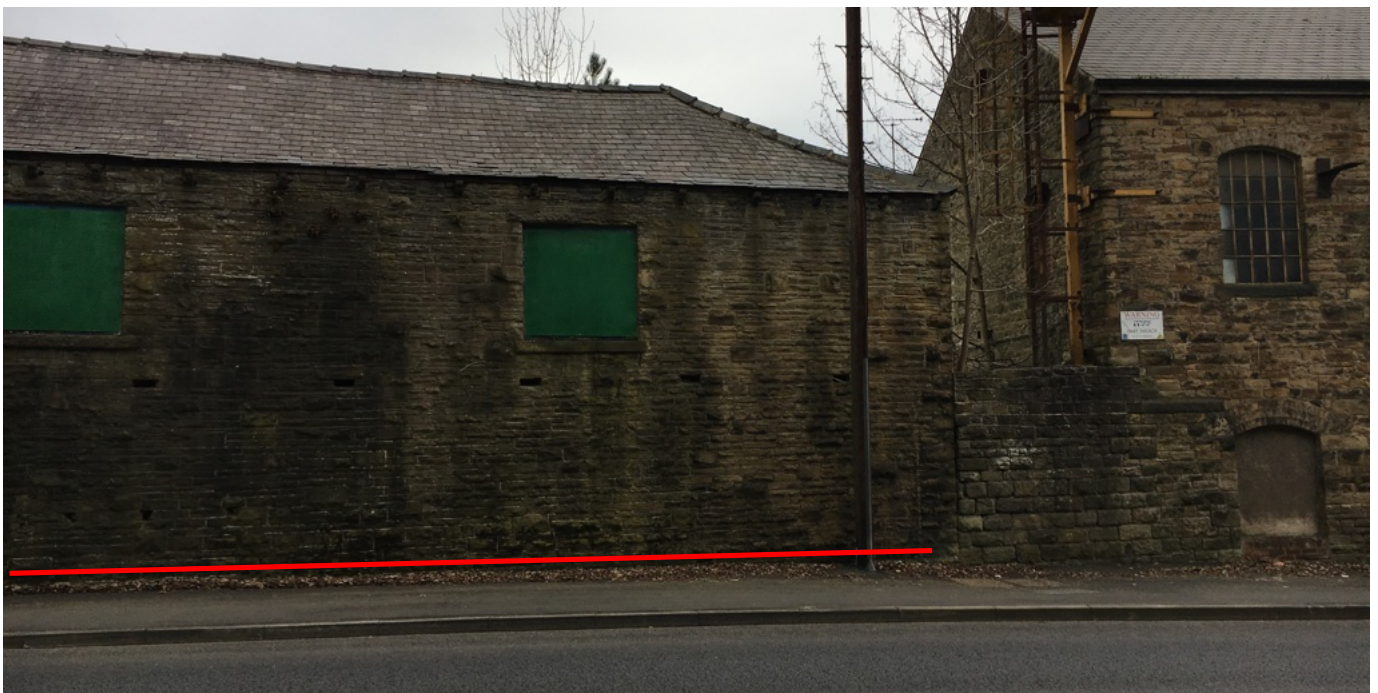
The existing Boiler House does not retain the highway to Langsett Road North, as shown in the photograph below, the approximate ground level within the building is shown in red.

The intention is to demolish the boundary wall of the building to approximately 900mm above footpath level to maintain a boundary separation.
