**PHASE 1 ENVIRONMENTAL ASSESSMENT  
AND  
DESK BASED COAL MINING RISK  
ASSESSMENT  
PROPOSED RETAIL DEVELOPMENT  
CROSS KEYS LANE, HOYLAND  
BARNSELEY

LIDL GREAT BRITAIN LTD

GDP PROJECT NUMBER 2047**

**Issue record: 1 FINAL for approval.**

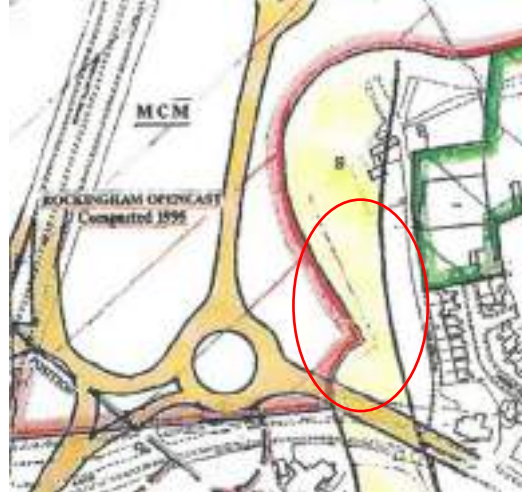
boundary of the Rockingham Opencast mine. The edge of the opencast mine is depicted in red on the plan below and approximately coincided with the location of a bank of trees that crosses the site.

The mineral report indicated that the Rockingham opencast site was worked during the 1990s and the opencast voids were subsequently backfilled with overburden/spoil and the land returned to agricultural use/open space. The backfill is indicated to vary in thickness from less than 2m in the west to in excess of 10m in the east. As the site is located on the eastern side of the Rockingham opencast site it is anticipated that approximately 10m of backfill is likely to be present along with the opencast highwall. The report indicated that the Rockingham opencast site was compacted back to provide a developable platform, although it is indicated that creep and/or differential settlement could still occur particularly across the high wall.

At this site the store could be built running east to west but it is very likely that the west section spanning the high wall and across the deep fill would need to be piled or significant ground improvement undertaken to prove that differential settlement would not occur. Piling would ensure that total and differential settlement of foundations was tolerable. Piling through the fill could be difficult and a rock socket would need to be formed in the base of the quarry. If the structure was to be entirely on the fill and not across the high wall zone it may be feasible, following further investigation and almost certainly ground improvement of upper layers, to support the structure on a shallow foundation solution. If records of the filling were available then this would be extremely beneficial in assessing the potential for future settlement of the infill. It is difficult to provide confidence on the settlement potential of the deeper layers. Due to the shape of the site and access and planning constraints it is not feasible to construct the store wholly in the backfill area.

The existing information indicates that traditional shallow foundations should be viable except potentially for the extreme southwest corner of the building where it may overhang the suspected highwall zone. The store shape can be amended to limit (or remove) any foundations that could sit over

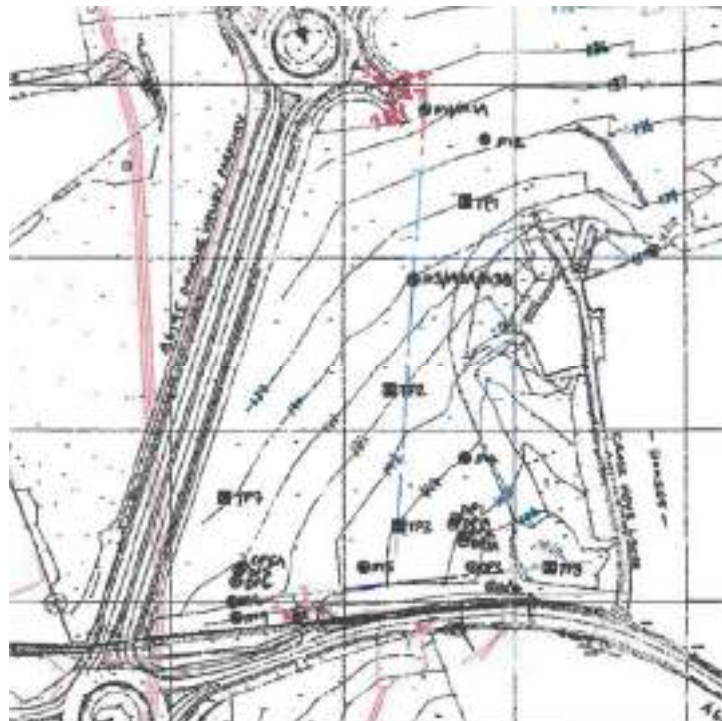
A previous site investigation report was prepared by Sub Surface NE. The purpose of the investigation was to assess the ground conditions for a new road network that has subsequently been constructed and forms the western boundary of the site. Consequently some of the exploratory holes were located within the site boundary. These include M4, TP8, DP1, DP1A, DP2A, DP3 and DP4.

Borehole M4, located in the northwestern part of the site was only drilled to a depth of 2.05m where the borehole was terminated due to an obstruction within the made ground. The made ground generally comprised clayey silty sandy fine to coarse gravel and cobble sized fragments of mudstone. Trial pit TP8 was located in the southeastern part of the site and encountered natural ground conditions beneath a thin layer of topsoil. Near surface the deposits were described as sandy gravel and cobble sized sandstone lithorelicts. At a depth of 0.7m weak thinly bedded sandstone was encountered which extended to a depth of 1.3m. Very weak mudstone was then encountered to the base of the trial pit at 2.35m. Dynamic probes DP1, DP1A, DP2A, DP3 and DP4 were all located in the southwestern part of the site. Several of the dynamic probes terminated at shallow depths, possibly due to obstructions within the made ground. However, DP2 in particular indicated that there was an increase in blow count at approximately 8.3m. This could potentially coincide with the base of the made ground.
