Site: Royd Hill Farm, Higham, Barnsley

Client: Darren Dickinson

Report Title: Desk Top Study

Report Number: 1900 - 151008

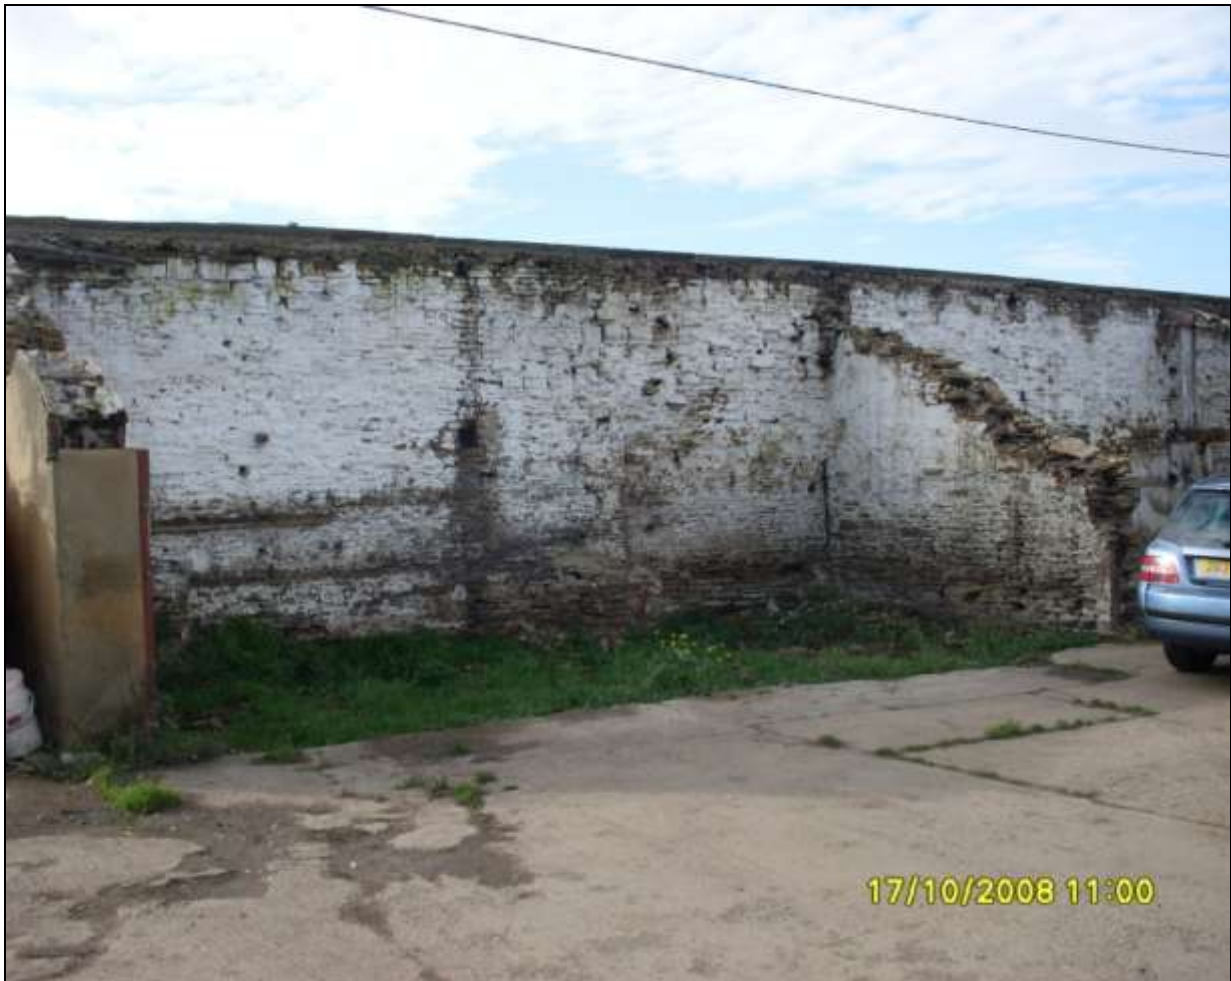
The partially demolished barns surround the western and southern boundaries of the concrete courtyard. The floors of these barns are of rough earth: again, no staining was apparent. Anecdotal evidence suggests the roofs of these barns were removed recently for health and safety reasons.

Photo 1: Partially demolished barns, south of the courtyard

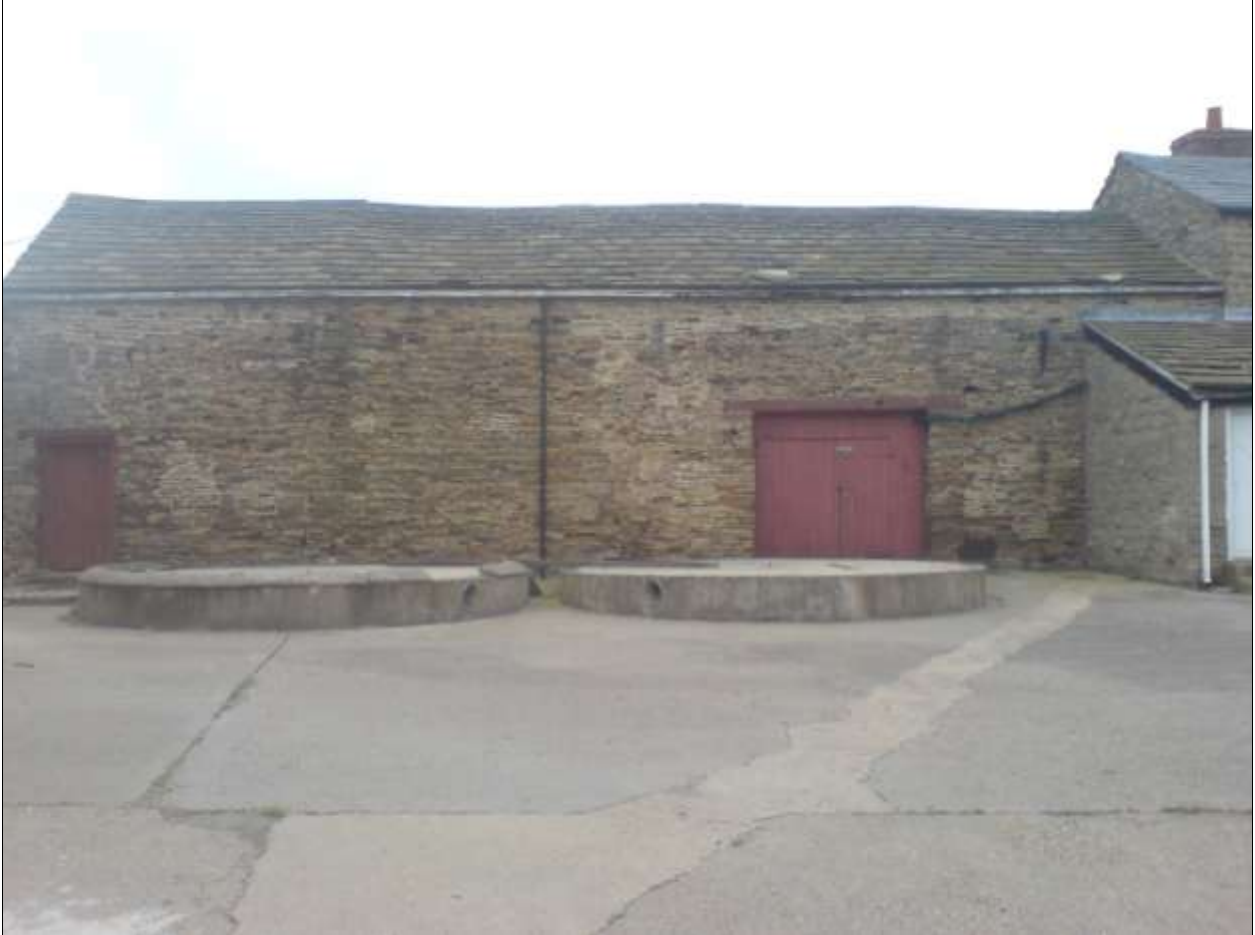
As mentioned previously, two grain silos were present within the courtyard, adjacent to the tithe barn (described on historical maps as "tanks"). Anecdotal evidence suggests these silos were sold quite recently for reuse, and that their foundations were removed for health and safety reasons.

Photo 2: Old silo foundations.

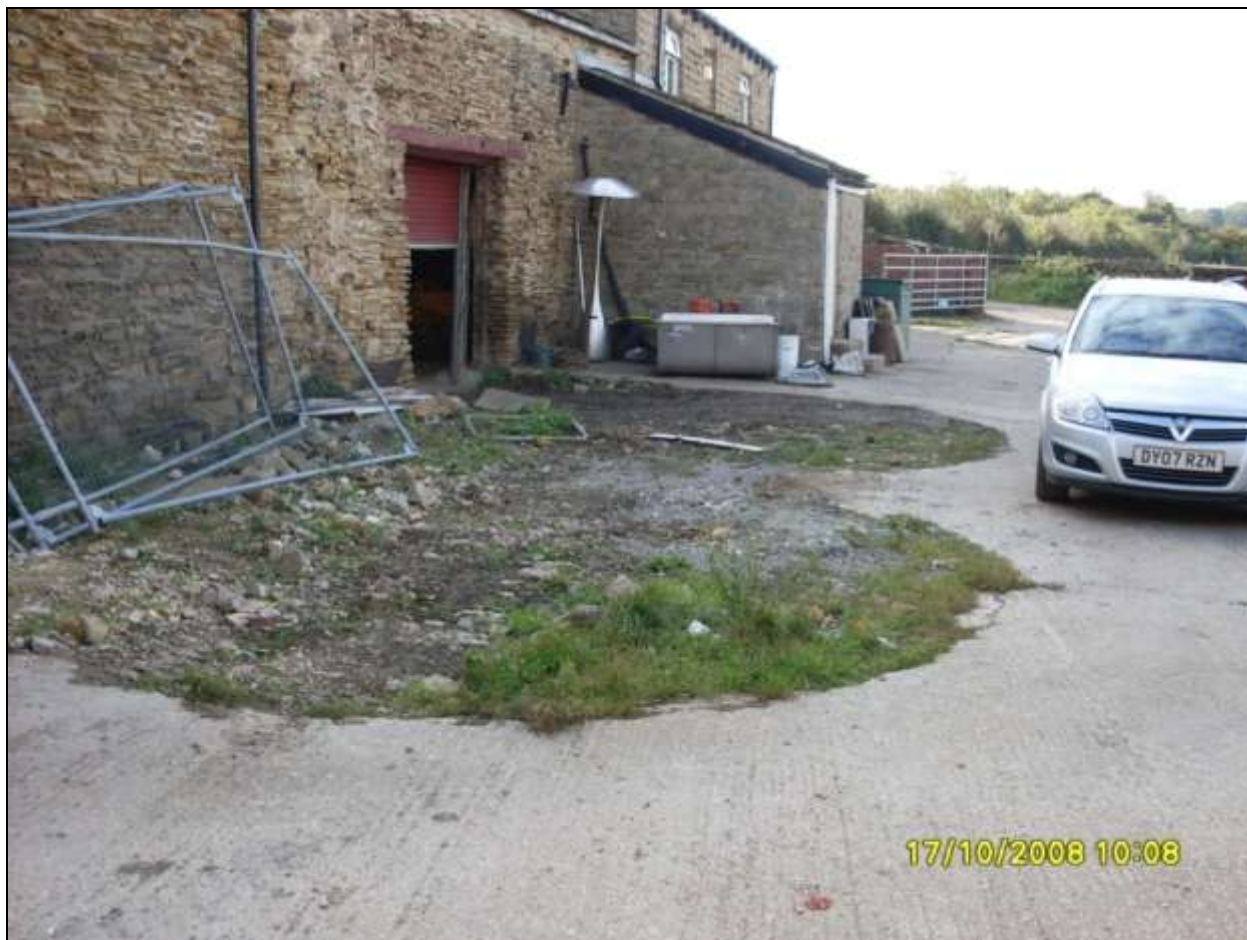
Photo 3: Removed silo foundations (looking south)

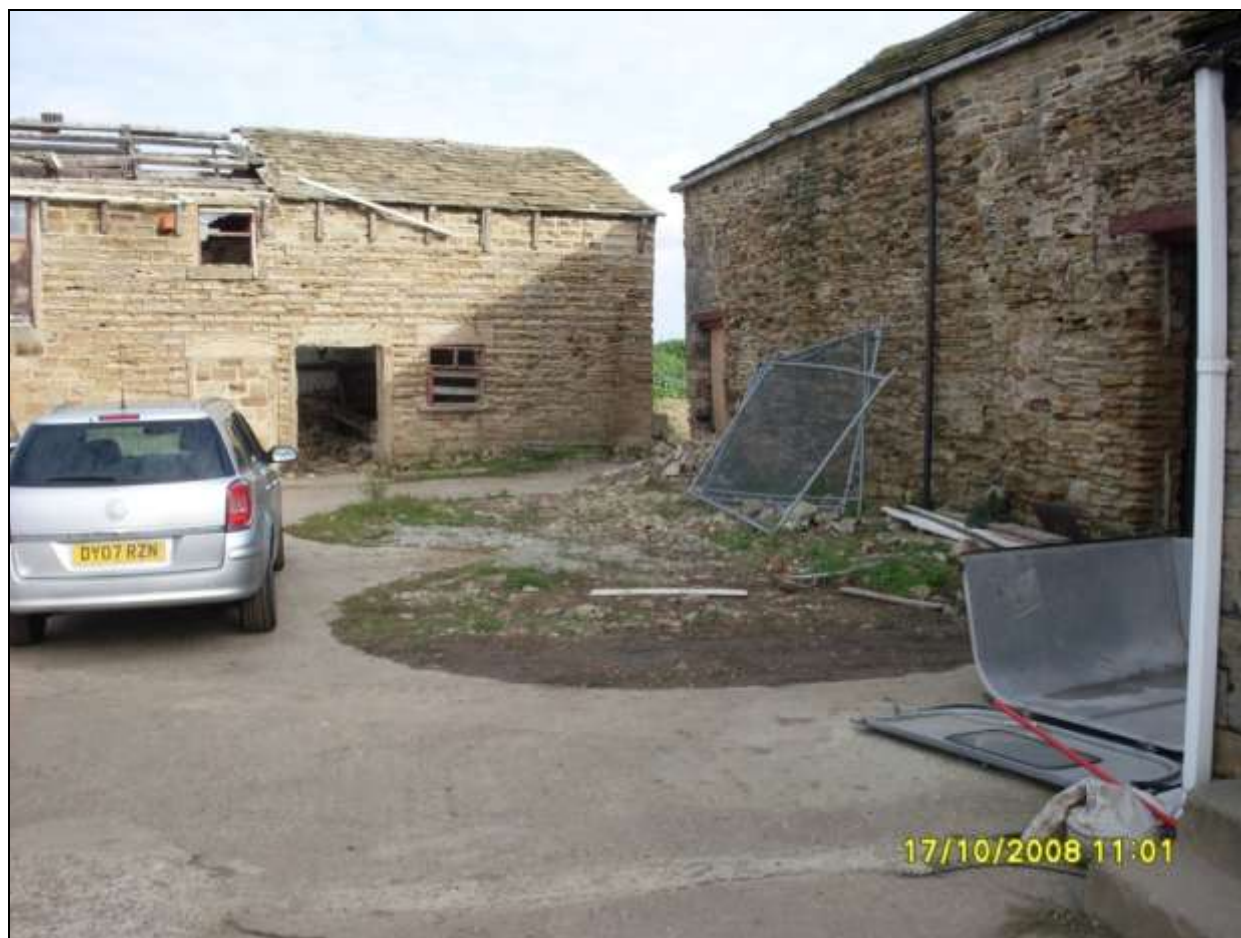
Photo 4: Removed silo foundation (looking north)

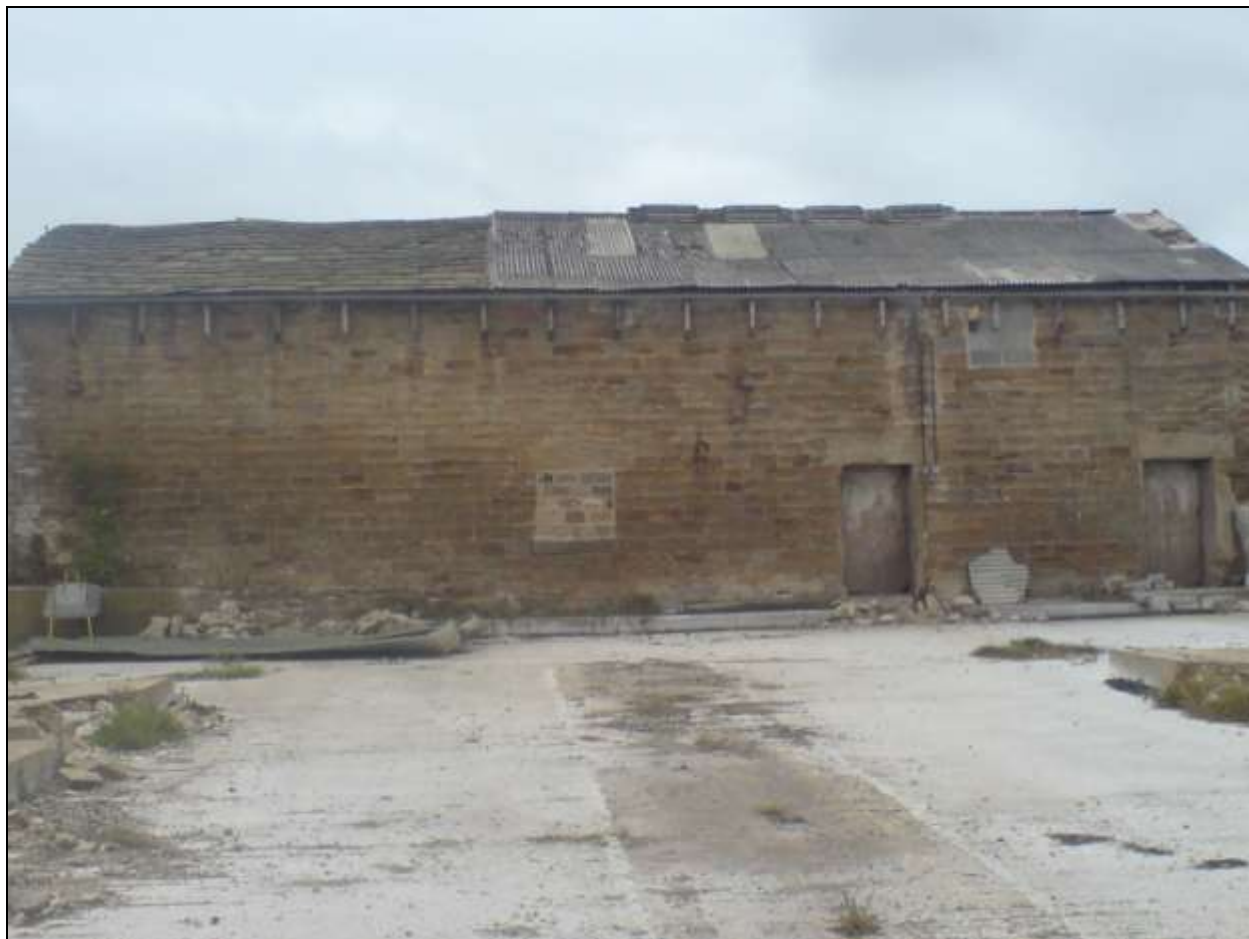
The area at the back of the milking parlour was formerly occupied by a concrete slab. This can be seen on the photo below.

Photo 5: Concrete slab behind milking parlour

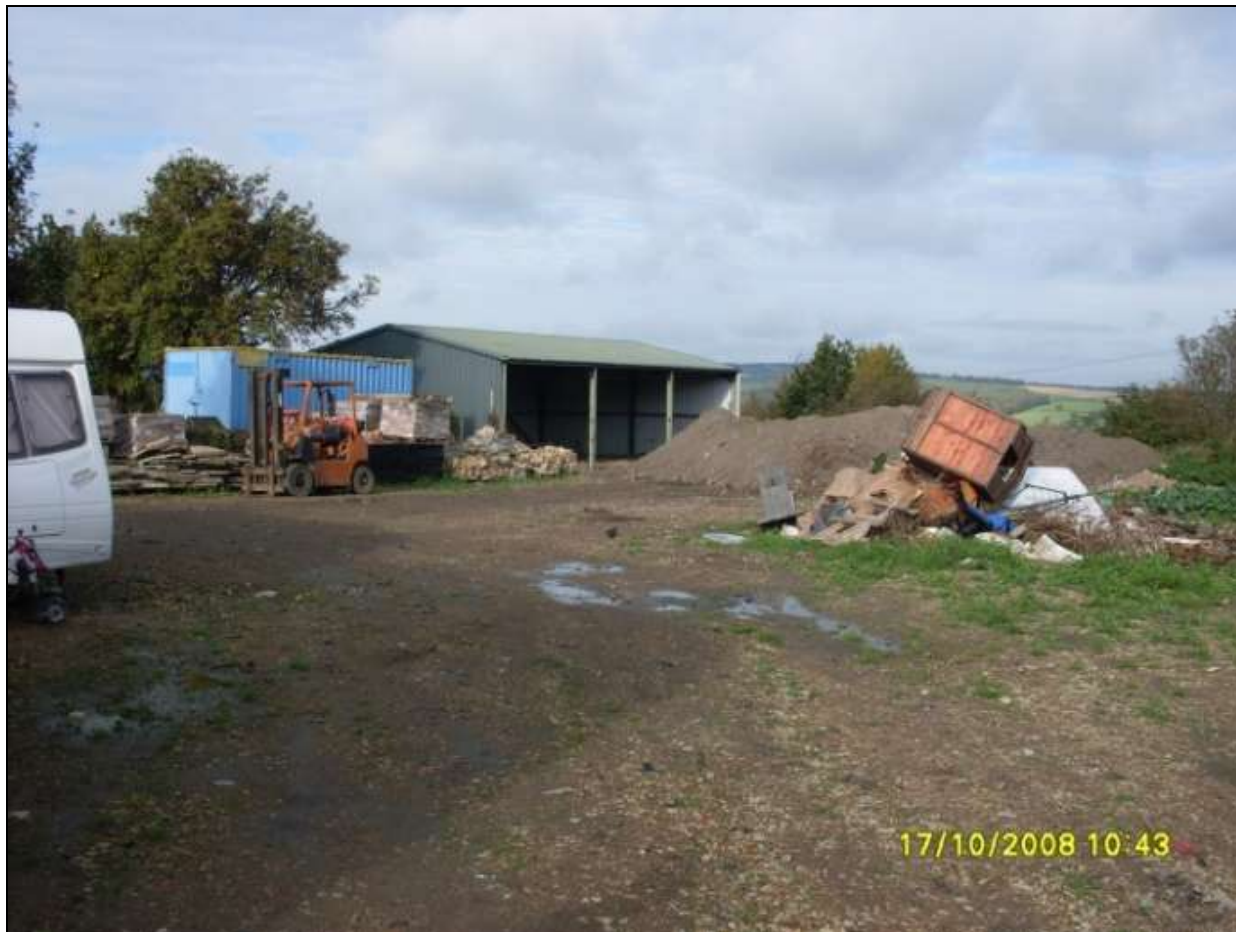
This concrete slab has since been removed as shown in the following photo.

Photo 6: Behind milking parlour

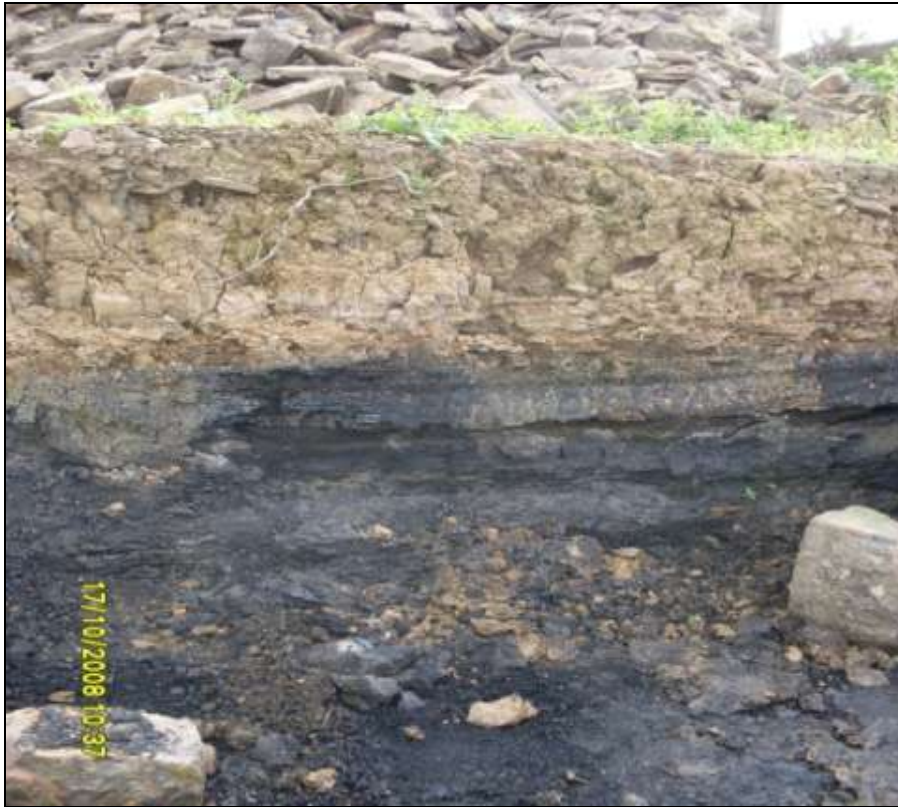
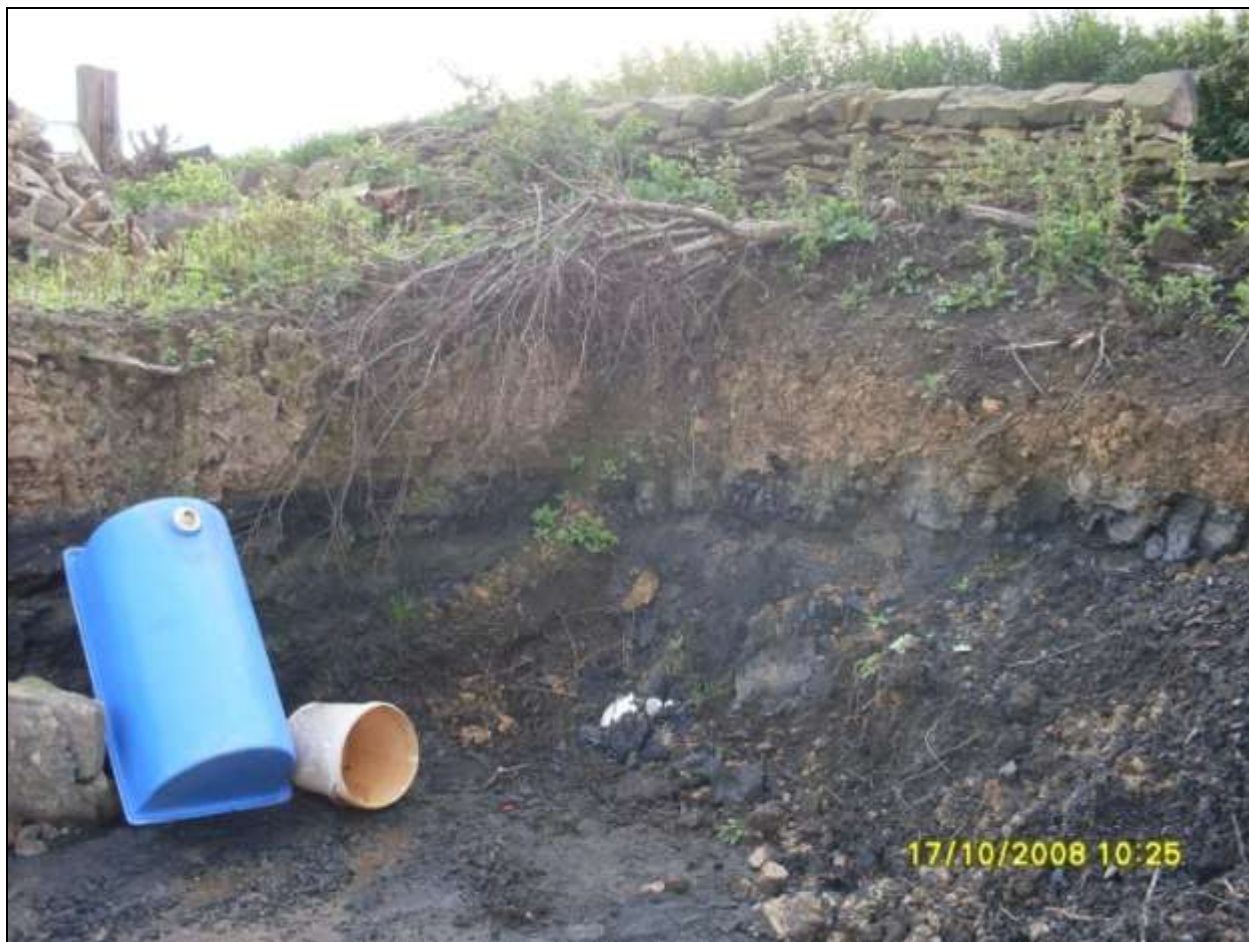
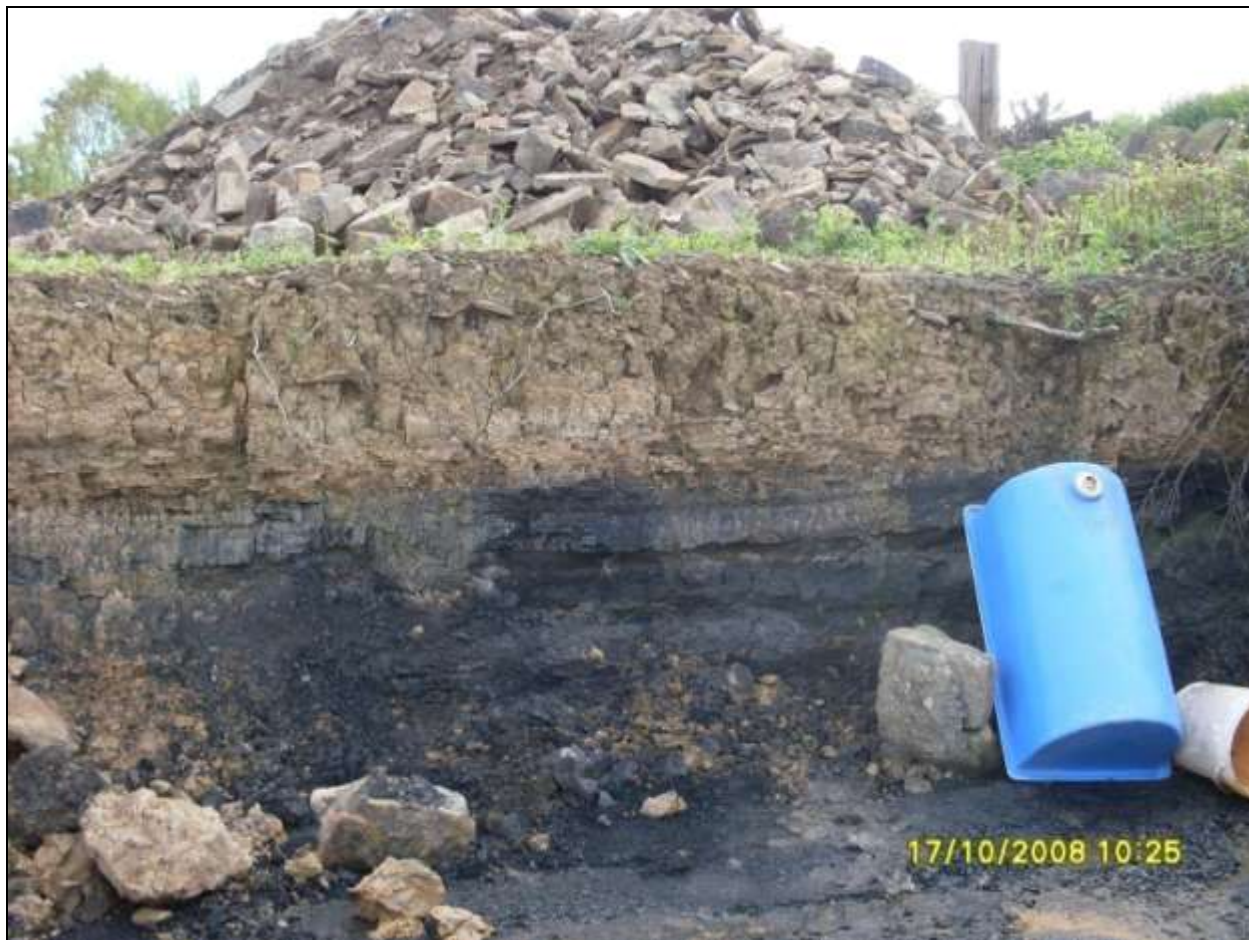
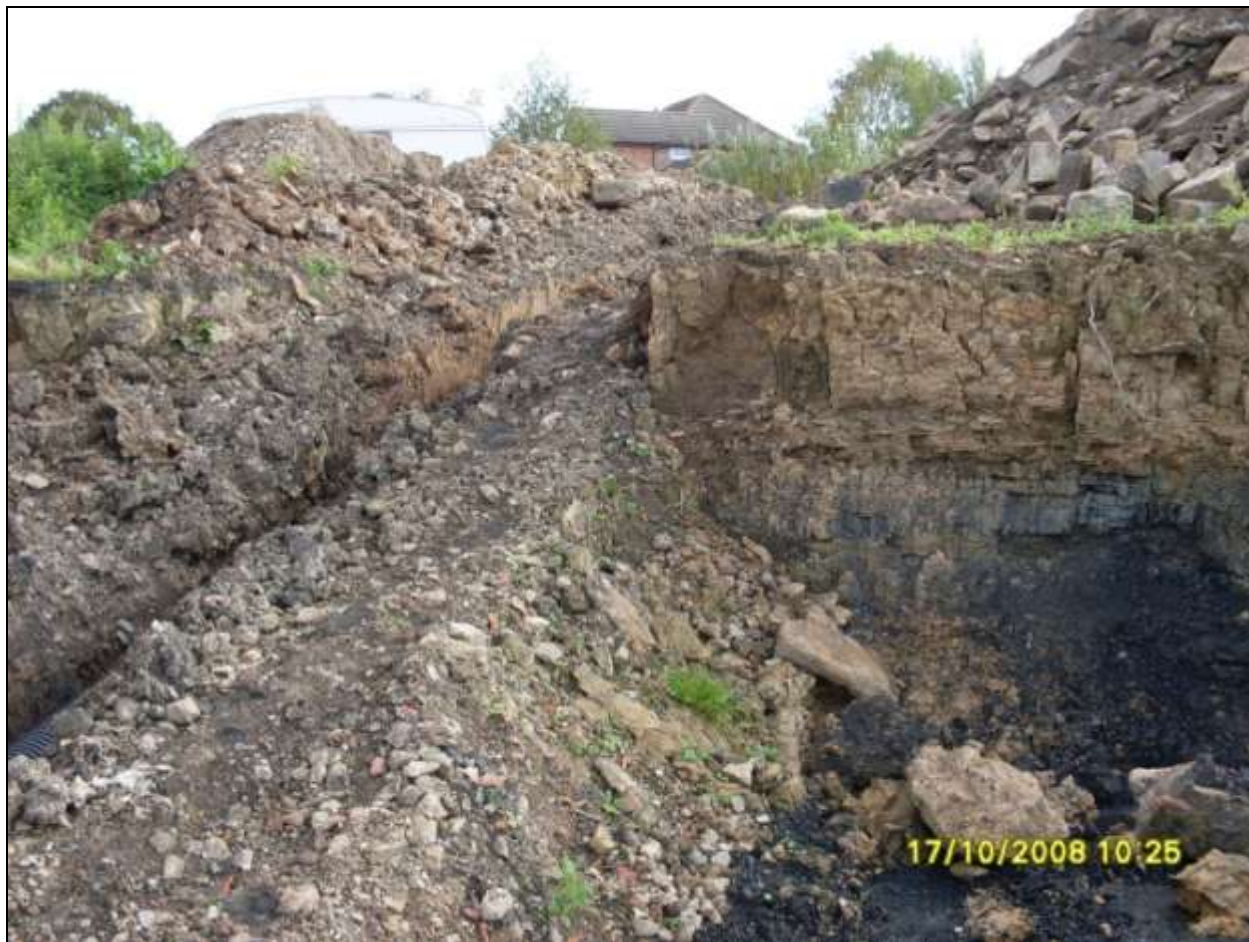
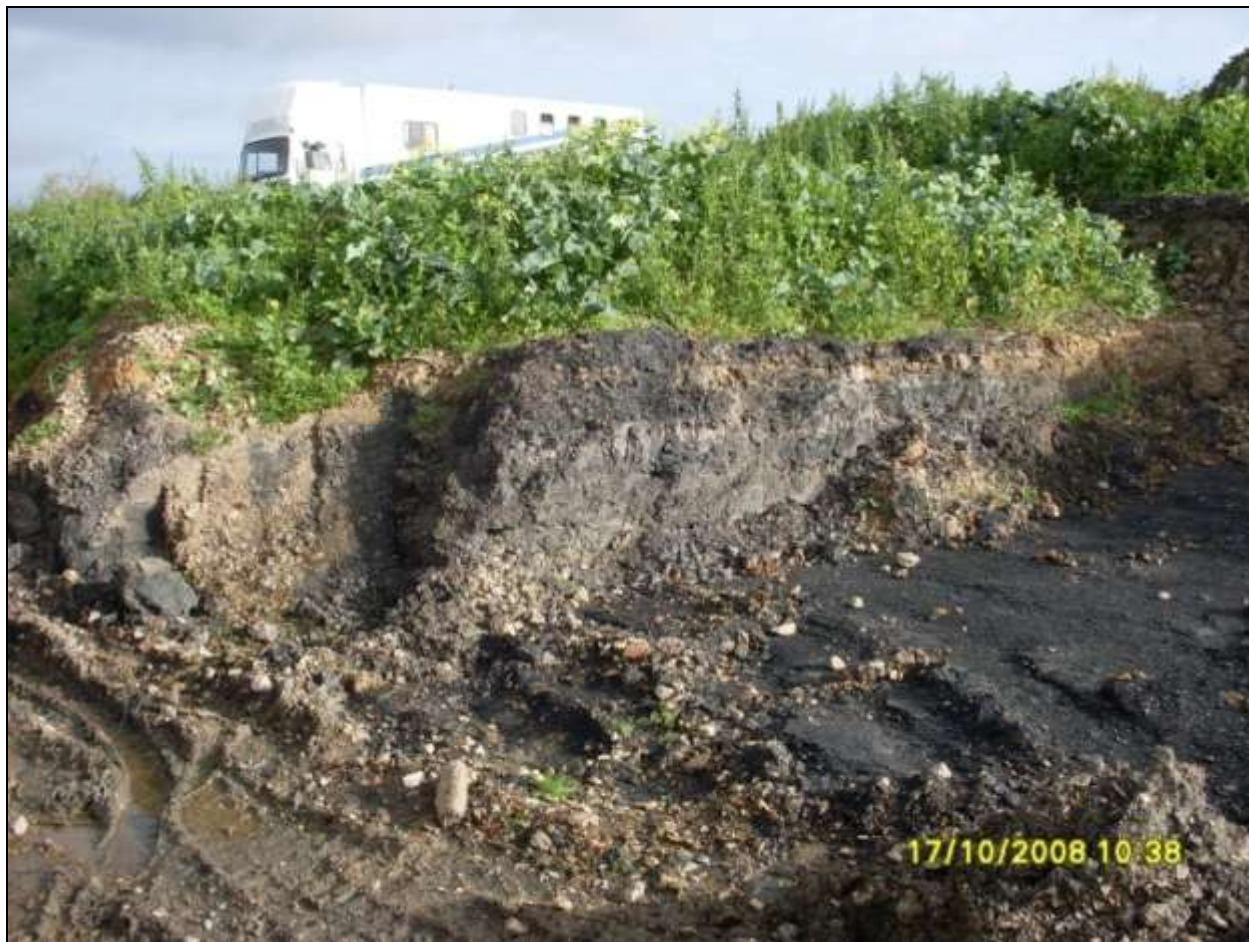
- *The 'cut' area.* It is understood that this area has been excavated for the footings of a proposed extension to the old farmhouse. Photos within the appendices show the presence of a seam of coal material very close to the surface in this area, *though this material was not observed in other areas.* The precise depth of the coal material was not apparent.

At the rear of the main building, cuts in the soil gave evidence of the following soil profiles; a few centimetres of topsoil, followed by approximately 1m of sandstone before an intermittent layer of coal.

- *Coal measures close to the surface*: although these coal measures were only observed in one area of the site, and were confirmed as absent from others areas (“the cut” and “the road cutting” respectively), coal within such close proximity to the surface will require several actions.

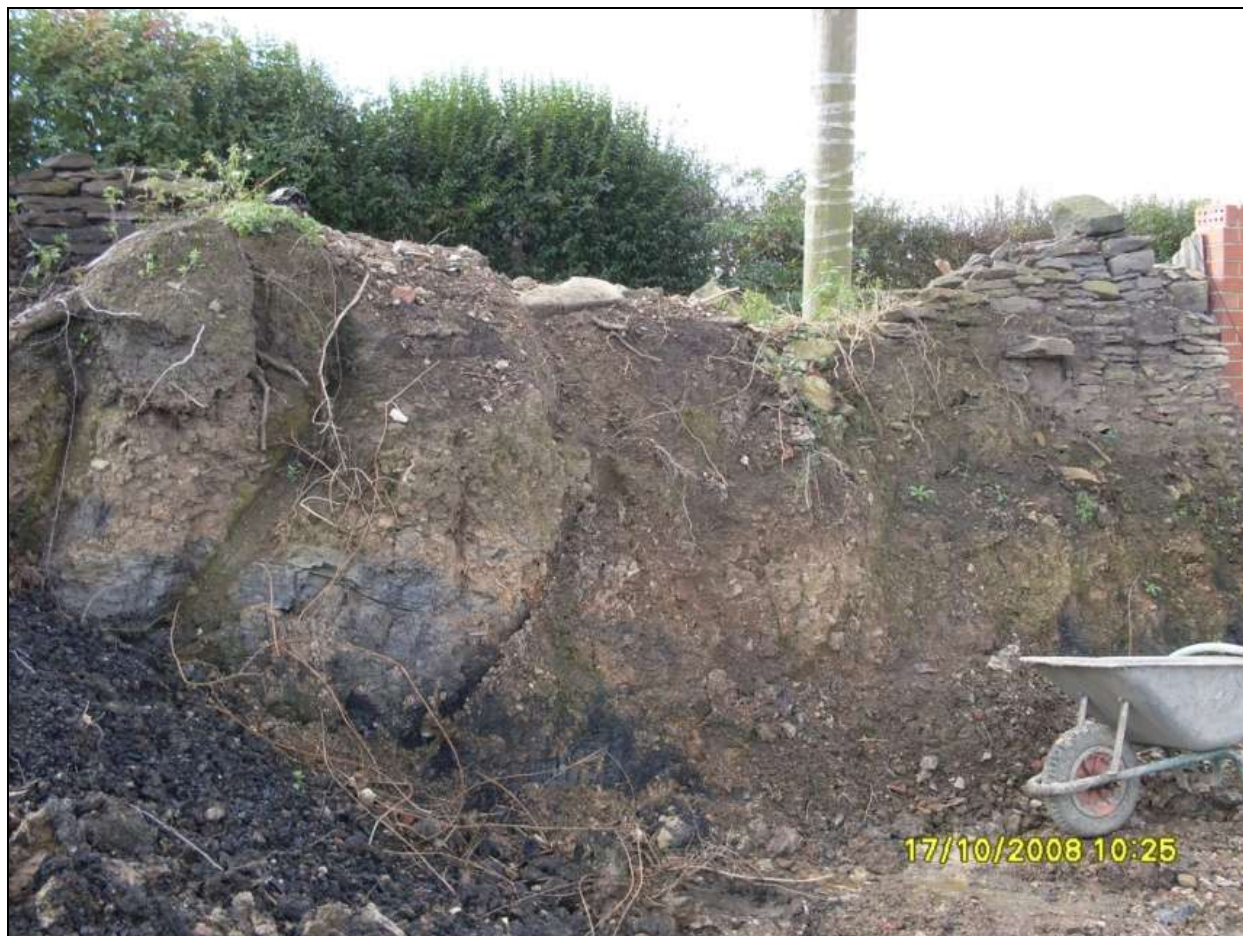
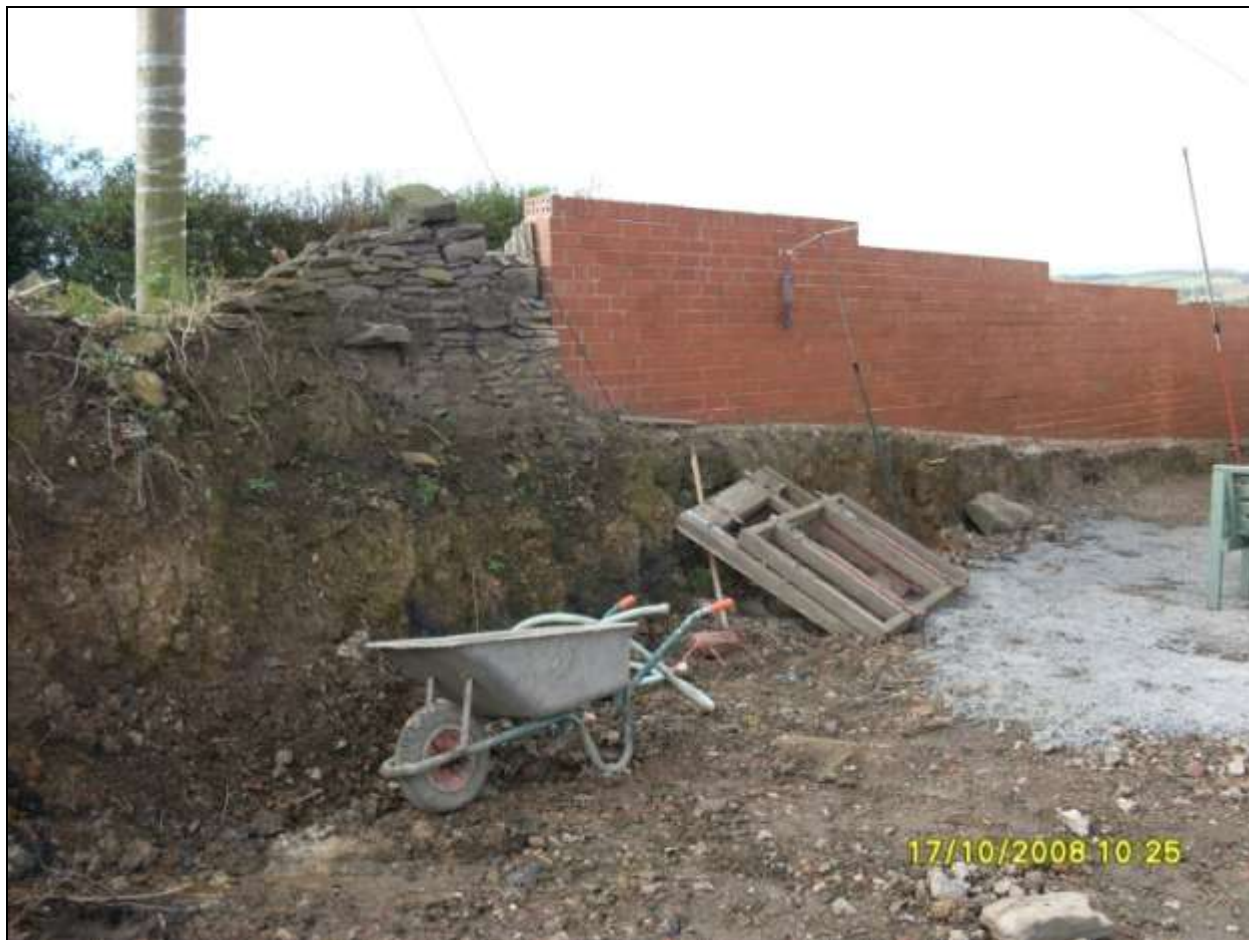
The coal layer has been observed to be intermittent as shown on the following photos.

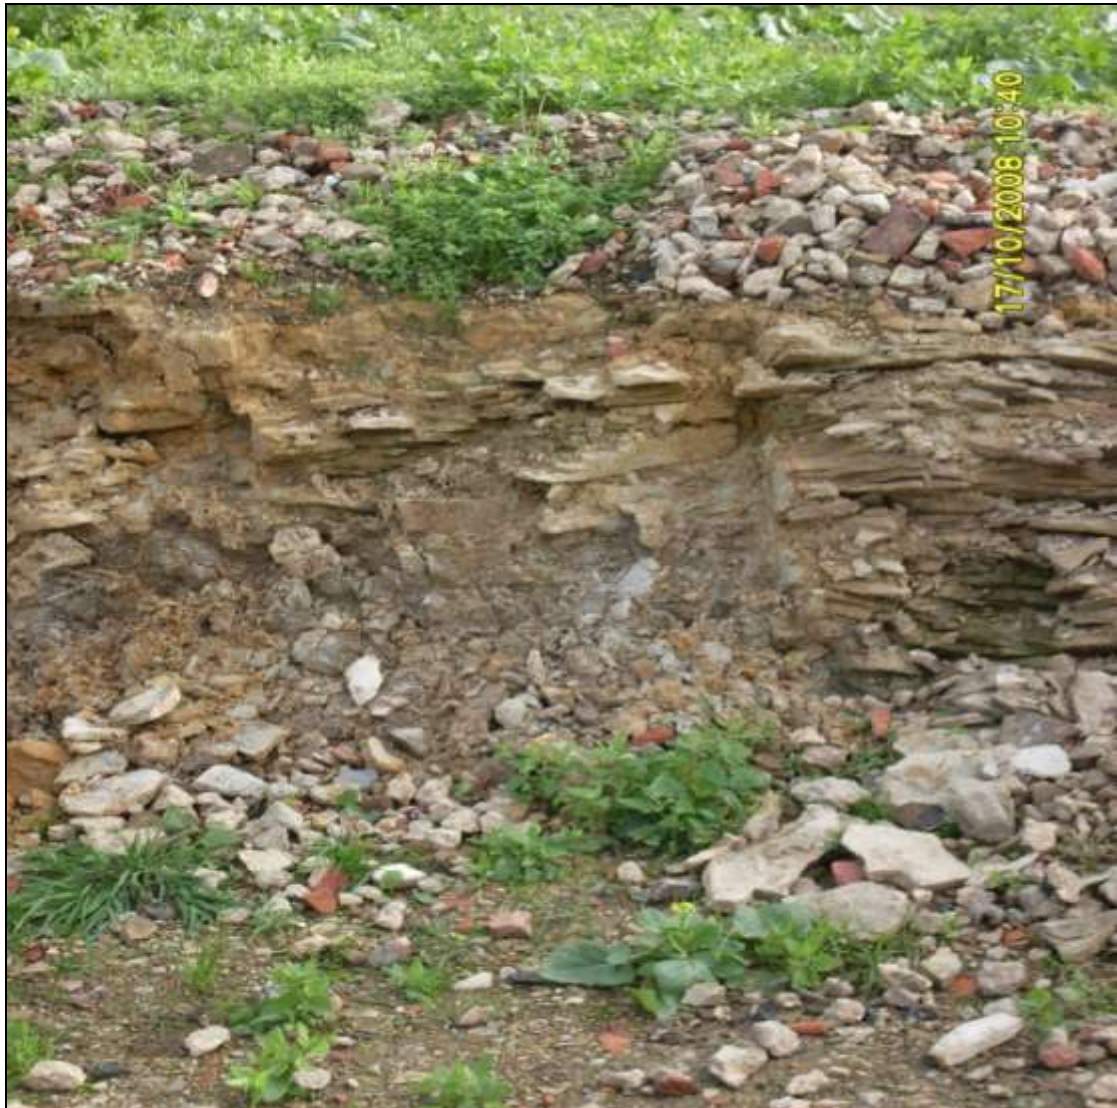
- *The road cutting* (not shown on site drawing). This cutting was excavated to permit vehicular access to the rear: the soil profile in this area did not show evidence of coal. This is believed to be the source of the topsoil material currently stockpiled behind the milking parlour (see above).

Photo 14: note absence of coal strata
