**PLACE DIRECTORATE**  
**South Yorkshire Mining Advisory Service**

**My Ref:** M734/1

**Subject:** MARTIN CROFT GARAGE SITE, SILKSTONE, BARNSELY S74 4JS.

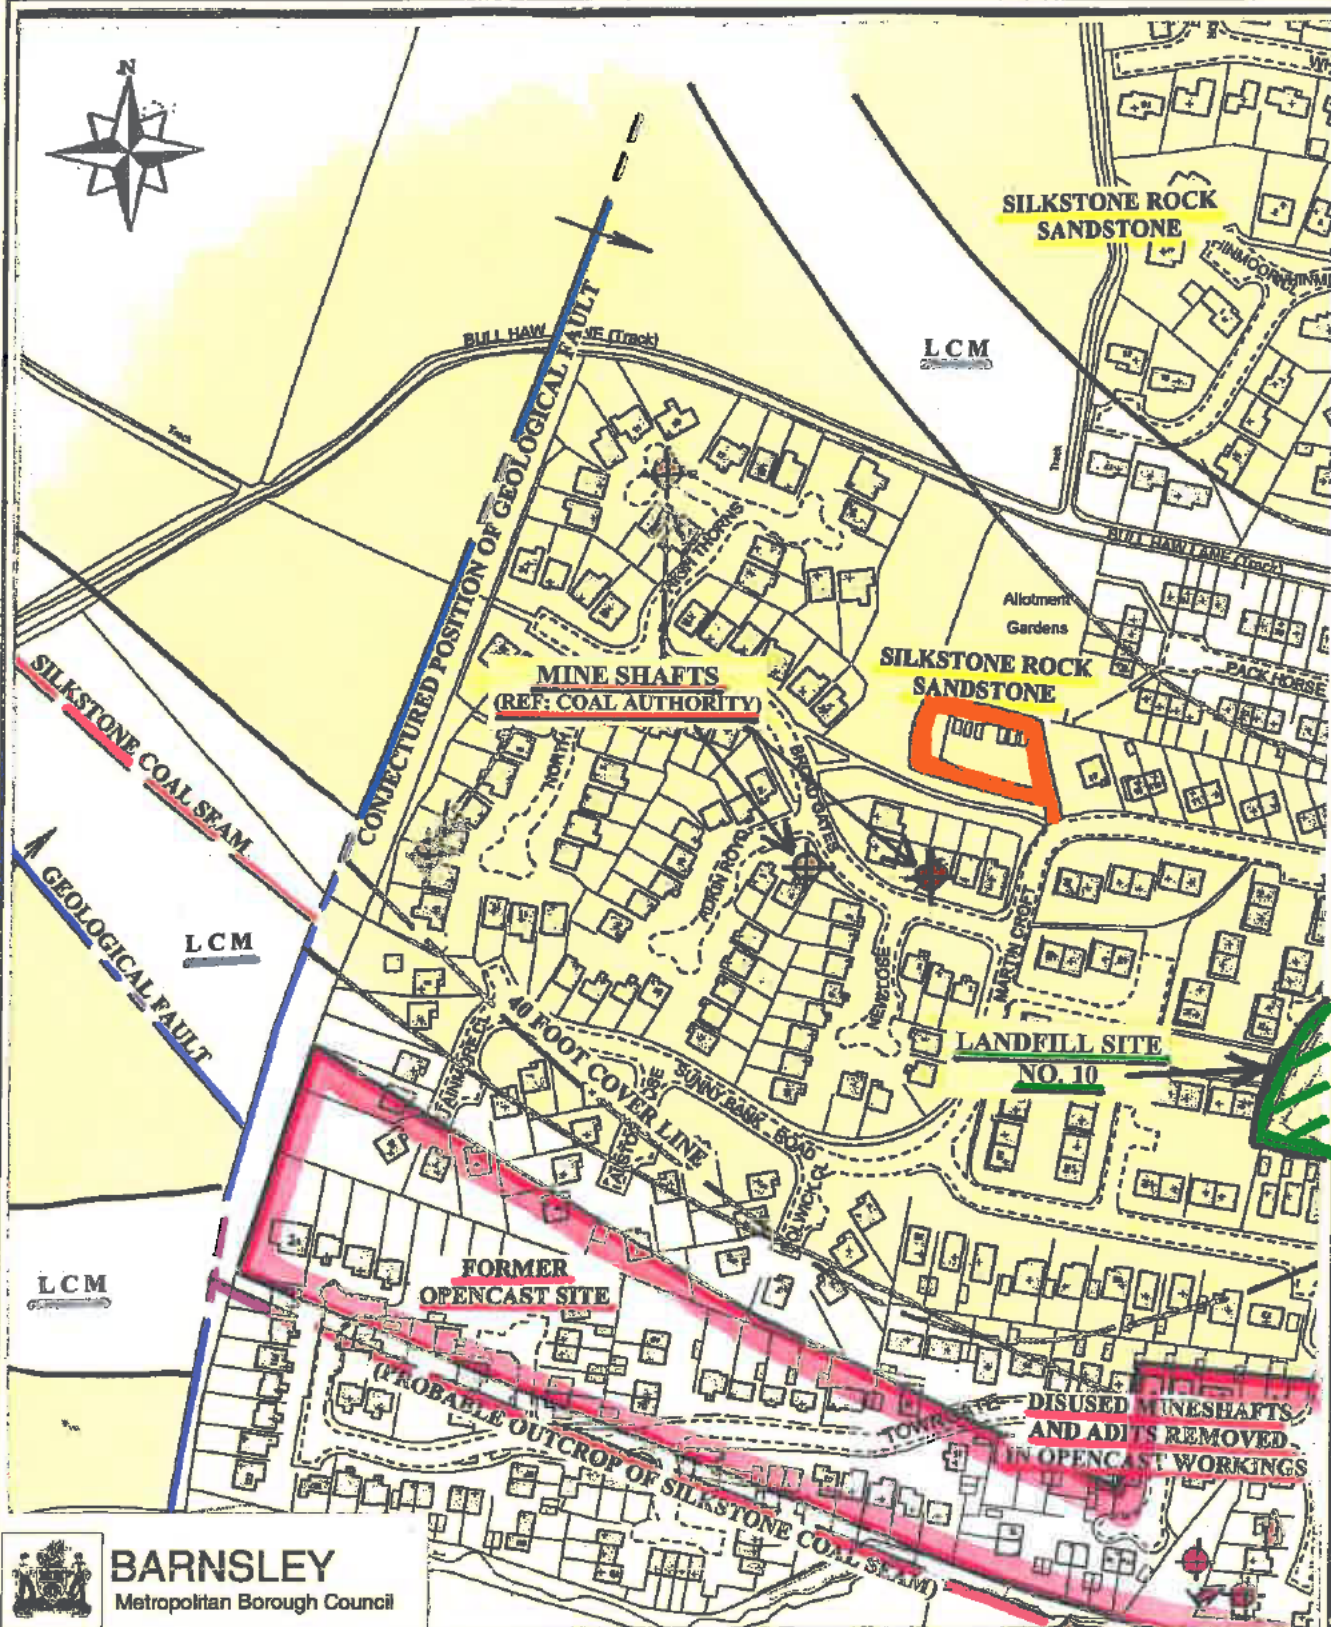
M734/1A

The site under consideration for future works or development is shown edged orange on the attached plan no. M734/1A.

The site is shown to be located on the Silkstone Rock Sandstone of the Lower Coal Measures as indicated on the above plan. The sandstone may contain fissures that could have been opened out by the past deep coal mining as detailed below.

The Silkstone Coal Seam (of around 1500mm thickness) is conjectured to outcrop some 250m away to the south-west as indicated on plan. Given the dip of the strata (around 1 in 10 to the north-east) and lay of the land, this coal is expected to be at depths of 25m or more beneath the site itself.

The past 'Sunnybank' Opencast coal operations during the 1950's are recorded some 190m away clear to the south-west, as shown on the attached plan.

None known within or in close proximity to the site. The closest (according to Coal Authority details) is shown around 27m away to the south, as indicated on plan. As such, a slight risk will exist for further unrecorded historic mine entries being present, particularly considering that a small quarrying operation occurred on part of the land (as detailed below).
