<b>* inc. architecture ltd</b>		the barn, mock hall farm, 63 leeds road, mirfield, wf14 6da, west yorkshire tel: 07831 275394, e-mail: mail@inc-architecture.co.uk, www.inc-architecture.com		© 2022	
project	HARRAL BUILDING, 32-38 ELDON STREET, BARNSLEY	status	PLANNING PERMISSION		
client	SIMON SANGHA	date	APRIL 2022	scale	1:50 @ A1
dwg title	PROPOSED REPAIR ELEVATIONS (SHEET 2)	dwg no.	132/P/204	rev.	
revision notes:

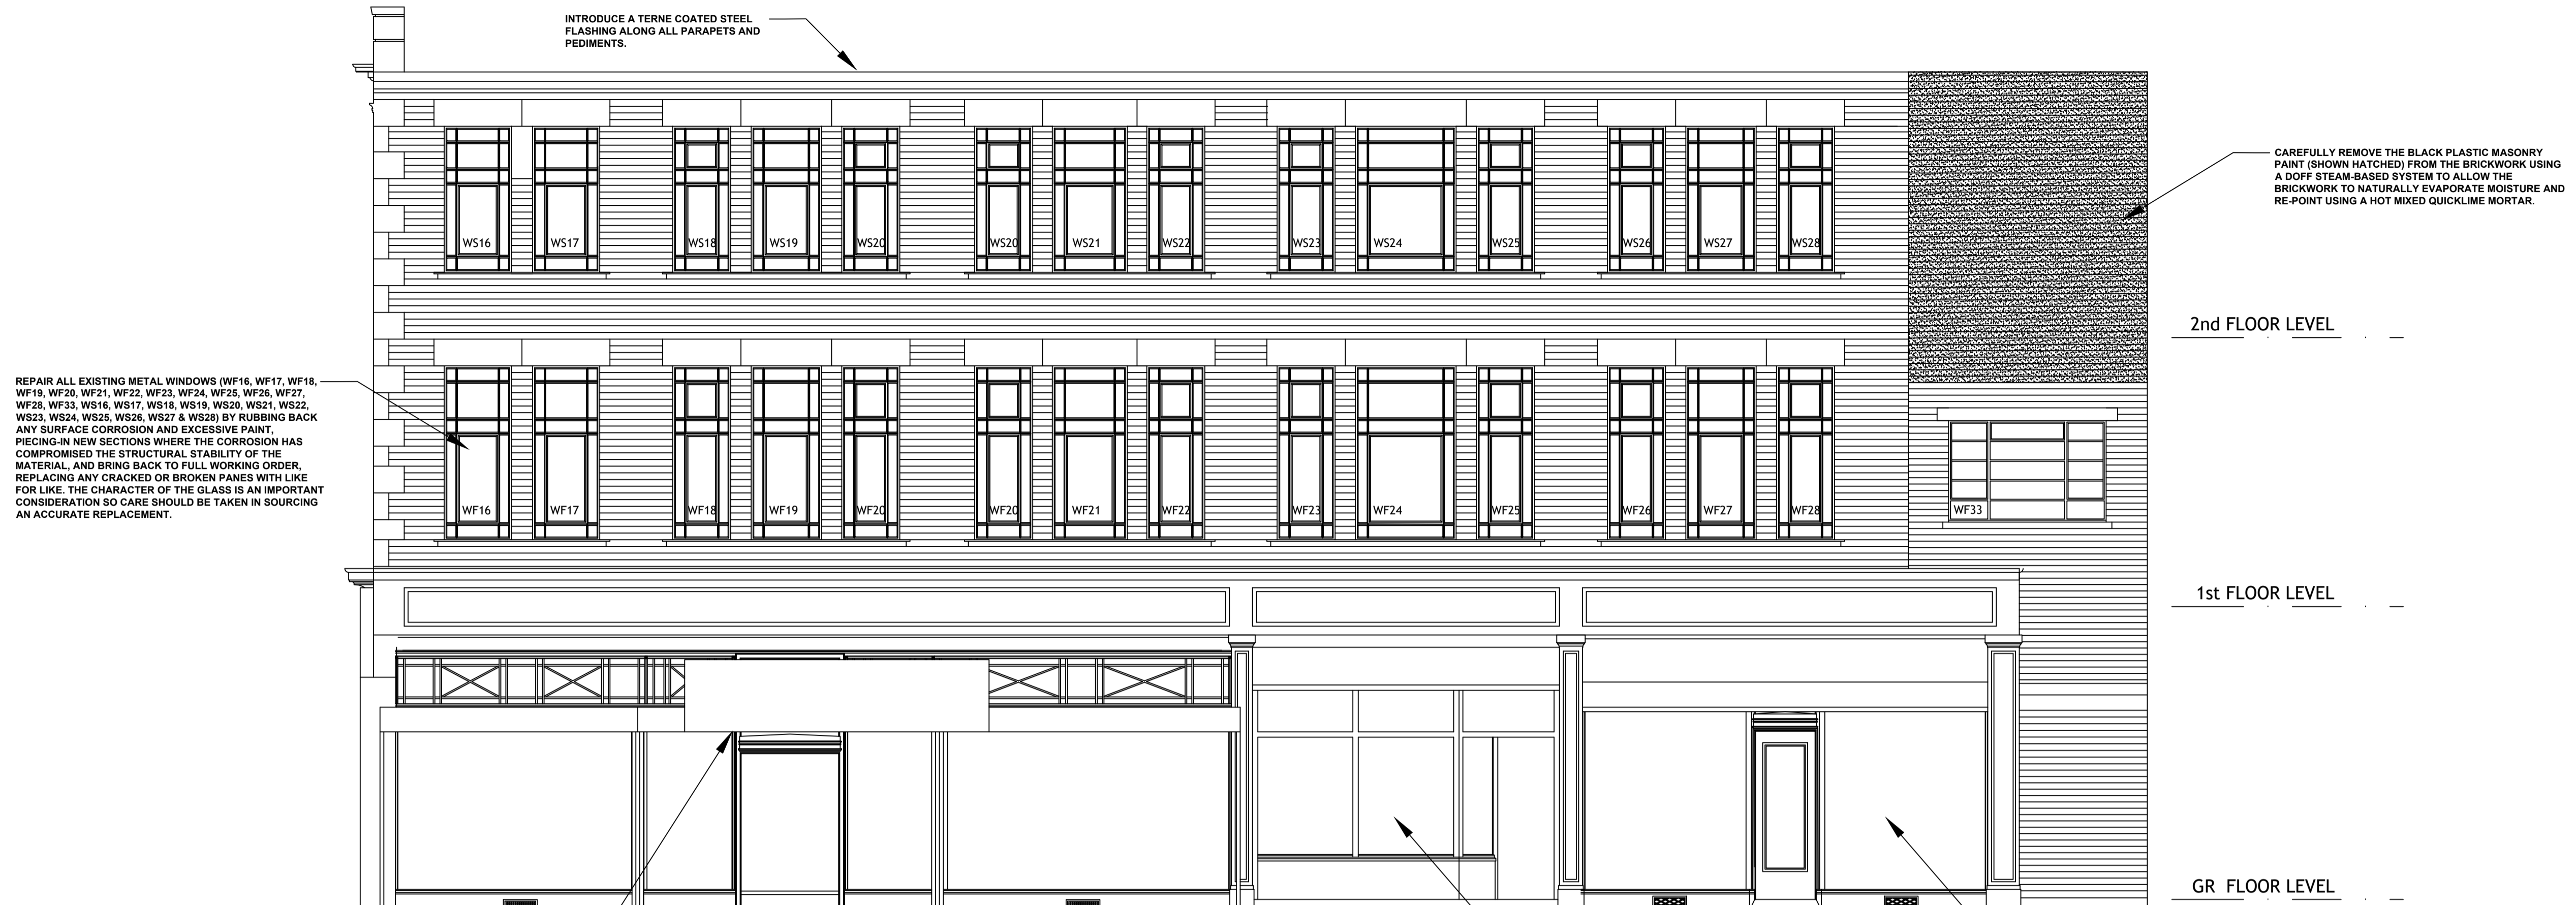
THE HISTORIC SHOPFRONT HAS RECENTLY BEEN MISTAKENLY REPLACED BY A MODERN PVC-U SHOPFRONT. CAREFULLY REMOVE THIS MODERN SHOPFRONT (INCLUDING DOOR, WINDOWS & SIGNAGE) AND DISPOSE OF OFF-SITE IN A RESPONSIBLE MANNER. REPLACE WITH A NEW 'HISTORICALLY REFERENTIAL' SHOPFRONT TO MATCH THE ADJOINING SHOPFRONT OF NO. 36-38 ELDON STREET IN LINE WITH THE ARCHITECT'S DETAIL AND SPECIFICATION.

STRIP THE GREEN BITUMEN BASED ROOFING FELT OFF THE LEAN-TO ROOF AND ITS UPSTAND AT THE ABUTMENT (THIS IS NOT CORRECTLY FLASHED INTO THE BRICKWORK AND IS ALLOWING RAINWATER INGRESS BEHIND THE UPSTAND). REPAIR OR REPLACE ANY ROTTEN ELEMENTS OF THE ROOF STRUCTURE (THE CONSERVATION ARCHITECT WILL DRAW UP A REPAIR SCHEDULE FOR THE ROOF ONCE THE ROOF COVERING HAS BEEN STRIPPED) AND RE-FINISH WITH BLUE/GREY NATURAL SLATE AND A TERNE COATED STEEL FLASHING ALONG THE RIDGE.

REPLACE THE ROTTEN TIMBER GUTTER WITH A BLACK PAINTED CAST IRON MOULDED GUTTER, HOPPER AND DOWNPIPE (WITH EARS) AND AN ANTI-SPLASH SHOE.

REPAIR THE DISLODGED BRICKS FORMING THE LINTEL TO WS33.

REPAIR THE CAST-IRON HOPPER AND DOWNPIPE (THIS HAS BEEN LEAKING FOR A SUBSTANTIAL TIME SO THE CORROSION IS LIKELY TO BE SEVERE IN PLACES). REPLACE ANY ELEMENTS OR SECTIONS BEYOND PRACTICAL REPAIR WITH LIKE FOR LIKE (BLACK PAINTED CAST IRON HOPPER, DOWNPIPE (WITH EARS) AND AN ANTI-SPLASH SHOE).

STRIP THE BITUMEN BASED ROOFING FELT OFF THE FLAT ROOF (THIS ROOF IS COVERED WITH A CARPET OF MOSS INDICATING LONG-TERM PONDING) AND REPAIR OR REPLACE ANY ROTTEN ELEMENTS OF THE SUBSTRATE (THE CONSERVATION ARCHITECT WILL DRAW UP A REPAIR SCHEDULE FOR THE ROOF ONCE THE ROOF COVERING HAS BEEN STRIPPED). INTRODUCE TAPERED FLAT ROOF INSULATION LAID TO FALL TOWARDS THE ARCADE AND FINISH WITH BLUE/GREY SINGLE PLY MEMBRANE (TO MATCH THE ADJOINING NATURAL SLATE).

REPAIR ALL EXISTING METAL WINDOWS (WF16, WF17, WF18, WF19, WF20, WF21, WF22, WF23, WF24, WF25, WF26, WF27, WF28, WS16, WS17, WS18, WS19, WS20, WS21, WS22, WS23, WS24, WS25, WS26, WS27 & WS28) BY RUBBING BACK ANY SURFACE CORROSION AND EXCESSIVE PAINT, PIECING-IN NEW SECTIONS WHERE THE CORROSION HAS COMPROMISED THE STRUCTURAL STABILITY OF THE MATERIAL, AND BRING BACK TO FULL WORKING ORDER, REPLACING ANY CRACKED OR BROKEN PANE WITH LIKE FOR LIKE. THE CHARACTER OF THE GLASS IS AN IMPORTANT CONSIDERATION SO CARE SHOULD BE TAKEN IN SOURCING AN ACCURATE REPLACEMENT.

CAREFULLY REMOVE THE SECURITY SHUTTERS, THEIR BOXES AND ALL GUIDE RAILS TO THE REAR OF 36-38 ELDON STREET SHOPFRONT ALONG WITH THE SIGNAGE AND DISPOSE OF OFF-SITE IN A RESPONSIBLE MANNER, RECYCLING WHEREVER POSSIBLE. TAKE CARE NOT TO DAMAGE THE HISTORIC SHOPFRONT IN THE PROCESS.

CAREFULLY REMOVE THE MODERN SHOPFRONT (INCLUDING DOOR, WINDOWS & SIGNAGE) AND DISPOSE OF OFF-SITE IN A RESPONSIBLE MANNER. REPLACE WITH A NEW 'HISTORICALLY REFERENTIAL' SHOPFRONT TO MATCH THE ADJOINING SHOPFRONT OF NO. 36-38 ELDON STREET IN LINE WITH THE ARCHITECT'S DETAIL AND SPECIFICATION.

REPLACE THE WHITE PLASTIC HOPPER AND DOWNPIPE WITH A CAST-IRON HOPPER, DOWNPIPE (WITH EARS) AND A SHOE.

REPAIR ALL EXISTING METAL WINDOWS (WF29, WF30, WF31, WF32, WS29, WS30, WS31 & WS32) BY RUBBING BACK ANY SURFACE CORROSION AND EXCESSIVE PAINT, PIECING-IN NEW SECTIONS WHERE THE CORROSION HAS COMPROMISED THE STRUCTURAL STABILITY OF THE MATERIAL, AND BRING BACK TO FULL WORKING ORDER, REPLACING ANY CRACKED OR BROKEN PANE WITH LIKE FOR LIKE. THE CHARACTER OF THE GLASS IS AN IMPORTANT CONSIDERATION SO CARE SHOULD BE TAKEN IN SOURCING AN ACCURATE REPLACEMENT. RUB BACK ANY SURFACE CORROSION TO THE SECURITY GRILLES, PRIME ANY BARE METAL WITH RED OXIDE PRIMER AND RE-DECORATE WITH BLACK LIMESEED OIL OR GLOSS PAINT.

INTRODUCE A TERNE COATED STEEL FLASHING ALONG ALL PARAPETS AND PEDIMENTS.

REMOVE THE CONCRETE PAN TILES. REPAIR OR REPLACE ANY ROTTEN ELEMENTS OF THE ROOF STRUCTURE (THE CONSERVATION ARCHITECT WILL DRAW UP A REPAIR SCHEDULE FOR THE ROOF ONCE THE PAN TILES HAVE BEEN STRIPPED) AND RE-FINISH WITH BLUE/GREY NATURAL SLATE AND BLUE-TERRACOTTA RIDGE-TILES BEDDED ON LIME MORTAR.

REPAIR EXISTING TIMBER WINDOWS (WS33 & WS34) BY CUTTING BACK ANY ROT TO SOUND TIMBER AND SPLICING IN NEW SECTIONS (PAYING PARTICULAR ATTENTION TO LOWER RAILS AND CILLS), RUB BACK ANY EXCESSIVE PAINT AND BRING THE OPENING CASEMENTS AND SASHES BACK TO FULL WORKING ORDER, REPLACING ANY MISSING CORDS AND CRACKED OR BROKEN PANE WITH LIKE FOR LIKE. THE CHARACTER OF THE GLASS IS AN IMPORTANT CONSIDERATION SO CARE SHOULD BE TAKEN IN SOURCING AN ACCURATE REPLACEMENT. RUB BACK ANY SURFACE CORROSION TO THE SECURITY GRILLES, PRIME ANY BARE METAL WITH RED OXIDE PRIMER AND RE-DECORATE WITH BLACK LIMESEED OIL OR GLOSS PAINT.

CAREFULLY REMOVE THE BLACK PLASTIC MASONRY PAINT (SHOWN HATCHED) FROM THE BRICKWORK USING A DOFF STEAM-BASED SYSTEM TO ALLOW THE BRICKWORK TO NATURALLY EVAPORATE MOISTURE AND RE-POINT USING A HOT MIXED QUICKLIME MORTAR.
