*Arboricultural report*

***Fontenay Barracks***

***Fontenay Barracks, Wakefield Road, Barnsley, S71 1NU***

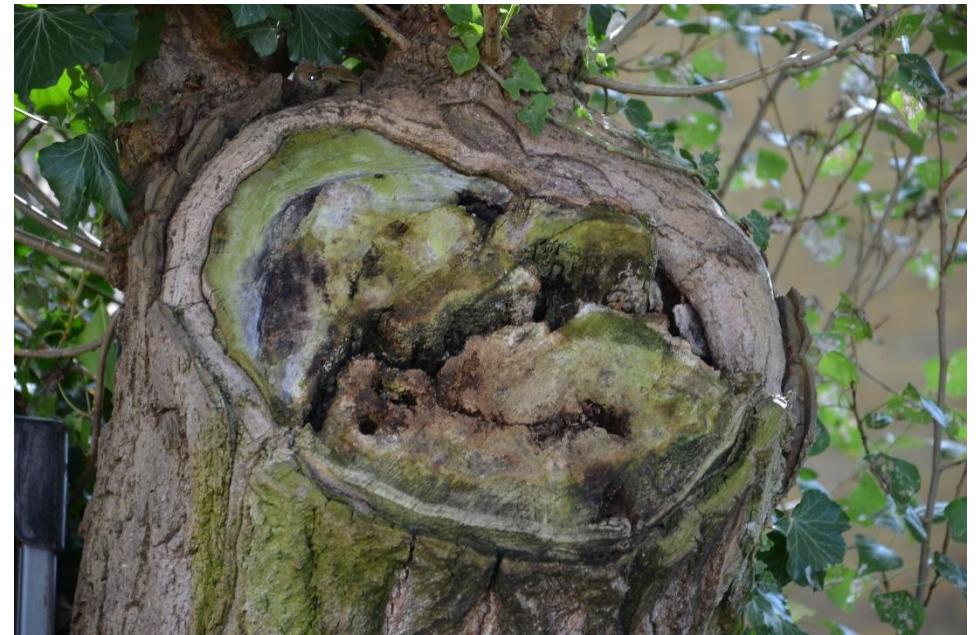
| T9 | Mature/Over mature.<br><br>Manchester Poplar<br><br>Populus nigra species | 17m | 6m | 68cm | <table><tr><td></td><td>7</td><td></td></tr><tr><td>5</td><td></td><td>7</td></tr><tr><td></td><td>8</td><td></td></tr></table> | | 7 | | 5 | | 7 | | 8 | | The tree leans towards the adjacent properties and has previously had limbs removed. Limb to Northern side has decay extending into trunk, limb to Southern aspect has a clear split developing and extending into trunk | This is one of the trees of most concern. Prune to remove overhang from boundary. | Poor<br><br>Poor | 20yr | B |

Photo to left showing split and decay extending into trunk to Southern aspect of T9

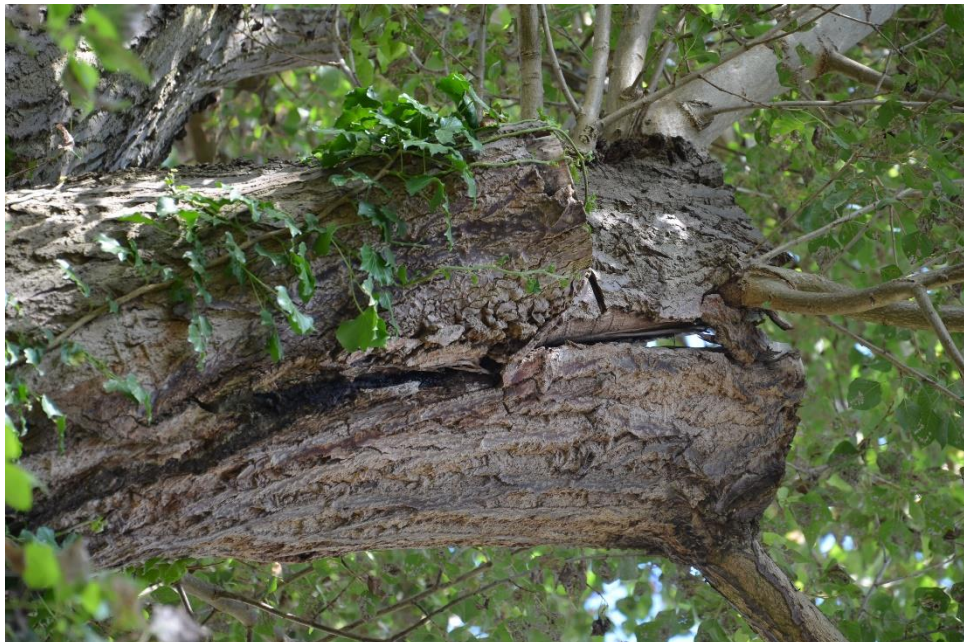
Photo to right shows decay developing in T9 to Northern aspect

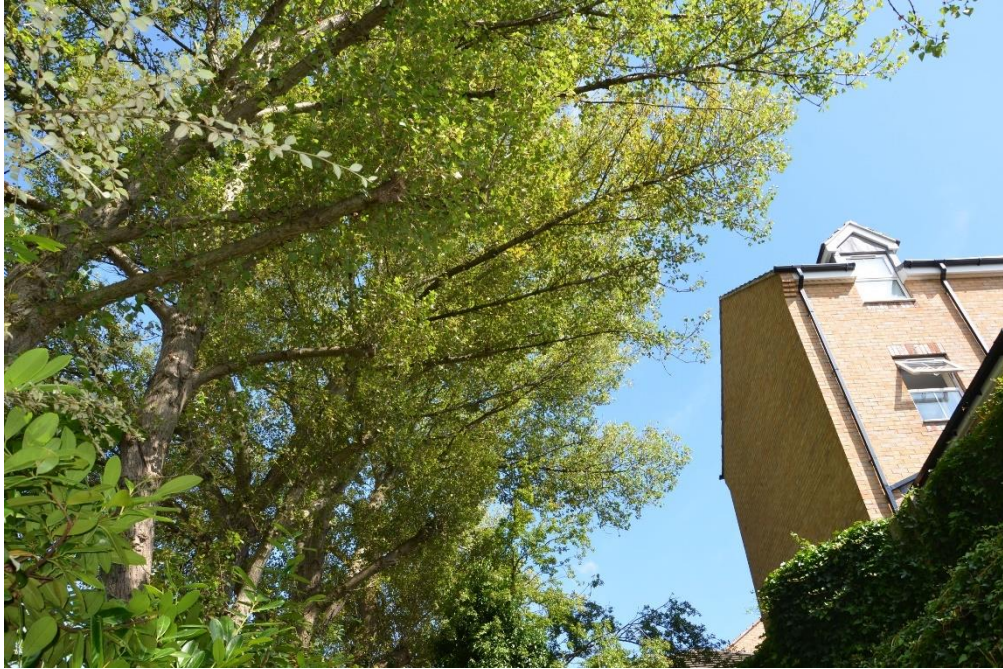
Photo above showing overhang to boundary of trees from T/A centre towards properties on High Greave looking East from Wakefield road

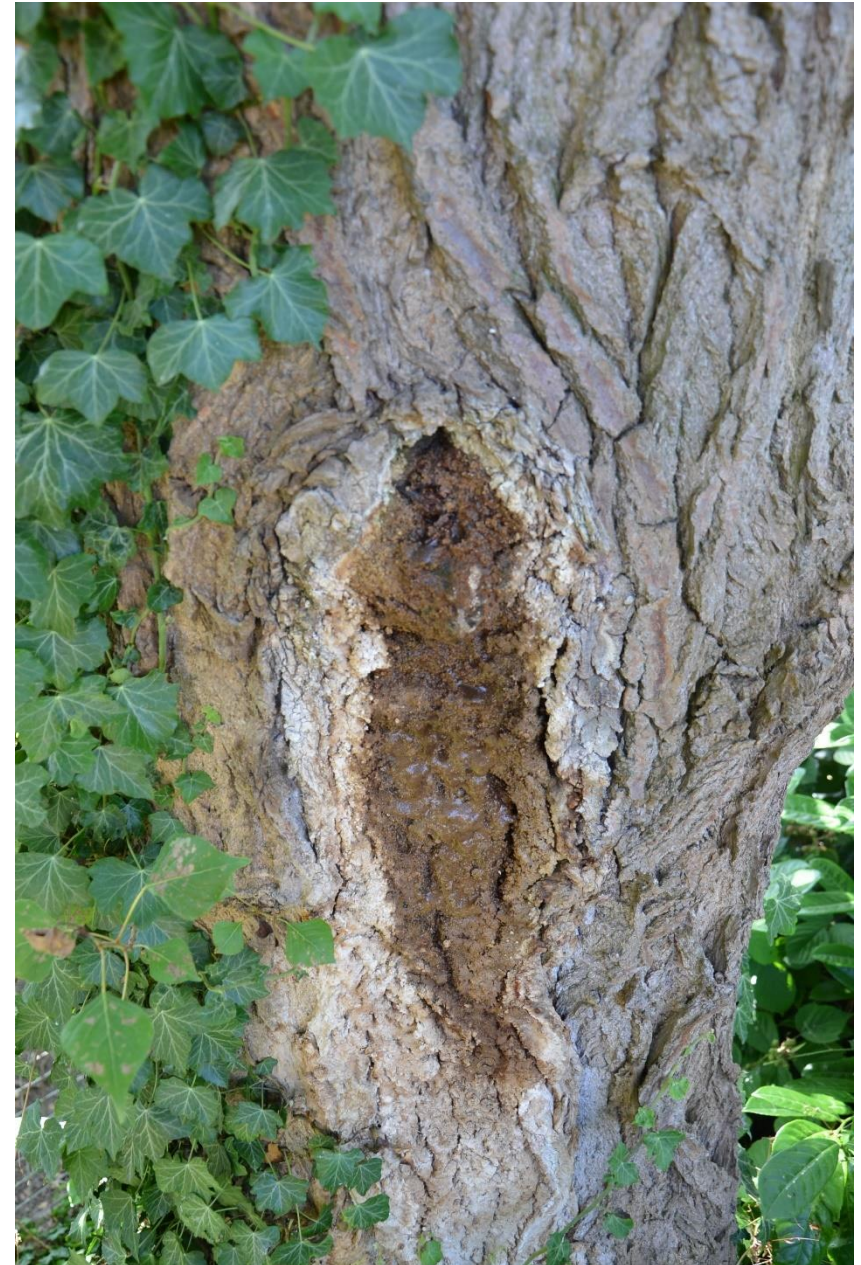
| T8 | Mature/Over mature.<br><br>Manchester Poplar<br><br>Populus nigra species | 18m | 7m | 53cm | <table><tr><td></td><td>7</td><td></td></tr><tr><td>7</td><td></td><td>7</td></tr><tr><td></td><td>8</td><td></td></tr></table> | | 7 | | 7 | | 7 | | 8 | | Along with T9 this is one of the largest trees in the row. Tree has 5 main limbs in the crown, extending over the boundary to the neighbouring gardens. There is slime flux exuding from a wound at 1.5 metres from the base of the tree. | This is one of the trees of most concern.<br>Remove tree to ground level.<br>Replant with Fastigate Oak to ensure continuity of screening. | Poor<br><br>Poor | 20yr | U |

Photo to right shows slime flux exuding from wound on T8

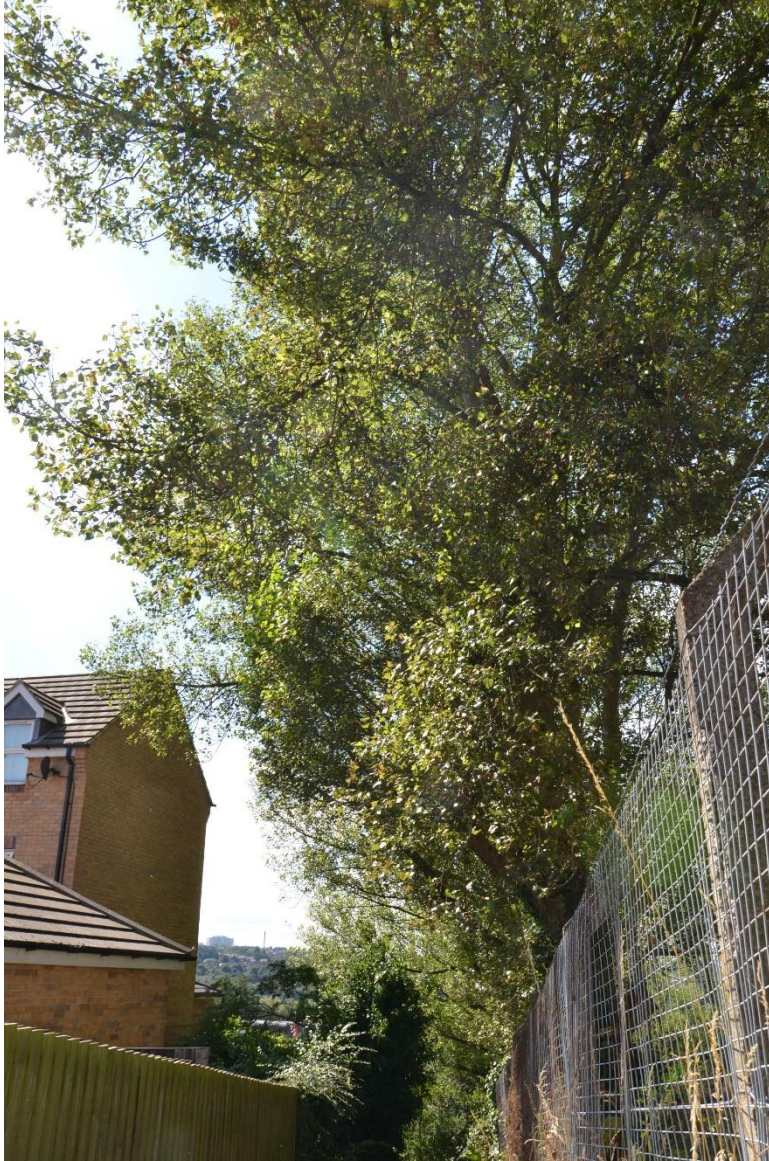
Photo looking west from footpath down to Wakefield road, showing overhang and proximity to properties on High Greave,
