National
Trust

Wentworth Castle Gardens Gun Room Roof Condition Survey

Prepared by: David Rankine
Date : 28th March 2025

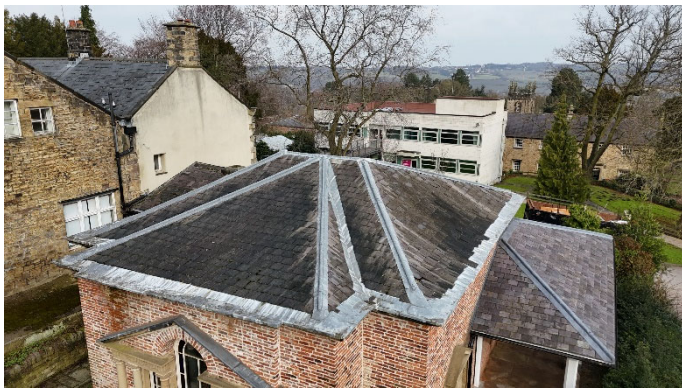
The below images show general views of the roof prior to the 2025 holding repair scheme commencing. Loose slates can be seen along the eaves of the south and east facing roof slopes and in isolated areas of the west and north slopes. In addition, flashings provided to the hips and chimney have slipped and become loose through loss of pointing in the brickwork.

West facing roof pitch

It is recommended that the roof coverings are removed and replaced with improved detailing. The higher quality Welsh slate roof coverings should be retained for reuse where possible. The new detailing should include counter battening to provide ventilation to the roof void and larger head laps to the slates. All leadwork should be replaced with new, appropriately sized sheets jointed and secured to LSTA approved details.

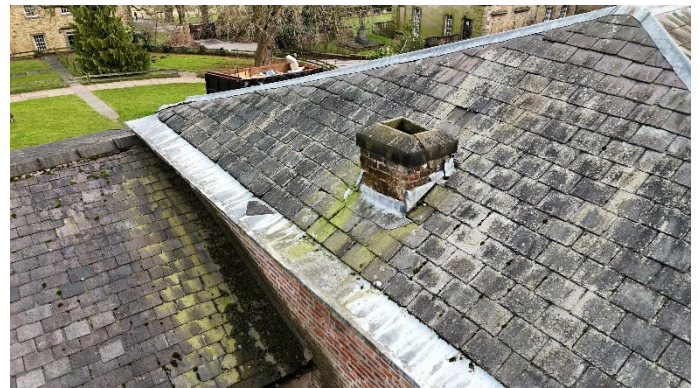
North facing roof pitch

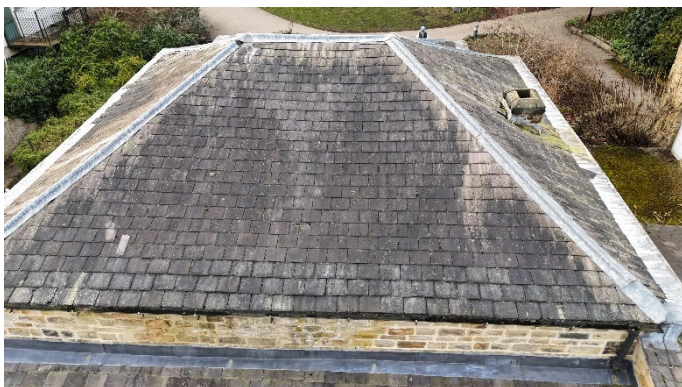
East facing roof pitch

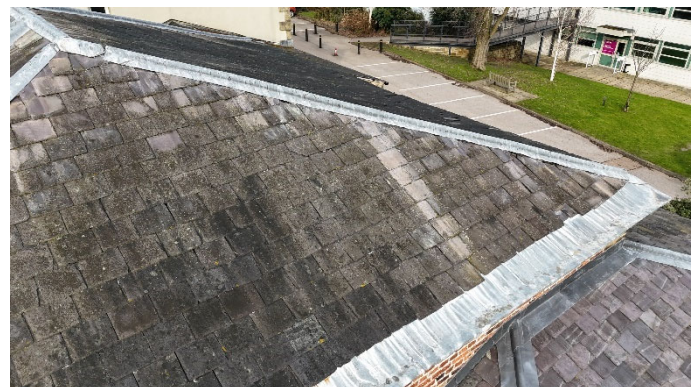
South facing roof pitch

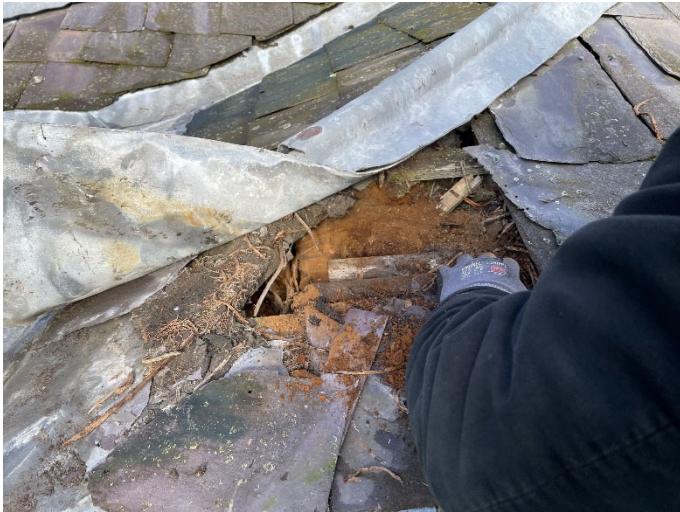
Severely decayed wall plate ends to the southwest corner

It is recommended that a structural assessment is undertaken following the removal of all roof coverings to ascertain the extent of timber replacement required. It is anticipated that around a third of the timbers require splice repairs or replacement.

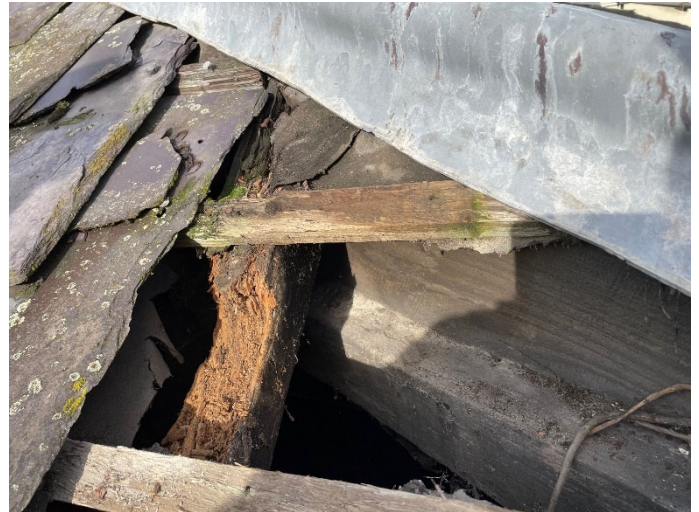
The roof slopes to the north, west and south facing slopes comprise good quality Welsh slate, with samples measured at 7-8mm thick and 270 x 520mm in width and length. The east facing pitch has been covered with a thinner replacement, possibly Spanish slate, around 4-5mm in thickness. The head lap provided to the slates is 75mm. Whilst this may have been appropriate when the roof was originally constructed, it is likely to be insufficient to cope with the more frequent, heavier driven downpours resulting from climate change. Potentially linked to this, a large proportion of the battens lower down the roof slopes are decayed and failing, resulting in further water ingress. In addition, a bitumen underfelt is provided, however this has perished and fallen away in places, no longer providing a secondary barrier to rainwater penetration.

Decayed rafter and roof laths and perished underfelt to southeast corner

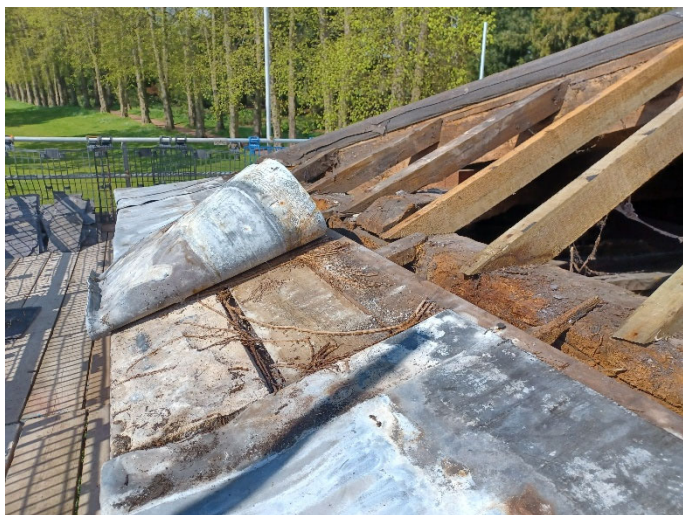
Lead flashings to the ridge, hips and stone cornice are poorly detailed. Sheets are generally longer than recommended in current standards and are simply lapped, allowing driven or standing water to penetrate the joints between sheets, affecting both the roof structure and wall heads. Underside corrosion was noted to the apron flashings to the stone cornice.

Simple lap detail and underside corrosion on the apron flashing to the stone cornice

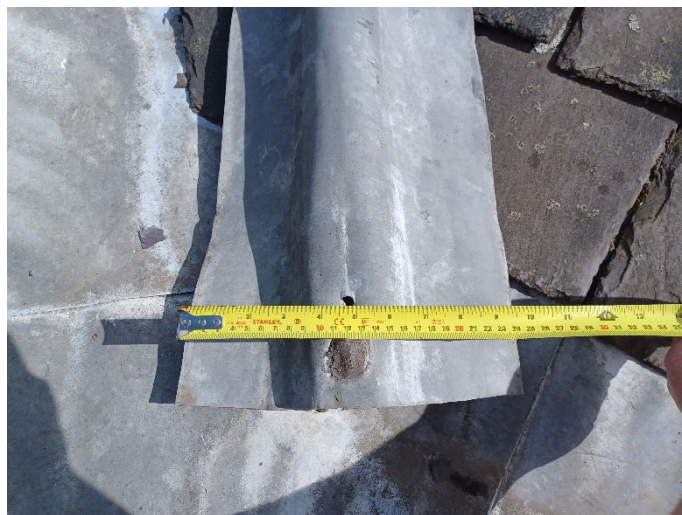
Laps provided to the slate coverings are also inadequate, providing further opportunity for water ingress. Flashings have been secured in place with clout nails and screws fixed directly through the lead sheet. On the hips the lead has torn around the fixings and left gaps at the head of the sheet as well as openings around the fixings. The valleys could not be fully investigated as part of the survey, however it is envisaged that similar detailing issues exist, which is supported by partial loss of the ceiling beneath the valley on the northwest corner of the building.

Extent of cover from hip flashings together with tear from mechanical fixing through the top of the sheet

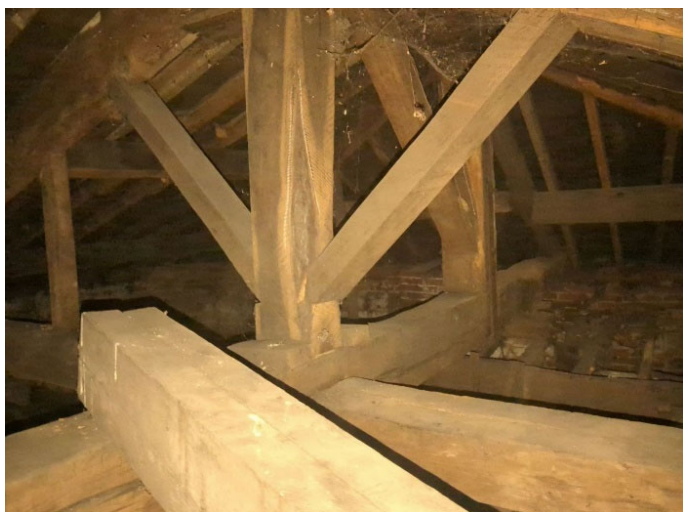
General view from northwest corner of roof void looking diagonally across at the back of the east and south facing roof pitches prior to opening up

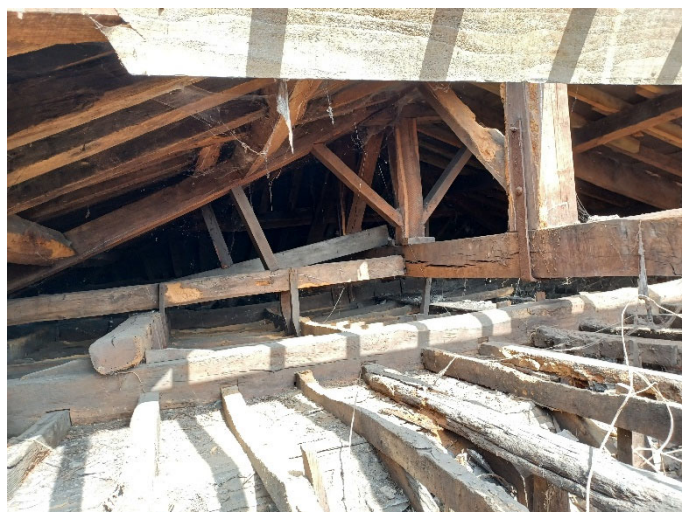
View of roof structure through the south roof slope following removal of roof coverings

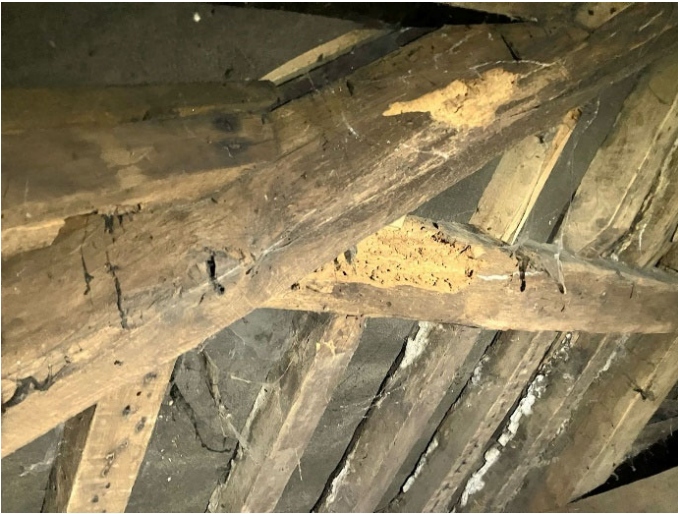
There is evidence of water ingress on all sides of the roof, with associated decay and wood boring insect activity noted on the oak roof components at lower levels, including to sprockets, wall plates, dragon beams, purlins, hip rafter ends and common rafters. The volume of frass and number of flight holes observed suggests that the environment within the roof void has supported insect activity for a long period of time. The size of flight holes noted during the survey varies, from 1-2mm to 4-5mm. The larger flight holes suggest the presence of deathwatch beetle.

Insect activity and water staining to the hip rafter and purlin on the northwest corner

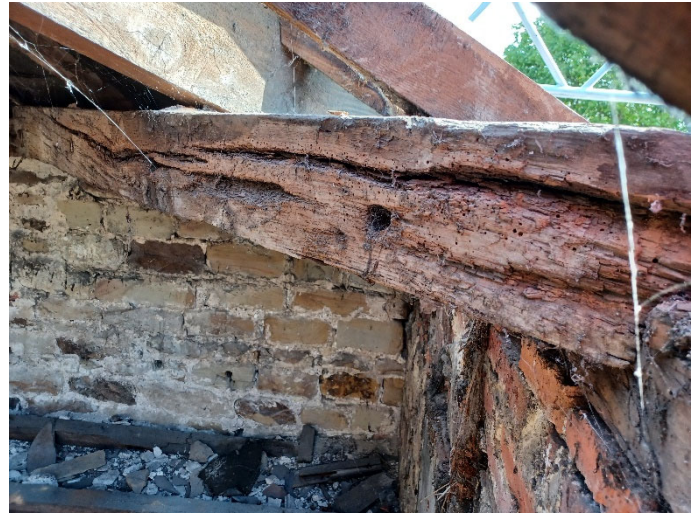
Flight holes in the dragon beam tie to the southeast corner

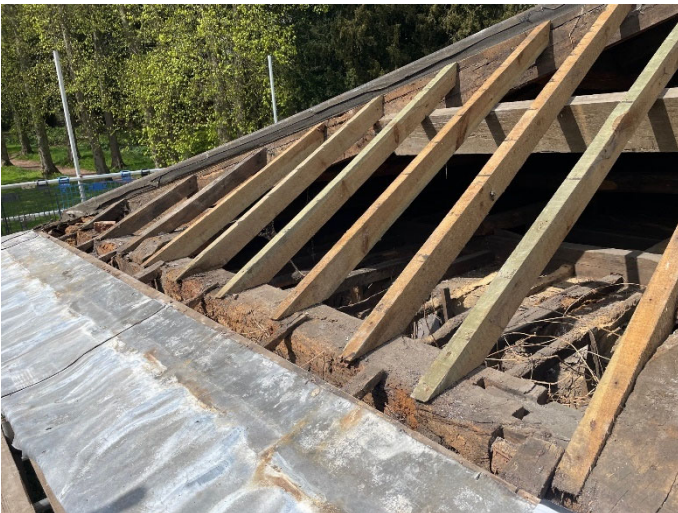
On the south elevation the central principal rafter to the girder truss, one half of the purlin and seven common rafters have been replaced with softwood timbers, possibly during the 2007 repair scheme. The new timbers are smaller in section than the originals and the connection detail between the new principal rafter and purlins is of poor quality. A short length of 50 x 50mm softwood is stitched into the side of the rafter to receive the end of the original purlin, which has been notched with less than 1/3 the depth of the purlin supported.

Replacement rafters and purlin provided to the west end of the south elevation and detail of

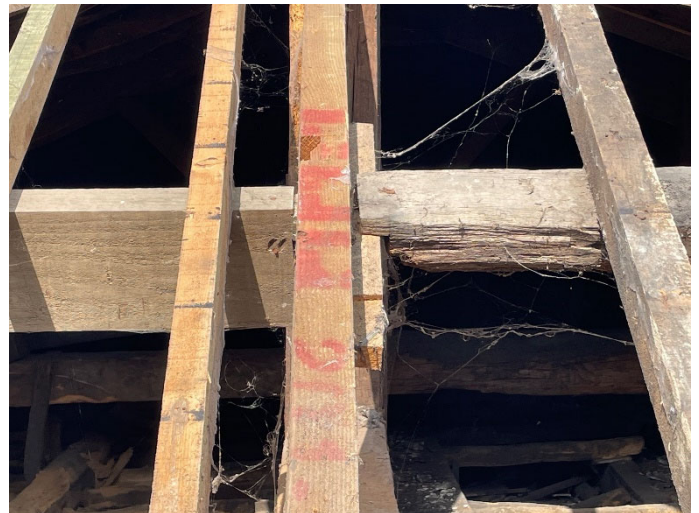
Connection detail between the original purlin and new principal rafter

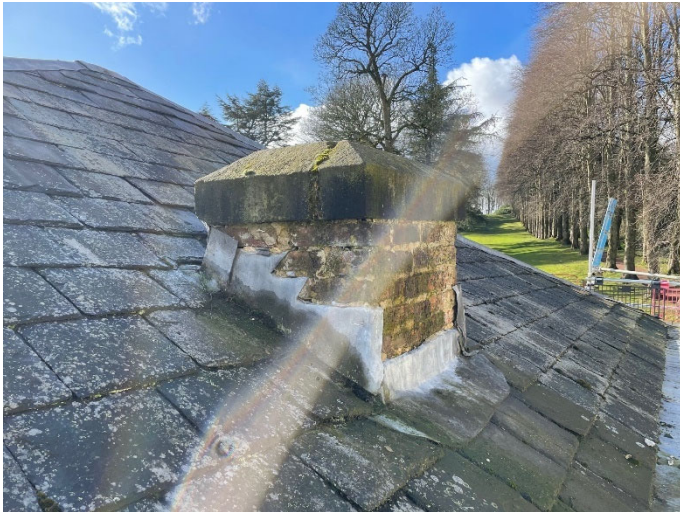
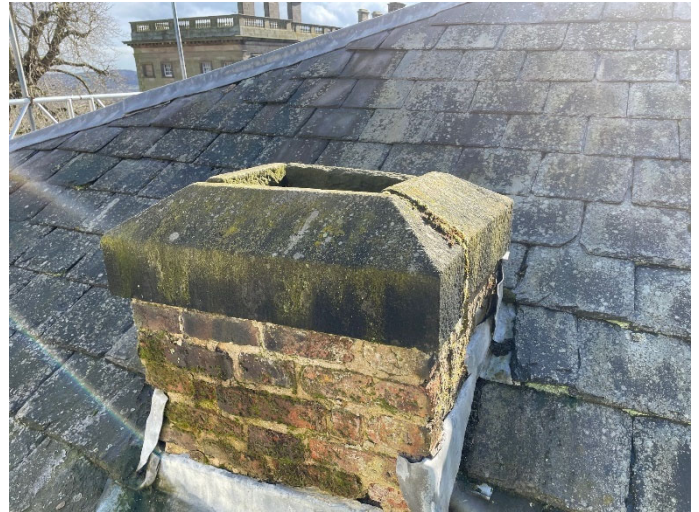
The chimney provided to the north roof slope is uncapped, with pointing in poor condition and flashings displaced. It is recommended that a stone cap is introduced on stone pedestals to prevent water ingress and maintain ventilation through the stack. The stack should also be repointed and flashing re-fixed or replaced as necessary.

General view of chimney

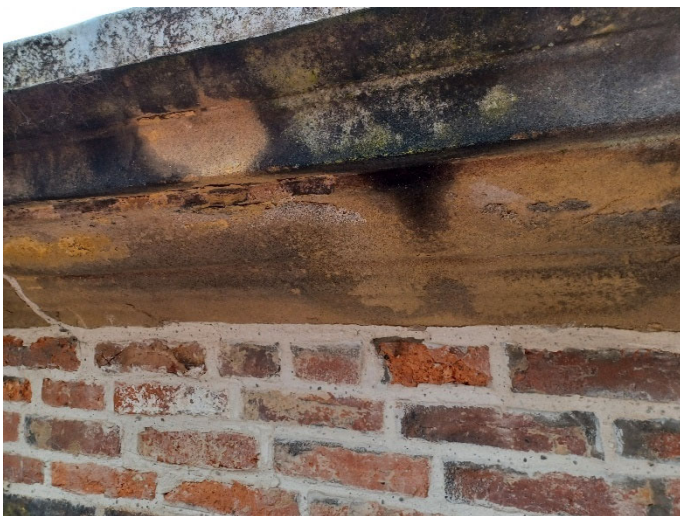
The sandstone cornice has been subject to significant moisture resulting in vegetation growth in some areas and the loss of detail. One cornice stone has tipped forward out of position at some stage and has been repointed in this position.

Ongoing delamination to the cornice on the north elevation

In addition to the provision of adequate flashings, it is recommended that where loose material is present on the face of the stonework this is lightly brushed away to promote air movement and assist in drying the stone. Consideration should also be given to replacing the iron cramps with stainless steel equivalents to ensure long term stability in the cornice.

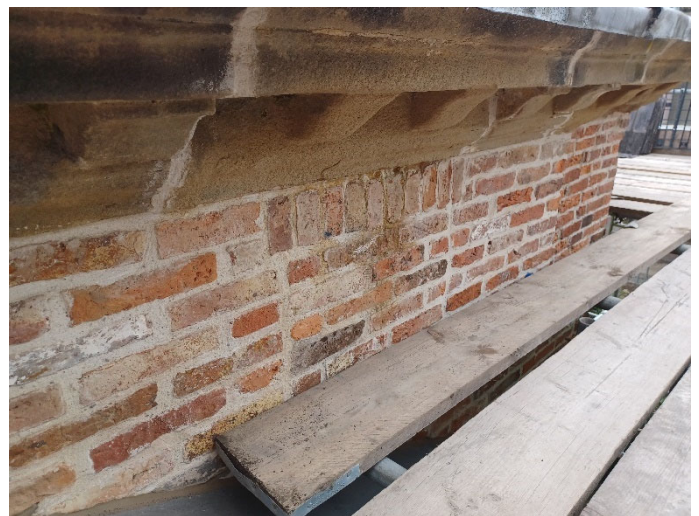
Loss of detail observed on the west elevation

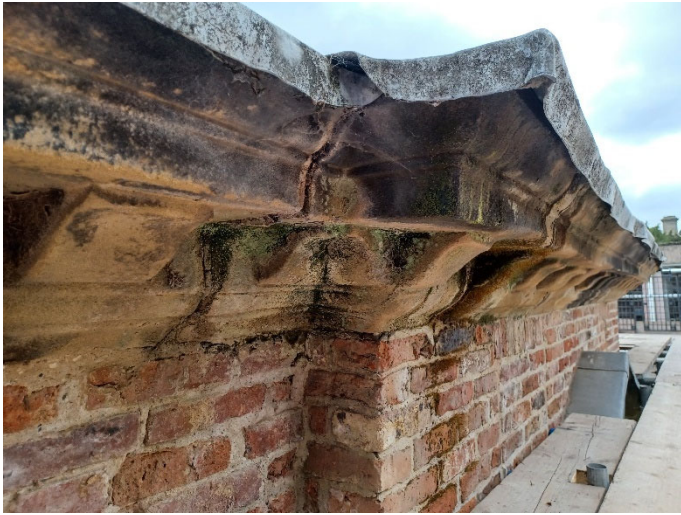
Water staining and vegetation growth on the west elevation

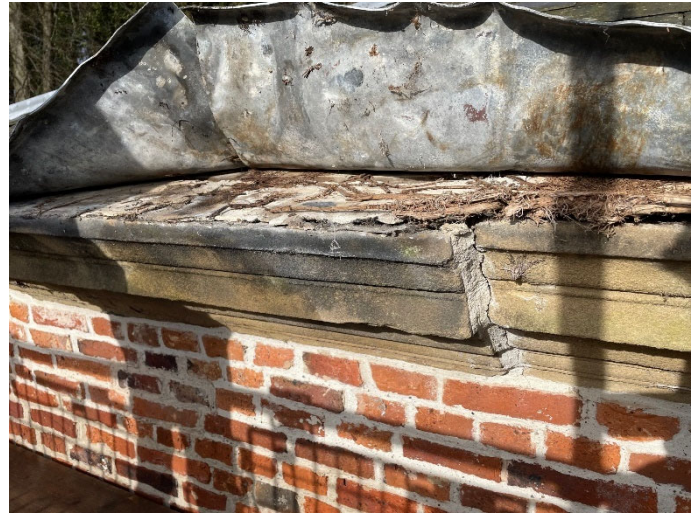
Displaced cornice stone and dead ivy growth beneath the lead apron

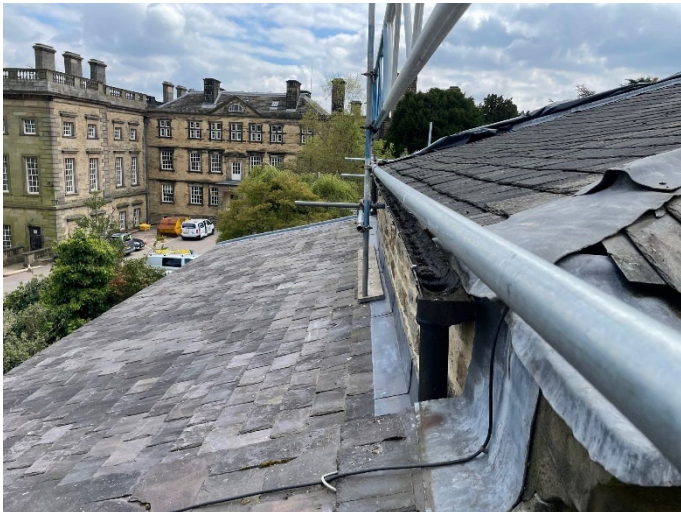
Round profiled cast iron rainwater goods provided to the east elevation are clear of debris and standing water and there is no evidence of staining indicating they are not performing, though it was not raining immediately prior to or during the survey.

View of the gutter from the north side

Rainwater goods are not provided to the other elevations. Considering the impact of climate change and the low-level damp issues noted within the building, it is recommended that a gutter is provided. The precise detailing will need to be carefully considered to ensure the aesthetic of the building is not significantly harmed.

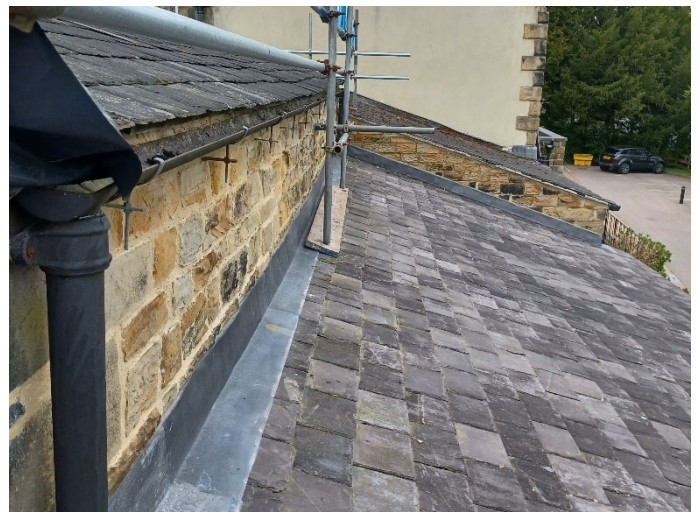
View of gutter from the south side

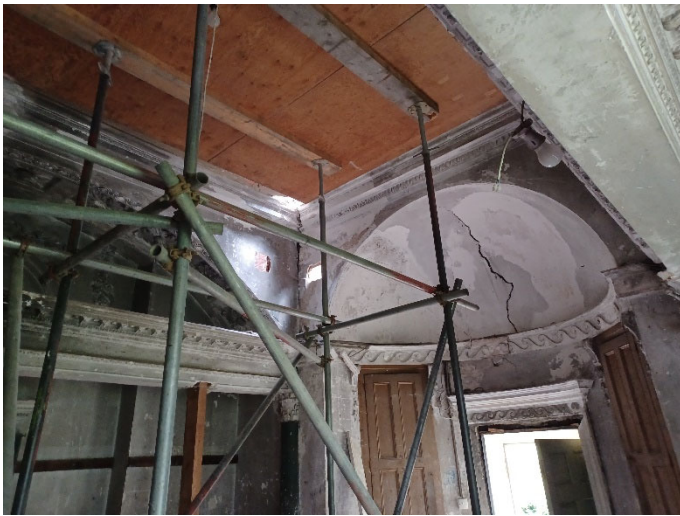
Room G1 is the principal room in the building and features a venetian window to the west elevation and opposing apses in the south and north ends of the room. A central scaffold has been installed to support the flat section of the main ceiling. Where unsupported, including to the decorative cornice and arched bay window, sections of the plasterwork have fallen away. The debris on the floor shows that the plaster had a good key with the lath, however the laths themselves have failed due to extensive insect attack and decay.

View of ceiling and supporting scaffold structure in G1

It is recommended that a specialist conservation report is commissioned to identify an appropriate remediation strategy to retain as much of the original fabric as possible, however a new ceiling structure is required. This will need to be executed from above and should be co-ordinated with the roofing work to ensure adequate access. Given the nature of these works, a fully covered scaffold should be provided.

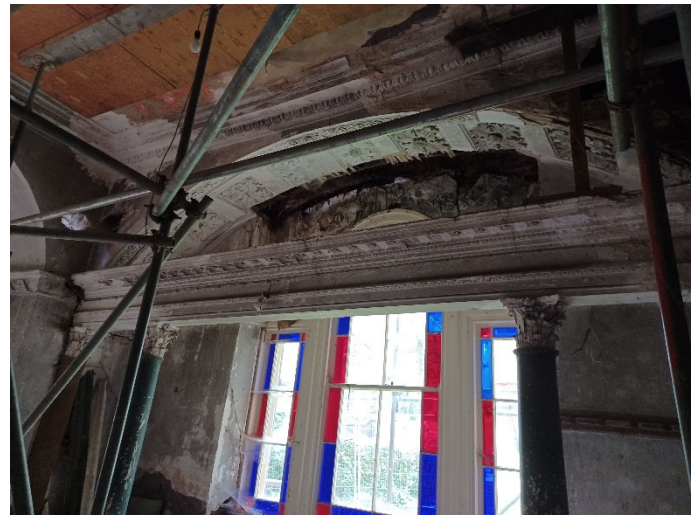
Central section of ceiling lost in the bay window

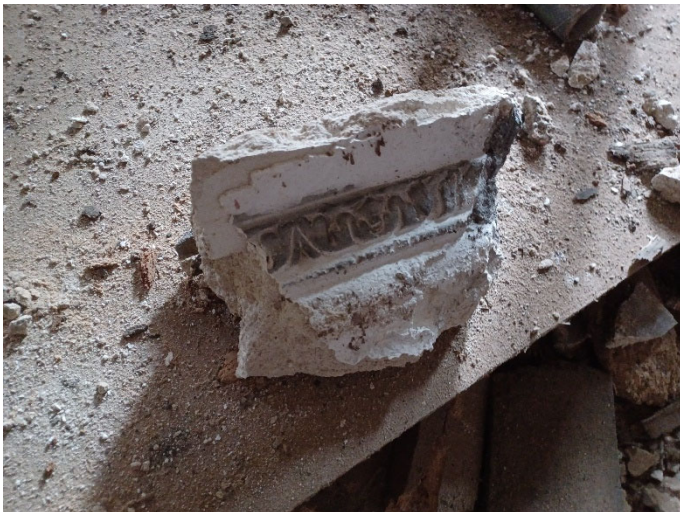
Section of cornice that has fallen away in G1

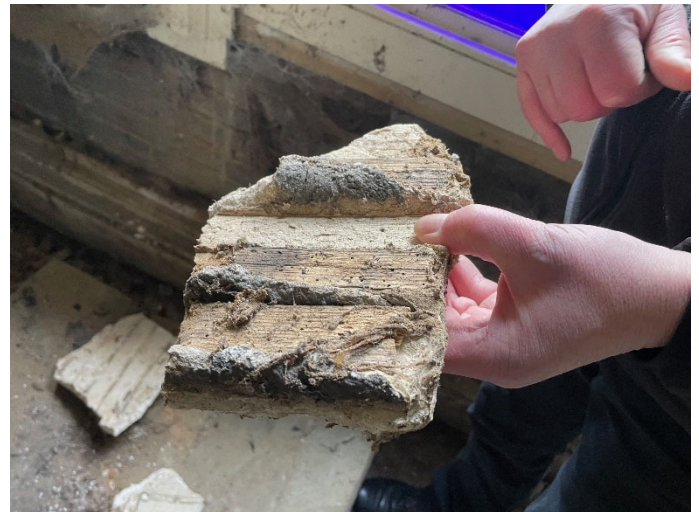
Laths still attached to a section of plaster fallen. Small insect flight holes present and the laths are brittle and friable.

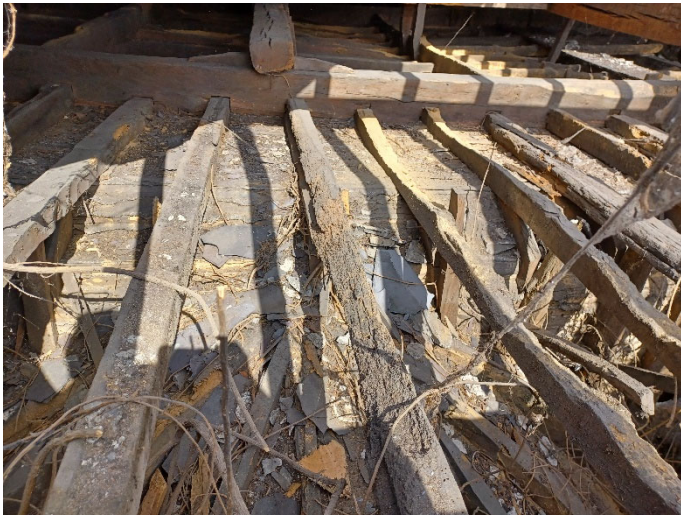
The ceiling structures comprise a series of primary beams, approx. 230 x 230mm in section, spanning between the walls and suspended from the roof trusses, with secondary joists approximately 80 x 80mm spanning the beams and receiving the lath and plaster ceilings. A series of struts and shaped joists form the apses. The secondary joists and laths show significant insect activity, with section loss and total failure evident in many areas.

Significant cross sectional loss to the ceiling joists above G1

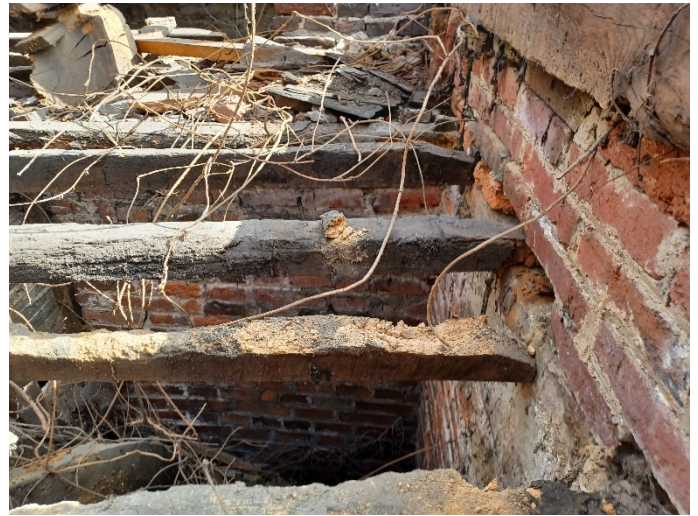
Ceiling joists have lost their connection to the wall on the south elevation in G1

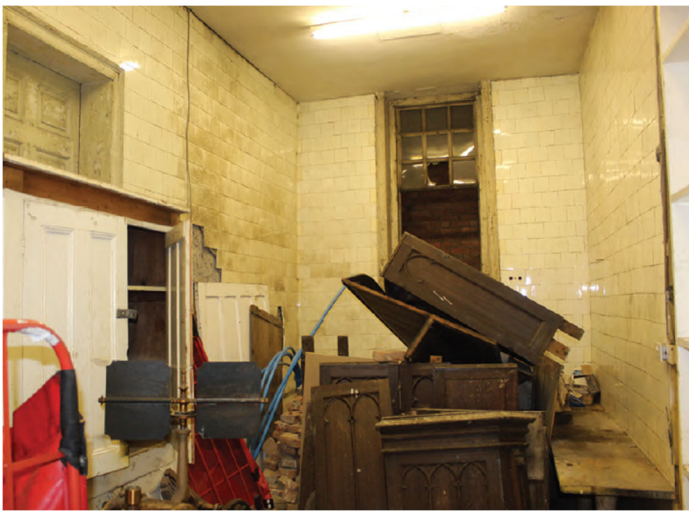
View of the west and north walls and plain ceiling in G2

There are two ceilings provided within Room G2, from within the room a plain ceiling is seen with three loft hatches spaced evenly along the centre line. This aligns with the top of the window openings and is an obvious later addition. Assessment of the ceiling structure from above confirms that the original ceiling remains at the higher level, with the more recent ceiling visible through the hatch. As with G1, the upper ceiling structure shows evidence of insect attack. The lower ceiling structure cannot be safely accessed.

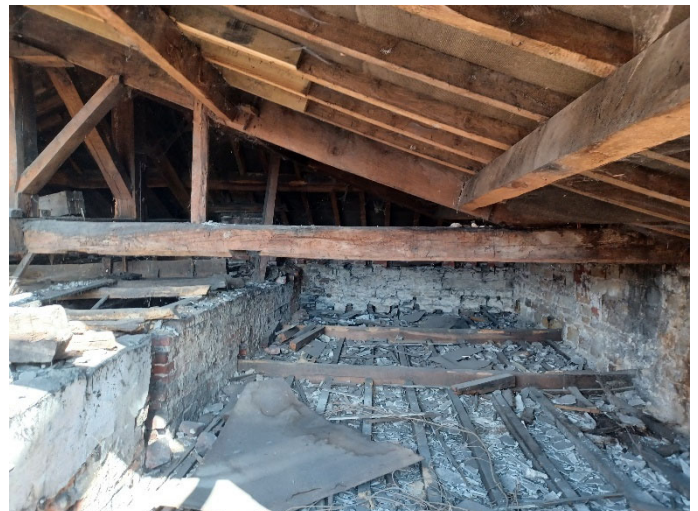
View of the ceiling structure to the upper ceiling in G2
