TREE SURVEY RISK REPORT

***The Mill Academy,
Lobwood,
Worsbrough Bridge,
Worsbrough,
Barnsley
S70 5EP***

Prepared for: *HCAT Multi-Academy Trust*

Reference: *AWA6604*

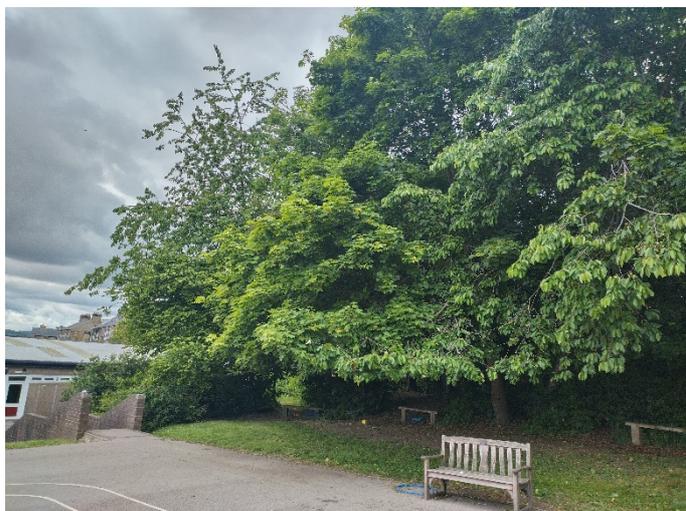
Photo 1: G5 from east.

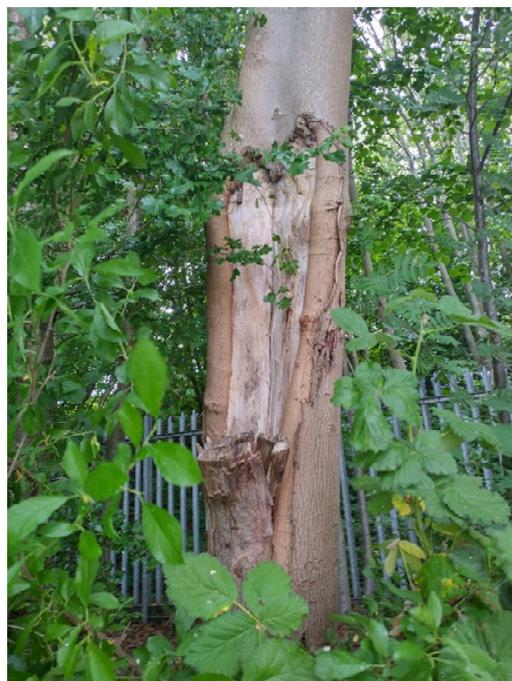
Photo 2: Maple within G5 which requires removal.

Tree ID	Tree Species		Measurements					Tree Condition			Risk Assessment	Next Survey	
	Common Name	Latin Name	Maturity	Height (m)	Number of Stems	Stem Diameter (mm) (Average)	Spread Radius (m) (Average)	Vitality	Obvious Defects	Additional Comments	Risk of Harm/ Urgency		Works
G5	Ash. Sycamore. Norway Maple. Field Maple. Cherry. Hazel. Hawthorn.	<i>Fraxinus sp.</i> <i>Acer sp.</i> <i>Prunus sp.</i> <i>Corylus sp.</i> <i>Crataegus sp.</i>	Semi-mature	15	10+	250 avg.	See plan	Fair	Tight unions. Partially included bark. Split unions. Old pruning wounds. Minor cavities. Minor decay. Bleeds	Linear tree group situated between boundary fence and playground. Shrubby Hazel and Hawthorn understorey. Most trees situated on banking. One Ash has large split union. Previous pruning and clearance works. Benches within group. Occasional minor dead stem likely due to overshadowing. One Maple overhanging the childrens playground which has a large historical wound with decay.	Lower/ Tolerable	Reduce the Maple to an eco pole.	18 months

- 3.2.1 Of the surveyed trees or tree groups, 2 were identified as requiring some level of management.
- 3.2.2 **Tree Removals:**
- 3.2.3 One Maple tree within G5 has had a removal recommendation made, yet this work is **Lower** priority and should be assessed in relation to the costs and benefits of risk control and should be reviewed as costs allow (highlighted in yellow on the attached tree plan and data schedule).
- 3.2.4 **Tree Pruning and Management:**
- 3.2.5 Tree T10 has had pruning work recommendations made, yet this work is **Lower** priority and should be assessed in relation to the costs and benefits of risk control and should be reviewed as costs allow (highlighted in yellow on the attached tree plan and data schedule).

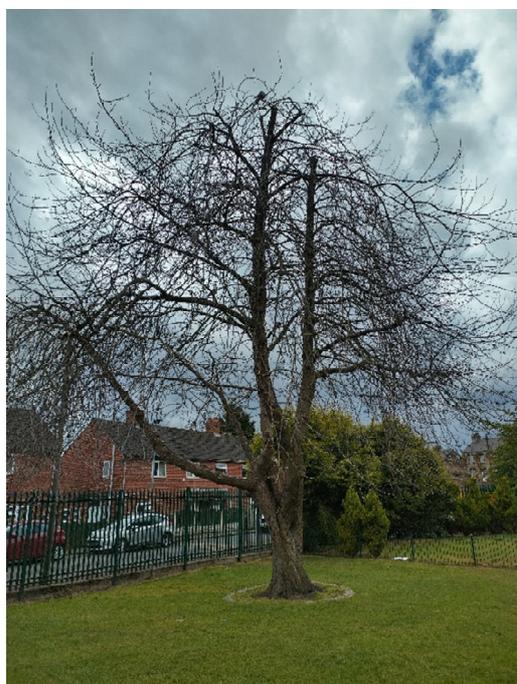
Photo 3: T10 from northeast.

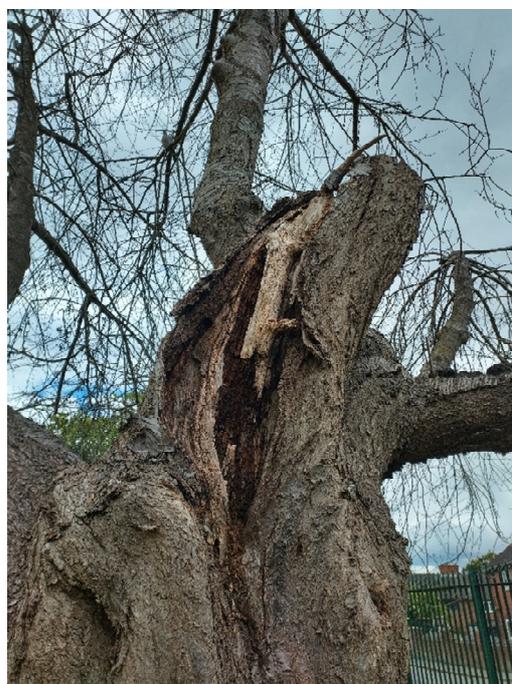
Photo 4: Cavity within crown of T10.

T10	Cherry	<i>Prunus sp.</i>	Mature	18	1	830	7	Fair	Old pruning wounds. Bark damage. Moderate decay. Bleeds. Slight lean. Tight unions. Partially included bark. Major cavity. Major decay	Significant decayed cavity at 2m to 3m to a western main stem, but stem above removed. Large pruning wound where stem removed. Telephone line through southern and south western crown. Occasional smaller snapout wounds in crown. Bleeds to stem. Adjacent telegraph pole to south east of crown. Numerous old pruning wounds to stems and lower crown from previous crown lifting works.	Lower/ Tolerable	Reduce the crown back to old pruning points.	18 months
