**Date of Survey:** 27.11.2018

39724/04/AP/JEST  
Rockingham, Hoyland  
Road Condition Survey

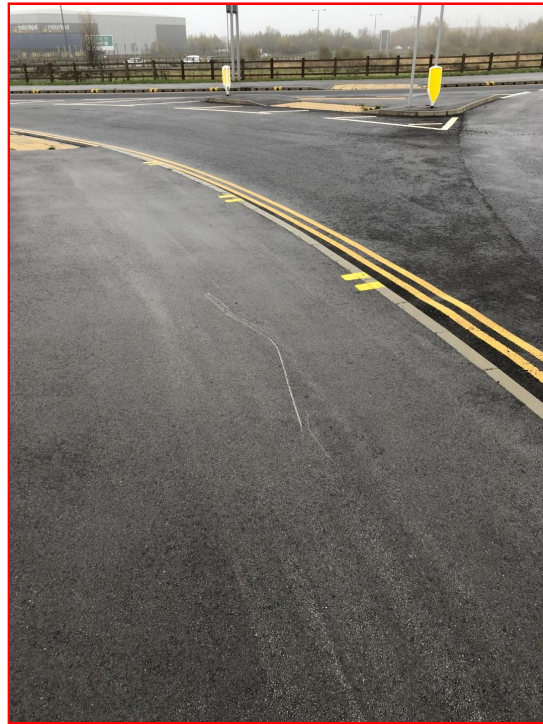
Gouge in footway tarmac.

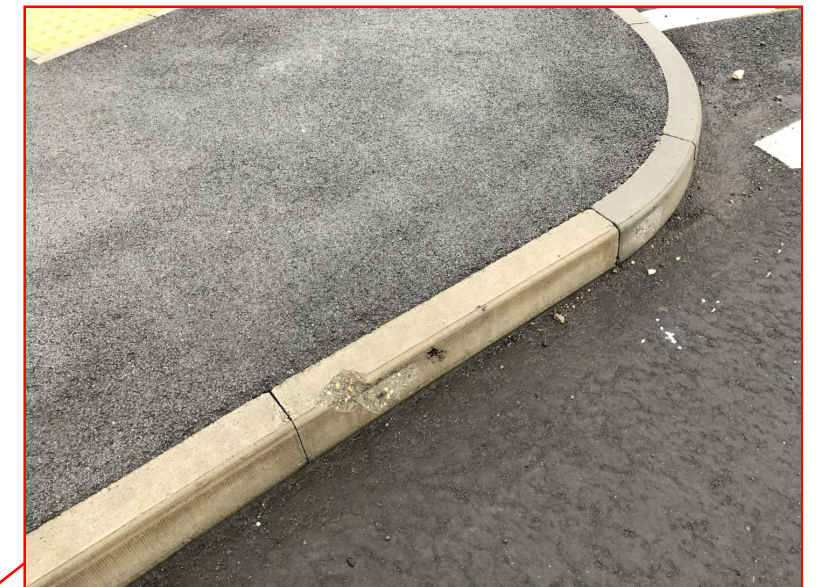
Chipped kerb on splitter island.

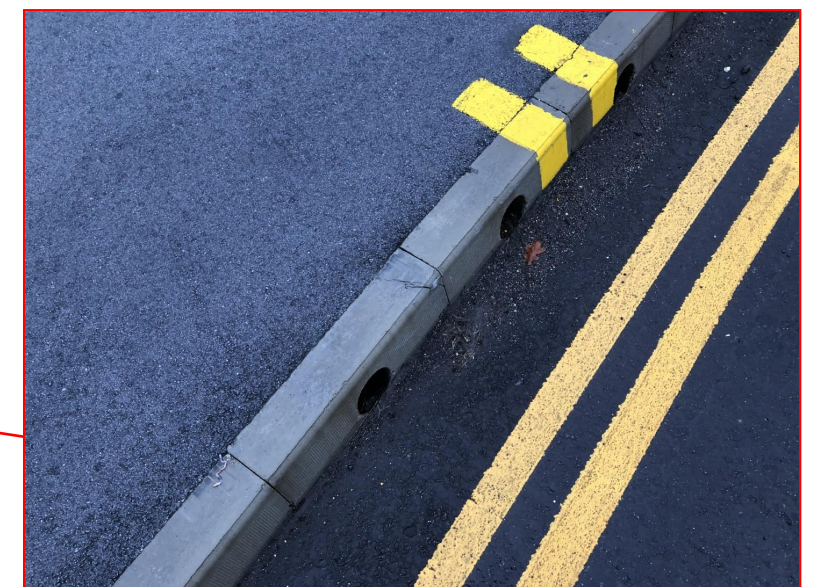
Cracked kerb on perimeter footway.

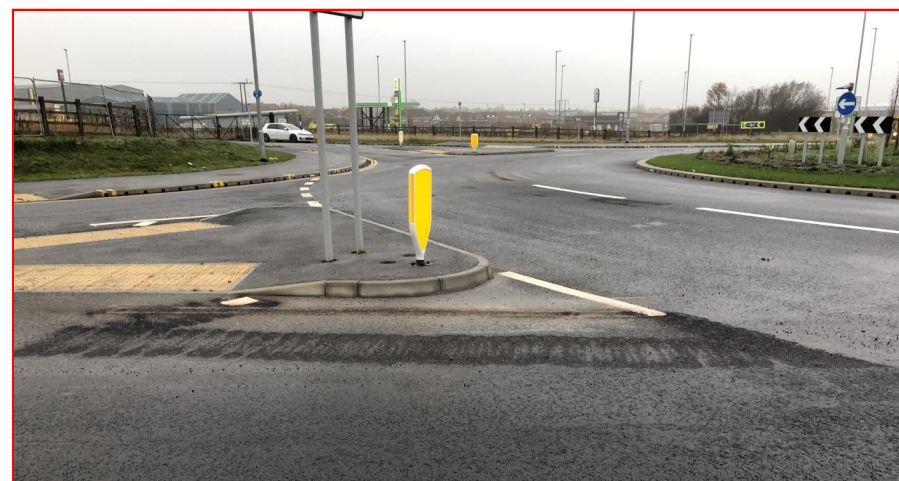
Existing road markings are in the process of being burnt off and repainted, extent of these works is unknown.
