Project Name: 10008578 - To Your Home Ltd, Manchester Road S36 9LQ
Project Date: 19/05/2021
Inspection Standard: MSCC5 Sewers & Drainage GB (SRM5 Scoring)

CCTV Survey Report

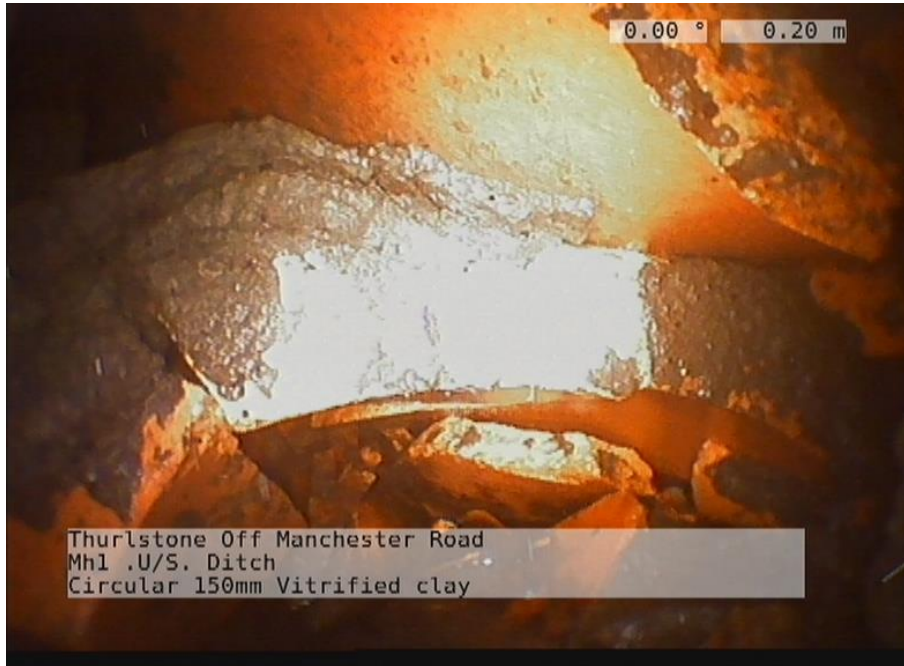
Section	PLR	Grade	Description
3	DitchX	5	Collapsed drain or sewer
5	Mh4X	4	Hole in drain or sewer at joint at 12 o'clock

Mh1-UDitch-1-8473.jpg, 00:00:15, 0.20 m
Collapsed drain or sewer

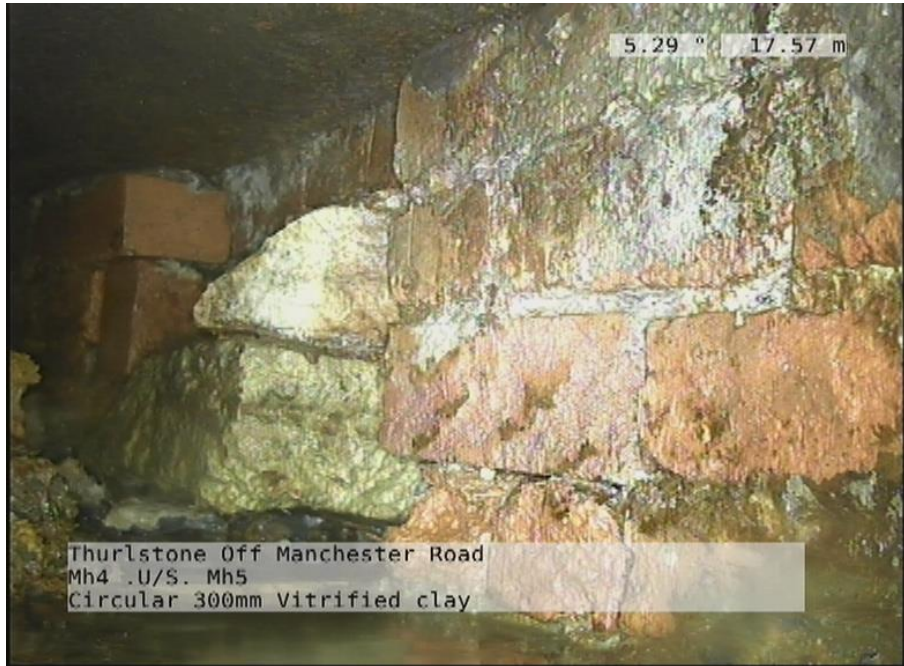
Mh4-UMh5-2-698.jpg, 00:04:01, 17.57 m
Pipe material changes to brick at this point

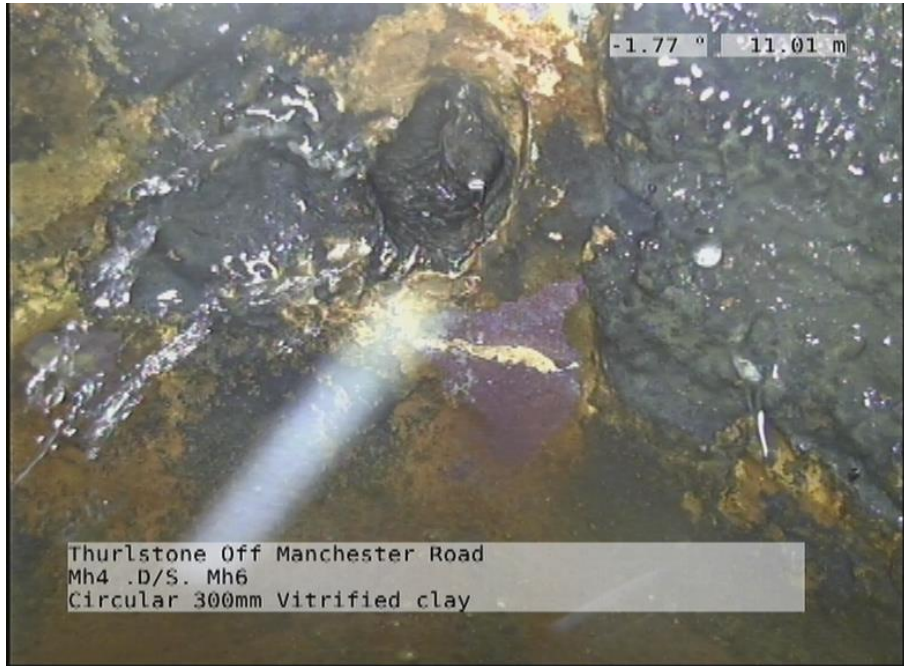
Mh4-DMh6-3-52642.jpg, 00:00:59, 11.01 m
Hole in drain or sewer at joint at 12 o'clock

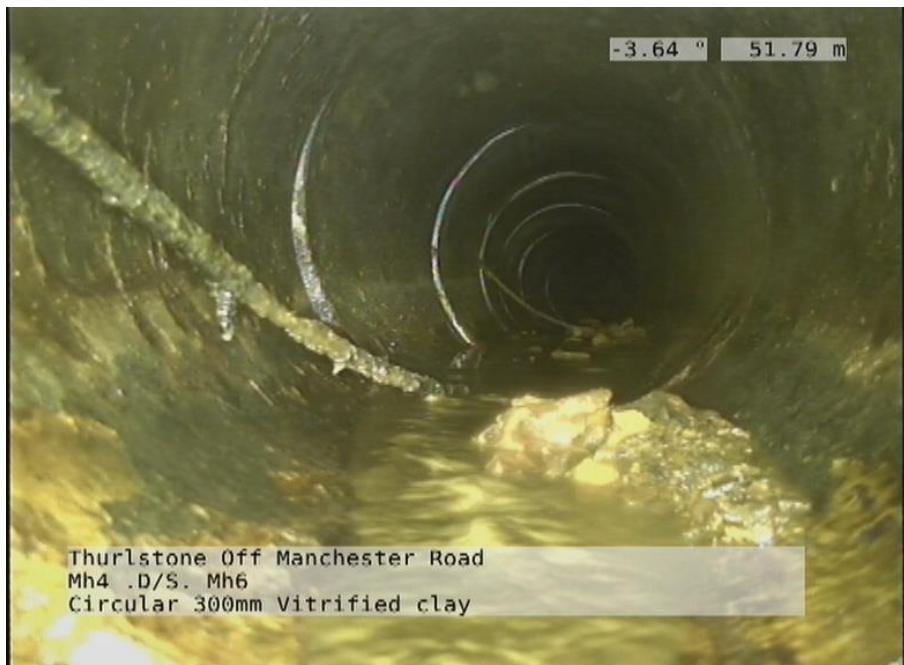
Mh4-DMh6-4-19649.jpg, 00:03:19, 51.79 m
Roots, tap at joint

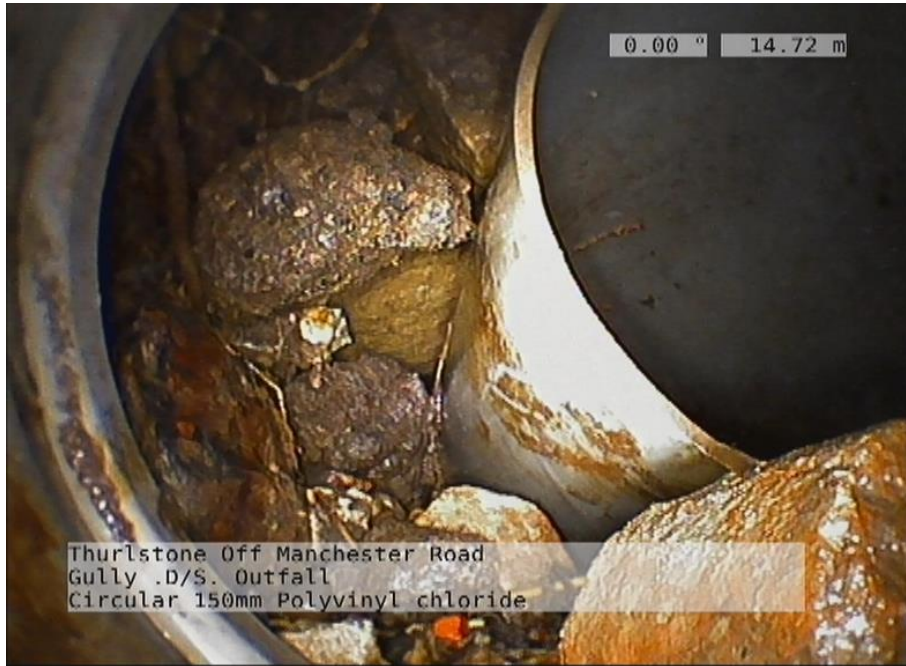
Gully-DOutfall-5-29960.jpg, 00:01:10, 14.72 m
Joint displaced, large
