**Repair of Long Gallery Ceiling
The Northern College, Wentworth Castle, Stainborough****Options appraisal and Method Statement****1.0 Introduction**

Method Statement: Urgent Ceiling Repairs, The Northern College, Wentworth Castle

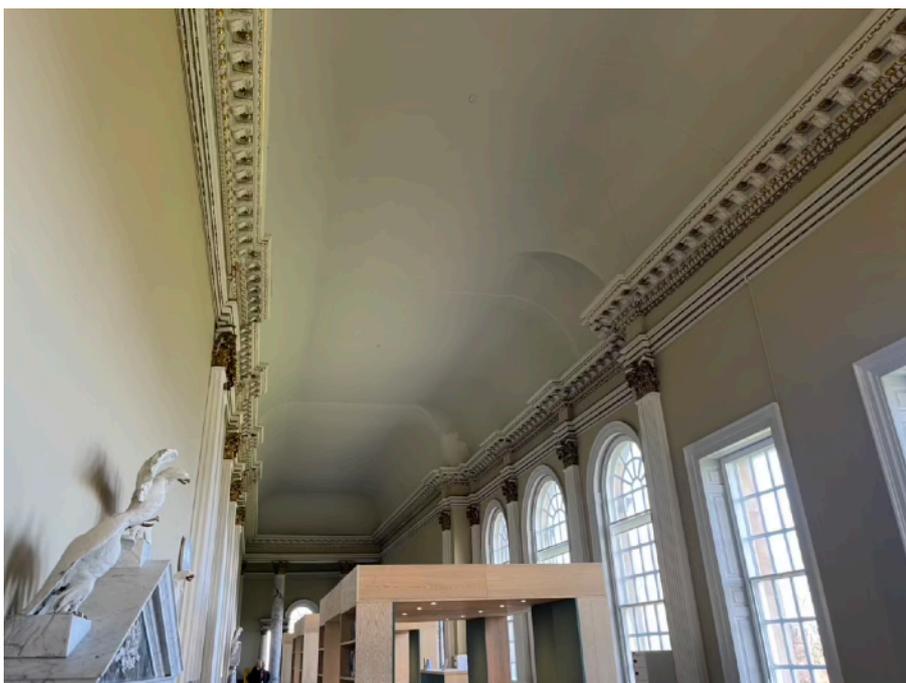
2. Plywood panelling - this solution has been applied as an emergency repair previously. It is considered unsightly and detrimental to the appearance and significance of the space.

Interior looking north, showing previous plywood repair.

Option 3, underdrawing with a matching fibrous plaster 'shell' is preferred, as this retains both the existing historic fabric and the appearance of the building. Although the option presents a finished appearance, the existing ceiling will be restrained and protected allowing the restraint and repair or full restoration of the existing ceiling at a later date.

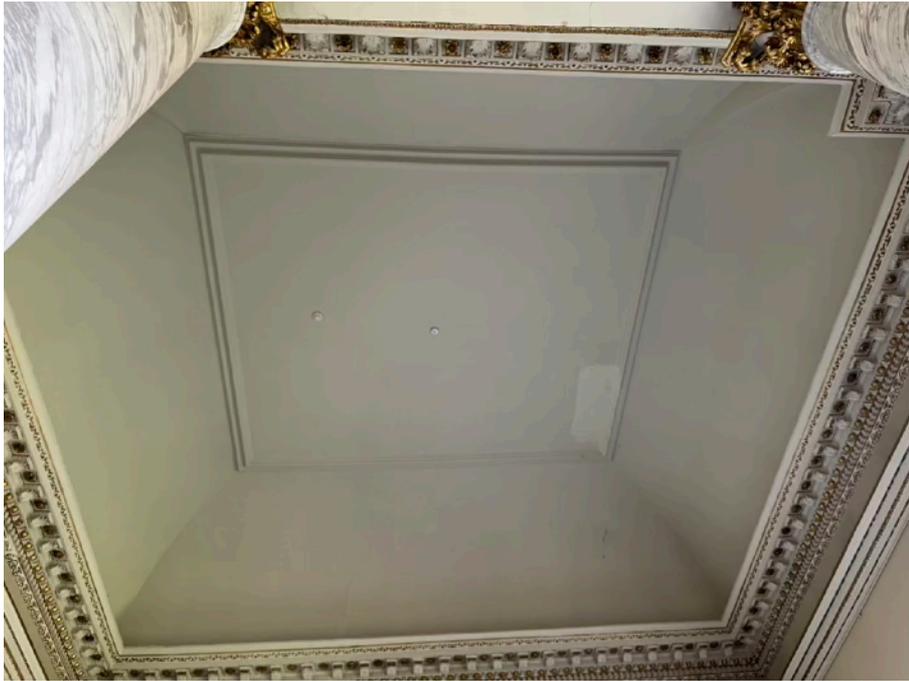
Interior of northern ante-space showing run moulded plaster detail at head of coffered ceiling section.

9. Services including fire and smoke detectors are to be extended to the new ceiling surface below their existing positions.
10. To the north and south bays, the shell is to be finished each side of the existing mouldings with a shadow gap to the run plaster mouldings. There's will remain visible, bur recessed. The mouldings are to be checked with additional fixings provided if required.

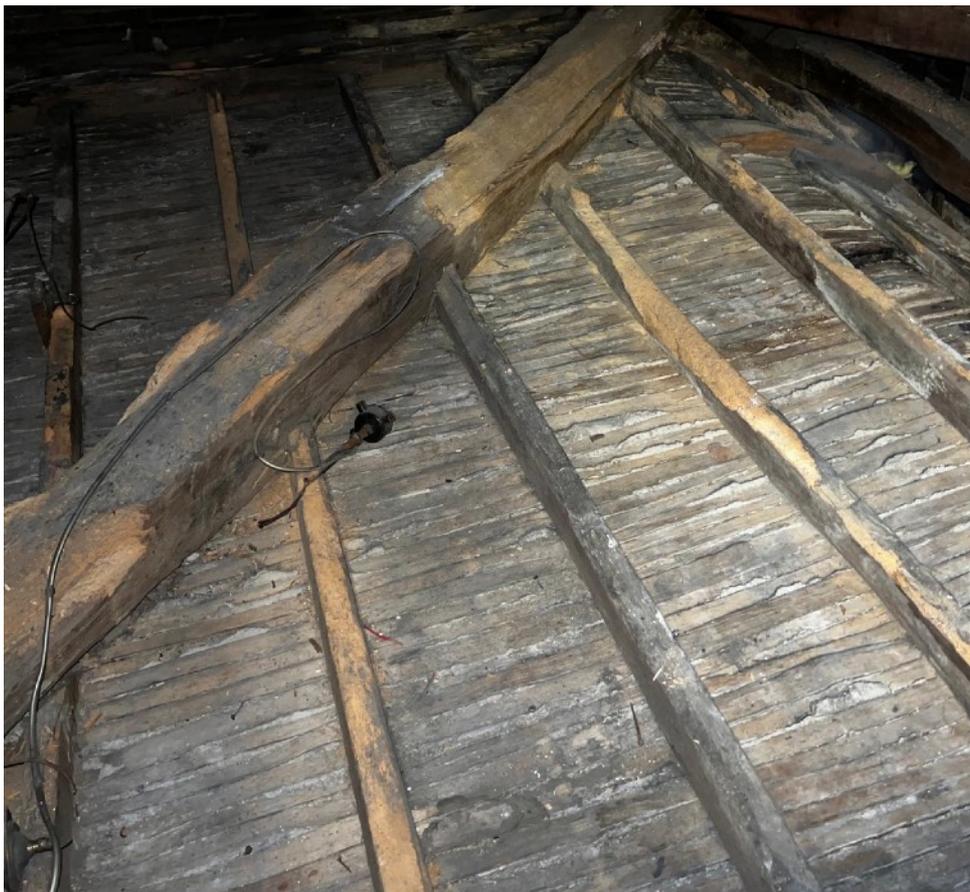
Area 1 showing lack of key and beetle damage

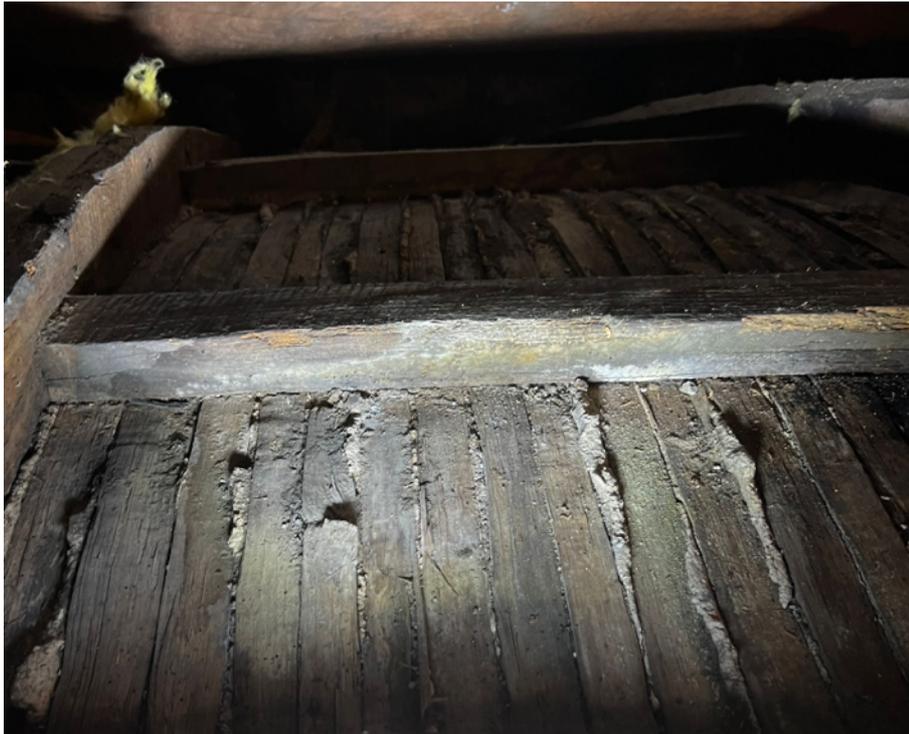
Area 1 showing lack of key and roll of coffered section.

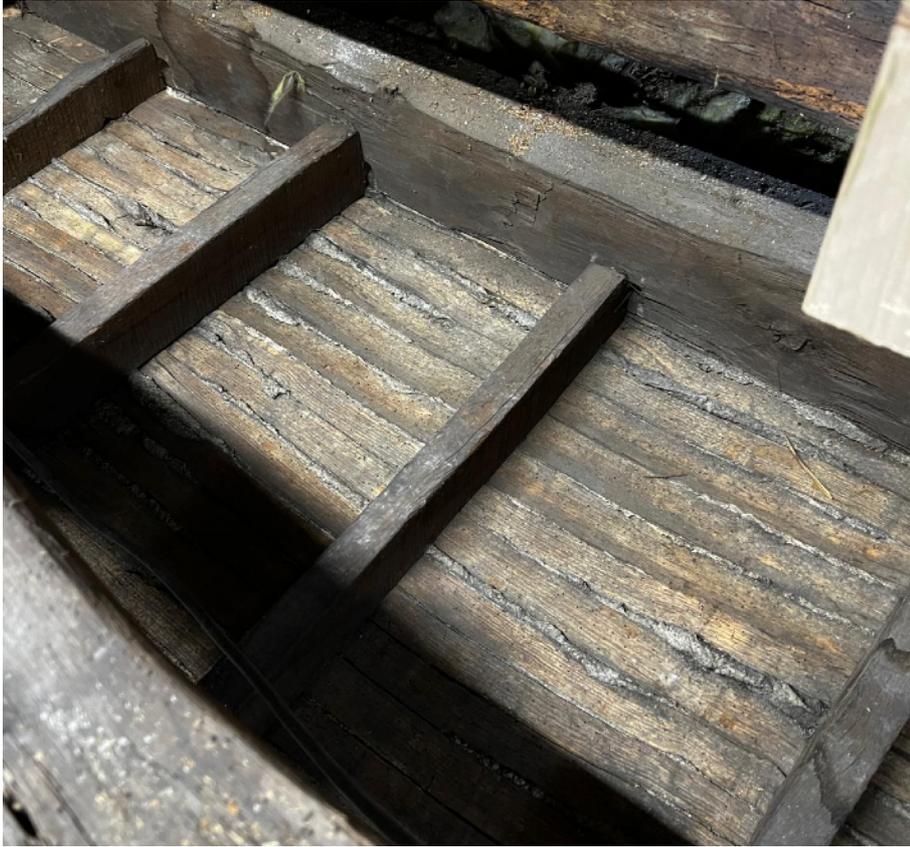
Area 2: Laths are close fixed with little key to the plaster.

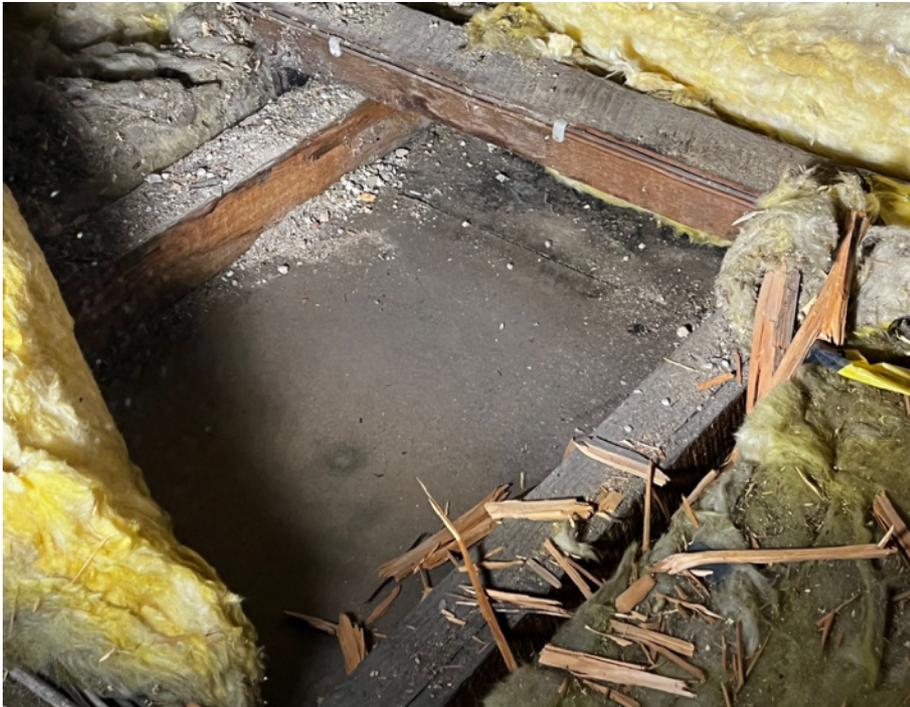
Area 3: This section has been renewed in plasterboard previously.

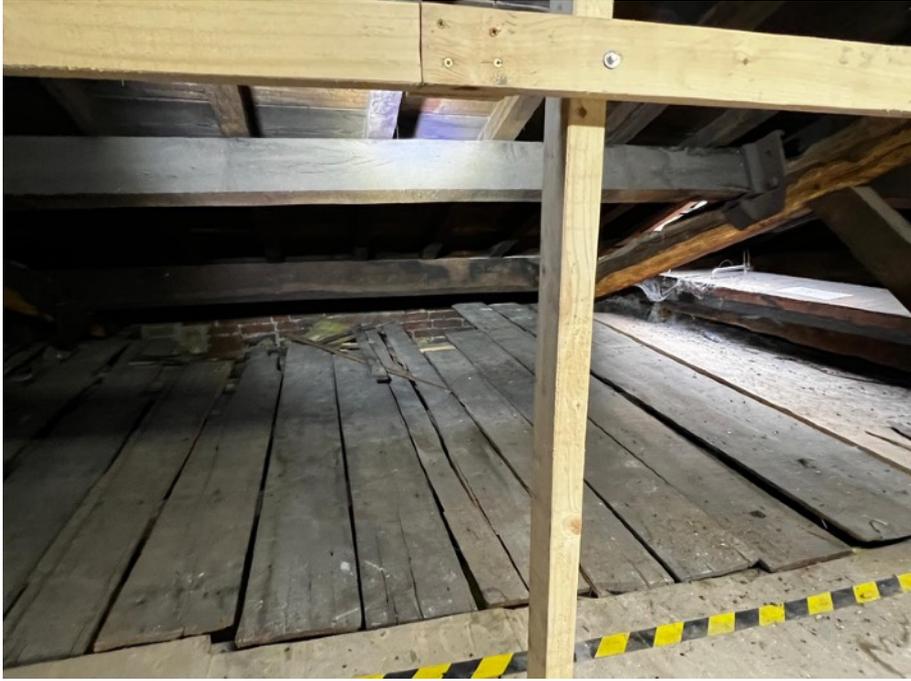
Area 4 Showing a typical section of floor boards.

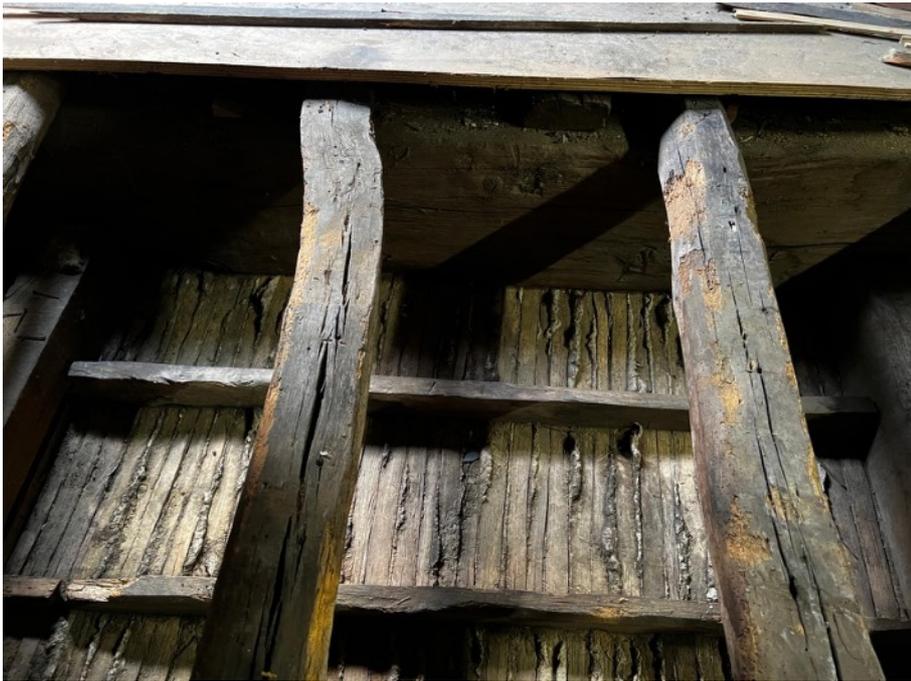
Area 4 Laths are close jointed with little plaster key.

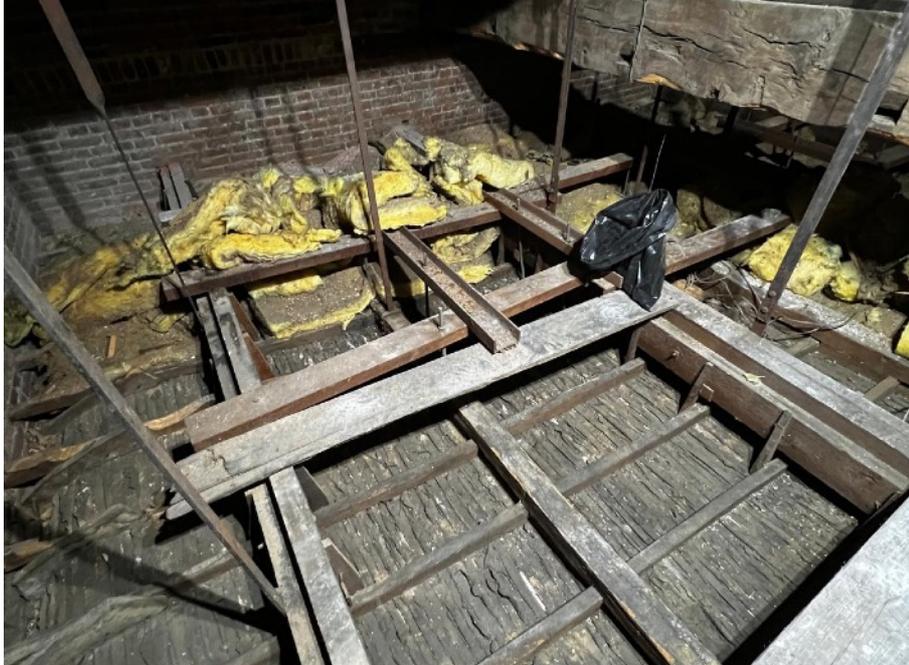
The structure above the ceiling has been reinforced in the past.

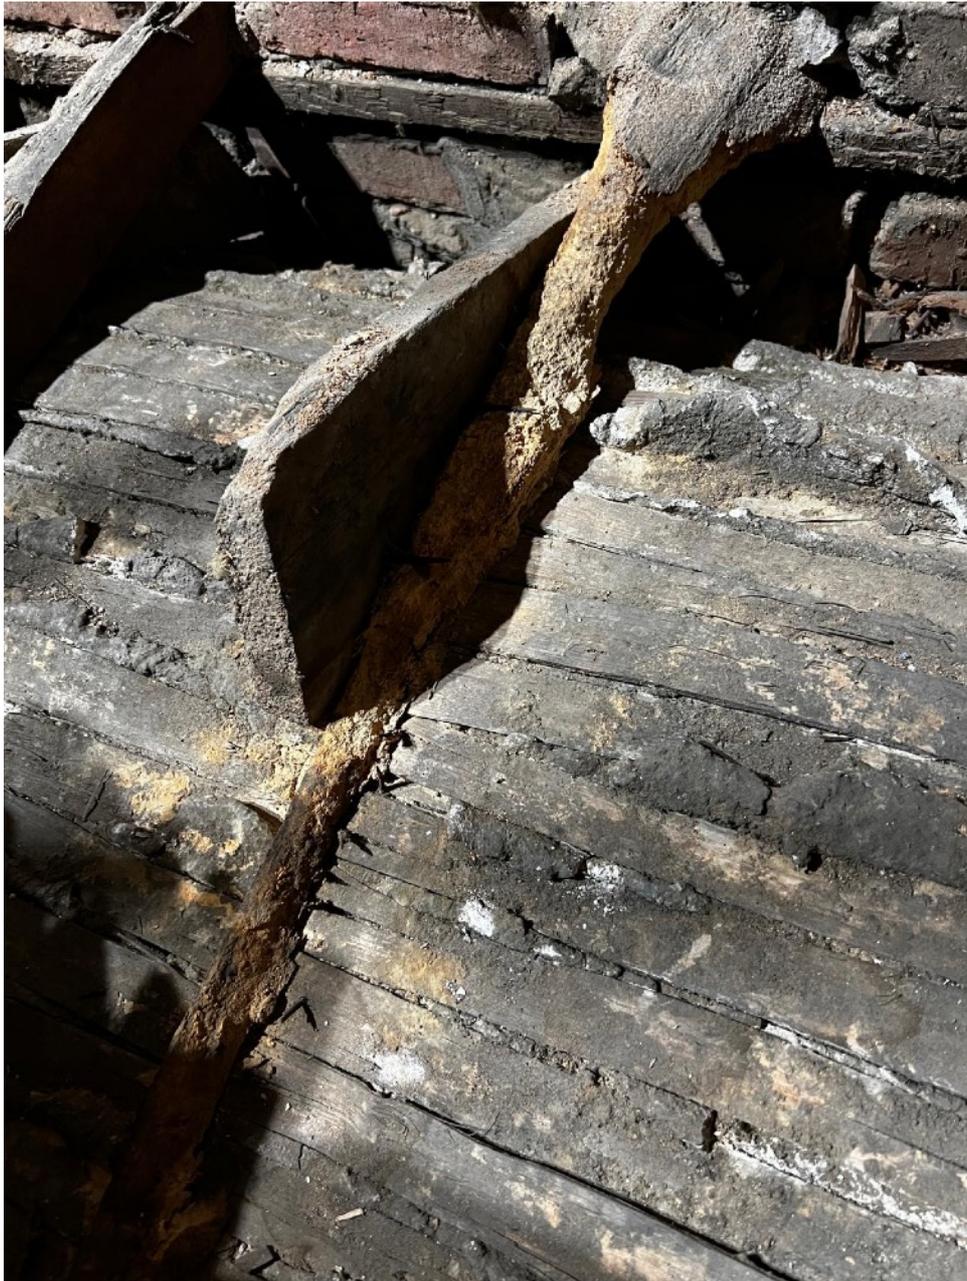
Area 5, there is extensive beetle damage to localised timbers.

Option 4, to net tight below the ceiling is preferred, as this retains both the existing historic fabric and the appearance of the building. The existing ceiling will be restrained and protected allowing the restraint and repair or full restoration of the existing ceiling at a later date.

1. The floor and staircase are to be checked to ensure adequacy to support the required scaffold.
2. Statuary will be protected.
3. A fine gauge net will be fitted tight to the underside of the ceiling anchored to walls and the central ceiling boss.

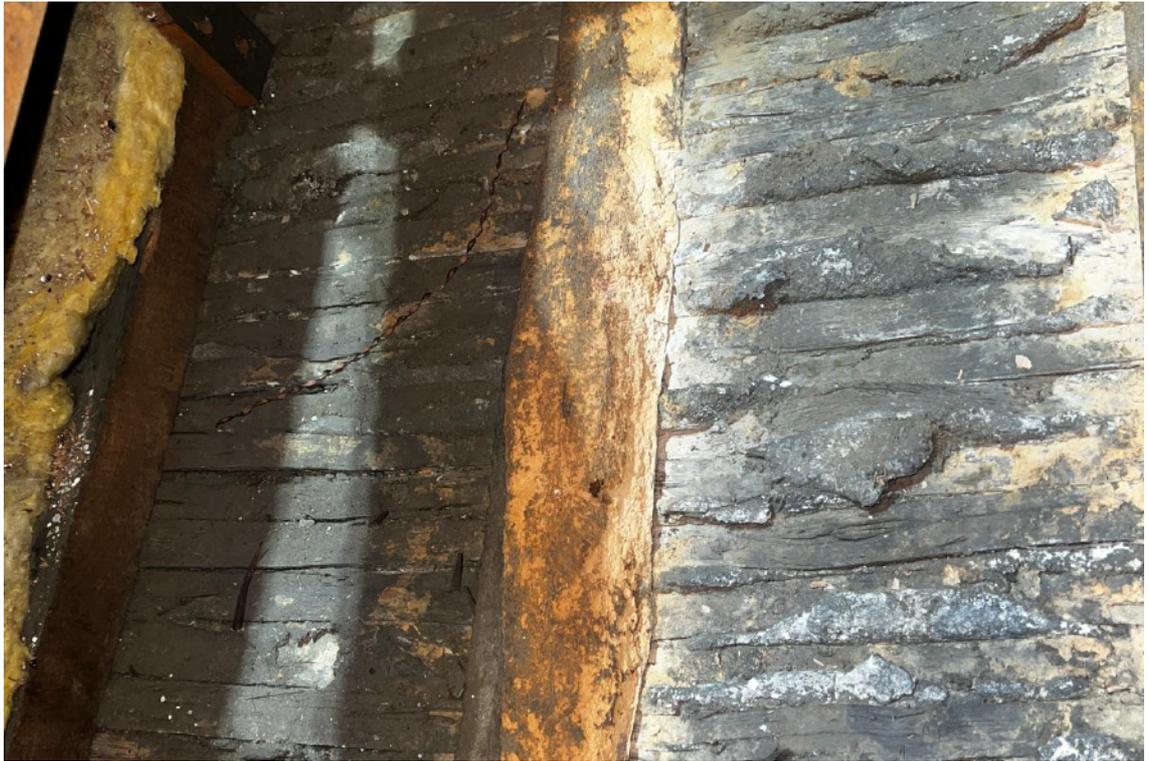
Area 5 the extent of the plaster keys is varied. There are areas of cracking.

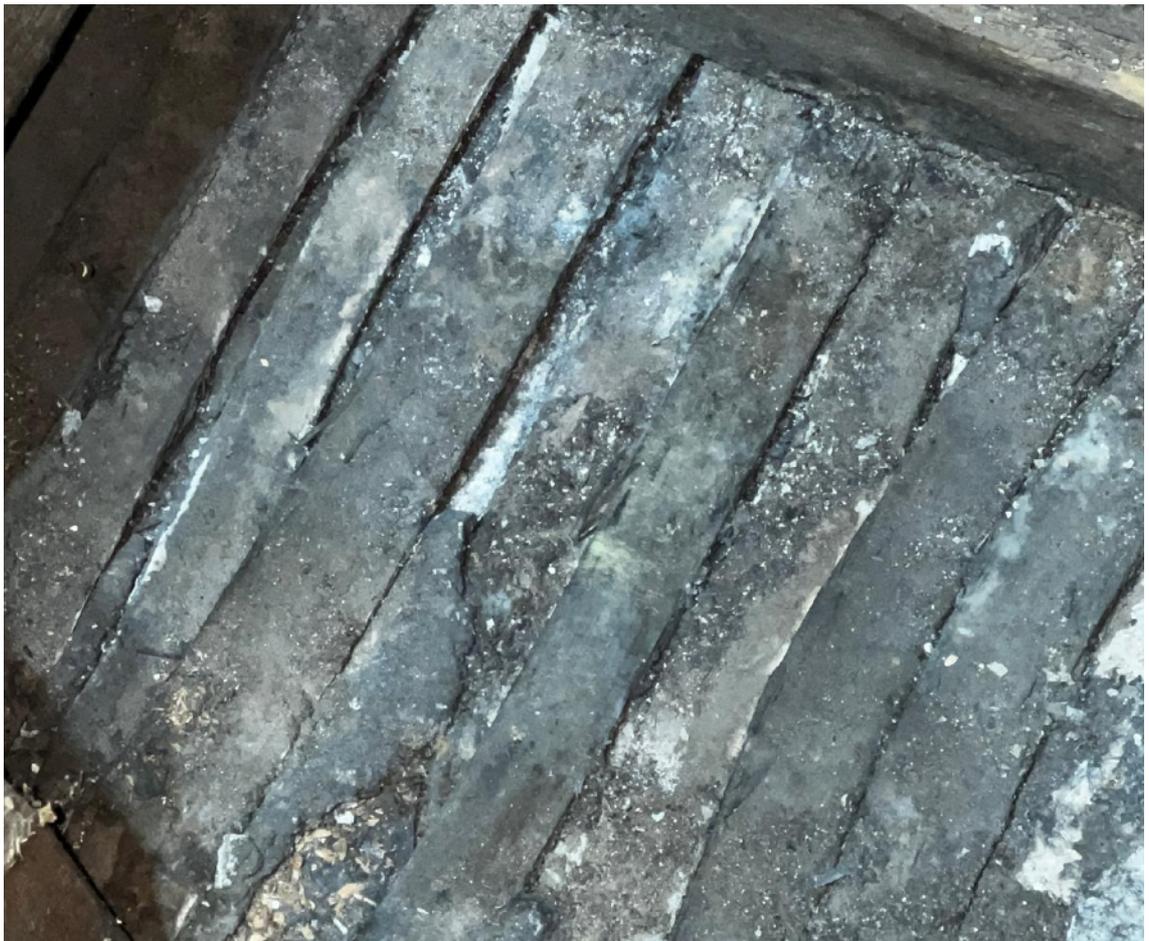
Area 5, some areas are debonded.
