Tree Survey; **Holiday Inn, Dodworth, Barnsley.  
(former Brooklands)**

Client; **Francis Hindle Esq. General Manager.**

Date of Survey; **January 19<sup>th</sup> 20<sup>th</sup>, 2010.**

File reference **new garden area 01**

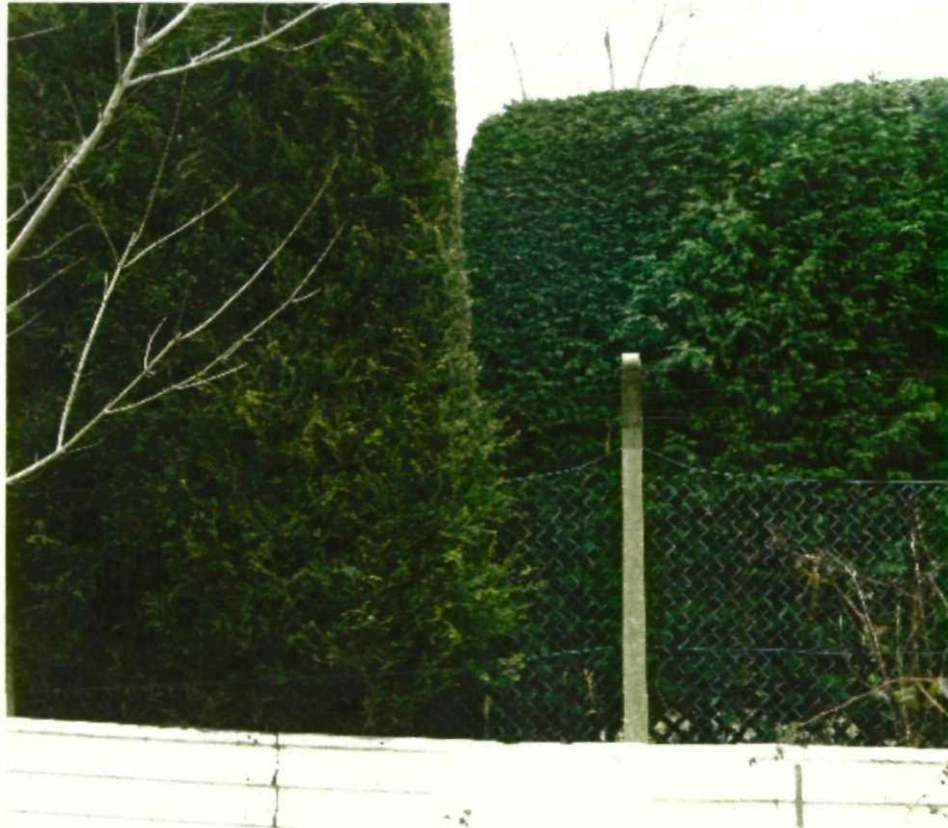
Figure 1.

I understand the former owner of the site to have been something of a gardening enthusiast and note that while the site is becoming overgrown, these hedges appear to have been regularly clipped. It is not uncommon in situations such as this, to see hedges only clipped at one side and becoming unkempt where they adjoin vacant lots.

The concrete posts, chain link fencing and sheet metal obviously needs screening or removing; it's not a particularly tasteful backdrop for a wedding photograph. We need to ensure that the person charged with clipping the hedge can properly position his equipment.

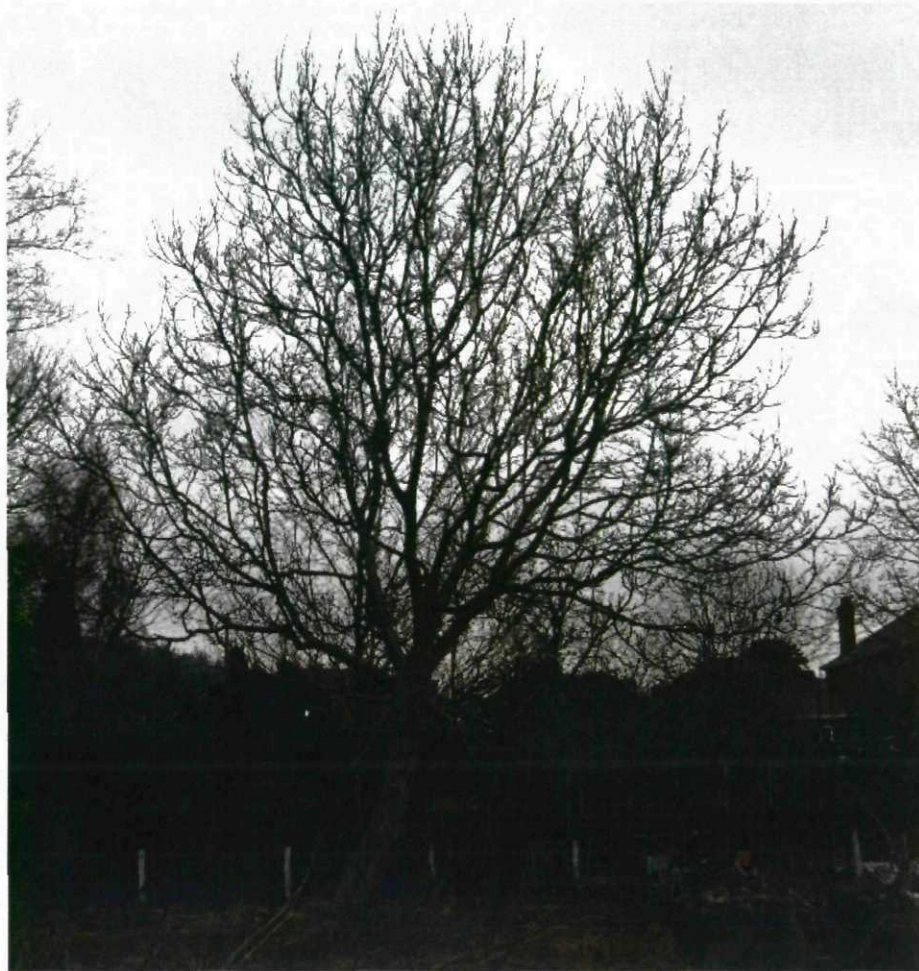
Figure 2 to the left shows tree 1, the Walnut. This is one of 3 Walnuts within the neighbouring garden but the only one in close proximity to the plot. I measured the tree's trunk diameter in August 2006 as 300mm suggesting it has only increased by 20mm after 3 growing seasons. I would expect a young Walnut tree to have grown considerably more than this over such a period. I accept that the measurements are not particularly scientific but if we look at the tree's form it is clear that it is not growing vigorously. The height suggests it is a young tree but its overall habit suggests it is well into maturity. It is no longer showing any signs of youthful vigour, it is no longer growing upwards or showing 'apical dominance.'

Dr Pierre Raimbault of the French National Horticultural Institute calls this subject "morpho-physiological tree assessment." He relates how a tree grows to its age. It is outside the scope of this report to go into the subject in detail but is reasonable to note that the life span of trees is not pre-ordained, but related to numerous factors such as breeding and surroundings. This tree is (apparently) prematurely aged and does not appear to be a specimen that is likely to achieve any great size or age. Also it is hard to imagine any realistic treatment that might rejuvenate the tree. Note in figure 2 the derelict outbuilding close to the tree; hardly a situation conducive to growing good specimens.

The boundary of the site is within the branch spread of this tree and some lower branches will require removal to permit the erection of a fence or whatever boundary treatment is decided upon.

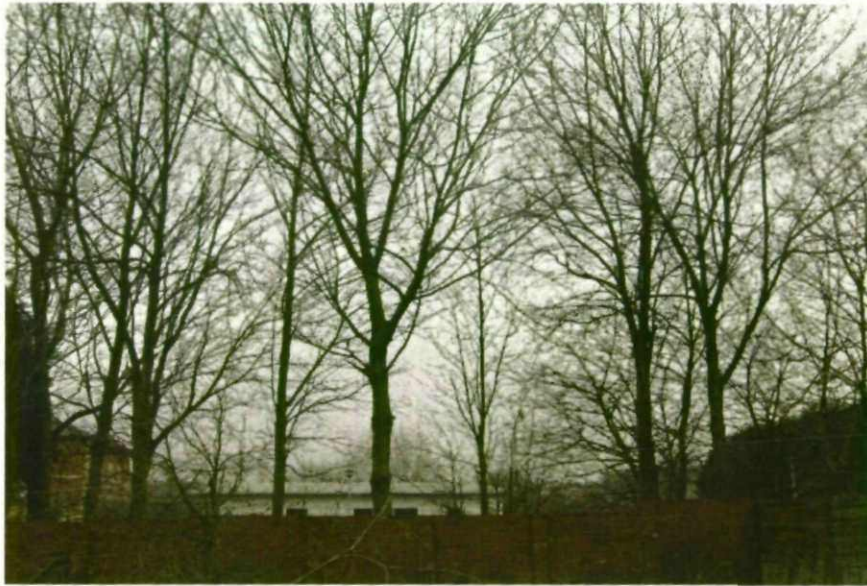
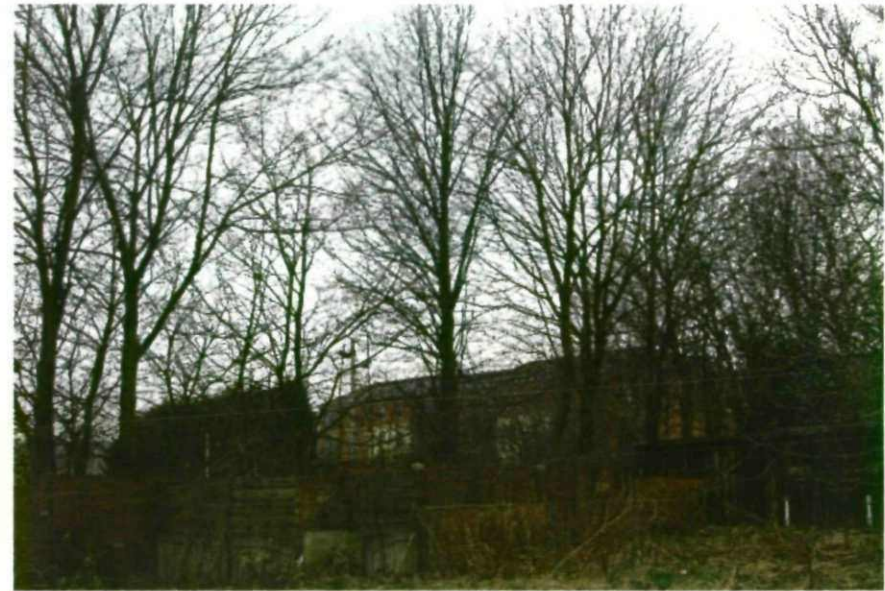
Figures 3 and 4 are views of the trees in group 2 as viewed from within the plot. Note the decrepit structures against the brick wall; I'm not sure of their purpose but I note that they probably support the wall a little. They will need to be removed carefully. Note that the trees are all somewhat slender for their height. This is because they have grown in close proximity to one another. Had the group been thinned out sometime in the past the individual specimens would probably have grown with better form.

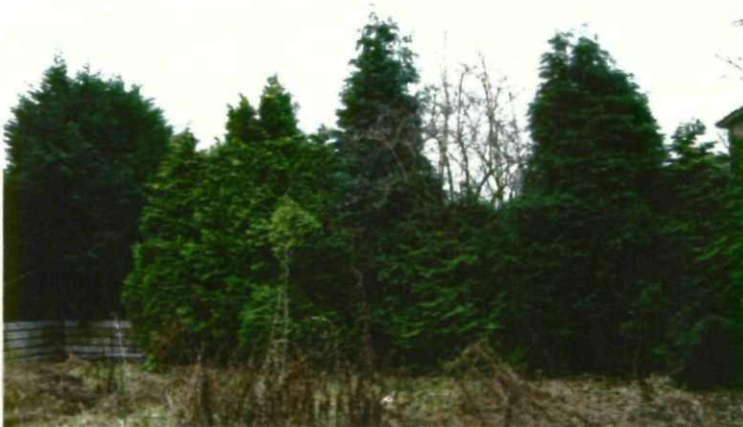
Figure 5.

Figure 5 is a view of the trees in group 5, taken from within the plot.

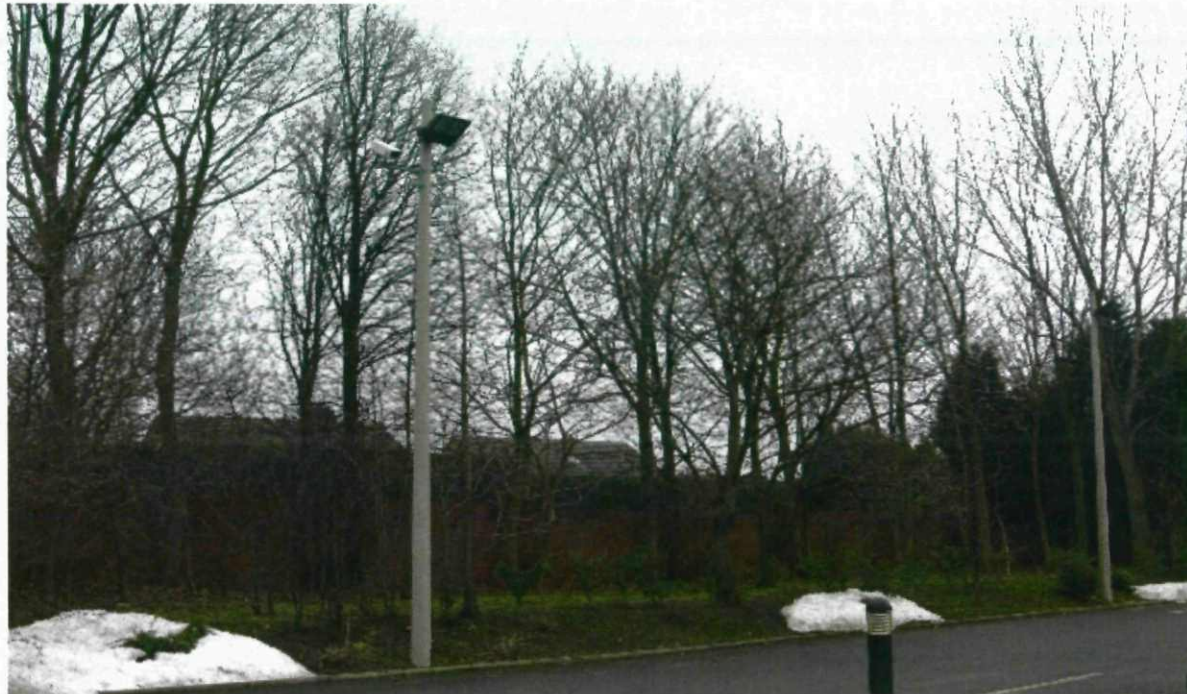
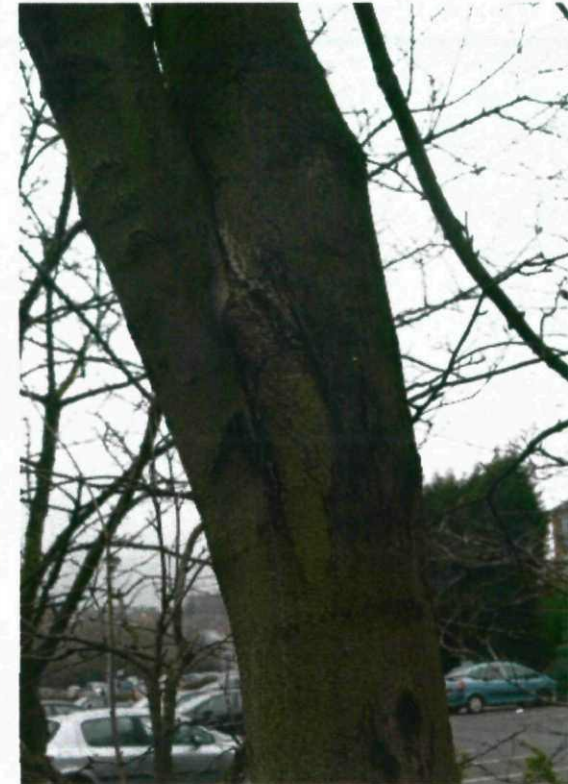
Figure 6 shows group 2 as viewed from the hotel car park. It is clear that the soil level adjacent to the trees has been altered, presumably without any great consideration for the roots of the trees, which must have been present when the excavations took place. Figure 7 shows one of the Maples within the group. Note the tree forks in 2 and the union 'includes' bark, this is a widely recognised structural fault on trees. It is possibly attributable to poor plant selection but also due to trees growing in close proximity. Careful husbandry would have removed either the whole tree or the offending branch. Note also the dark stains on the trunk of the tree in figure 7. These are a symptom of "Bleeding Canker" (*Phytophthora*). Currently this disease is seen as a great threat to the Country's Horse Chestnut population although it is known to affect other species. In my experience it infects trees that are stressed, perhaps by root damage or other abiotic factors. (Figure 10 is a better picture of this symptom)

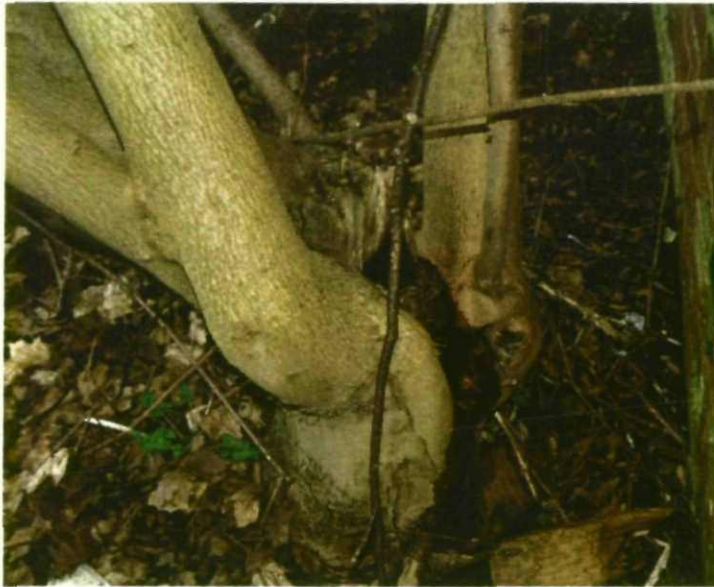
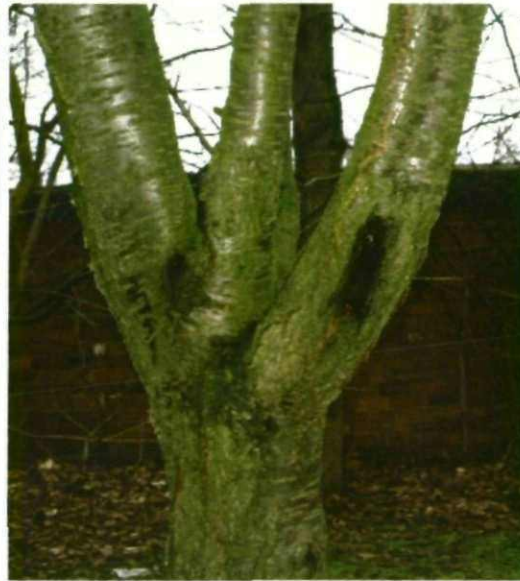
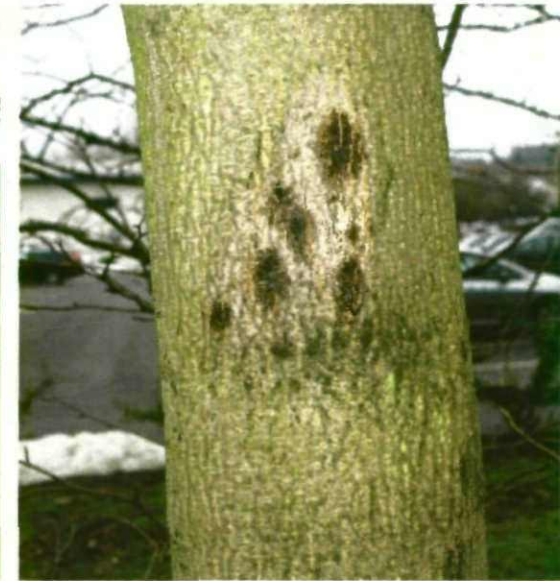
Figures 8, 9, & 10 show various tree problems in group 2. Figure 8 is the coppice growth from a Maple stump that was cut down, presumably because it was too close to the wall. Currently the re-growth is protected by the Tree Preservation Order. I don't suppose the Council would pursue a prosecution if it were to be removed (to stop it disturbing the wall) but technically this mundane task would require a written application including technical advice. Figure 9 is a Cherry showing weak branch unions as well as bacterial canker, and figure 10 more clearly shows the aforementioned Maple's *Phytophthora* infection.

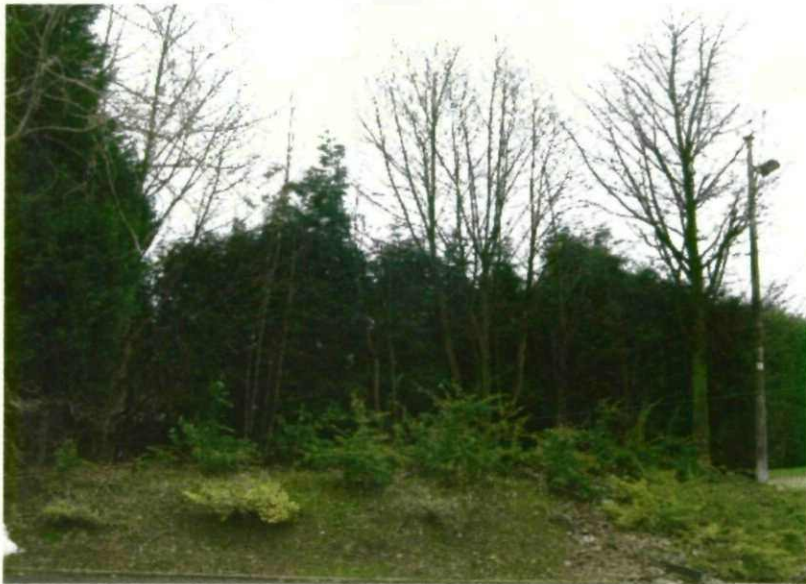
Figure 11.

Figure 11 to the left shows group 3 and tree 4 adjacent to the utility pole. The new planting of shrubs is into soil that appears to have been remodelled, presumably when the car park was installed. A geo-textile membrane can be seen through the topsoil. This was presumably installed in order to prevent weed germination. While it's been reasonably successful the ground between the shrubs looks rather sterile.

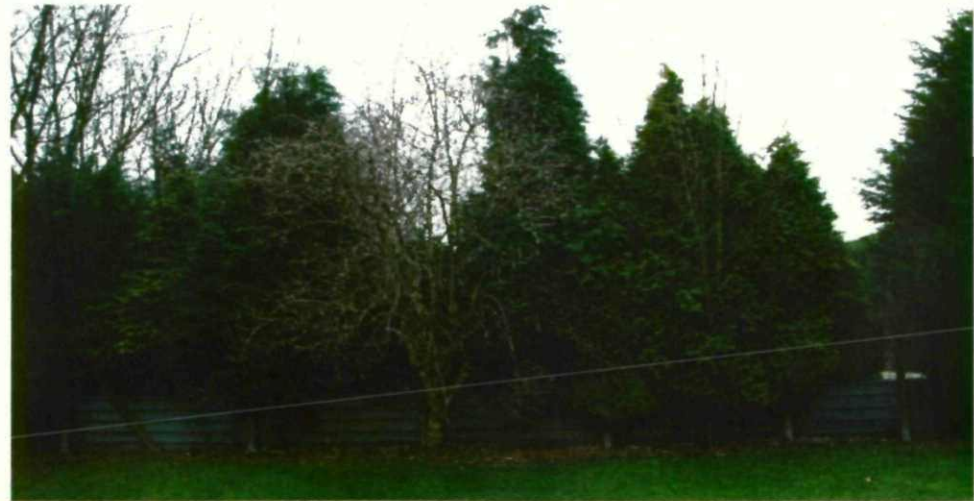
Figure 12.

Figure 12 to the right shows the opposite side of group 5 to the view in figure 5. It is intended to access the new plot through this group and I presume they will all be removed. It is no great loss.
